#### Airworthiness Directives; Textron Aviation Inc. Airplanes

**SUMMARY:** We propose to adopt a new airworthiness directive (AD) for all Textron Aviation Inc. Models A36TC and B36TC airplanes. This proposed AD was prompted by a fatal accident where the exhaust tailpipe fell off during takeoff. This proposed AD would add a life limit to the exhaust tailpipe v-band coupling (clamp) that attaches the

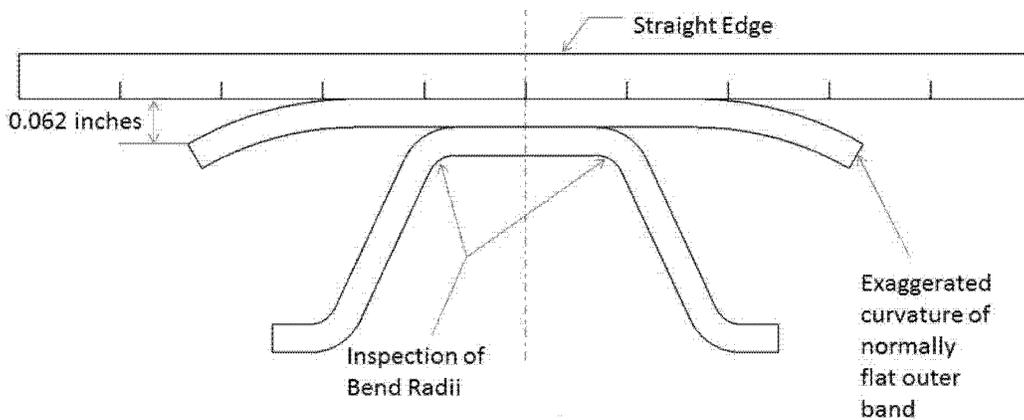
Figure 1 to paragraphs (h)(1)(iii) and (v) of this AD: Cross section of v-band coupling

(iii) Visually inspect the flatness of the outer band using a straight edge. Lay the straight edge across the width of the outer band. The gap must be less than 0.062 inches. See figure 1 to paragraphs (h)(1)(iii) and (v) of this AD. If the gap exceeds 0.062 inches between the outer band and the straight edge, do not re-install the v-band coupling. Before further flight, you must install a new v-band coupling and restart the hours TIS for the repetitive replacement of the v-band coupling.

(v) Visually inspect the bend radii of the coupling v-retainer coupling segments for cracks. Inspect the radii throughout the length of the segment. See figure 1 to paragraphs (h)(1)(iii) and (v) of this AD. If any cracks are found, do not re-install the v-band coupling. Before further flight, you must install a new v-band coupling and restart the hours TIS for the repetitive replacement of the v-band coupling.
