[Docket No. FAA-2016-9418; Directorate Identifier 2016-NE-23-AD]

#### Airworthiness Directives; Honeywell International Inc. Turboprop and Turboshaft Engines

**ACTION:** Notice of proposed rulemaking (NPRM).

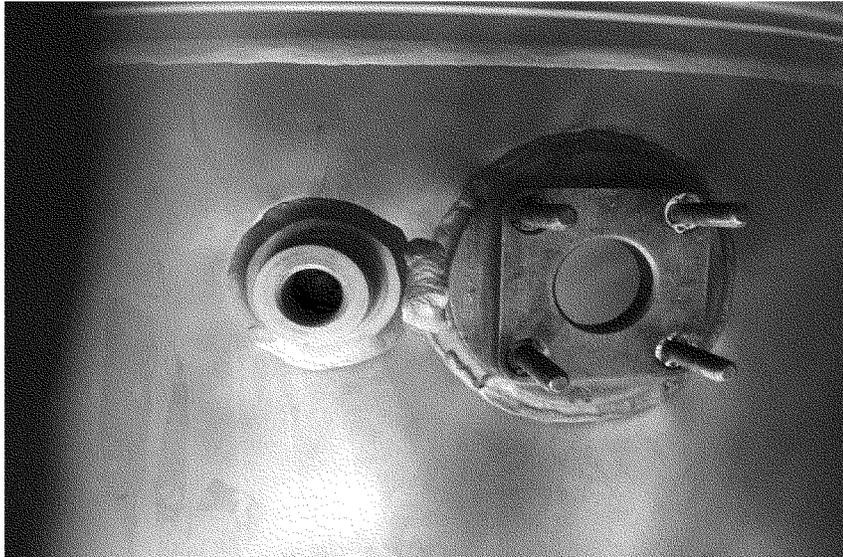
**Figure 1 to Paragraph (g) of this AD. Combustion Chamber Case Assembly  
Without the One-Piece Bleed Pad with P3 Boss**

(2) Figures 1 and 2 to paragraph (g) of this AD illustrate the appearance of combustion chamber case assembly, P/N 893973-5, without and with, respectively, the one-piece bleed pad with the P3 boss.

After the effective date of this AD, do not install a combustion chamber case assembly, P/N 869728-1, 869728-3, or 893973-5, in an engine, unless the combustion chamber case assembly has a one-piece bleed pad with P3 boss.
