[Docket No. FAA-2016-6651; Directorate Identifier 2016-SW-015-AD; Amendment 39-18867; AD 2017-09-05]

Airworthiness Directives; Airbus Helicopters

SUMMARY: We are adopting a new airworthiness directive (AD) for Airbus Helicopters Model AS332C, AS332C1, AS332L, AS332L1, AS332L2, and EC225LP helicopters. This AD requires repetitively checking screws in the emergency flotation gear. This AD is prompted by a report that a screw ruptured on a Model AS332 helicopter's emergency flotation gear. These actions are intended to correct an unsafe condition on these products.

2017-09-05 Airbus Helicopters:

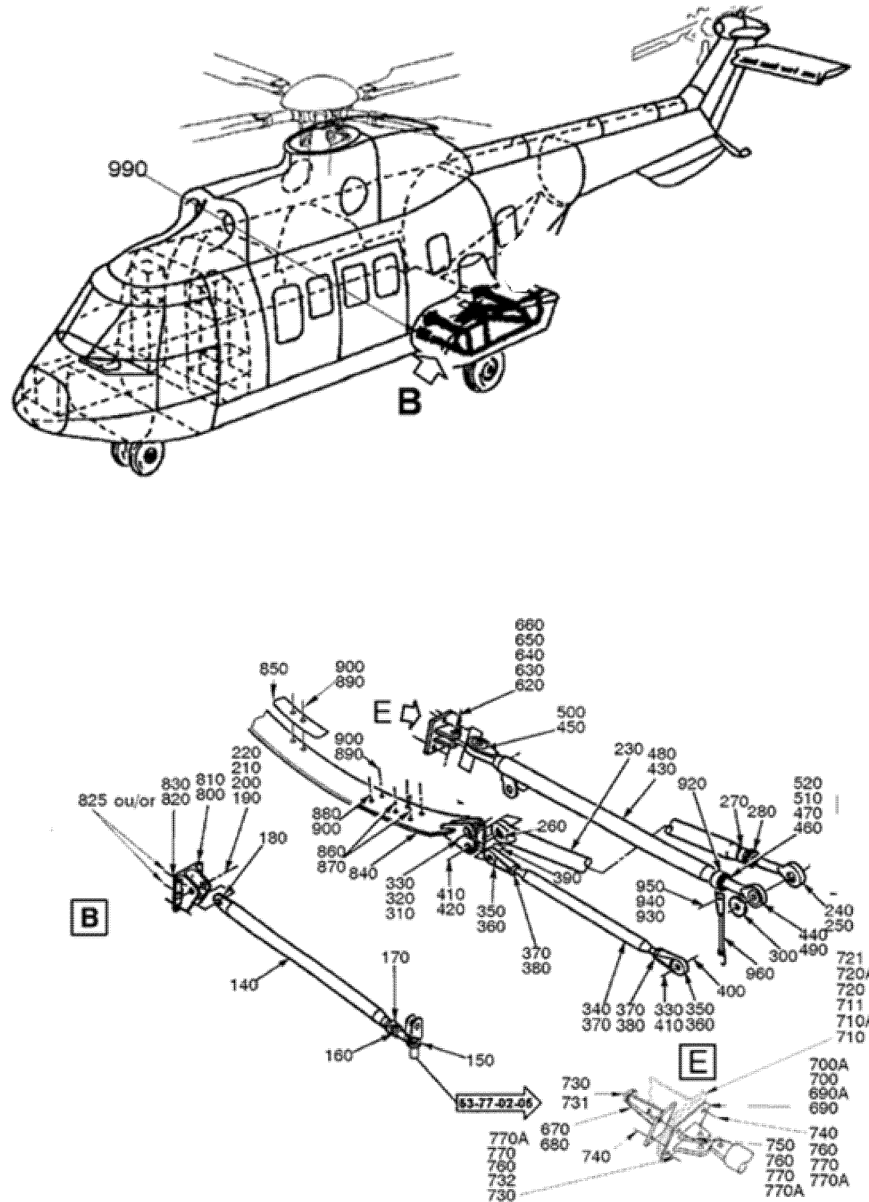
Figure 1 to Paragraph (e)(1) of this AD

This AD defines the unsafe condition as failure of a rear upper screw fitting on the emergency flotation gear. This condition, if not detected and corrected, could result in failure of the emergency flotation system and subsequent capsizing of the helicopter.

(1) Visually check each emergency flotation gear left hand and right hand rear upper fitting to determine whether the heads of the lower screws are present. Figure 1 to paragraph (e)(1) of this AD depicts where the lower three screws (noted as B and E) are located. Check each screw for looseness by

(2) If a screw head is missing or if a screw is loose, before further flight over water, replace all screws in the fitting. Replacing the screws is not a terminating action for the repetitive checks required by this AD.
