[Docket No. FAA-2016-9254; Directorate Identifier 2015-CE-030-AD; Amendment 39-18948; AD 2017-14-04]

Airworthiness Directives; Piper Aircraft, Inc. Airplanes

2017–14–04 Piper Aircraft, Inc.:
Amendment 39–18948; Docket No. FAA–2016–9254; Directorate Identifier 2015–CE–030–AD.

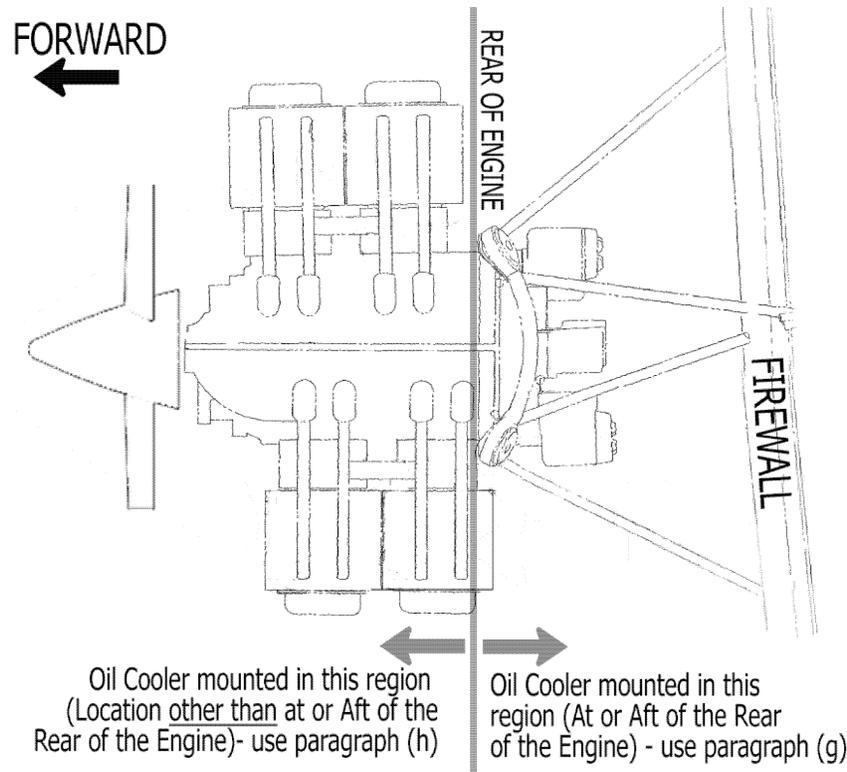
For any oil cooler hose assemblies that do not meet TSO–C53a, Type D requirements: Within the next 100 hours time-in-service (TIS) after February 5, 1996 (the effective date retained from AD 95–26–13), and repetitively thereafter at intervals not to exceed 100 hours TIS, inspect the fire sleeve of each oil cooler hose assembly for soaked oil, a brownish or whitish color, and any evidence of brittleness or deterioration as a result of heat or oil seepage. See figure 1 to paragraphs (g) and (h) of this AD for additional information.

Figure 1 to paragraphs (g) and (h) of this AD: Oil cooler

after February 5, 1996 (the effective date retained from AD 95-26-13), and repetitively thereafter at intervals not to exceed 100 hours TIS, inspect the fire sleeve of each oil cooler hose assembly for soaked oil, a brownish or whitish color, and any evidence of brittleness or deterioration as a result of heat or oil seepage. See figure 1 to paragraphs (g) and (h) of this AD for additional information.

(1) If any of the conditions described in paragraph (g) or (h)(1) of this AD are found on an oil cooler hose assembly during the inspection required in paragraph (g) or (h)(1) of this AD, as applicable, before further flight, replace the oil cooler hose assembly with a serviceable new or used TSO-C53a Type D oil cooler hose assembly or TSO-C53a Type C oil cooler hose assembly. If a used TSO-C53a Type C oil cooler hose assembly is installed, it must have documented hours TIS.

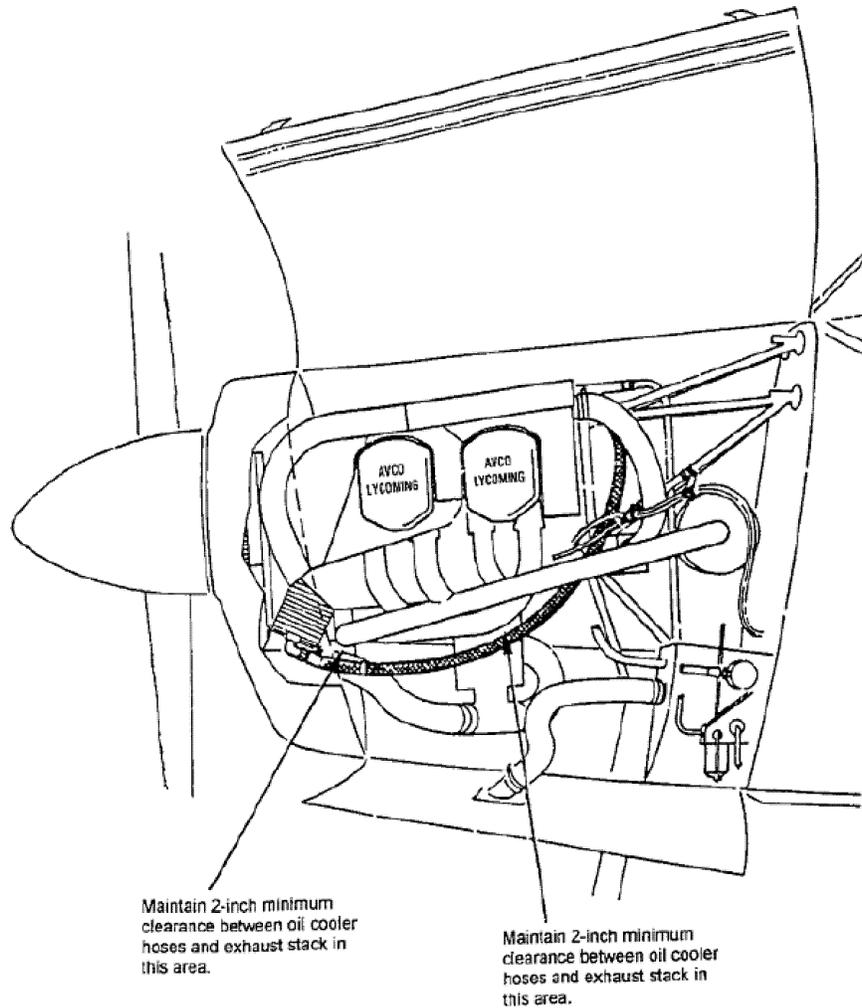
(i) The oil cooler hose assemblies pass underneath and behind the electrical ground cable and in front of the lower of the two engine mounts.

(ii) The oil cooler hose assemblies are secured to the engine mount strut and a clearance of at least 2 inches exists between the oil cooler hose assemblies and the exhaust stack.

(iii) Oil cooler hose assemblies with a minimum outer diameter of 0.75 inch are installed with a bend radius of at least 6.5 inches.

Figure 2 to paragraph (h)(2) of this AD: Acceptable clearances

(h) of this AD for additional information. If the conditions listed in paragraphs (h)(2)(i) through (iii) of this AD are not met, before further flight, make any necessary adjustments. See figure 2 to paragraph (h)(2) of this AD for additional information.
