[Docket No. FAA-2017-0288; Product Identifier 2017-CE-007-AD]

Airworthiness Directives; Textron Aviation Inc. Airplanes

ACTION: Supplemental notice of proposed rulemaking (SNPRM); reopening of comment period.

SUMMARY: We are revising an earlier proposal for all Textron Aviation Inc. Models A36TC and B36TC airplanes. This action revises the notice of proposed rulemaking (NPRM) by adding all Textron Aviation Inc. Models S35, V35, V35A, and V35B airplanes that have the optional turbocharger engine installed to the applicability and adding an annual visual inspection of the exhaust tailpipe v-band coupling (clamp). We are proposing this airworthiness directive (AD) to address the unsafe condition on these products. Since these actions would impose an additional burden over those in the NPRM, we are reopening the comment period to allow the public the chance to comment on these changes.

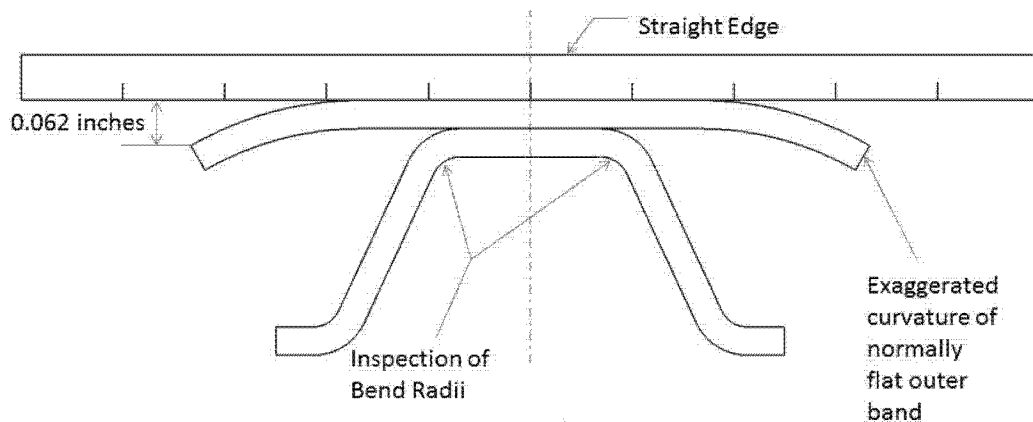
Figure 1 to paragraphs (k)(1)(iii) and (v) of this AD: Cross section of v-band coupling

(iii) Visually inspect the flatness of the outer band using a straight edge. Lay the straight edge across the width of the outer band. The gap must be less than 0.062 inches. See figure 1 to paragraphs (k)(1)(iii) and (v) of this AD. If the gap exceeds 0.062 inches between the outer band and the straight edge, do not re-install the v-band coupling. Before further flight, you must install a new v-band coupling and restart the hours TIS for the repetitive replacement of the v-band coupling.

(v) Visually inspect the bend radii of the coupling v-retainer coupling segments for cracks. Inspect the radii throughout the length of the segment. See figure 1 to paragraphs (k)(1)(iii) and (v) of this AD. If any cracks are found, do not re-install the v-band coupling. Before further flight, you must install a new v-band coupling and restart the hours TIS for the repetitive replacement of the v-band coupling.
