[Docket No. FAA–2016–9418; Product Identifier 2016–NE–23–AD; Amendment 39–19167; AD 2018–02–14]

Airworthiness Directives; Honeywell International Inc. Turboprop and Turboshift Engines

SUMMARY: We are adopting a new airworthiness directive (AD) for certain Honeywell International Inc. (Honeywell) TPE331 turboprop and TSE331 turboshift engines. This AD was prompted by reports that combustion chamber case assemblies have cracked and ruptured. This AD requires inspection of the affected combustion chamber case assembly, replacement of those assemblies found cracked, and removal of affected assemblies on certain TPE331 and TSE331 engines. We are issuing this AD to address the unsafe condition on these products.

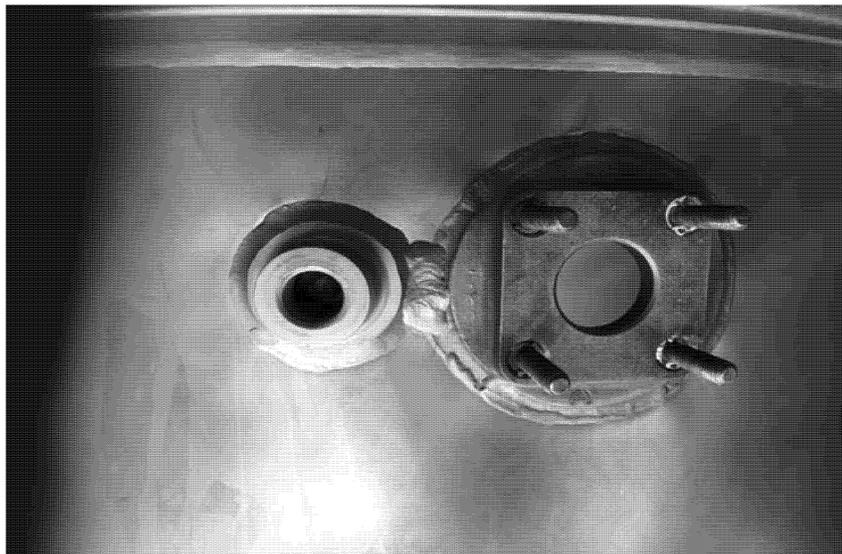
Figure 1 to Paragraph (h) of this AD. Combustion Chamber Case Assembly Without the One-Piece Bleed Pad with P3 Boss

We agree. We note that five of the six combustion chamber case assemblies that ruptured were assemblies without the one-piece bleed pad. P/N 3101668-x has the one-piece bleed pad with P3 boss, which demonstrated significantly reduced cracking between the P3 and bleed boss; therefore, this combustion chamber case assembly is not affected by this AD. No further changes are needed. We did not change this AD.

TPE331 model engines modified by STC SE383CH may be defined as the “Super 1” and “Super 2” for the compressor modification of the TPE331–1 and the TPE331–2, –2U, and –2UA engines, respectively. Figures 1 and 2 to paragraph (h) of this AD illustrate the appearance of combustion chamber case assembly, P/N

893973-5, without and with, respectively, the one-piece bleed pad with the P3 boss.

After the effective date of this AD, do not install a combustion chamber case assembly,

P/N 869728-1, 869728-3, or 893973-5, in TPE331-3U, -3UW, -5, -5A, -5AB, -5B, -6, and -6A engines or in TPE331-1, -2, and -2UA engines modified by National Flight

Services, Inc., STC SE383CH, unless the combustion chamber case assembly has a one-piece bleed pad with P3 boss.
