[Docket No. FAA–2016–9418; Product Identifier 2016–NE–23–AD; Amendment 39–19167; AD 2018–02–14]

#### **Airworthiness Directives; Honeywell International Inc. Turboprop and Turboshift Engines**

**SUMMARY:** We are adopting a new airworthiness directive (AD) for certain Honeywell International Inc. (Honeywell) TPE331 turboprop and TSE331 turboshift engines. This AD was prompted by reports that combustion chamber case assemblies have cracked and ruptured. This AD requires inspection of the affected combustion chamber case assembly, replacement of those assemblies found cracked, and removal of affected assemblies on certain TPE331 and TSE331 engines. We are issuing this AD to address the unsafe condition on these products.

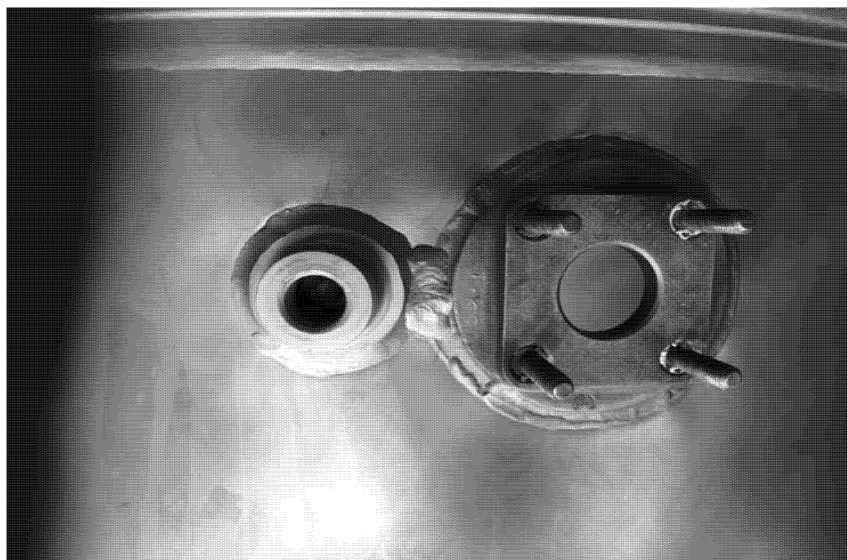
**Figure 1 to Paragraph (h) of this AD. Combustion Chamber Case Assembly Without the One-Piece Bleed Pad with P3 Boss**

We agree. We note that five of the six combustion chamber case assemblies that ruptured were assemblies without the one-piece bleed pad. P/N 3101668-x has the one-piece bleed pad with P3 boss, which demonstrated significantly reduced cracking between the P3 and bleed boss; therefore, this combustion chamber case assembly is not affected by this AD. No further changes are needed. We did not change this AD.

TPE331 model engines modified by STC SE383CH may be defined as the “Super 1” and “Super 2” for the compressor modification of the TPE331–1 and the TPE331–2, –2U, and –2UA engines, respectively. Figures 1 and 2 to paragraph (h) of this AD illustrate the appearance of combustion chamber case assembly, P/N

893973-5, without and with, respectively, the one-piece bleed pad with the P3 boss.

After the effective date of this AD, do not install a combustion chamber case assembly,

P/N 869728-1, 869728-3, or 893973-5, in TPE331-3U, -3UW, -5, -5A, -5AB, -5B, -6, and -6A engines or in TPE331-1, -2, and -2UA engines modified by National Flight

Services, Inc., STC SE383CH, unless the combustion chamber case assembly has a one-piece bleed pad with P3 boss.
