[Docket No. FAA-2016-9418; Product Identifier 2016-NE-23-AD; Amendment 39-19167; AD 2018-02-14]

Airworthiness Directives; Honeywell International Inc. Turboprop and Turboshift Engines

SUMMARY: We are adopting a new airworthiness directive (AD) for certain Honeywell International Inc. (Honeywell) TPE331 turboprop and TSE331 turboshift engines. This AD was prompted by reports that combustion chamber case assemblies have cracked and ruptured. This AD requires inspection of the affected combustion chamber case assembly, replacement of those assemblies found cracked, and removal of affected assemblies on certain TPE331 and TSE331 engines. We are issuing this AD to address the unsafe condition on these products.

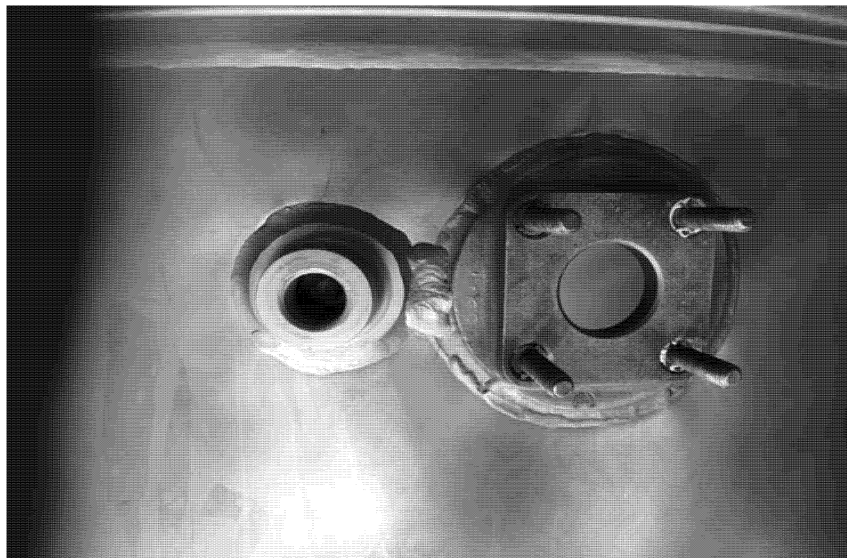
Figure 1 to Paragraph (h) of this AD. Combustion Chamber Case Assembly Without the One-Piece Bleed Pad with P3 Boss

We agree. We note that five of the six combustion chamber case assemblies that ruptured were assemblies without the one-piece bleed pad. P/N 3101668-x has the one-piece bleed pad with P3 boss, which demonstrated significantly reduced cracking between the P3 and bleed boss; therefore, this combustion chamber case assembly is not affected by this AD. No further changes are needed. We did not change this AD.

TPE331 model engines modified by STC SE383CH may be defined as the “Super 1” and “Super 2” for the compressor modification of the TPE331–1 and the TPE331–2, –2U, and –2UA engines, respectively. Figures 1 and 2 to paragraph (h) of this AD illustrate the appearance of combustion chamber case assembly, P/N

893973-5, without and with, respectively, the one-piece bleed pad with the P3 boss.

After the effective date of this AD, do not install a combustion chamber case assembly,

P/N 869728-1, 869728-3, or 893973-5, in TPE331-3U, -3UW, -5, -5A, -5AB, -5B, -6, and -6A engines or in TPE331-1, -2, and -2UA engines modified by National Flight

Services, Inc., STC SE383CH, unless the combustion chamber case assembly has a one-piece bleed pad with P3 boss.
