**[Docket No. FAA–2018–0479; Product Identifier 2016–NE–23–AD]**

**Airworthiness Directives; Honeywell International Inc. Turboprop and Turboshaft Engines**

**ACTION:** Notice of proposed rulemaking (NPRM).

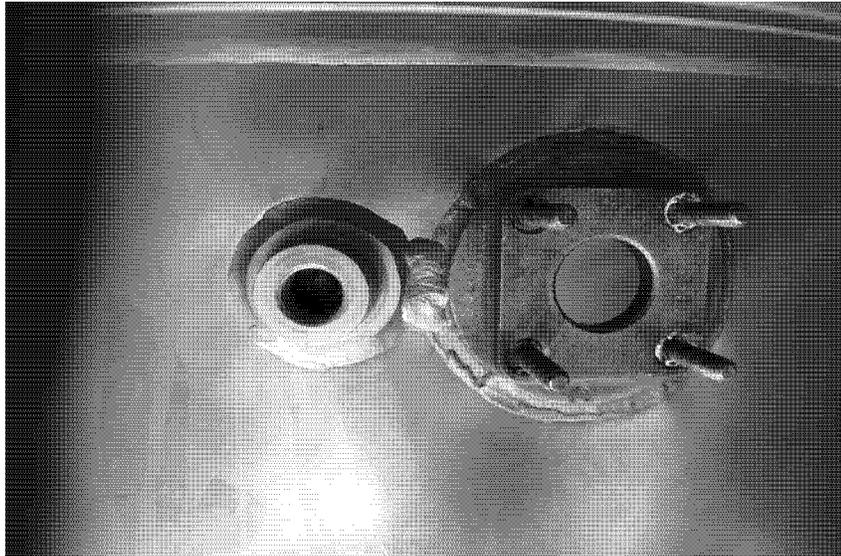
**Figure 1 to Paragraph (h) of this AD. Combustion Chamber Case Assembly Without the One-Piece Bleed Pad with P3 Boss**

(2) For TPE331–3U, –3UW, –5, –5A, –5AB, –5B, –6, and –6A engine models with combustion chamber case assemblies, P/Ns 869728–1, 869728–3, or 893973–5, installed, and without the one-piece bleed pad with P3 boss; and for TPE331–1, –2, and –2UA engine models modified by National Flight Services, Inc., supplemental type certificate (STC) SE383CH, remove the combustion chamber case assembly from service at the next removal of the combustion chamber case assembly from the engine, not to exceed 3,700 hours TIS since last hot section inspection.

(2) Figures 1 and 2 to paragraph (h) of this AD illustrate the appearance of combustion chamber case assembly, P/N 893973–5, without and with, respectively, the one-piece bleed pad with the P3 boss.

After the effective date of this AD, do not install a combustion chamber case assembly, P/N 869728-1, 869728-3, or 893973-5, in TPE331-3U, -3UW, -5, -5A, -5AB, -5B, -6, and -6A engine models or in TPE331-1, -2, and -2UA engine models modified by National Flight Services, Inc., STC SE383CH, unless the combustion chamber case assembly has a one-piece bleed pad with P3 boss.
