**DEPARTMENT OF TRANSPORTATION****Federal Railroad Administration**

[Docket No. FRA-2017-0074, Notice No. 2; Safety Advisory 2018-01]

**Addressing Electrode-Induced Rail Pitting From Pressure Electric Welding**

**Safety Advisory 2018-01**

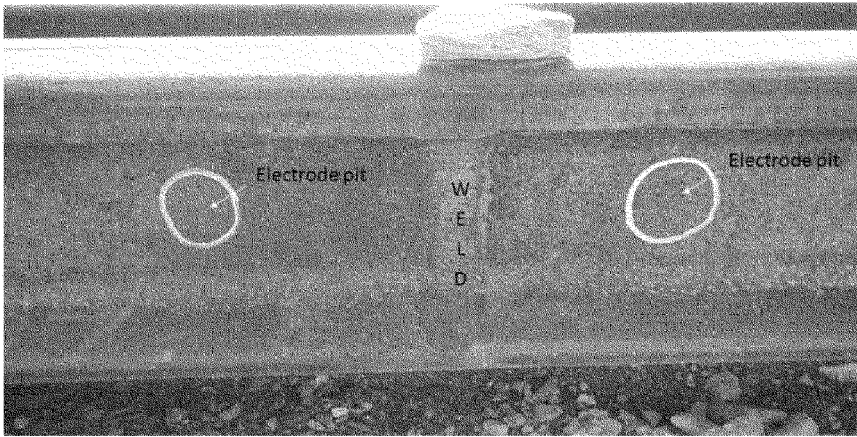
Figure 1 below shows a photograph of a rail with electrode pits in the web. The location of these electrode pits, when they occur, is typically four to eight inches on either side of the weld. Electrode-induced pitting from pressure electric welding may also occur in the head and base of the rail. It is unclear whether traditional ultrasonic rail

Figure 1: Electrode-Induced Pits in a Rail

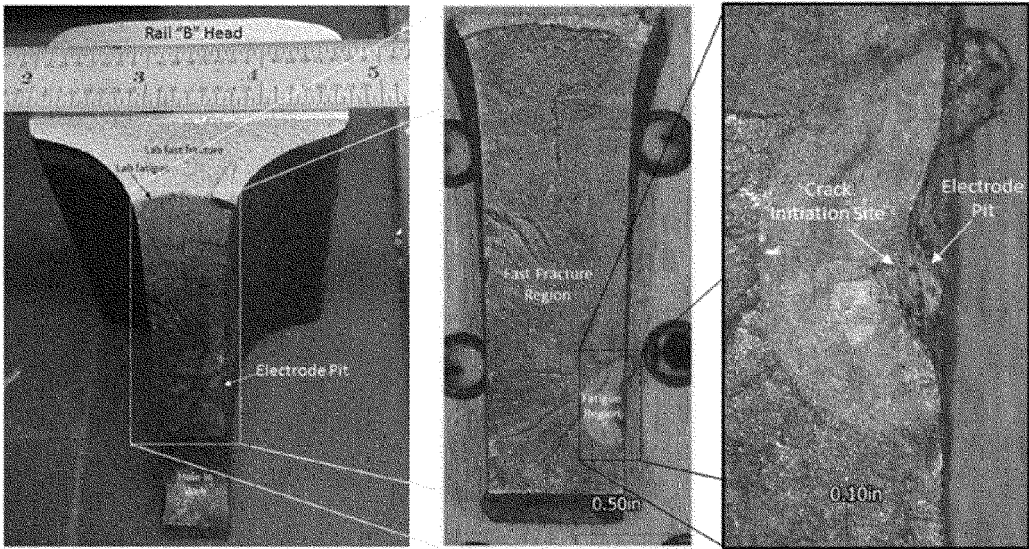
Specifically, Benét's metallurgical analyses concluded the cracking in the rail web originated from the pitting created by inadequate electrode-to-rail contact during the pressure electric welding process. The fractographic and metallographic examinations revealed evidence of fatigue cracking originating from the pitting and fast fracture once the fatigue crack reached a critical length. Figure 2 below shows three photographs of the fracture surface of a crack found in one of the rails Benét examined. These photographs support the metallurgical evidence indicative of three stages of fatigue fracture: (1) Crack initiation or formation originating from the pitting; (2) crack propagation or growth by metal fatigue; and (3) final rupture or fast fracture. Figure 3 below shows photographs of the microstructure near the electrode pits in each examined rail, providing further evidence the cracking originated from the pitting created by improper electrode contact during welding.

Figure 2: Photographs of Crack Fracture Surface in Examined Rail

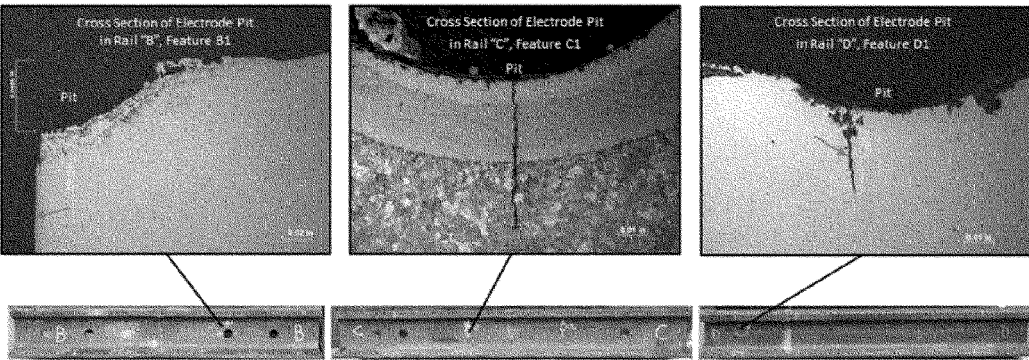
Figure 3: Photographs of Rail Cross Sections
