**DEPARTMENT OF TRANSPORTATION****Federal Railroad Administration**

[Docket No. FRA-2017-0074, Notice No. 2;  
Safety Advisory 2018-01]

**Addressing Electrode-Induced Rail Pitting From Pressure Electric Welding**

**Safety Advisory 2018-01**

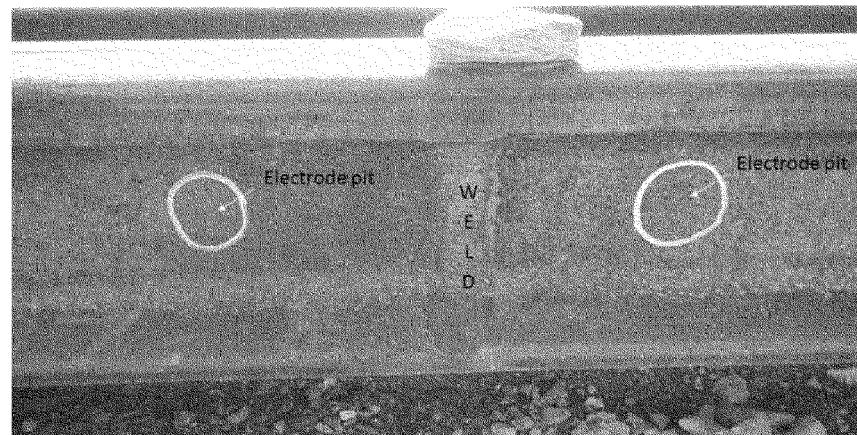
Figure 1 below shows a photograph of a rail with electrode pits in the web. The location of these electrode pits, when they occur, is typically four to eight inches on either side of the weld. Electrode-induced pitting from pressure electric welding may also occur in the head and base of the rail. It is unclear whether traditional ultrasonic rail

Figure 1: Electrode-Induced Pits in a Rail

railroad employees, railroad contractors, and welding companies and their employees of the importance of complying with those procedures to prevent electrode pitting and, ultimately, to prevent rail failures. (FRA has posted a copy of this notice on its public website, [www.fra.dot.gov](http://www.fra.dot.gov), where you may view the figures below in their full resolution.)

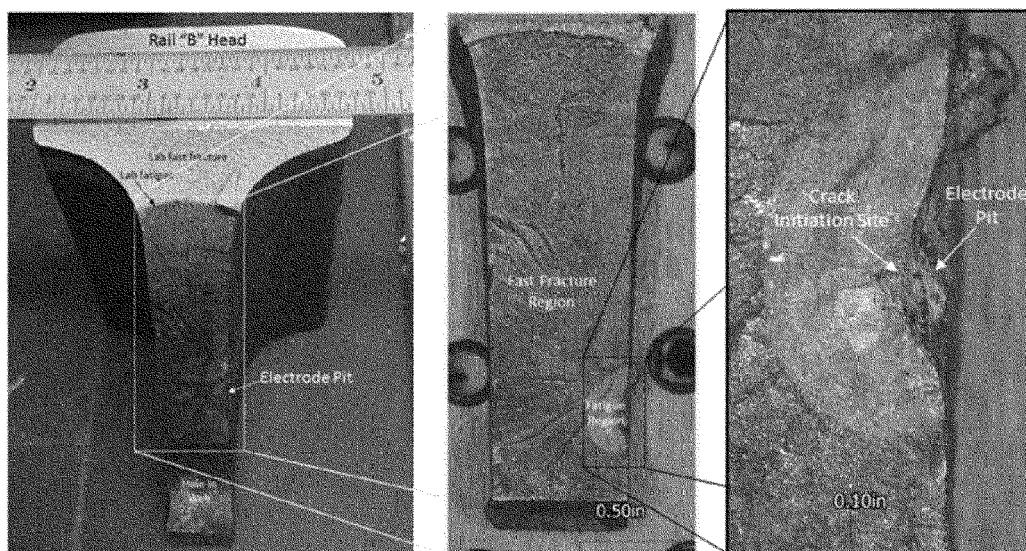
Specifically, Benét's metallurgical analyses concluded the cracking in the rail web originated from the pitting created by inadequate electrode-to-rail contact during the pressure electric welding process. The fractographic and metallographic examinations revealed evidence of fatigue cracking originating from the pitting and fast fracture once the fatigue crack reached a critical length. Figure 2 below shows three photographs of the fracture surface of a crack found in one of the rails Benét examined. These photographs support the metallurgical evidence indicative of three stages of fatigue fracture: (1) Crack initiation or formation originating from the pitting; (2) crack propagation or growth by metal fatigue; and (3) final rupture or fast fracture. Figure 3 below shows photographs of the microstructure near the electrode pits in each examined rail, providing further evidence the cracking originated from the pitting created by improper electrode contact during welding.

Figure 2: Photographs of Crack Fracture Surface in Examined Rail

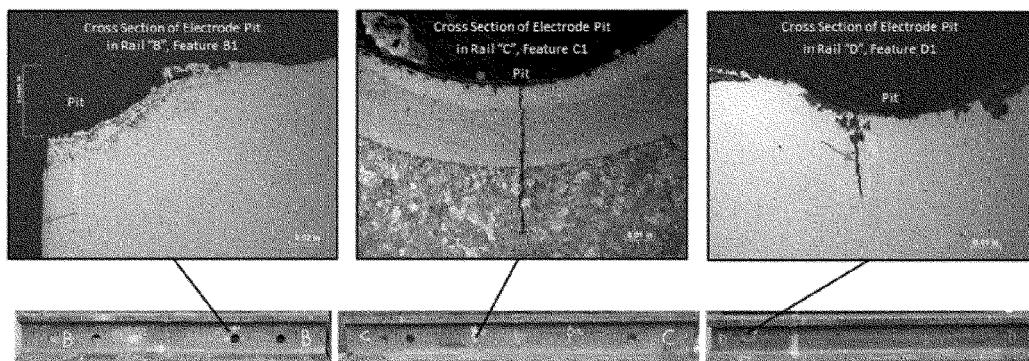
Figure 3: Photographs of Rail Cross Sections
