[Docket No. FAA-2019-0469; Product Identifier 2019-CE-028-AD; Amendment 39-19664; AD 2019-12-09]

**Airworthiness Directives; Rockwell Collins, Inc. Flight Display System Application**

**2019–12–09 Rockwell Collins, Inc.:**  
Amendment 39–19664 ; Docket No. FAA–2019–0469 Product Identifier 2019–CE–028–AD.

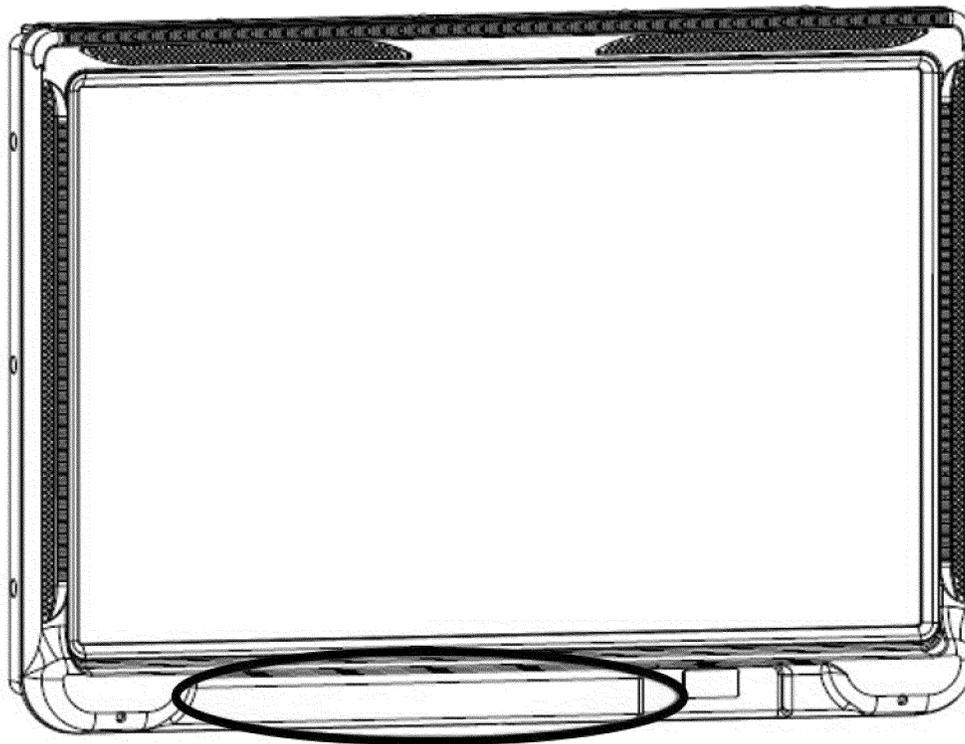
Figure 1 to paragraph (g)(3) of this AD; placard location on bezel

(2) Fabricate a placard for each aircraft primary flight display, using at least 1/8 inch letters, with the following text: TCAS Flight Ops—TA Only mode (TA/RA mode prohibited).

(3) Install the placard on the bottom of each aircraft primary flight display bezel in the area depicted in figure 1 to paragraph (g)(3) of this AD.
