[Docket No. FAA-2019-0715; Product Identifier 2019-NM-151-AD; Amendment 39-19760; AD 2019-20-07]

Airworthiness Directives; The Boeing Company Airplanes

2019–20–07 The Boeing Company:
Amendment 39–19760; Docket No. FAA–2019–0715; Product Identifier 2019–NM–151–AD.

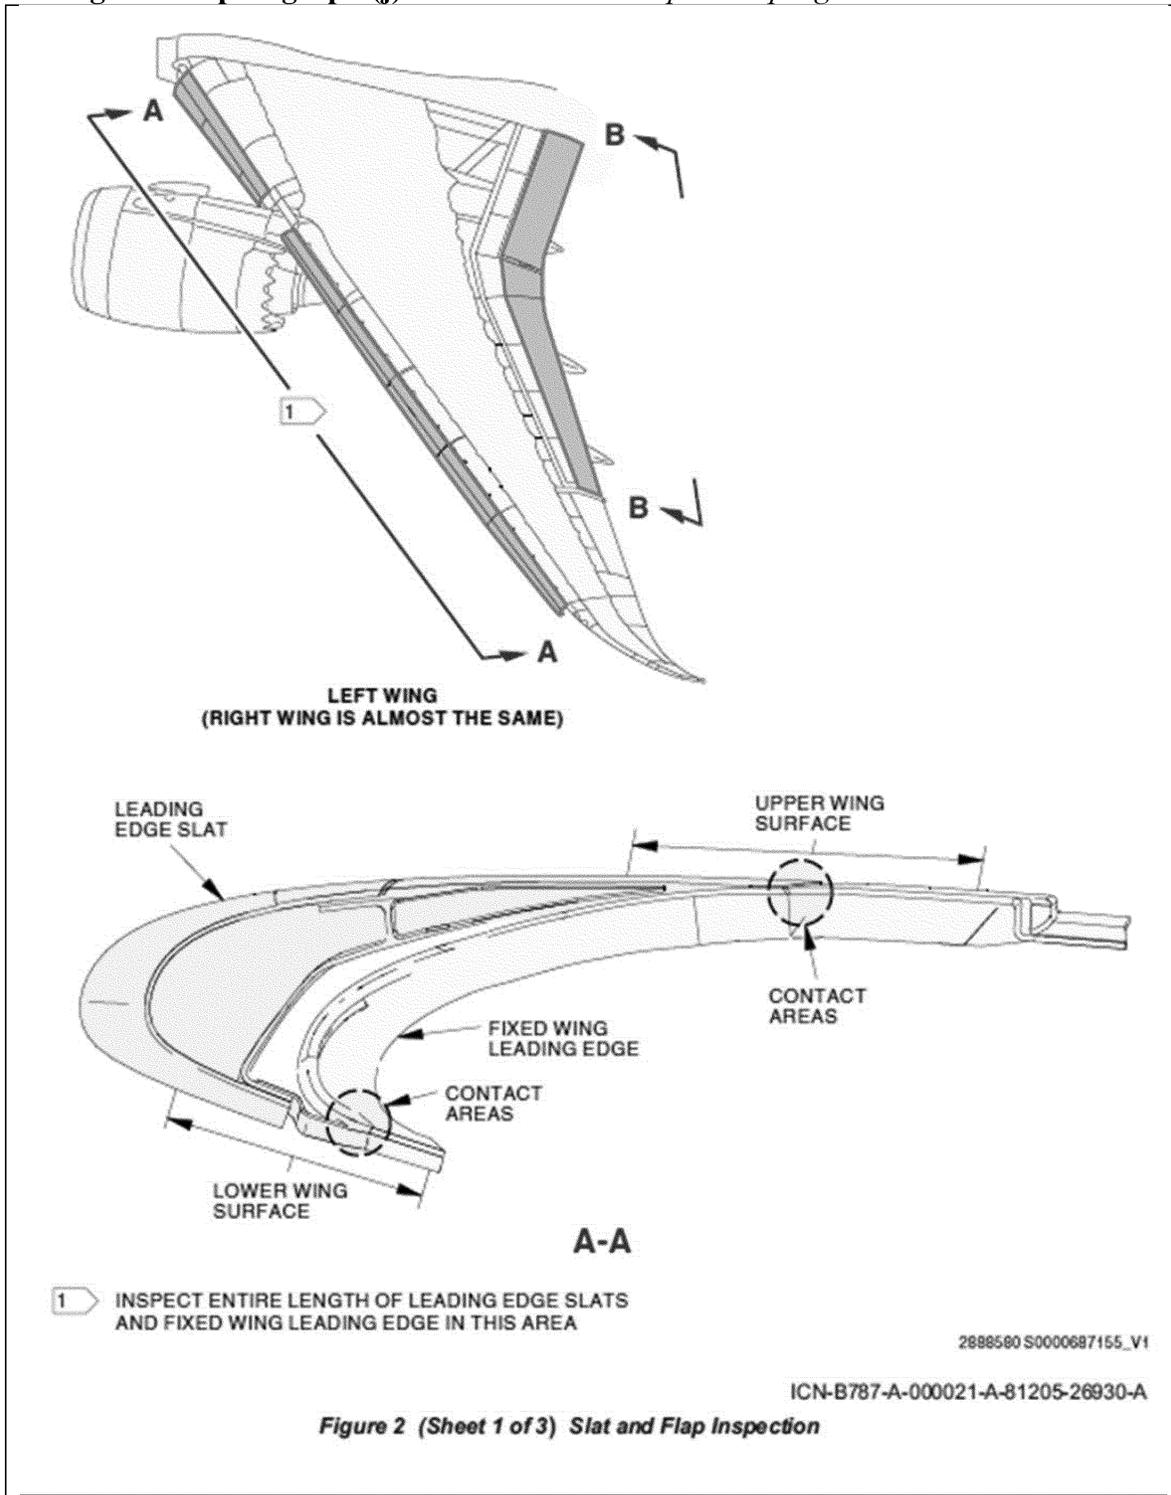
Figure 2 (Sheet 1 of 3) Slat and Flap Inspection

- (a) Do this inspection to make sure that contaminants (ice, snow, slush) are not present which can either obstruct retraction of the LE slats or TE flaps, or freeze the slats to the fixed leading edge after retraction.

- (a) Examine these areas for contaminants (ice, snow, slush):

- 1) Slats/flaps surfaces
- 2) Leading edge contact surfaces

- 3) Slat actuation areas, including exposed areas of the slat track cavity, and slat cove
- 4) Flap tracks, hinges, seals

- (b) Remove the contamination that you find.

- (c) Confirm a contaminant-free condition in these areas immediately prior to retraction of the slats/flaps surfaces.
- 1) Slats/flaps surfaces
 - 2) Leading edge contact surfaces
NOTE: “Contact surfaces” refers to the areas of the slat and the fixed wing that will be in contact after slat retraction.
