[Docket No. FAA-2020-0455; Product Identifier 2019-SW-105-AD; Amendment 39-21130; AD 2020-11-05]

Airworthiness Directives; Airbus Helicopters

2020–11–05 Airbus Helicopters:
Amendment 39–21130; Docket No. FAA–2020–0455; Product Identifier 2019–SW–105–AD.

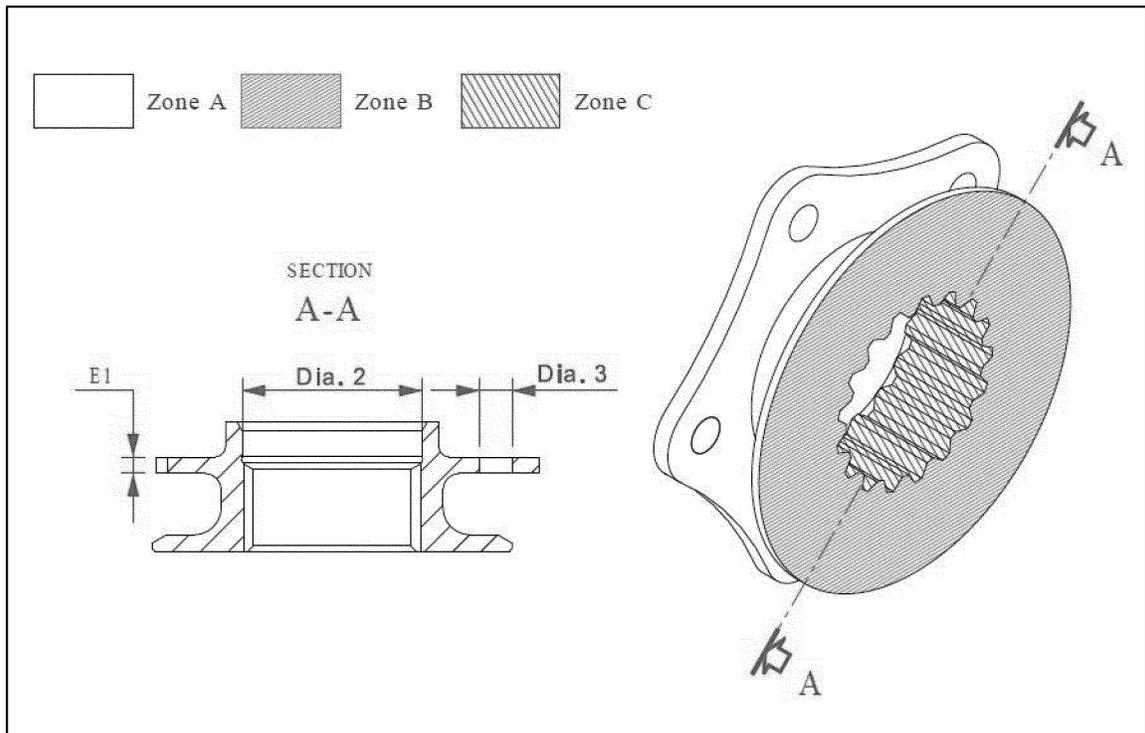
Figure 2 to paragraph (i)(1) – Inspection Areas of Tail Rotor Splined Flange

Location as specified in figure 2 to paragraph (i)(1) of this AD	Maximum damage, which causes replacement (E1, Dia. 2, and Dia. 3 are shown in figure 2 to paragraph (i)(1) of this AD)
Zone A	Score, depth more than 0.2 millimeters (mm) (0.008 in.) Crack E1 less than 2.75 mm (0.108 in.) Dia. 3 more than 6.02 mm (0.2371 in.) Dia. 2 more than 33.03 mm (1.3004 in.)
Zone B	Sanding depth more than 0.1 mm (0.004 in.) Crack
Zone C	Crack Score, depth more than 0.2 mm (0.008 in.)

(2) If, during any inspection of the tail rotor splined flange required by paragraph (i)(1) of this AD, the condition of the part exceeds the criteria as specified in figure 1 to paragraph (i)(1) of this AD, before next flight, replace the tail rotor splined flange with an

airworthy tail rotor splined flange in accordance with the instructions of section 3.B.4 of Airbus Helicopters Emergency Alert Service Bulletin 05A020, Revision 1, dated November 8, 2019.
