## DEPARTMENT OF TRANSPORTATION

[Docket No. FAA-2018-0893; Product Identifier 2018-SW-032-AD]

#### Airworthiness Directives; Airbus Helicopters

**ACTION:** Notice of proposed rulemaking (NPRM).

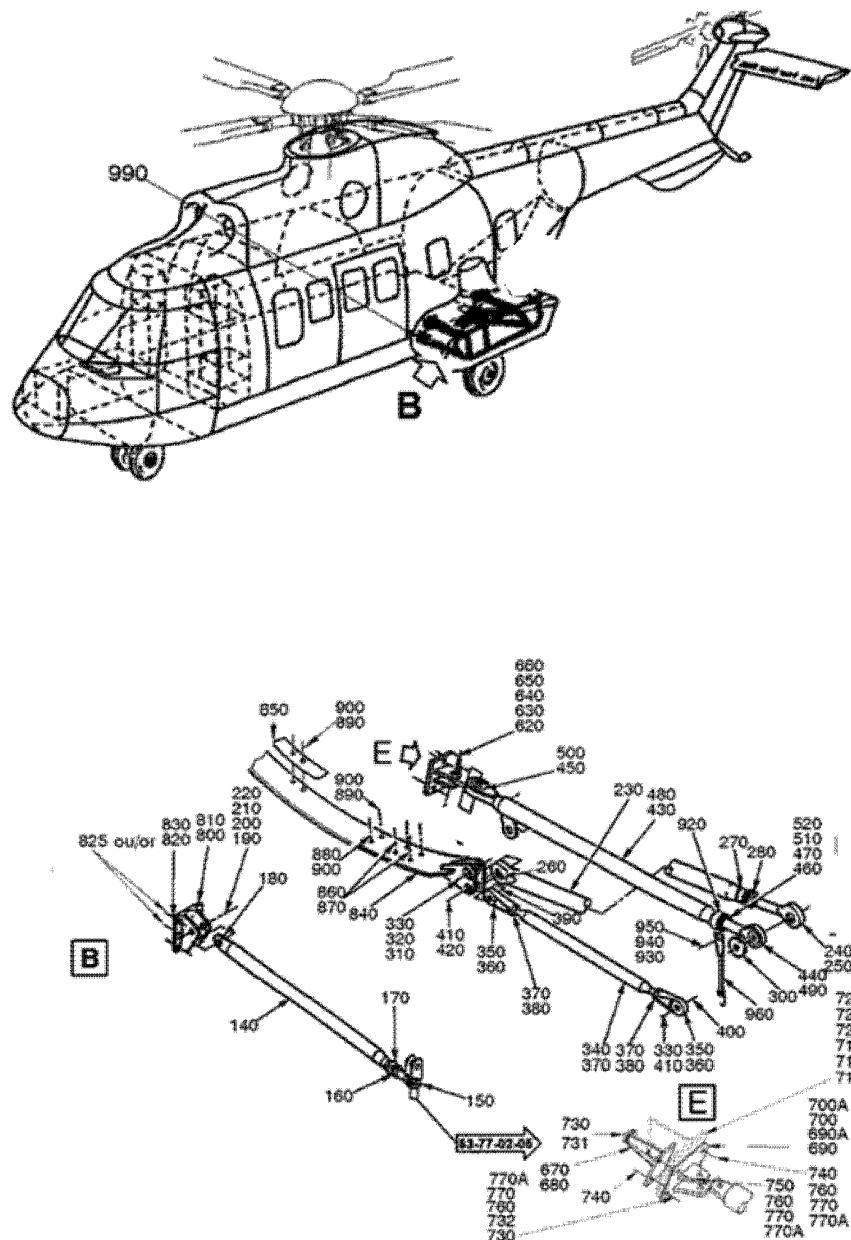
Figure 1 to Paragraph (f)(1)

This AD defines the unsafe condition as failure of a rear upper screw fitting on the emergency flotation gear. This condition, if not detected and corrected, could result in failure of the emergency flotation system and subsequent capsizing of the helicopter.

(1) Within 15 hours time-in-service (TIS), and before each flight over water thereafter, visually check each emergency flotation gear left hand (LH) and right hand (RH) rear upper fitting to determine whether the heads of the lower screws are present. Figure 1 to paragraph (f)(1) of this AD depicts where the lower three screws (noted as B and E) are located. Check each screw for looseness by determining whether it can be rotated by hand. These actions may be performed by the owner/operator (pilot) holding at least a private pilot certificate and must be entered into the aircraft records showing compliance with this AD in accordance with Title 14 Code of Federal Regulations (14 CFR) §§ 43.9(a)(1) through (4) and 14 CFR 91.417(a)(2)(v). The record must be maintained as required by 14 CFR 91.417, 121.380, or 135.439.

(2) If a screw head is missing, or if a screw is loose, before further flight over water, install MOD 0728456 by completing paragraph (f)(3) of this AD.

(3) Within 300 hours TIS, unless required before further flight over water by paragraph (f)(2) of this AD, install MOD 0728456 by doing the following:
