DEPARTMENT OF TRANSPORTATION**National Highway Traffic Safety Administration**

[Docket No. NHTSA–2019–0105]

Denial of Motor Vehicle Defect Petition

ACTION: Denial of petition for a defect investigation.

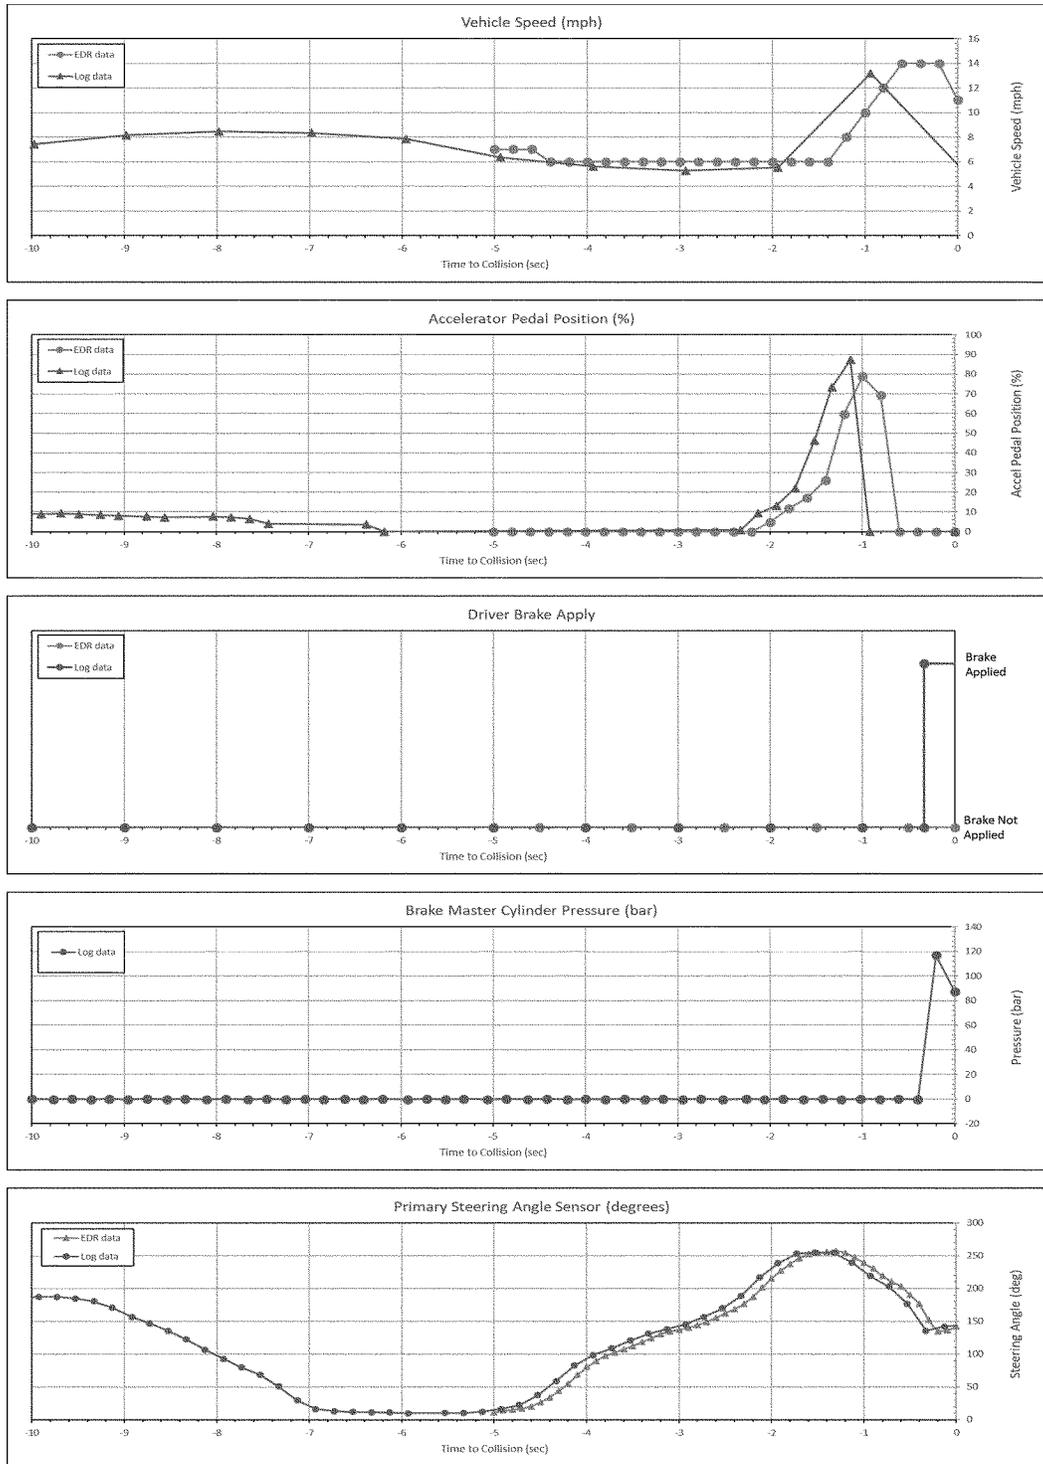
angle returns from a large positive value to neutral. Over the next second, the driver releases the accelerator pedal and the vehicle begins a moderate deceleration under regenerative braking. The vehicle begins to turn right toward the owner's driveway approximately five seconds before impact. Approximately two seconds before impact, as the vehicle nears the apex of the turn into the driveway, the accelerator pedal position begins to increase. The accelerator pedal increases from 0% to 88% in about one second.

Figure 1. Pre-crash operator control data, from top-to-bottom: vehicle speed, accelerator pedal position, brake pedal application, brake master cylinder pressure, and steering angle.

The accelerator pedal returns to 0% approximately 0.9 seconds before impact and the brake pedal is applied approximately 0.5 seconds later. The late brake application initiates ABS braking approximately 0.2 seconds before impact.

- The evidence shows that the brake light switch functioned as designed in the event analyzed by Dr. Belt (see Figure 1).
- The ESC and Traction Control systems cannot request positive torque in the subject vehicles.
- The APPS data recorded in the EDR report and data log show the physical position of the accelerator pedal (see section 3.5 System Safeguards). There is no other source for the accelerator pedal data.
- The vehicle does not veer to the left at any point during the crash event (see Figure 1 and section 3.3.4 ODI Analysis of Event Video File).
