Airworthiness Directives; Robinson Helicopter Company Helicopters

ACTION: Notice of proposed rulemaking (NPRM).

Robinson Helicopter Company: Docket No. FAA-2023-2232; Project Identifier AD-2023-00943-R.

This AD was prompted by reports of helicopters losing a TRB tip cap. The FAA is issuing this AD to detect and prevent TRB tip cap failures. The unsafe condition, if not addressed, could result in increased vibrations, reduced controllability, and subsequent loss of control of the helicopter.

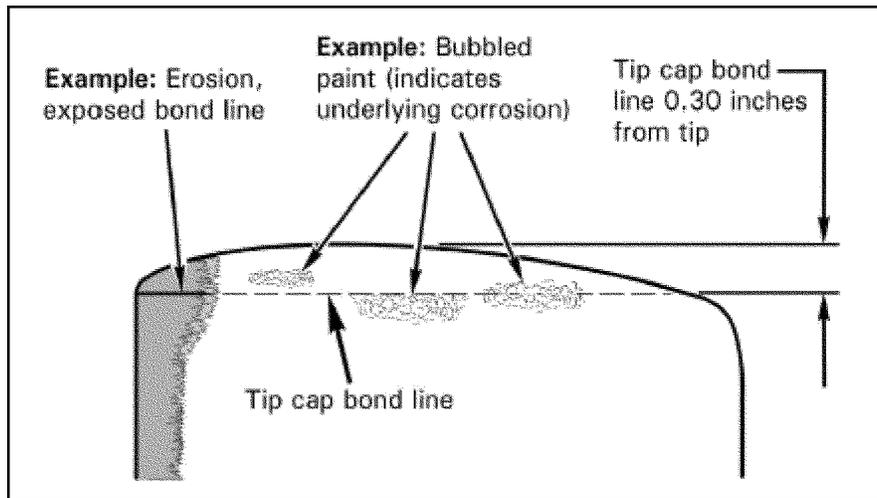
Figure 1 to Paragraph (g)(1)—TRB Tip Cap Check/Inspection

The FAA has received three reports of TRB tip caps coming loose due to corrosion at the bond on Robinson Helicopter Company Model R44 helicopters. Due to the similarity of the TRB tip caps on Robinson Helicopter Company Model R22, R22 Alpha, R22 Beta, R22 Mariner, R44 II, and R66 helicopters, those model helicopters are also affected by this issue. According to Robinson Helicopter Company, it has also seen TRBs that have corroded to an unserviceable condition, including severe leading edge pitting and degradation of the bond at the tip cap. Robinson Helicopter Company advises that helicopters operating near saltwater are particularly susceptible to corrosion, especially if stored outdoors. Affected TRBs were factory-installed or shipped as spares prior to November 2022. The three reports include a TRB tip cap departing its helicopter. The separate incidents occurred during a run-up check, after landing, and during a landing on different helicopters. Accordingly, this proposed AD would require repetitively checking and inspecting the tips caps of TRB part number (P/N) A029-2 with TRB serial numbers (S/N) up to 11279 inclusive (P/N A029-2 REV A through U inclusive), TRB P/N C029-3 with TRB S/N up to 14329 inclusive (P/N C029-3 REV A through Q inclusive), and TRB P/N F029-1 with TRB S/N up to 3099 inclusive (P/N F029-1 REV A through F inclusive) for evidence of corrosion, removing corrosion, and eventual removal of those TRBs from service.

A debonded TRB tip cap can cause severe vibration and possible failure of the tail rotor gearbox housing. This condition, if not addressed, could result in increased vibrations, reduced controllability, and subsequent loss of control of the helicopter.

(1) Within 10 hours time-in-service (TIS) after the effective date of this AD and thereafter before the first flight of each day, visually check each TRB tip cap area (at and adjacent to the tip cap bond line on each surface and edge of the TRB) for an exposed tip cap bond line or bubbled paint, as depicted in Figure 1 of paragraph (g)(1) of this AD. These items may indicate evidence of corrosion. The owner/operator (pilot) holding at least a private pilot certificate may accomplish this TRB tip cap check and must enter compliance with this paragraph of the AD into the helicopter maintenance records in accordance with 14 CFR 43.9(a) and 91.417(a)(2)(v). The record must be maintained as required by 14 CFR 91.417, 121.380, or 135.439.

(2) Within 100 hours TIS or during the next 100 hour or annual inspection after the effective date of this AD, whichever occurs first, and thereafter at intervals not to exceed 100 hours TIS or during the next 100 hour or annual inspection, whichever occurs first, visually inspect each TRB tip cap area (at and adjacent to the tip cap bond line on each surface and edge of the TRB) for evidence of corrosion, which may be indicated by an exposed tip cap bond line or bubbled paint, as depicted in Figure 1 of paragraph (g)(1) of this AD.

(3) As a result of the actions required by either paragraph (g)(1) or (2) of this AD, if there is evidence of corrosion, an exposed tip cap bond line, or bubbled paint, before further flight, remove all of the corrosion.

(4) Within 10 months of the effective date of this AD, remove all TRBs identified in paragraph (c) of this AD from service.
