DEPARTMENT OF TRANSPORTATION**Federal Aviation Administration****14 CFR Part 39**

[Docket No. FAA-2023-1993; Project Identifier AD-2023-00129-T]

Airworthiness Directives; The Boeing Company Airplanes**AGENCY:** Federal Aviation Administration (FAA), DOT.**ACTION:** Notice of proposed rulemaking (NPRM).

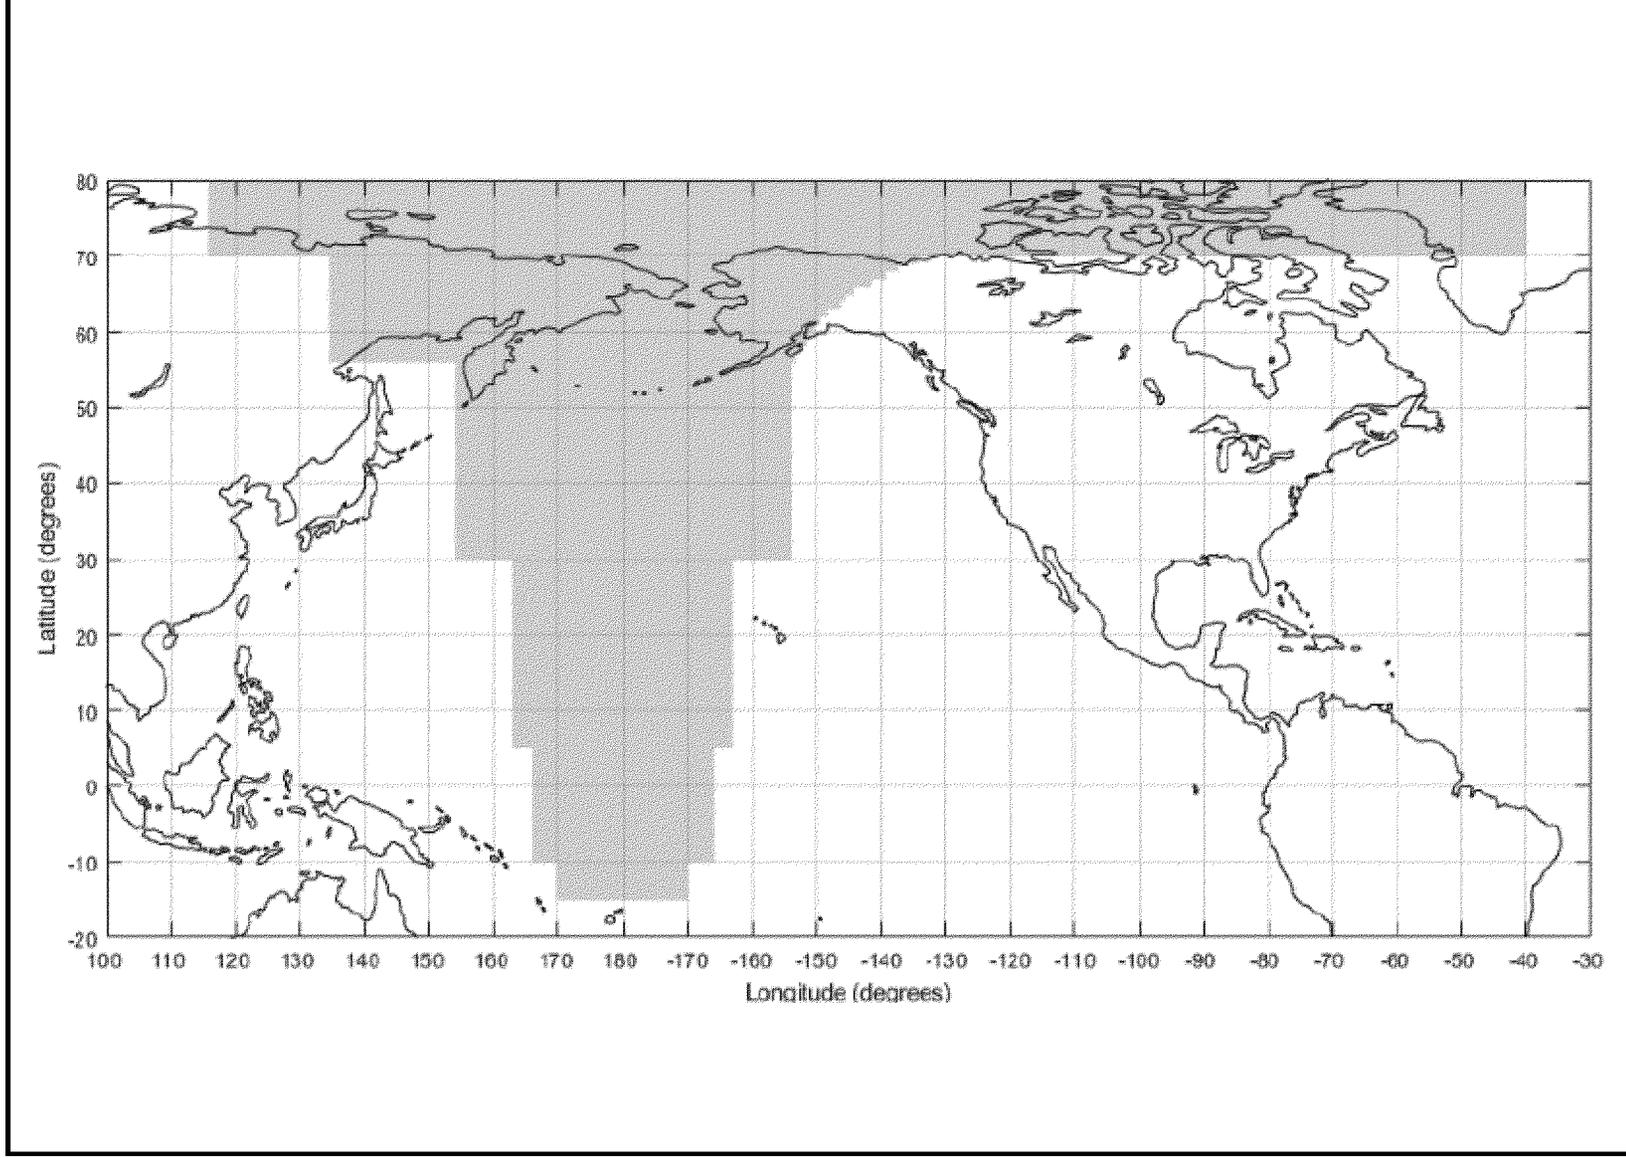
Figure 2 to Paragraph (g)—AFM—
Limitations or Certificate Limitations
Continued

Operations that require less than 0.3 RNP (For example, 0.1, 0.11, 0.15, etc.) in the region identified below are prohibited with GLU-2100 OPS software number COL4D-0087-0002, COL4E-0087-0001, COL48-0087-0700, or COL49-0087-0701 installed.

Exception: Anchorage (PANC) approach procedures that allow less than RNP 0.3 are authorized provided the instructions outlined in the Electronics – Global Landing Unit Section of Normal Procedures Chapter are followed.

Note: Currently, Fairbanks (PAFA) and Anchorage (PANC) are the only airports in the region with an RNP approach that requires better than 0.3 nmi performance.

Region bounded by the following coordinates:
