#### 14 CFR Part 39

[Docket No. FAA-2024-0237; Project Identifier AD-2023-00491-R]

#### Airworthiness Directives; Robinson Helicopter Company Helicopters

**ACTION:** Notice of proposed rulemaking (NPRM).

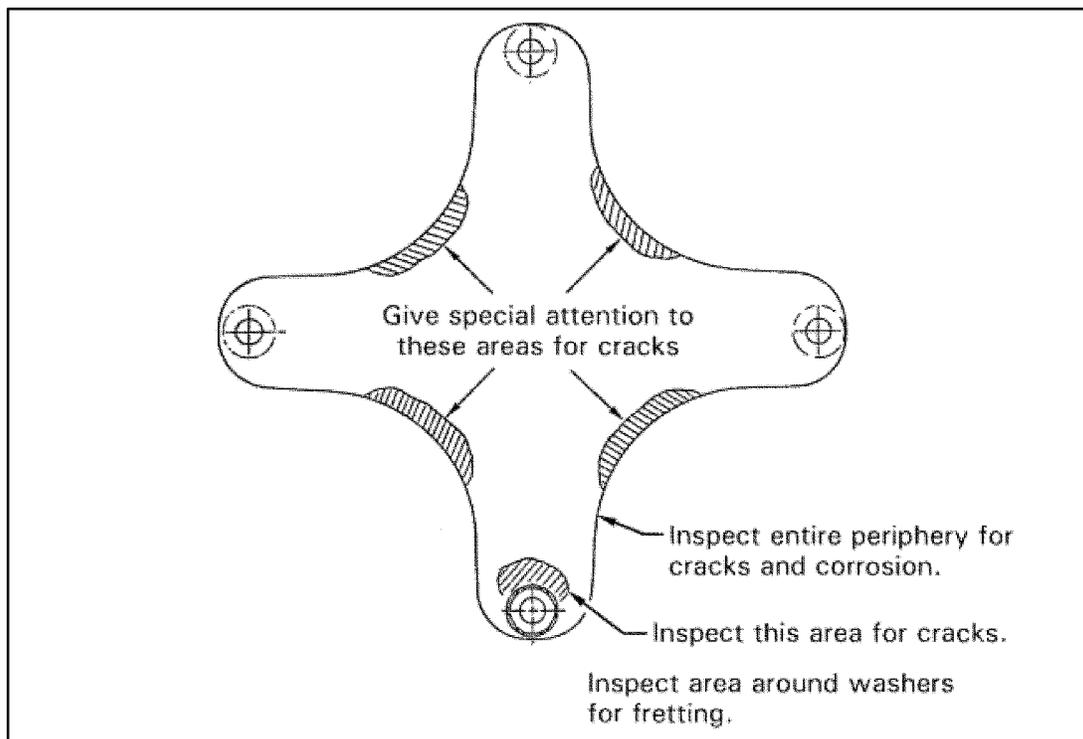
#### Figure 1 to Paragraph (g)(1)(i)—Flex Plate Inspection

The FAA reviewed Robinson Helicopter Company R44 Maintenance Manual and Instructions for Continued Airworthiness, Volume 1, Chapter 2 and Chapter 23, dated September 2023, which specifies procedures for inspecting the yoke and flex plate of the M/R drive, removing paint, applying torque, and performing a magnetic particle inspection. This service information also contains the information specified in Appendix 1 to this proposed AD, which specifies torque values, and Figure 1 to paragraph (g)(1) of this proposed AD, which depicts the areas for the flex plate inspection.

(i) Visually inspect forward flex plate assembly (flex plate) part number (P/N) C947–1 for any loose fasteners, cracks, fretting, corrosion, wear, and to ensure that the washers are bonded to both sides of each flex plate arm, in the areas depicted in Figure 1 to paragraph (g)(1)(i) of this AD, which includes the four bolt holes. If there is any loose fastener (can be moved by hand), crack, fretting, corrosion, or wear in any area including the four bolt holes, or wear that consists of the washers not securely bonded to both sides of each flex plate arm, before further flight, remove the flex plate from service and replace with an airworthy flex plate.
