Airworthiness Directives; The Boeing Company Airplanes

ACTION: Notice of proposed rulemaking (NPRM).

The Boeing Company: Docket No. FAA–2024–0769; Project Identifier AD–2023–00556–T.

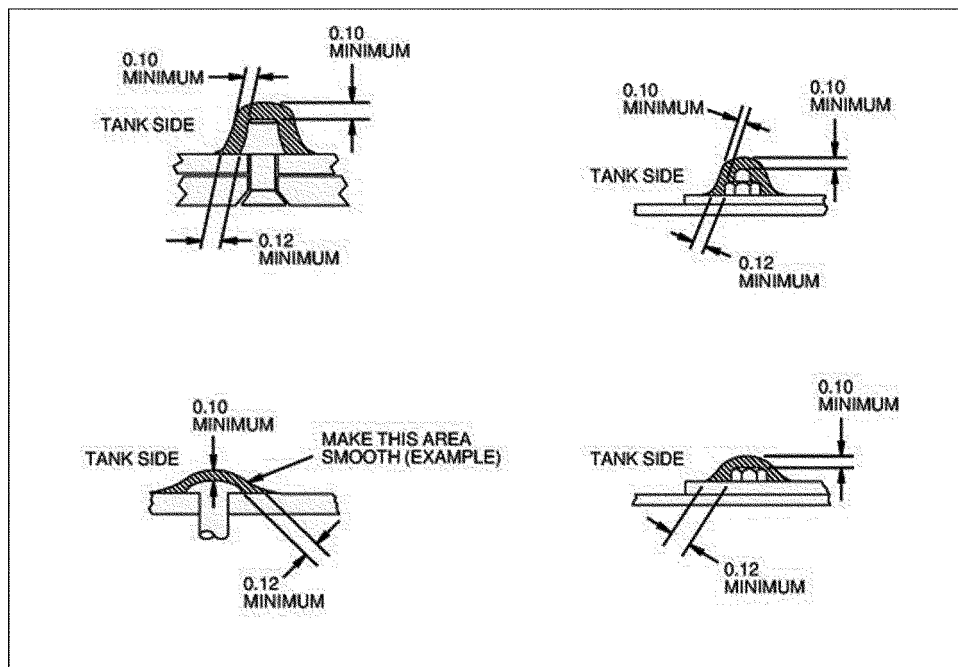
Figure 1 to Paragraph (h)(3)—Cap Sealing Dimensions (all Dimensions are in Inches)

(3) Where any service information referenced in Boeing Alert Requirements Bulletin 777–53A0100 RB, dated March 16, 2023, specifies applying a cap seal (sealant) to a fastener, fastener head, and fastener threads and collars, for this AD, during application of any cap seal to a fastener, fastener head, or fastener threads and collars, the cap seal must be applied using a cap sealing procedure with thickness greater than or equal to the dimensions given in Figure 1 to paragraph (h)(3) of this AD.

heads, and fastener threads and collars for the airplane groups and configurations identified in paragraphs (h)(6)(ii)(A) through (D) of this AD. For those airplane groups and configurations, the application of a cap seal to the underwing longeron fasteners at the locations identified in Figures 81 and 144 is required during installation of the underwing longeron and must be applied using a cap sealing procedure with thickness greater than or equal to the dimensions given in Figure 1 to paragraph (h)(3) of this AD.

(iii) For any inspection that may require the removal of fastener cap seals, if the cap seal is removed, a cap seal of BMS 5-45 sealant must be reapplied using a cap sealing procedure with a thickness equal to or greater than the dimensions specified in Figure 1 to paragraph (h)(3) of this AD before further flight after completion of the inspection.
