DEPARTMENT OF TRANSPORTATION**Federal Aviation Administration****14 CFR Part 39**

[Docket No. FAA–2024–1896; Project Identifier MCAI–2023–00978–T; Amendment 39–22966; AD 2025–04–08]

Airworthiness Directives; MHI RJ Aviation ULC (Type Certificate Previously Held by Bombardier Inc.) Airplanes

ACTION: Final rule.

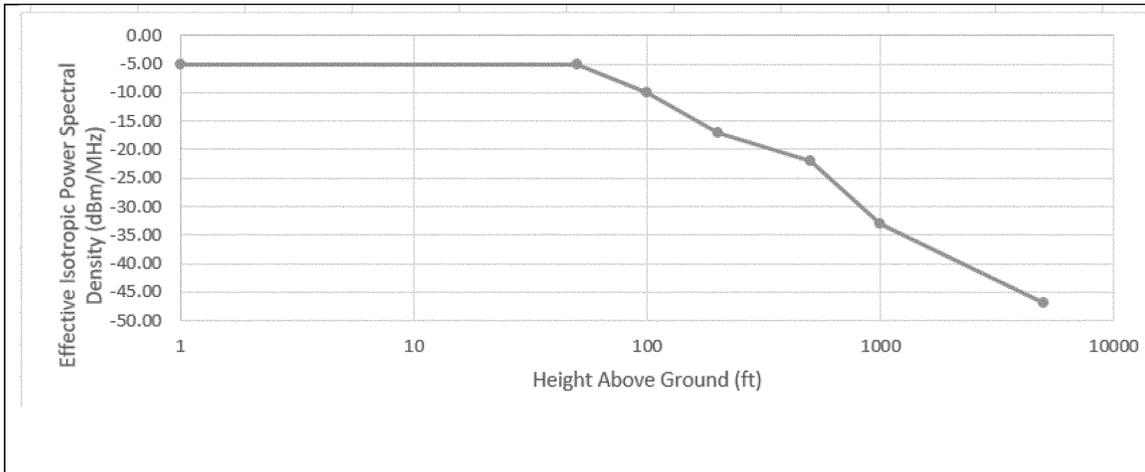
Figure 1 to Paragraph (g)(1)—Fundamental Effective Isotropic PSD at Outside Interface of Airplane Antenna

(1) Tolerance to radio altimeter interference, for the fundamental emissions (3.7–3.98 GHz), at or above the power

spectral density (PSD) curve threshold specified in figure 1 to paragraph (g)(1) of this AD.

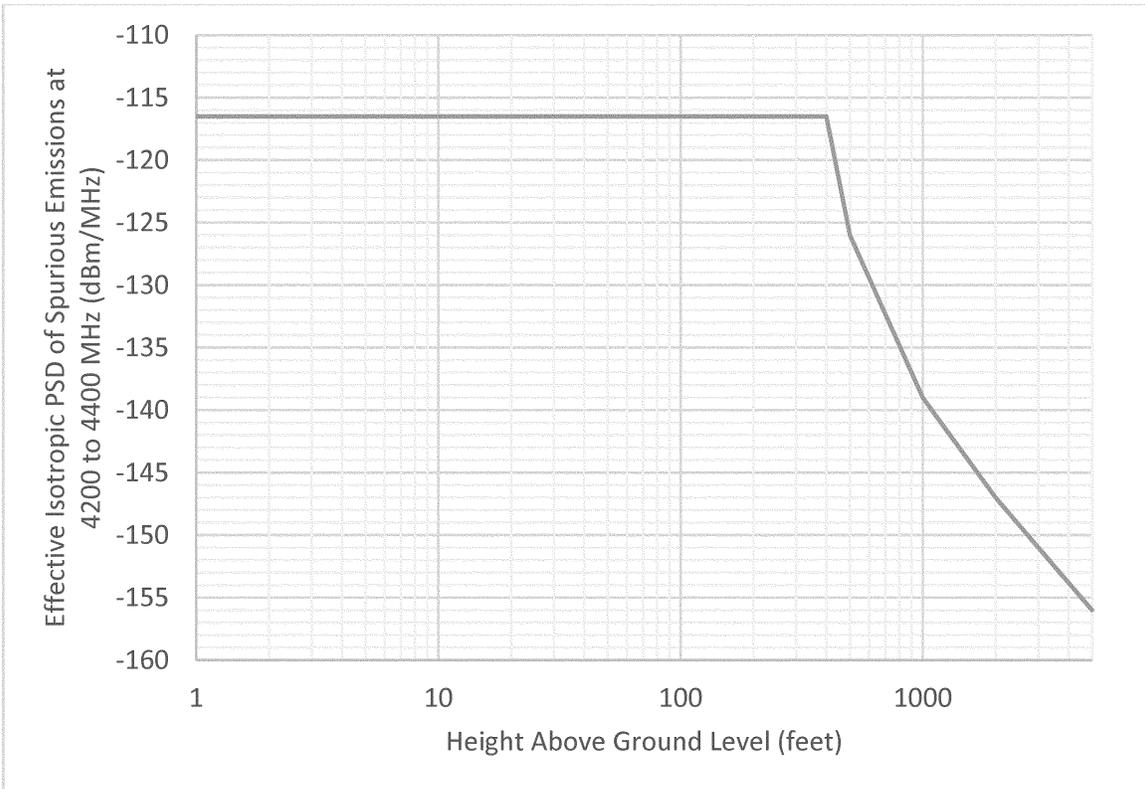
Figure 2 to Paragraph (g)(2)—Spurious Effective Isotropic PSD at Outside Interface of Airplane Antenna

(2) Tolerance to radio altimeter interference, for the spurious emissions (4.2–4.4 GHz), at or above the PSD curve threshold

specified in figure 2 to paragraph (g)(2) of this AD.
