Airworthiness Directives; Twin Commander Aircraft LLC Airplanes

SUMMARY: The FAA proposes to adopt a new airworthiness directive (AD) for all Twin Commander Aircraft LLC (Twin Commander) Model 685, 690, 690A, 690B, 690C, 690D, 695, and 695A

Twin Commander Aircraft LLC: Docket No. FAA–2025–3438; Project Identifier AD–2025–01163–A.

Appendix 1 to Docket FAA-2025-3438

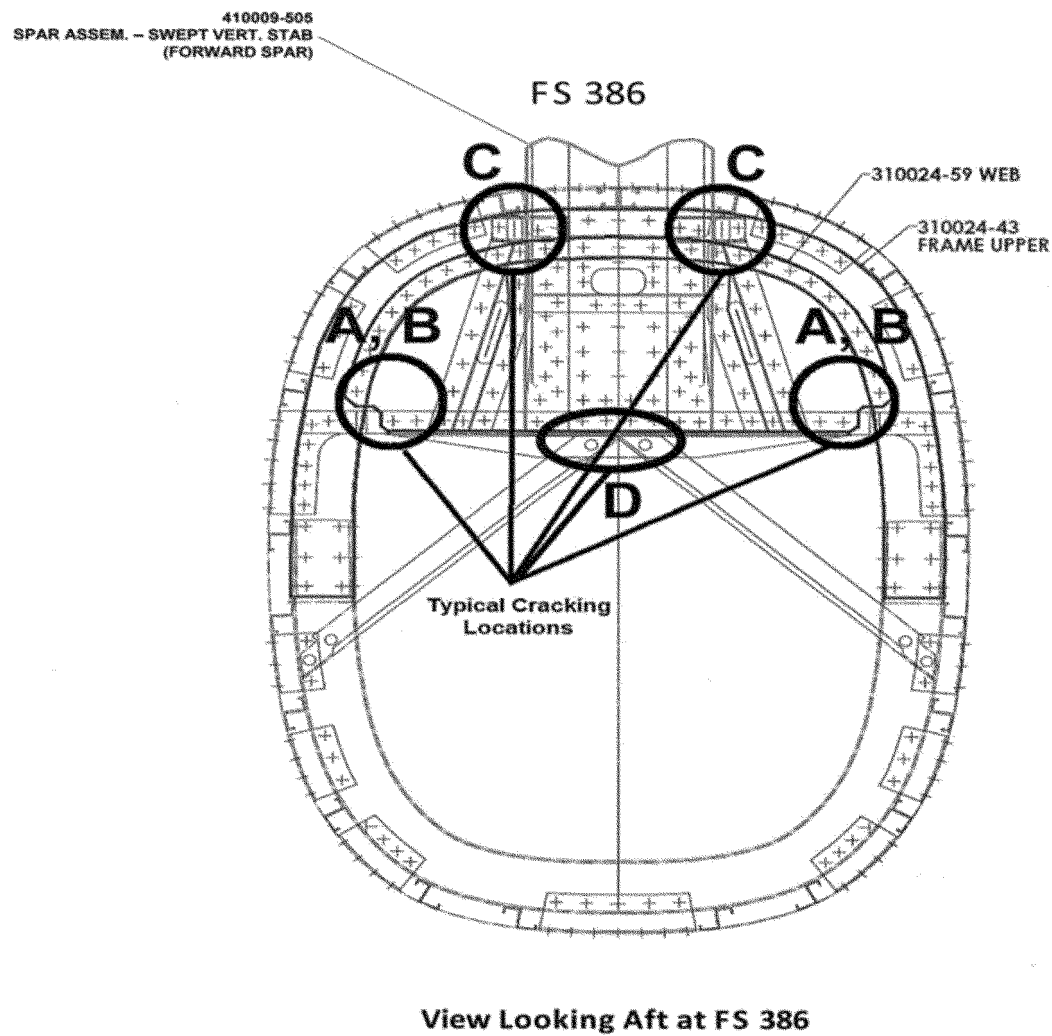
Figure 1 to Appendix 1

- View Looking Aft at FS 386**
- (A) FS 386: Frame Web at each corner radius
 - (B) FS 386: Horizontal Brace Joggles
 - (C) FS 386: Frame Upper Cable Cutouts
 - (D) FS 386: Elongation of Holes at the Diagonal Braces

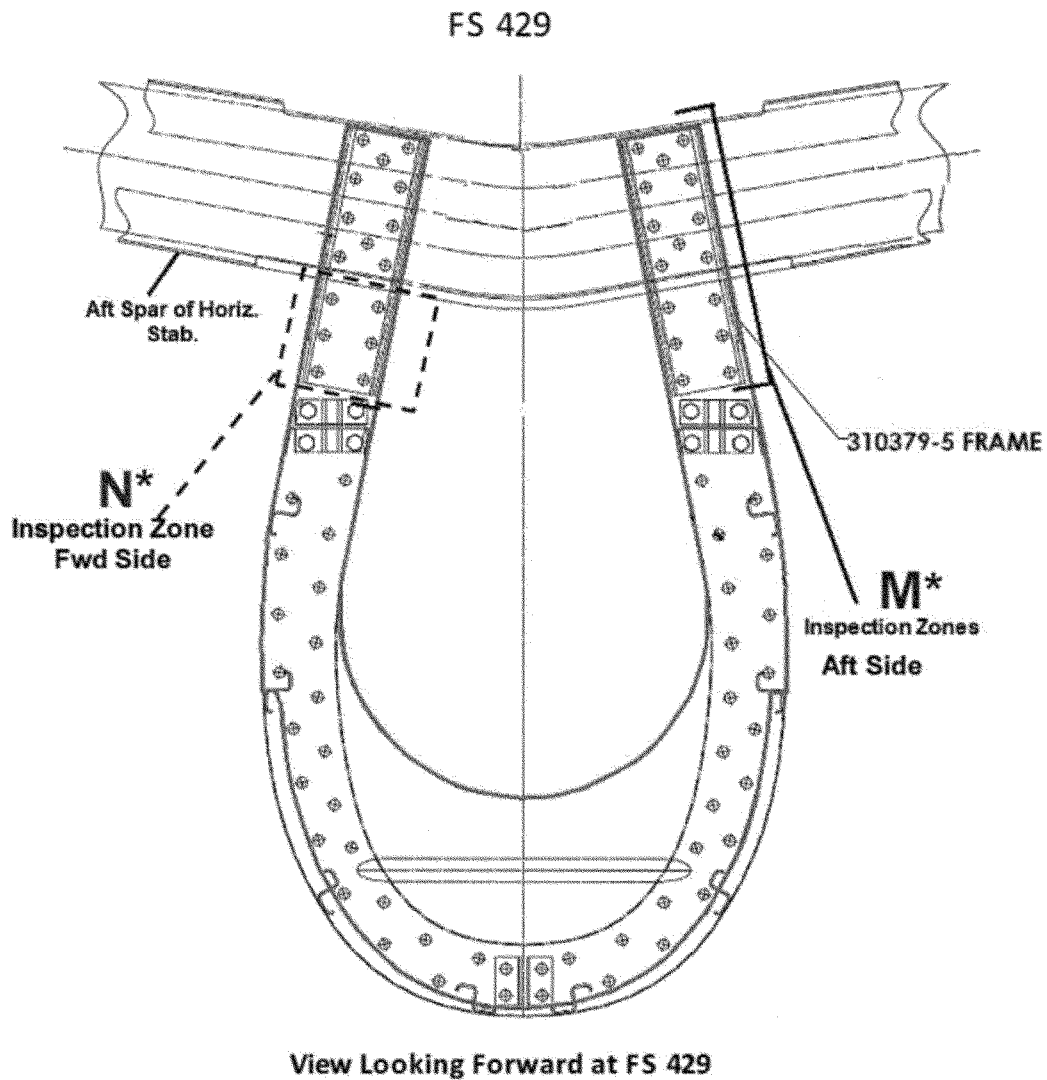
Figure 3 to Appendix 1

- (M) FS 429: Aft Frame Channel and Web (* inspection mirrored on opposite side)
(N) FS 429: Forward Channel attached to Frame (* inspection mirrored on opposite side)
