[Docket No. FAA-2025-3987; Project Identifier AD-2025-00017-R]

Airworthiness Directives; MD Helicopters, LLC Helicopters

ACTION: Notice of proposed rulemaking (NPRM).

MD Helicopters, LLC: Docket No. FAA–2025–3987; Project Identifier AD–2025–00017–R.

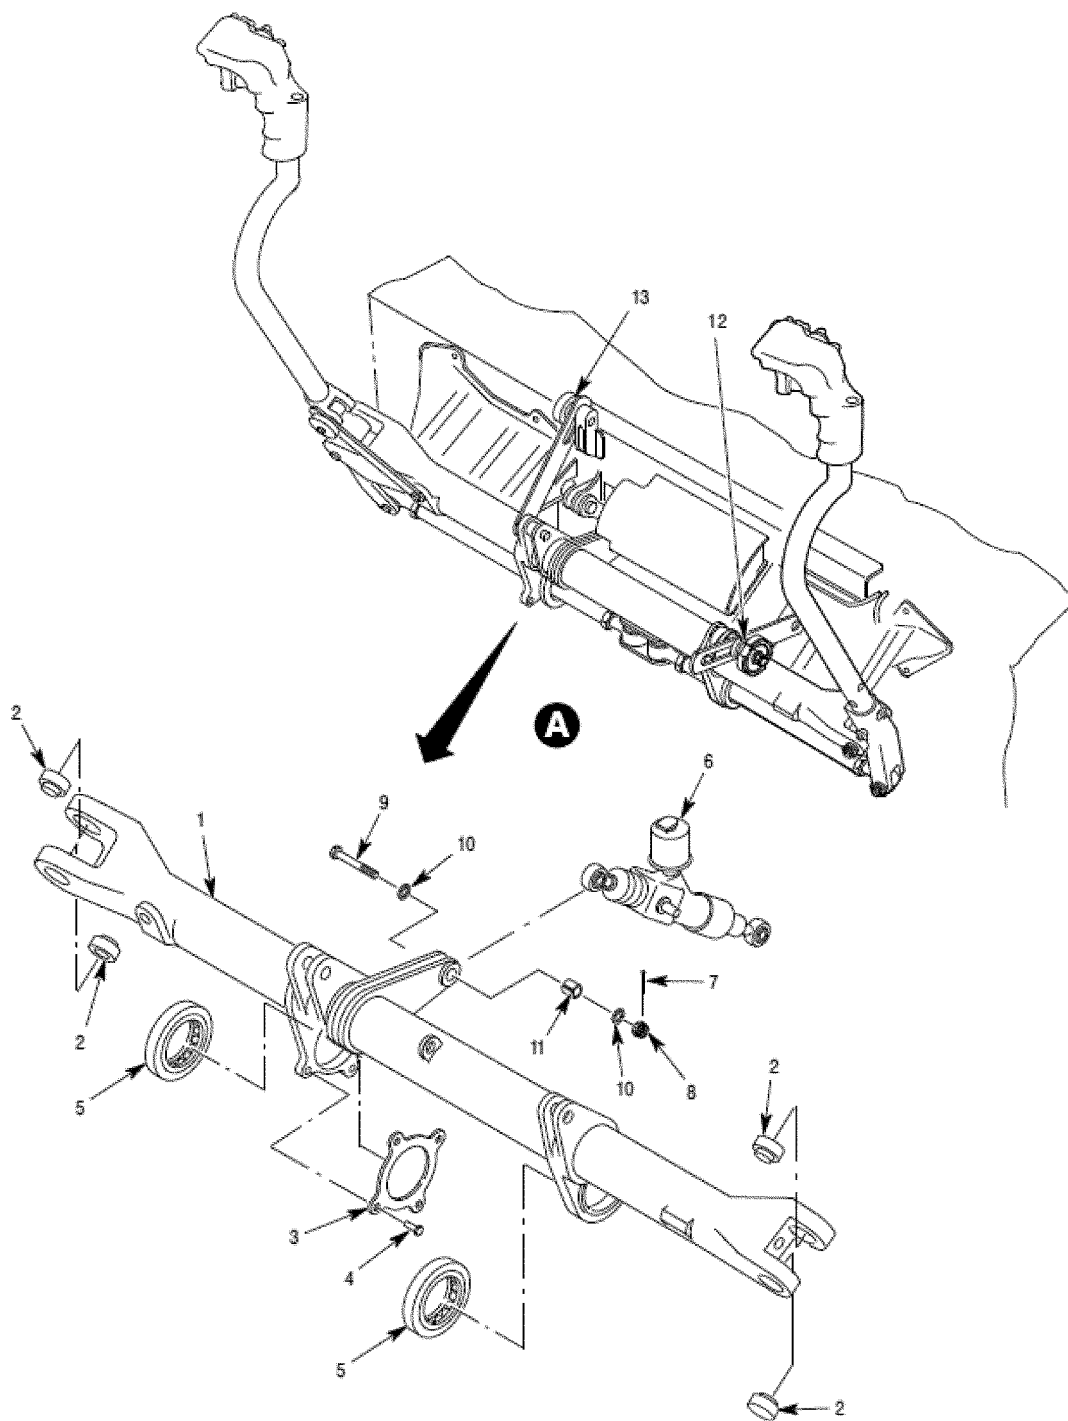
Figure 1 to Paragraph (g)(1) –Torque Tube Assembly

This AD was prompted by a report of a seized and damaged roller bearing in the

torque tube assembly. The FAA is issuing this AD to prevent failure of the torque tube assembly. The unsafe condition, if not addressed, could result in reduced controllability and subsequent loss of control of the helicopter.

(ii) Visually inspect each roller bearing (number 5) as depicted in Figure 1 to paragraph (g)(1) of this AD for corrosion and degradation. If a roller bearing has any corrosion or degradation, before further flight, remove the roller bearing from service and install an airworthy roller bearing.

inspect each roller bearing (number 5) as depicted in Figure 1 to paragraph (g)(1) of this AD for damage. For the purposes of this inspection, damage may be indicated by corrosion, lack of lubrication (dry exterior surface), or material degradation.

(i) Using a flashlight and mirror, visually inspect the torque tube for corrosion and cracks. If there is any corrosion or a crack, before further flight, remove the torque tube from service and install an airworthy torque tube.

(2) Before the helicopter accumulates 3,000 total hours TIS or within 100 hours TIS after the effective date of this AD, whichever occurs later, and thereafter at intervals not to exceed 100 hours TIS, perform a freedom-of-movement inspection on the torque tube assembly by accomplishing the actions required by paragraphs (g)(2)(i) through (v) of this AD.

(i) Disconnect the one-way lock (number 6) of the torque tube by removing the cotter pin (number 7), nut (number 8), bolt (number 9), washers (number 10), and slotted bushing (number 11) from the torque tube assembly as depicted in Figure 1 to paragraph (g)(1) of this AD.

(B) If any roller bearing (number 5) as depicted in Figure 1 to paragraph (g)(1) of this AD has any damage, before further flight, remove the roller bearing from service and install an airworthy roller bearing.

(A) Install the slotted bushing (number 11), washers (number 10), bolt (number 9), nut (number 8), and new (zero total hours TIS) cotter pin (number 7) as depicted in Figure 1 to paragraph (g)(1) of this AD.

(B) Ensure the edge of the slotted bushing (number 11) protrudes 0.010 to 0.080 inch (0.25 to 2.03 mm) above the surface of the cyclic torque tube after the nut is tightened.
