[Docket No. FAA–2025–0922; Project Identifier MCAI–2024–00650–R; Amendment 39–23163; AD 2025–20–10]

Airworthiness Directives; Airbus Helicopters

2025–20–10 Airbus Helicopters:

Joint Aircraft System Component (JASC) Code 6422, Tail Rotor System.

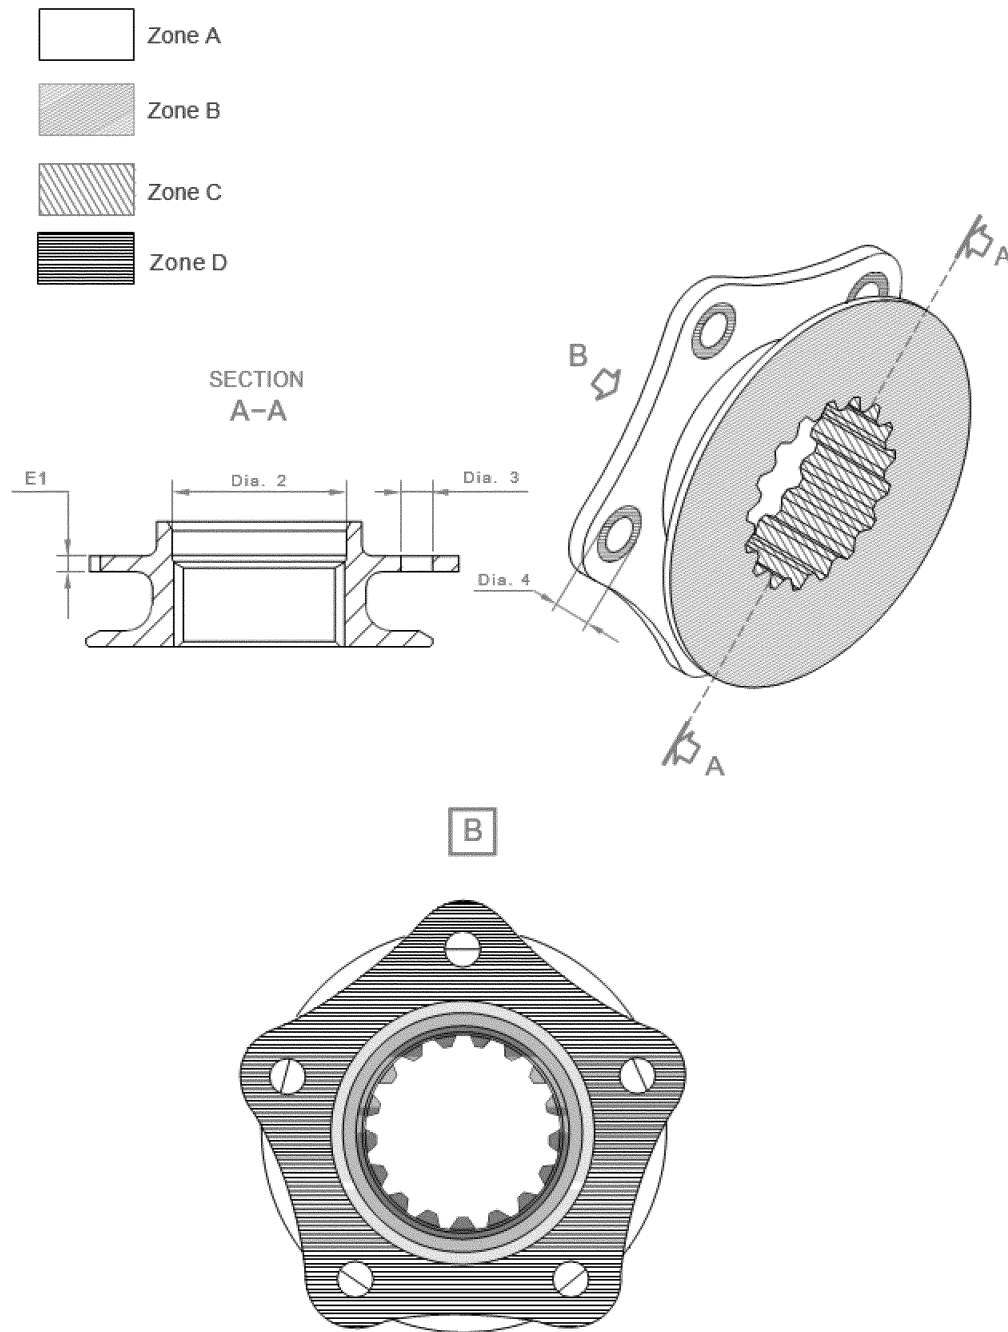
Figure 2 to paragraph (g)(1)(ii)—Inpsection
Area of Tail Rotor Splined Flange

(ii) Inspect the TR splined flange for corrosion, impacts, fretting, wear, and a crack in the areas identified in Figure 2 to paragraph (g)(1)(ii) of this AD. If the condition of the part (including corrosion, impacts, fretting, wear, or cracks) exceeds the criteria as specified in Figure 1 to paragraph (g)(1)(ii) of this AD, before further flight, remove the splined flange from service and replace with an airworthy part.

Location as specified in Figure 2 to paragraph (g)(1)(ii) of this AD	Maximum damage, which causes replacement (E1, Dia. 2, Dia. 3, and Dia. 4 are shown in Figure 2 to paragraph (g)(1)(ii) of this AD)
Zone A	Scratch depth > 0.2 mm (0.008 in.). Crack. E1 < 2.75 mm (0.108 in.). Dia. 3 > 6.02 mm (0.2371 in.). Dia. 2 > 33.03 mm (1.3004 in.).
Zone B	Touch-up depth > 0.1 mm (0.004 in.). Crack.
Zone C	Crack. Scratch depth > 0.2 mm (0.008 in.).
Zone D [Dia. 4 = 14 mm +/- 0.1 mm (0.548; 0.555in.)]	Touch-up depth > 0.1 mm (0.004 in.). Crack. E1 < 2.75 mm (0.108 in.).
