## DEPARTMENT OF TRANSPORTATION

[Docket No. FAA–2025–5394; Project Identifier AD–2025–01194–R]

### Airworthiness Directives; Restricted Category Model CH–47D Helicopters

**ACTION:** Supplemental notice of proposed rulemaking (SNPRM).

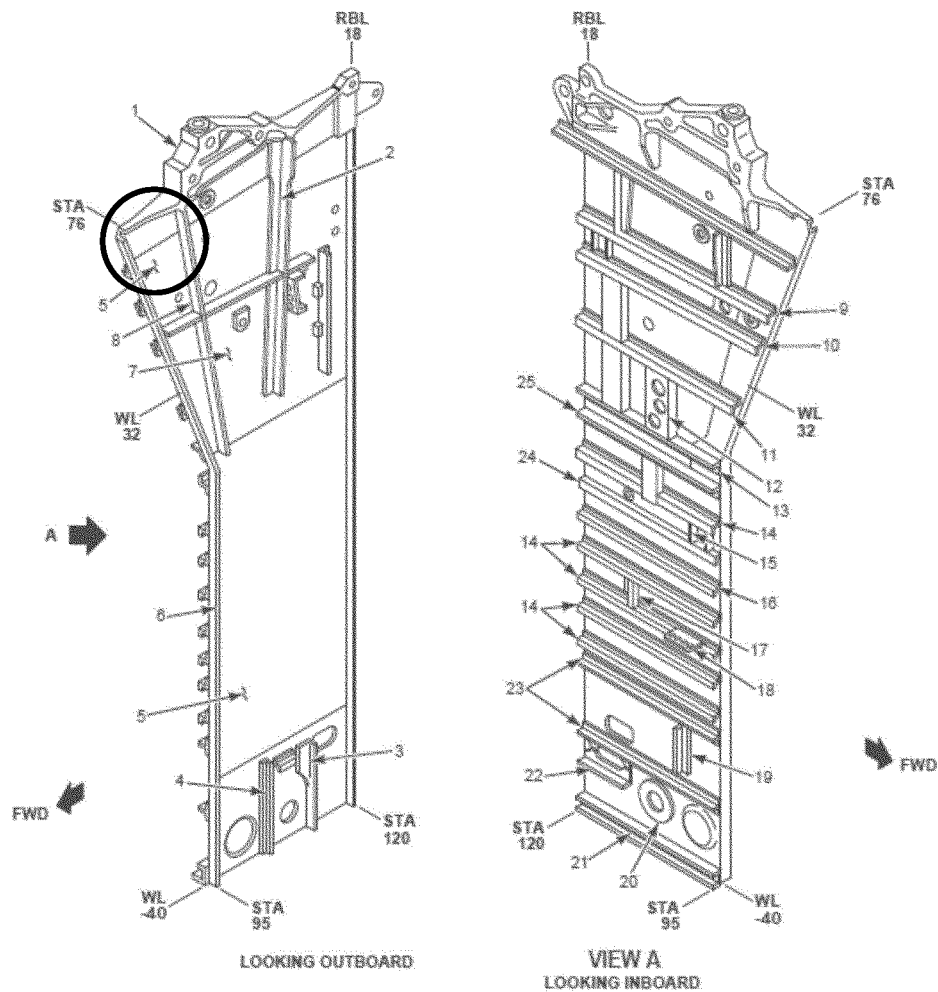
**Figure 1 to Paragraph (g)(1)—Transmission Support Beam Inspection**

Billings Flying Service stated that if the reported cracks are exclusively found to be in the forward area on the inboard face of the mount ("area of interest"), then the inspection should be conducted and specified where the damage has been found. The commenter further stated requiring full open-up and complete mount inspection every 100 hours TIS would be a significant burden to the operator, and complete access to the installed part would require significant additional maintenance.

order to provide a boundary area. Paragraph (g)(1) of the Required Actions paragraph of this proposed AD has been revised by adding, “and from the top cap to lower termination of the fitting for cracks” when describing the area of inspection.

This AD was prompted by reports of fatigue cracking of the right-hand (RH) forward transmission support beam fittings. The FAA is issuing this AD to detect and address fatigue cracking of the RH forward transmission support beam fittings. The unsafe condition, if not addressed, could result in crack propagation and lead to failure of the RH forward transmission support beam fittings, excessive vibration, and loss of control of the helicopter.

(1) Within 30 hours time in service (TIS) after the effective date of this AD and thereafter at intervals not to exceed 100 hours TIS, using a 7X or higher power magnification and light source, visually inspect the RH forward transmission support beam fitting, any part number, at right butt line (RBL) 18 from station (STA) 76 to STA 95, and from the top cap to lower termination of the fitting for cracks. Fastener holes in the area circled in figure 1 to paragraph (g)(1) of this AD are most susceptible to cracking. If any crack is detected, before further flight, repair or replace parts using a method approved by the Manager, West Certification Branch, FAA, in accordance with the procedures specified in paragraph (i) of this AD.
