[Docket No. FAA-2025-2546; Project Identifier AD-2025-01060-T; Amendment 39-23414; AD 2026-15-02]

#### Airworthiness Directives; The Boeing Company Airplanes

**SUMMARY:** The FAA is superseding Airworthiness Directive (AD) 2024-19-14, which applied to certain The Boeing Company Model 777-200, 777-200LR, 777-300ER, and 777F series airplanes. AD 2024-19-14 required repetitive inspections and bond resistance measurement of the bonding jumpers on the first fuel feed tube installed immediately forward of the wing front spar at the left and right main fuel tank penetrations and applicable corrective actions. This AD was prompted by a determination that additional inspections are required to address the unsafe condition. This AD requires repetitive detailed inspections (DETs), repetitive bond resistance measurement, and applicable on-condition actions. This AD also expands the applicability and requires revising the existing maintenance or inspection program, as applicable, to incorporate a certain airworthiness limitation. The FAA is issuing this AD to address the unsafe condition on these products.

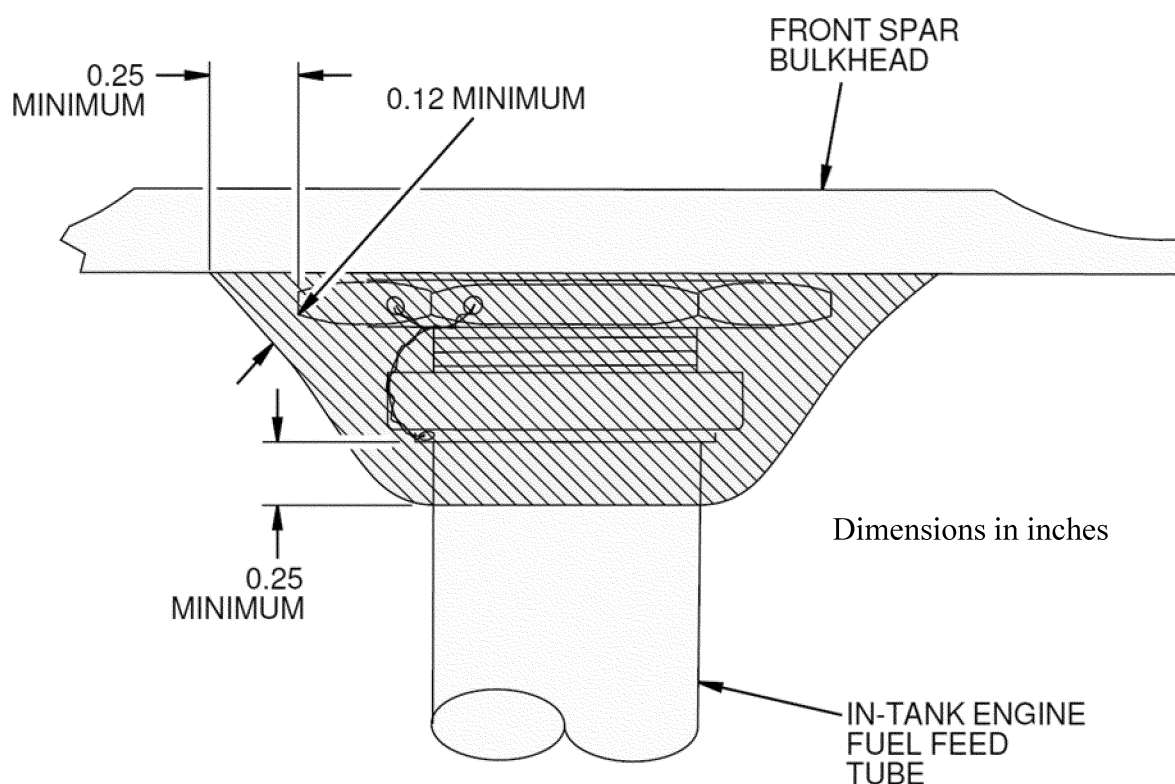
**Figure 2 to paragraph (i) – Fuel Feed Encapsulation**

| AWL NUMBER | TASK | INTERVAL | APPLICABILITY | DESCRIPTION |
|---|---|---|---|---|
| 28-AWL-05 | CDCCL | N/A | ALL | <p>Lightning Protection – Engine Fuel Feed Line Fuel Tank Penetration Bonding to Spar</p> <p>Concern: Potential for arcing or sparking inside the tank at the interface between the bulkhead fitting and the spar during a lightning strike event.</p> <p>The following design features must be verified (refer to Boeing AMM 28-22-15) if the bulkhead fitting or attached tubing is removed and reinstalled or replaced:</p> <ol style="list-style-type: none"> <li>1. A fay sealed fay surface bond is installed between the bulkhead fitting and the front spar inside the tank.</li> <li>2. The electrical bonding resistance across the fay surface between the bulkhead fitting and the front spar inside the tank is 0.0010 ohm (1.0 milliohm) or less.</li> <li>3. Bonding jumpers are installed as follows. <ol style="list-style-type: none"> <li>a. For airplane line number 1-829: <ol style="list-style-type: none"> <li>i. A bonding jumper is installed between the first fuel tube mating with the bulkhead fitting and structure inside the tank. <ol style="list-style-type: none"> <li>1. If the tube-to-structure bonding jumper was removed and reinstalled or replaced, the electrical bonding resistance between the structure and the first fuel tube mating with the bulkhead fitting inside the tank is 0.0100 ohm (10.0 milliohms) or less.</li> </ol> </li> </ol> </li> <li>b. For airplane line numbers 830 and on: <ol style="list-style-type: none"> <li>i. A bonding jumper is installed between the first fuel tube mating with the bulkhead fitting and the second AFT fuel tube inside the tank. <ol style="list-style-type: none"> <li>1. If the tube-to-tube bonding jumper was removed and reinstalled or replaced, the electrical bonding resistance between the first fuel tube mating with the bulkhead fitting and second AFT fuel tube inside the tank is 0.0100 ohm (10.0 milliohms) or less.</li> </ol> </li> </ol> </li> </ol> </li> </ol> |

| <p>ii. A bonding jumper is installed between the second AFT fuel tube and structure inside the tank.</p> <p>1. If the tube-to-structure bonding jumper was removed and reinstalled or replaced, the electrical bonding resistance between the structure and the second AFT fuel tube inside the tank is 0.0100 ohm (10.0 milliohms) or less.</p> <p>4. A full-bodied fillet seal is installed that encapsulates the bulkhead fitting to the front spar and the coupling nut inside the tank. (Refer to Boeing AMM 28-22-15/201 Temporary Revision published between September 16, 2025, and September 17, 2025; Boeing AMM 28-22-15/201 published on or after January 5, 2026.)</p> <p>a. The sealant is smooth and the sealant meets the required dimensions as specified in the accompanying figure.</p> <p>i. Sealant is considered sufficiently thick when the outline of the coupling or fitting hardware is not visible under the sealant.</p> <p>b. Each sealant interface passes an adhesion test using a Fixion eraser.</p> <p>i. Peeling of the brushcoat is not considered a failure if the peeling stops before the Class B seal.</p> | | | | |
