**April 1999**

# MILITARY SAFETY

Army M939 5-Ton Truck Accident History and Planned Modifications

B-282071

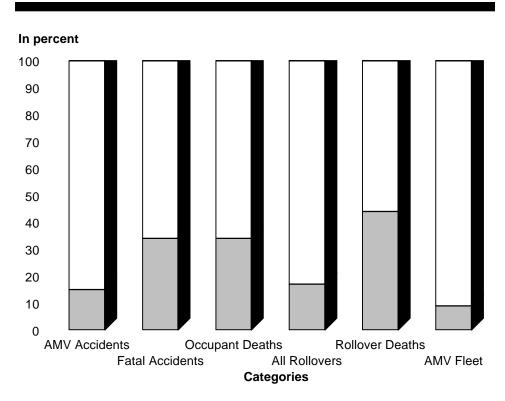
Figure 2: Comparison of Selected M939 Accident Statistics to Remaining Army Motor Vehicle Fleet, 1987-1998

Our comparison of M939 accident statistics with accident statistics for the rest of the Army motor vehicle fleet showed that the M939 accounted for about 34 percent of all Army motor vehicle fatal accident events, and 34 percent of all Army motor vehicle occupant deaths. Comparative rollover statistics revealed much the same. The M939 rollovers accounted for 17 percent of the total Army motor vehicle rollovers, and 44 percent of the total Army motor vehicle rollover fatalities. Figure 2 shows these accident statistics.

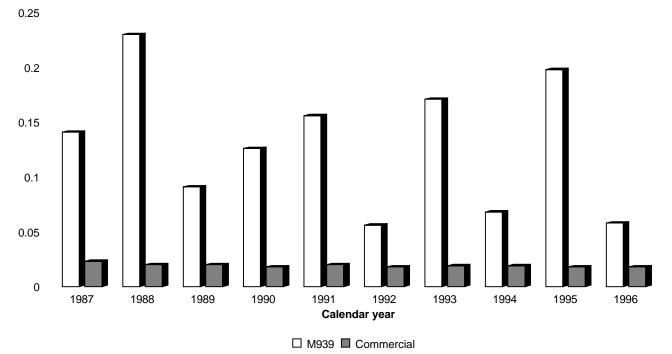
Figure 3: Comparison of Rate of Commercially Driven Single-Unit Medium and Heavy Trucks Fatal Crashes With Related M939 Statistics, 1987-1996

We found that over the 10-year period, 1987-1996, the frequency rates of fatal crashes per million miles driven for M939s averaged about seven times higher than those for commercial trucks. The M939 accident rate ranged from a high of 12 to a low of 3 times higher than the commercial truck rate. In 1988, the M939's accident rate was 0.23 and the commercial truck rate was 0.02—about 12 times higher; and in 1992, the M939 accident rate was 0.056 and the commercial truck rate was 0.018—about 3 times higher. Figure 3 shows these statistics.

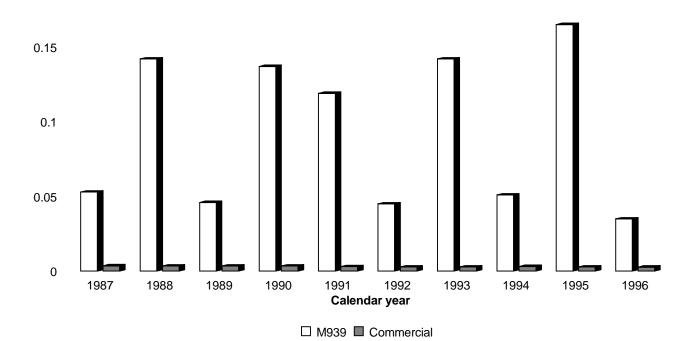
Figure 4: Comparison of Rate of Commercially Driven Single-Unit Medium and Heavy Trucks Occupant Fatalities With Related M939 Statistics, 1987-1996

We also found that, over this same 10-year period, the M939 occupant fatality rate averaged about 30 times higher than those for commercial

trucks. The M939 occupant fatality rate ranged from a high of 59 to a low of 13 times higher than the commercial truck rate. In 1995, the M939 occupant fatality rate was 0.165 and the commercial truck rate was 0.0028—about 59 times higher; and in 1989, the M939 rate was 0.046 and the commercial truck rate was 0.0035—about 13 times higher. Figure 4 shows these statistics.

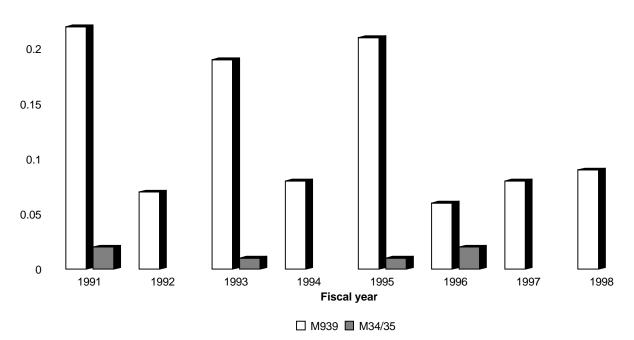
Figure 5: Comparison of Rate of Class A M939 and M34/35 Truck Mishaps, 1991-98

The Army Safety Center's analysis found accident rates for M939s to be higher than the comparison vehicles. The analysis showed M939 Class A mishap frequency rates per million miles driven to be 3 to 21 times higher than those of similar M34/M35 series 2-1/2 ton trucks.³ For example, the 1995 Class A mishap rate for the M939 was 0.21 and for the 2-1/2 ton M34/35s, it was 0.01 per million miles driven—about a 21-fold difference. Figure 5 shows this comparison.

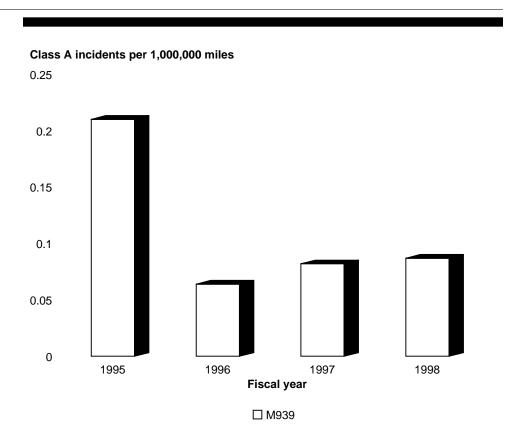
Figure 6: M939 Class A Incident Rates Since 1995

Although most scheduled modifications will not be completed until fiscal year 2005 or later, tacom and Army Safety Center personnel noted that accident rates have declined significantly since the reduced speed limits instituted by the December 1995 precautionary message. Figure 6 shows the drop in the number of mishaps since 1995.
