# NATIONAL BUREAU OF STANDARDS REPORT

9838

EXAMINATION OF FAILURE OF  
PRINTING PLATE, NO. 29724

Electrolytic Section  
Bureau of Engraving and Printing  
Washington, D. C.

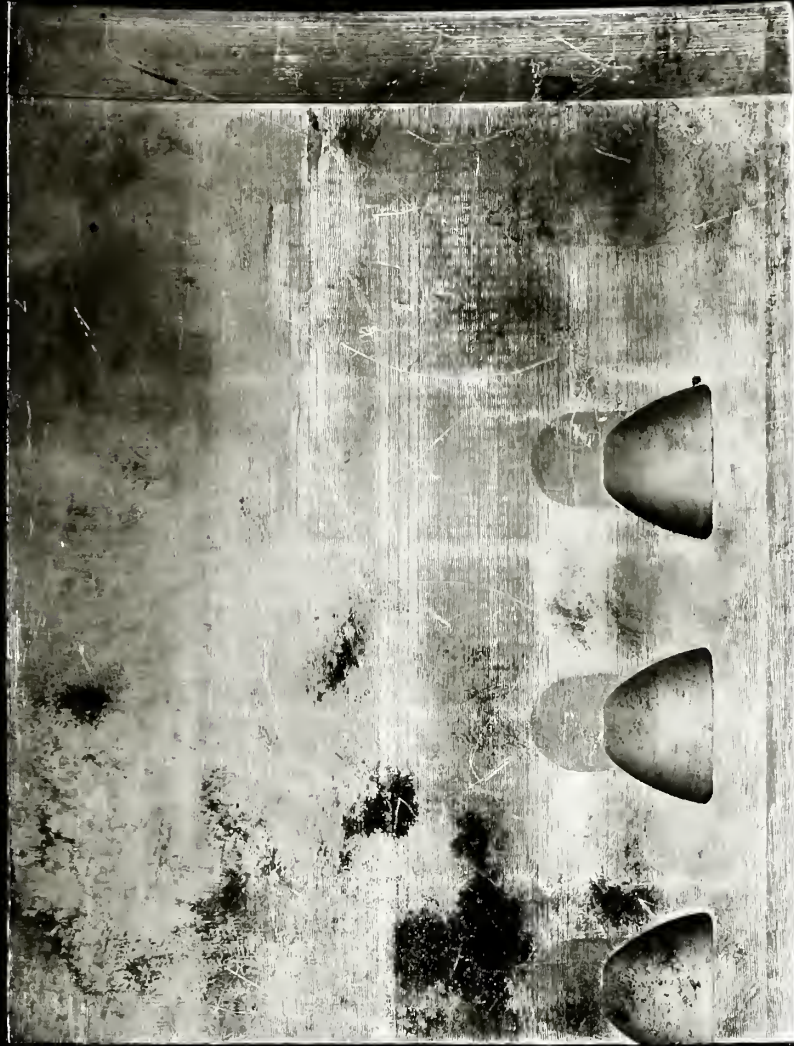
These dimensions show appreciable deviations from intended slot separation and from intended slot base length in both plates. As a result of these deviations and because the Roosevelt plate is thinner, the net material section area between slot corners is approximately 8 per cent less in the Roosevelt plate. The Roosevelt plate is also approximately 10 per cent thinner in the slot areas. Interestingly, the Lincoln plate did not crack at the slot corners as did the Roosevelt plate. Because the overall thickness of the Roosevelt plate is less than the Lincoln plate, and the steel under the gripper slots is substantially thinner, the cooling rate during a quench from 1550°F would be greater in the Roosevelt plate. This would produce a slightly higher hardness than previously observed in other plates, and in particular, the hardness in the vicinity of the gripper slots would be higher. Less available material to resist cyclic bending and higher hardness at the notch corners could produce an unfavorable combination that would accelerate the formation of fatigue cracks.

In comparison with a previously examined plate that did not fail in service, gripper slot separation in the subject plate was found to be closer and slot walls thinner. These conditions weakened the plate. The first condition increased the unit stress in the area between slots under the loading imposed. The second condition created an area that became excessively hard in heat treatment.

Figure 3, a Section cut from subject Roosevelt 4 cent plate that did not crack in gripper slot area.

Figure 3, b Section cut from subject Roosevelt 6 cent plate that did not crack in gripper slot area.

Note that slot separation is less and that slot size and depth are greater in the Roosevelt plate. X 1

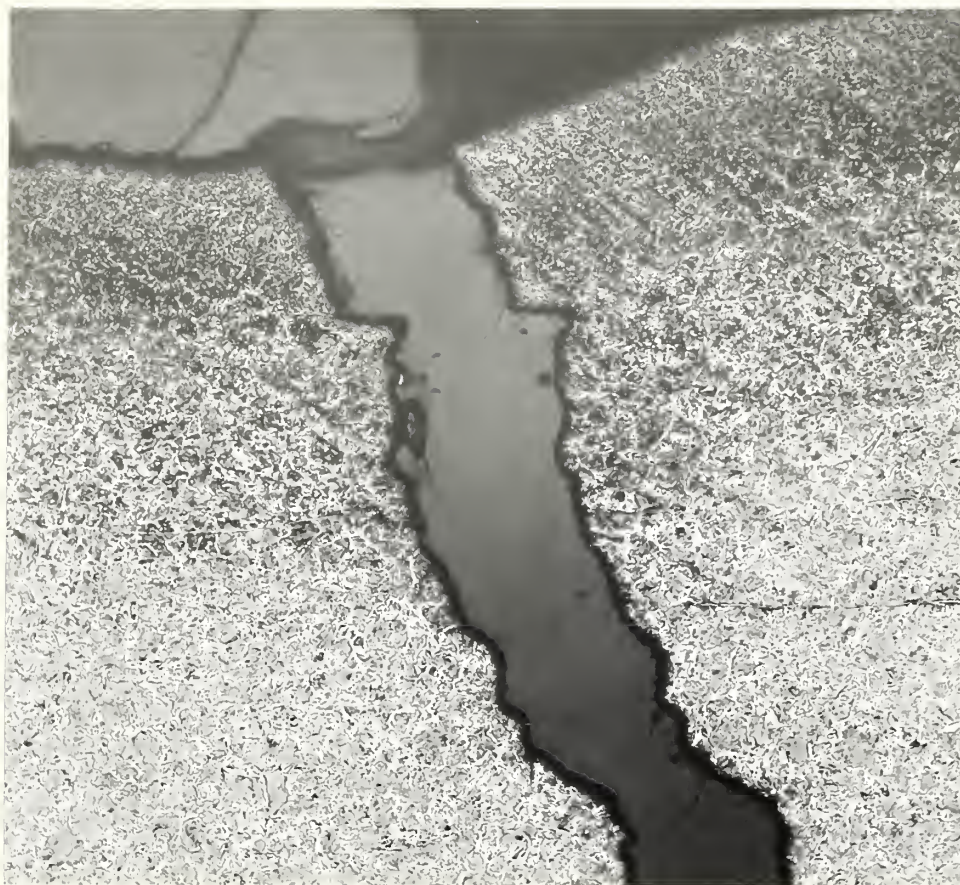
The hardness traverse indicated the presence of a case approximately 0.001 inch deep on both faces. It also indicated that the interior was uniformly hardened throughout inasmuch as there was no appreciable variation in hardness in the interior.

Depth of martensitic case  
approx. 0.0015 inch

**Figure 7.** Structure of longitudinal section of plate sample adjacent to fracture origin. Show no decarburization at plate surface. Martensitic case is approximately 0.0015 inch deep. Core is composed of partially spheroidized carbides (dark) in a ferrite matrix (white). Etched with 2% picral. X 500

5. Equalize loads on the grippers.
6. Temper plate to obtain a hardness of 79.5 to 81.5  $R_{15N}$  in the case, as measured on an area of full plate thickness.
