# Investigation of L'Ambiance Plaza Building Collapse in Bridgeport, Connecticut

Center for Building Technology  
National Engineering Laboratory  
National Bureau of Standards  
Gaithersburg, MD 20899

Issued September 1987

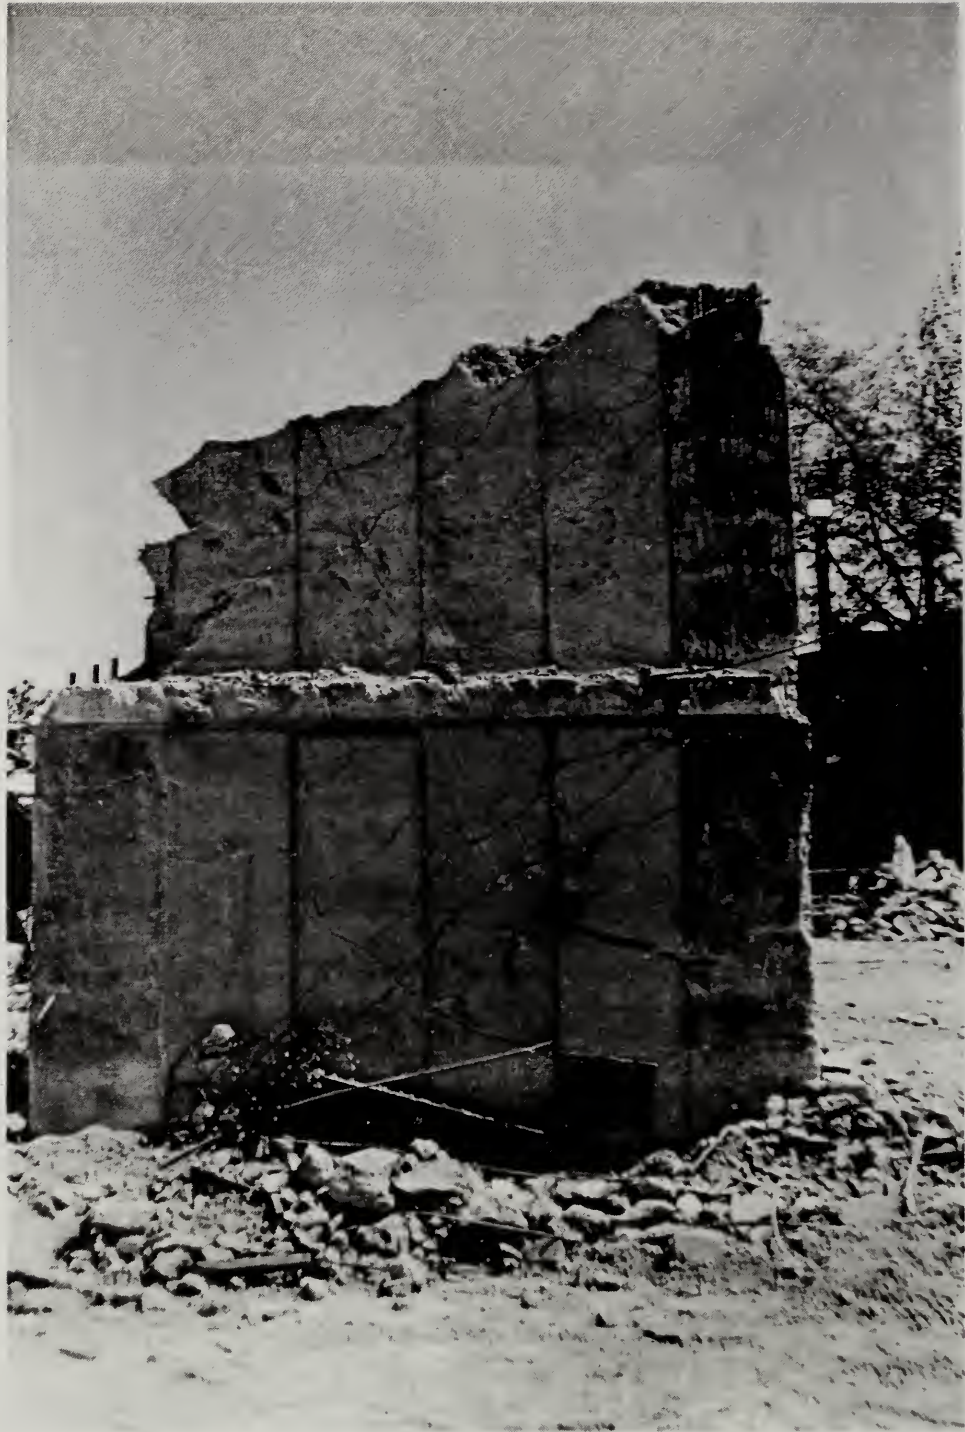
Figure 4.4.5 Diagonal tension crack in East tower shearwall -  
View to the South

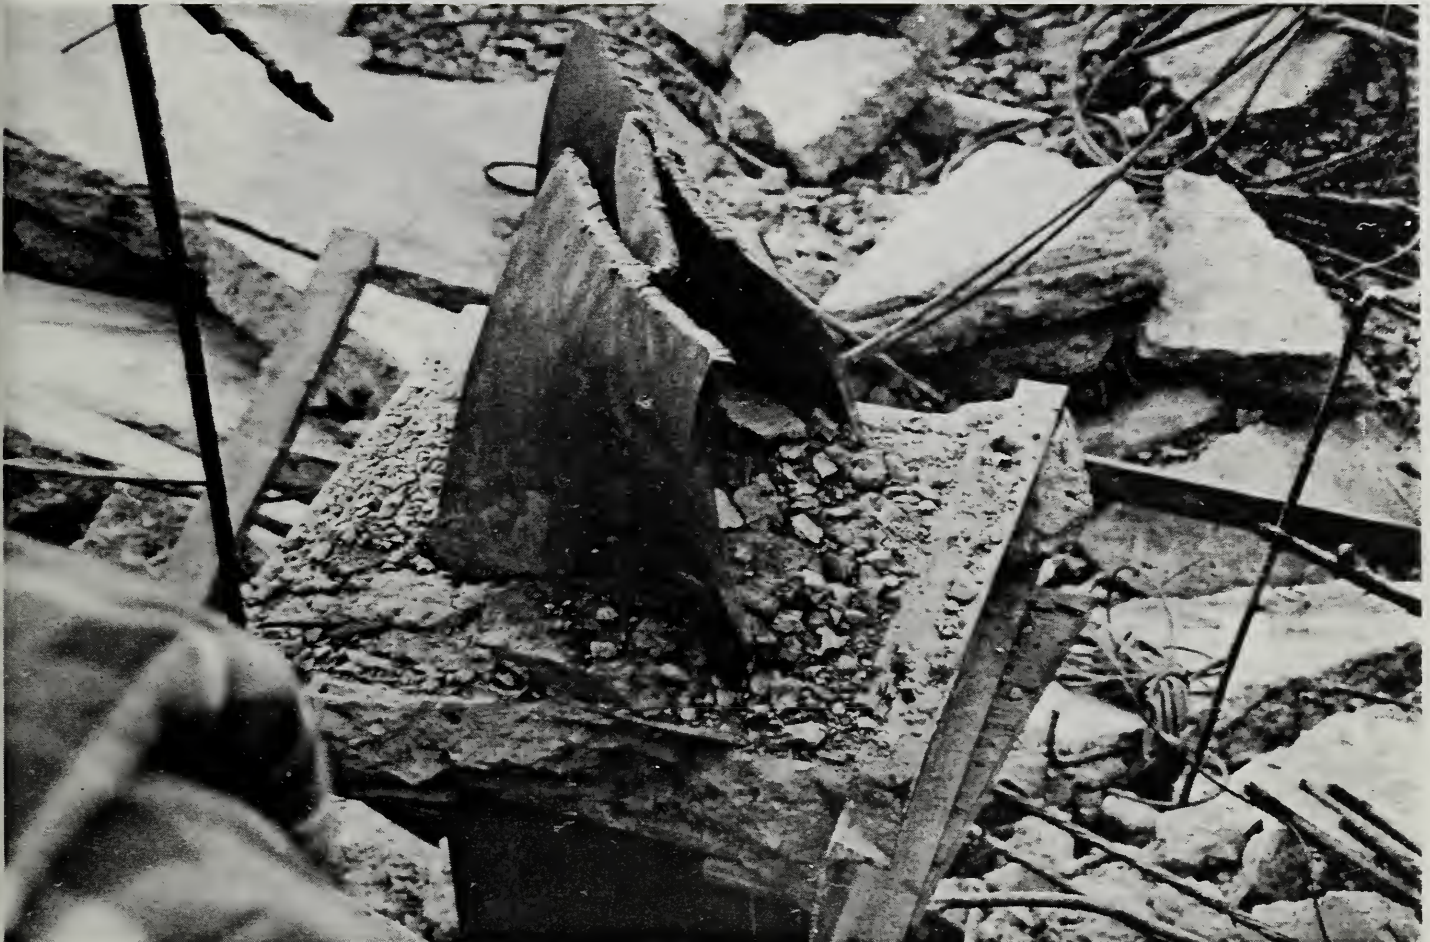
Figure 4.4.6 Twisting deformation of column in West tower

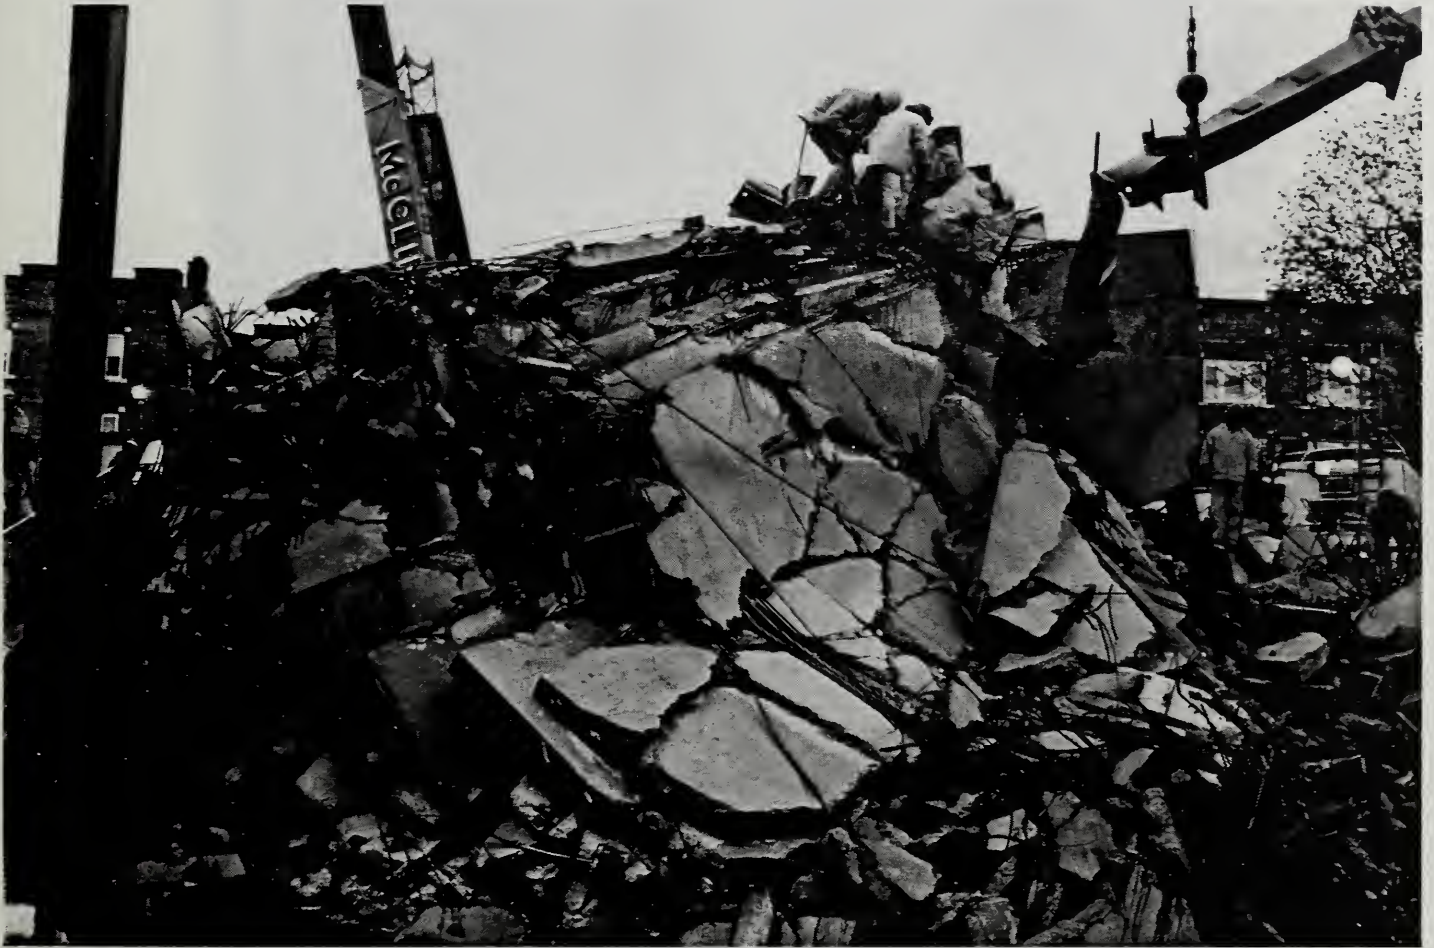
Typical crack patterns and broken floor slabs are shown in figures 4.4.16 and 4.4.17. Note the slabs broke into a number of small pieces. This would be expected once the post-tensioning is lost due to the lack of conventional reinforcing steel except in the vicinity of the columns.

Figure 4.4.16 Floor slab crack pattern

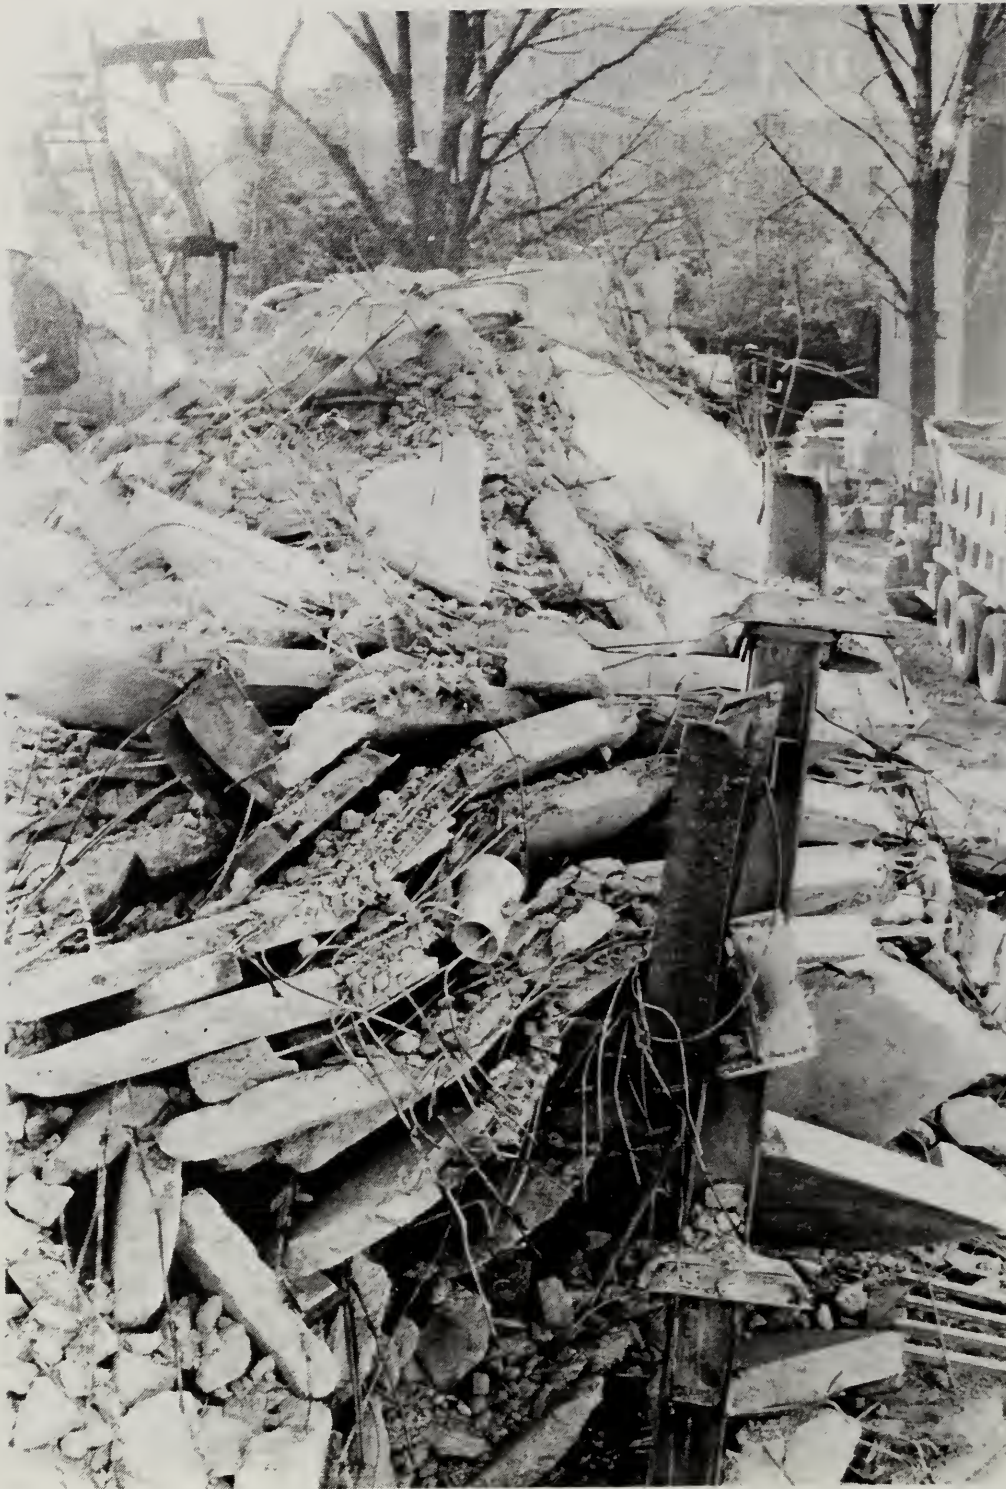
Figure 4.4.17 Broken floor slabs – View to the Southeast; column line H

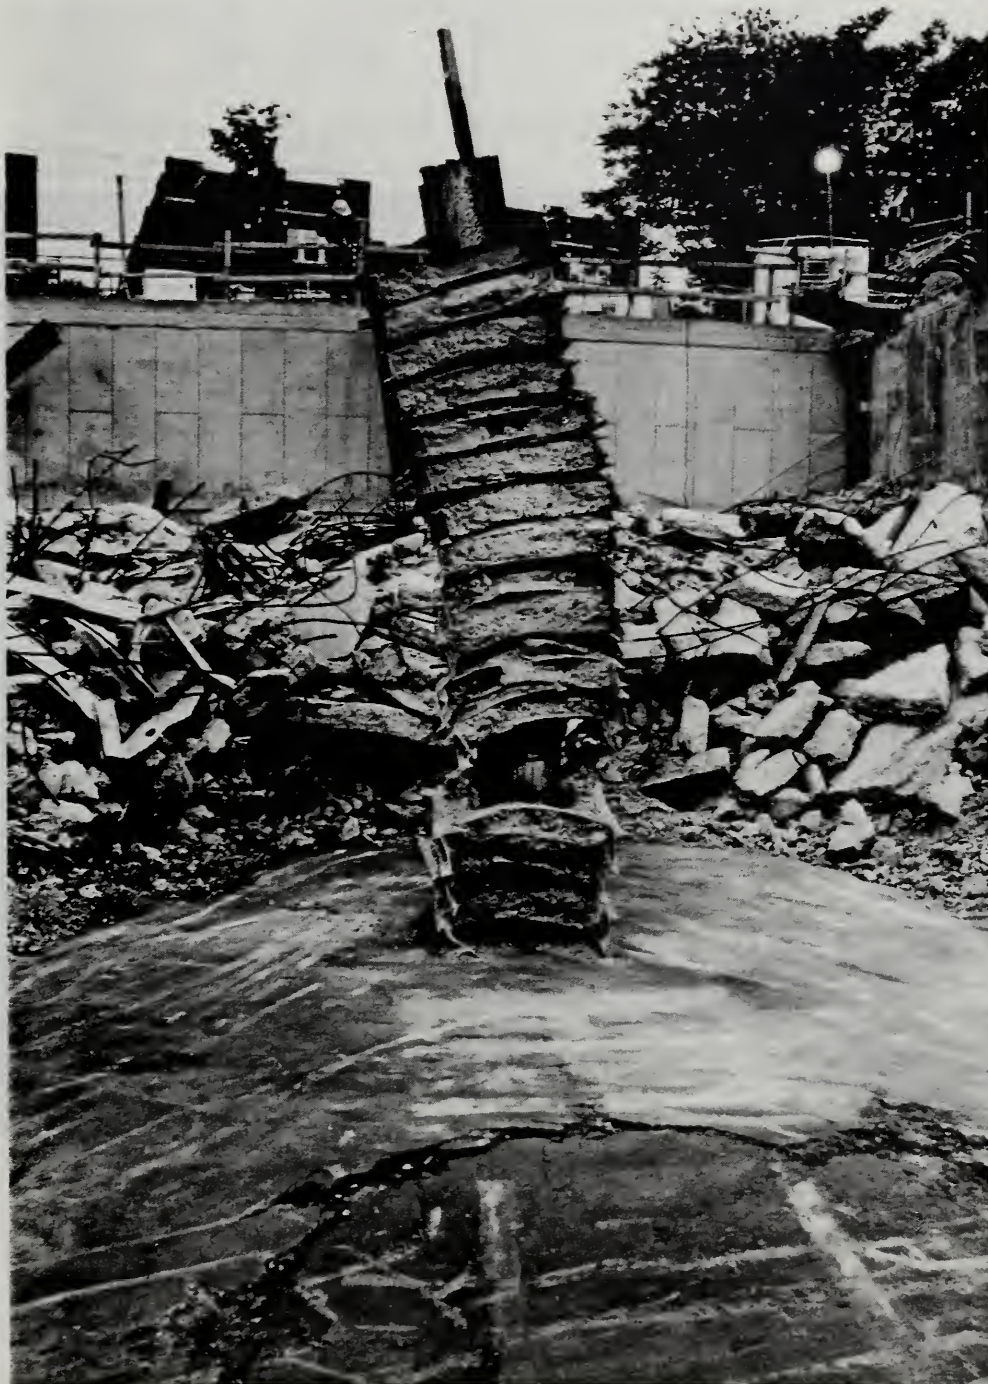
Figure 4.4.18 Deformation pattern of shearheads  
- column D10

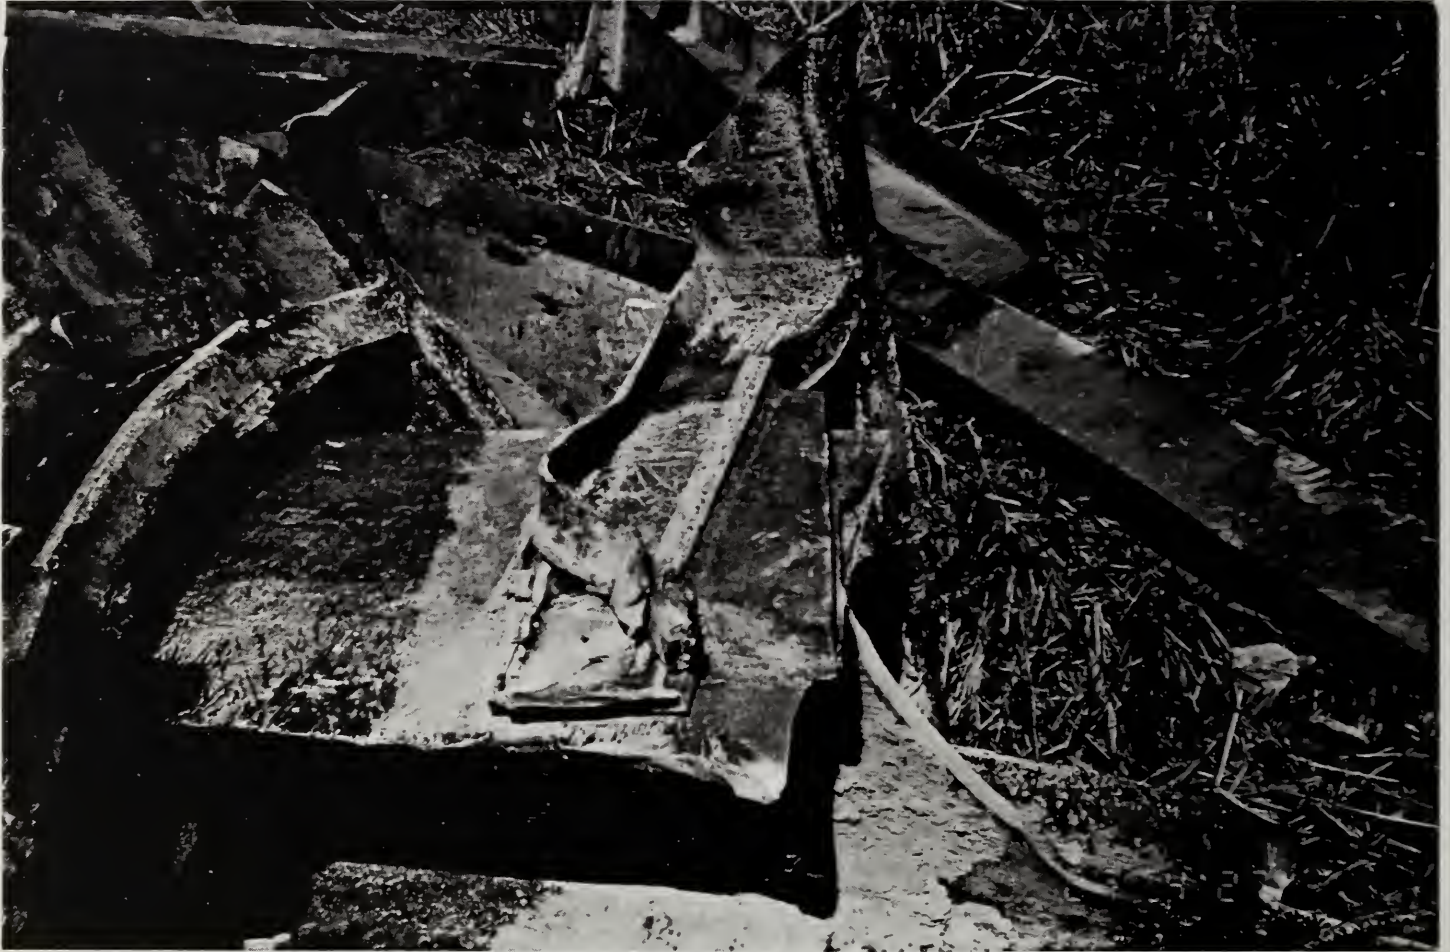
Figure 4.4.19 Failed shearheads

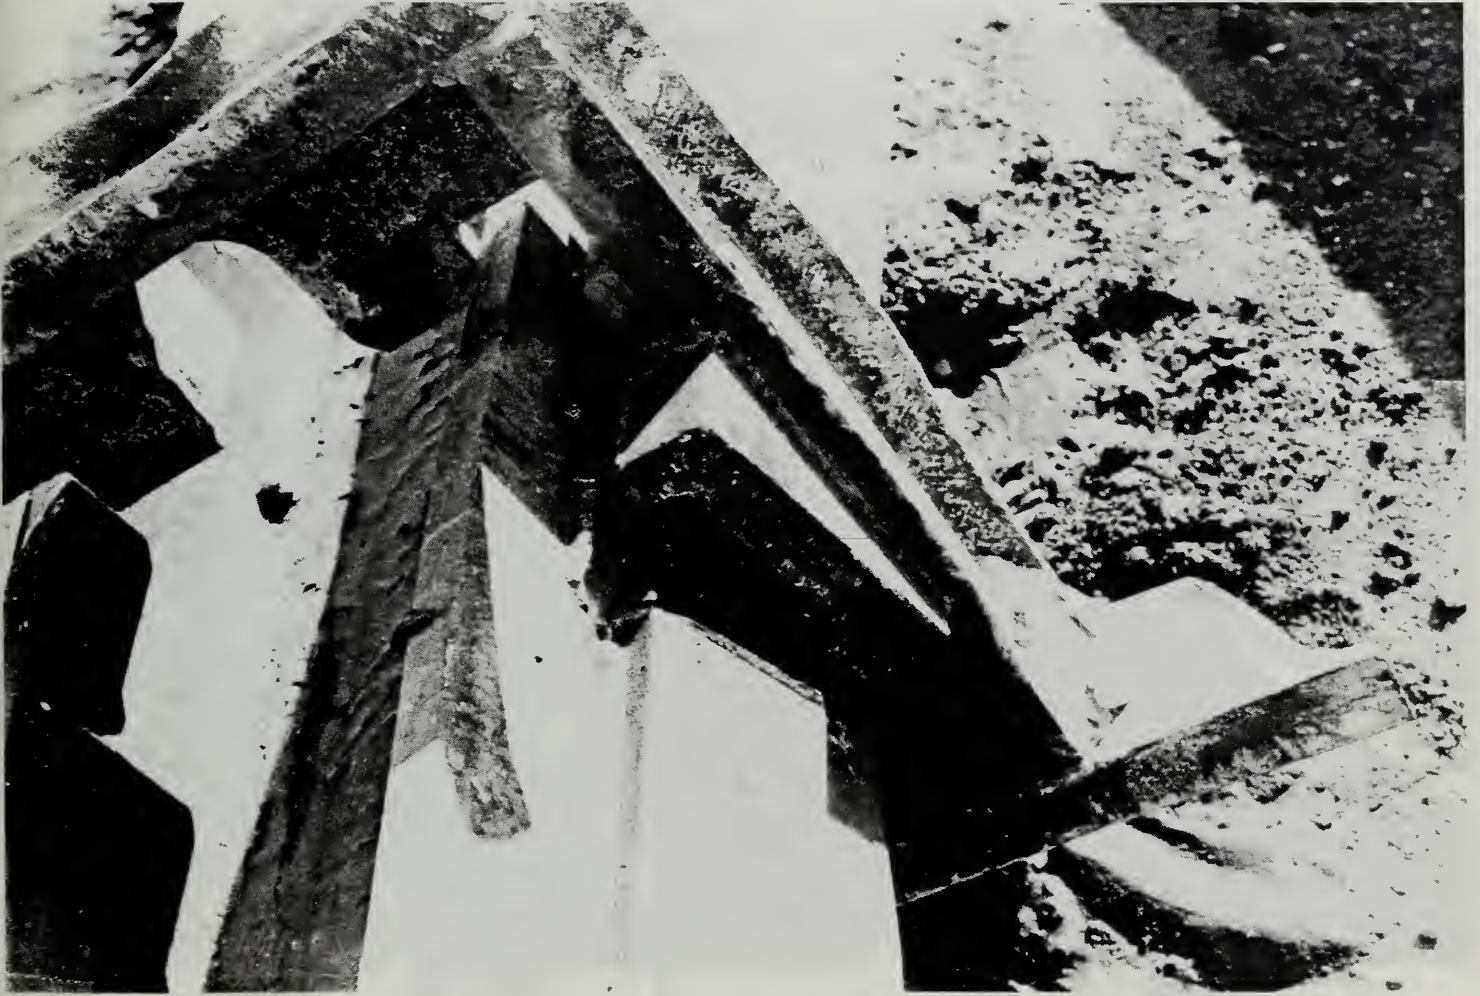
Figure 4.4.24 Weld failure at weld block

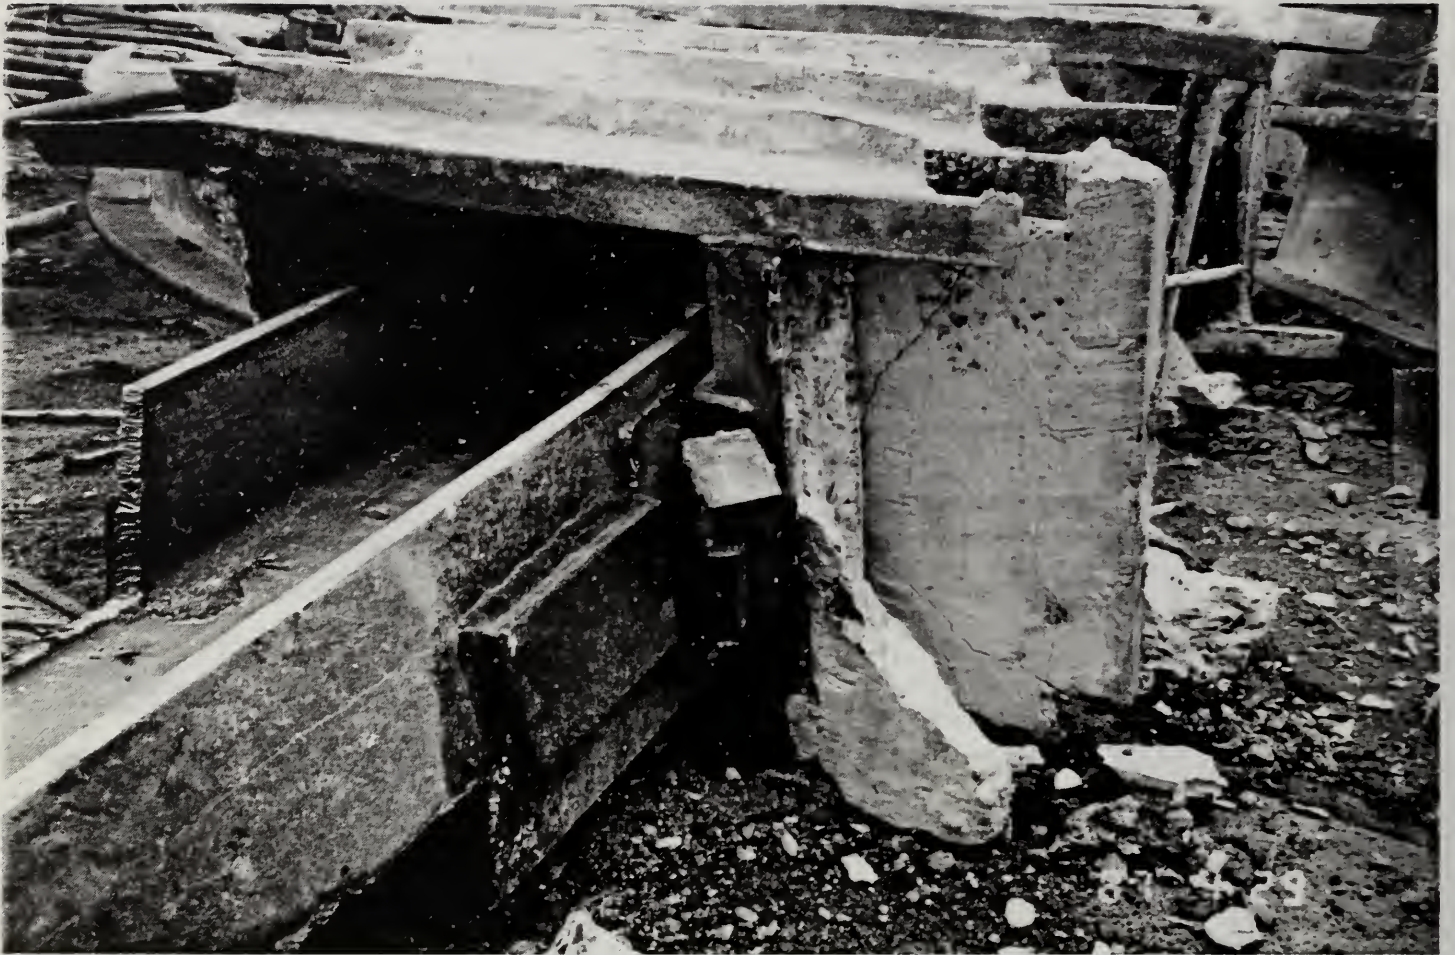
Figure 4.4.25 Weld failure at weld block with shim

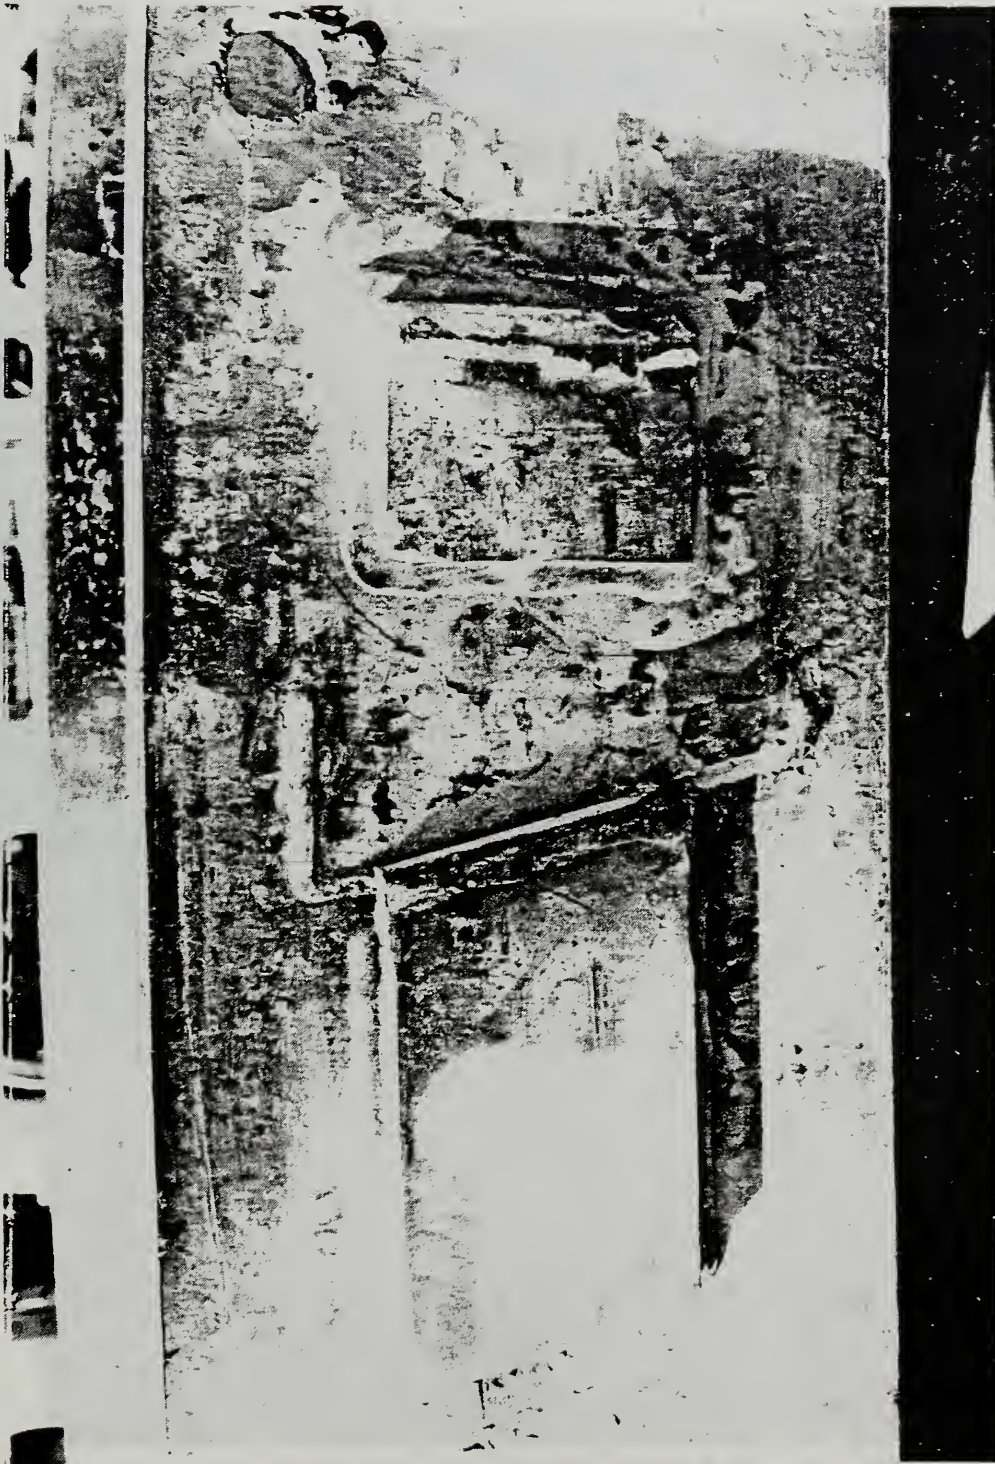
Figure 4.4.26 Weld failure at weld block

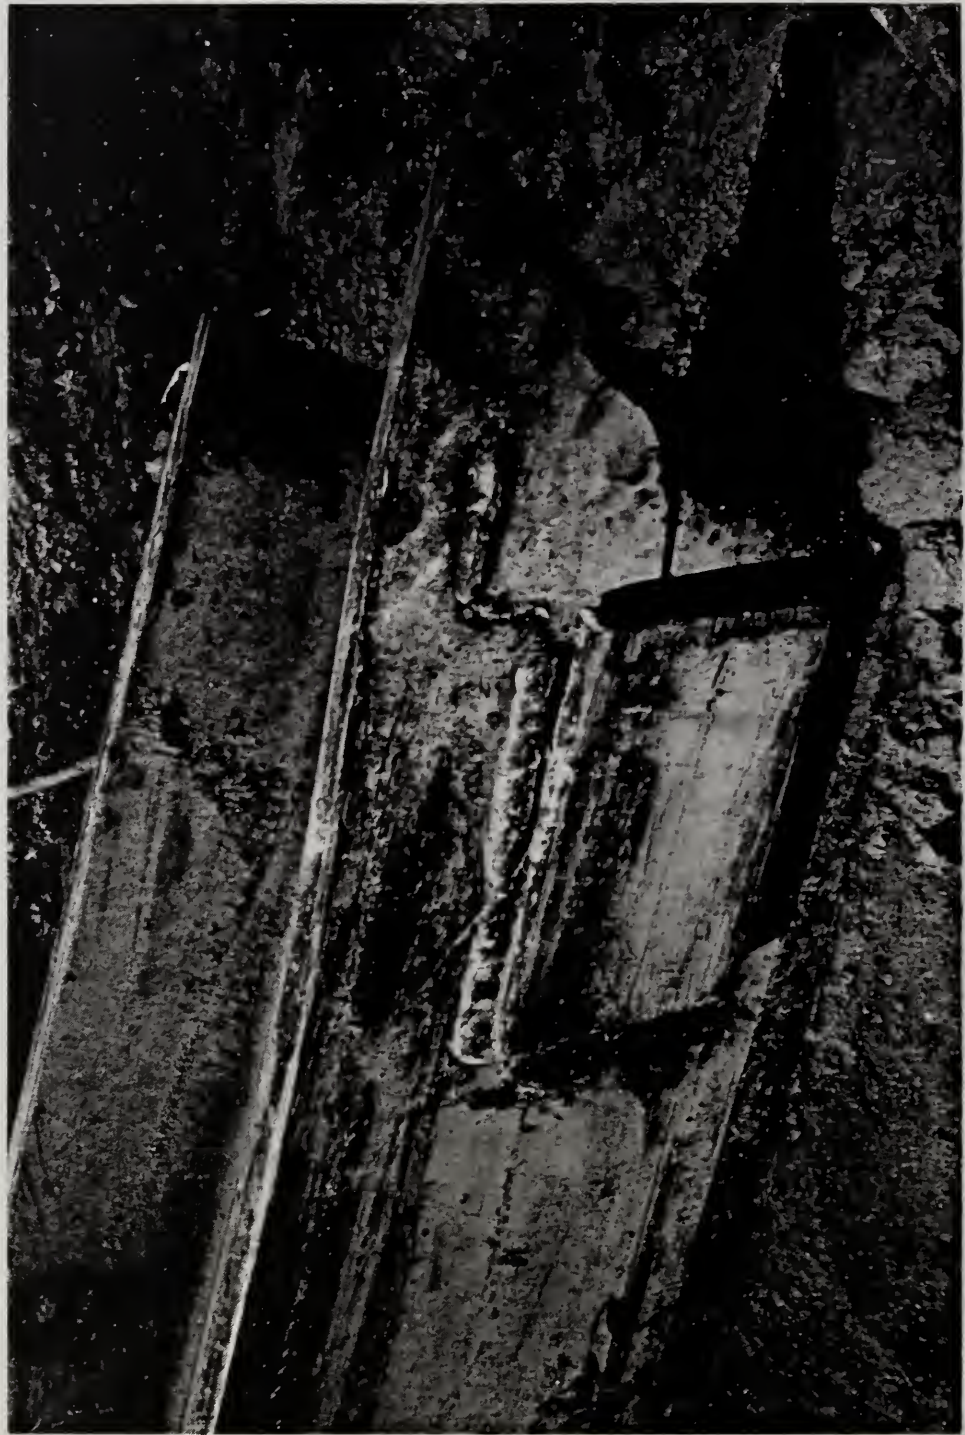
Figure 4.4.27 Weld block weld failure

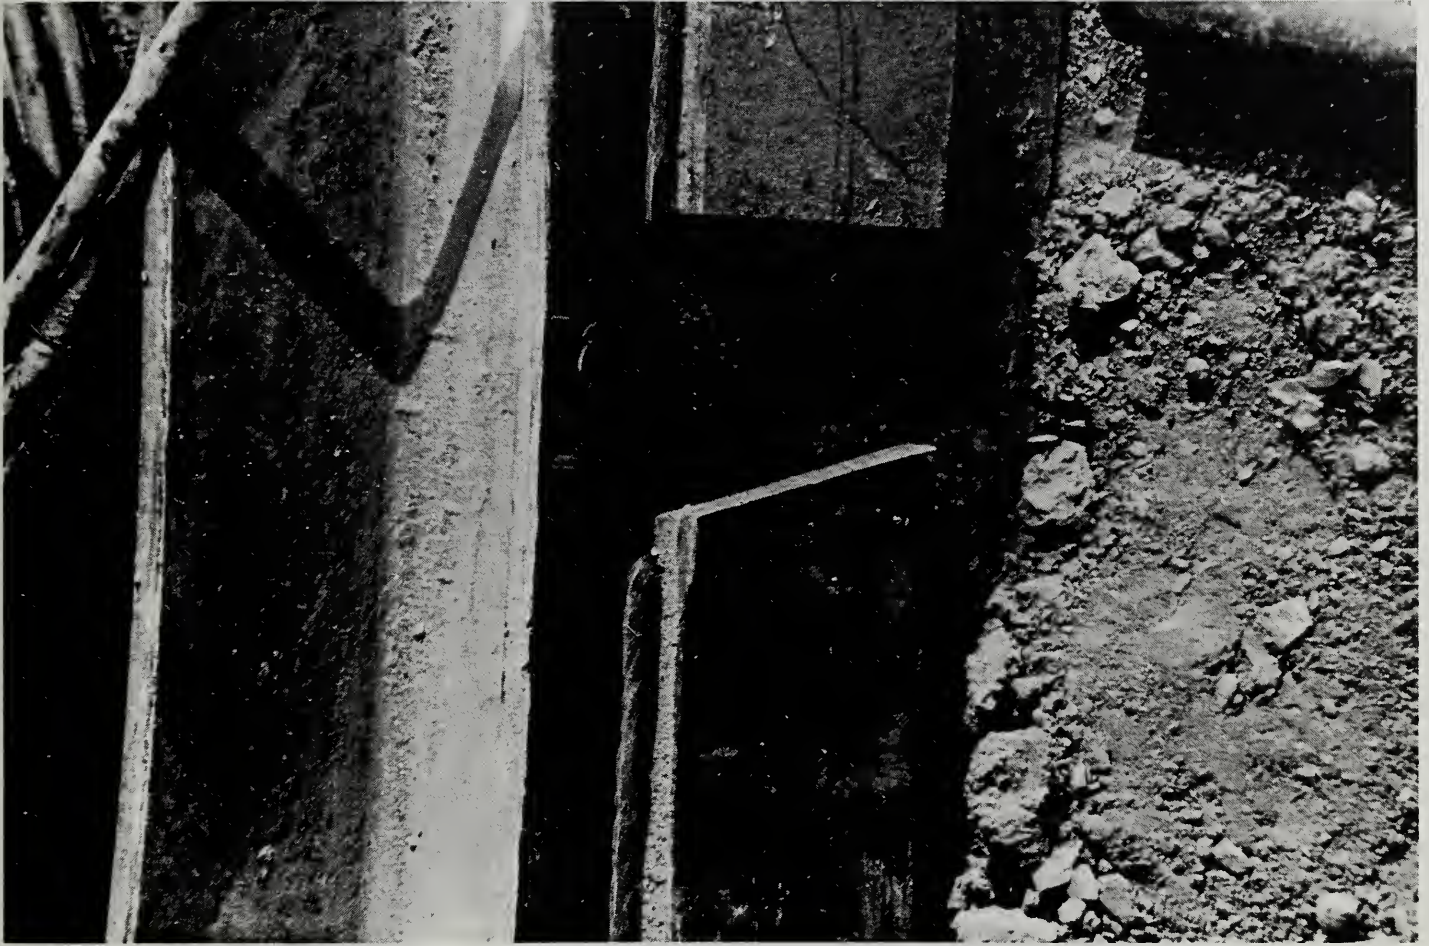
Figure 4.4.28 Failure of temporary weld at shearhead support

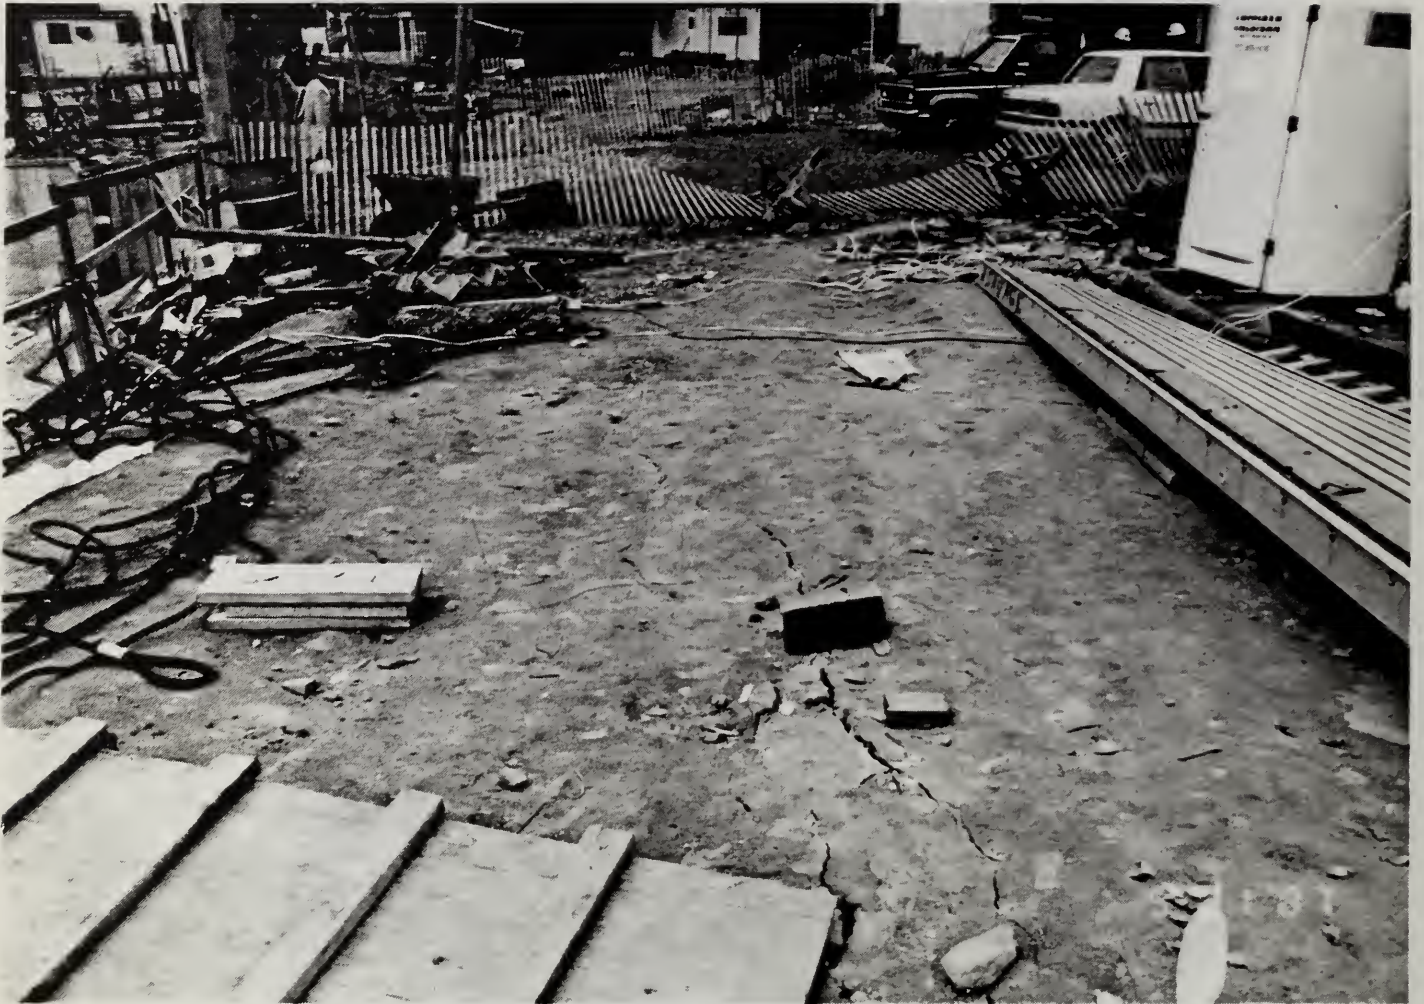
Figure 4.4.31 Tension cracks in backfill behind basement wall - North side of building

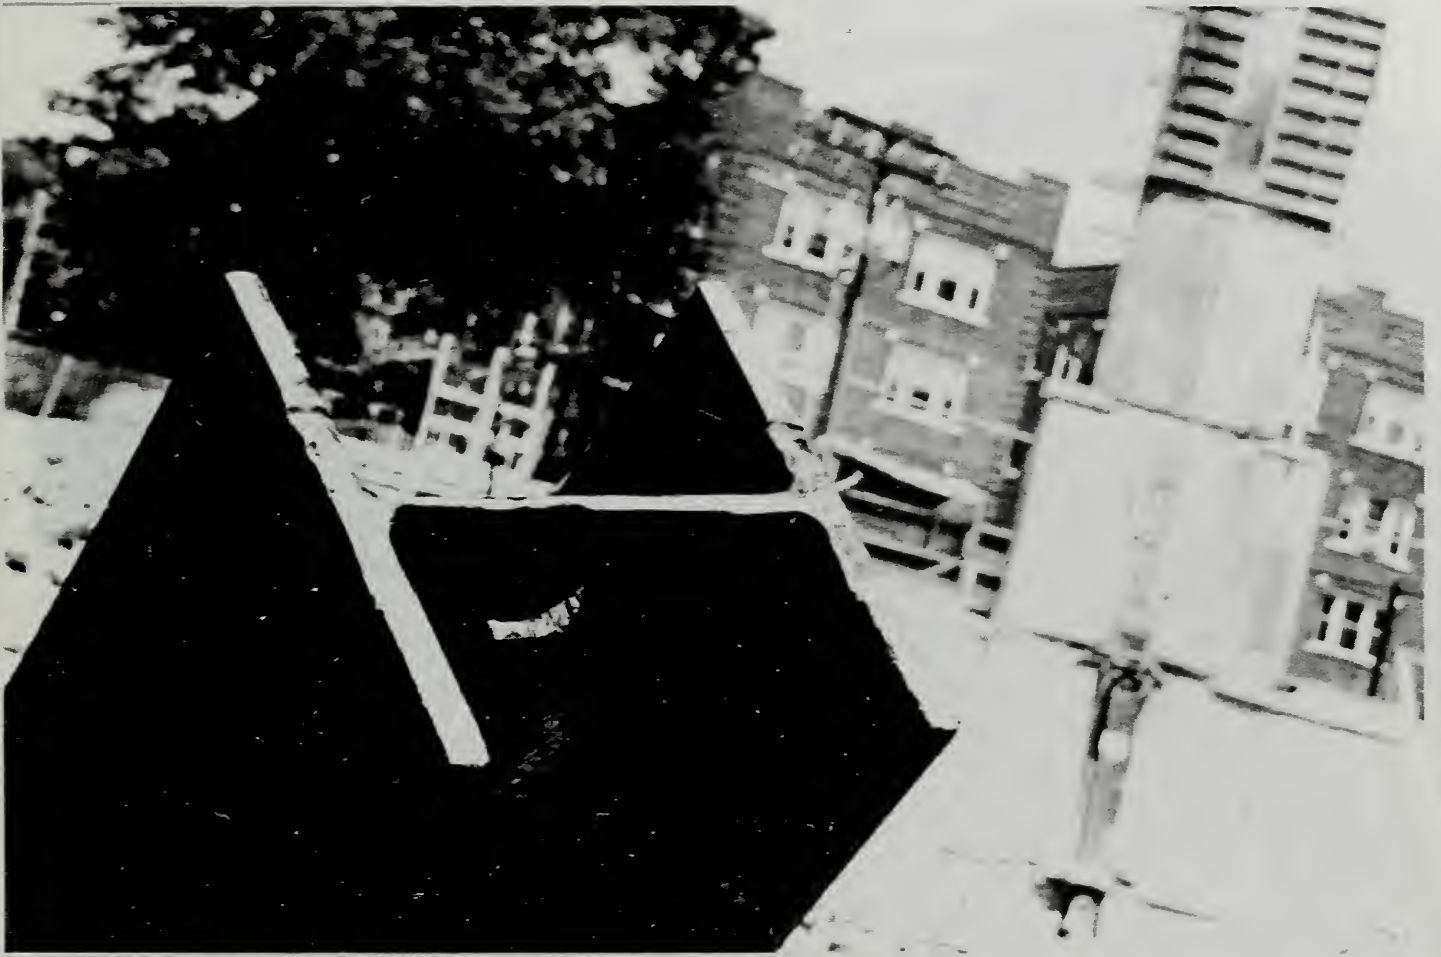
Figure 4.4.32 Typical indentation in top of column due to lifting jack

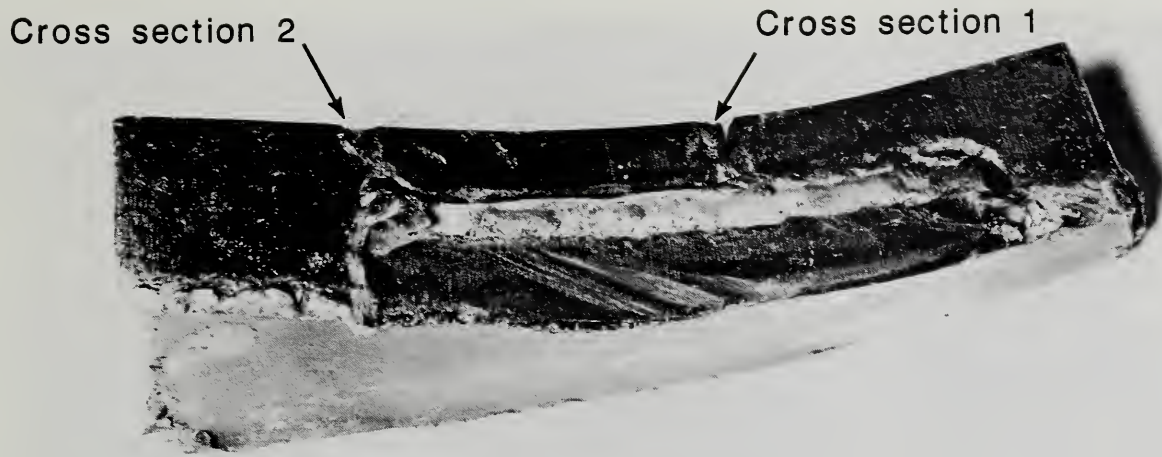
Figure 5.4.12 Fracture of fillet weld on wedge – specimen NBS 33B

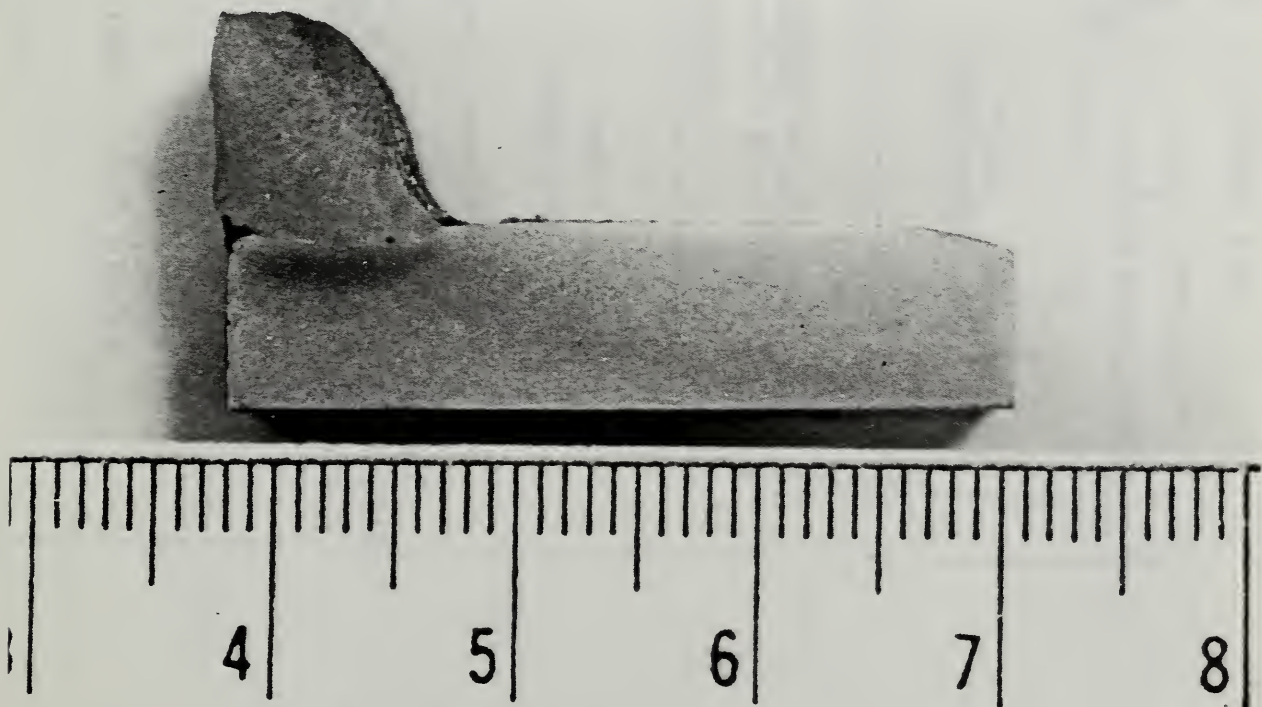
Figure 5.4.16 Metallographic cross section of failed weld along weld/column interface - specimen NBS 33A

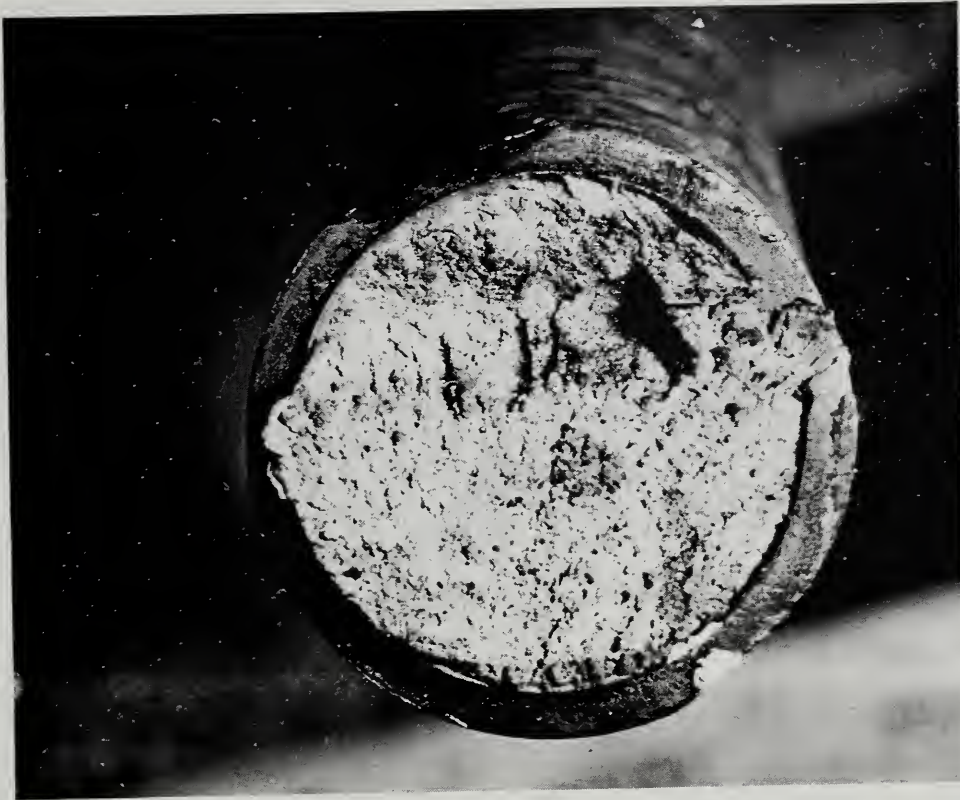
Figure 5.5.5 Fracture surface of jack rod, sample NBS 11-2 (x 1)

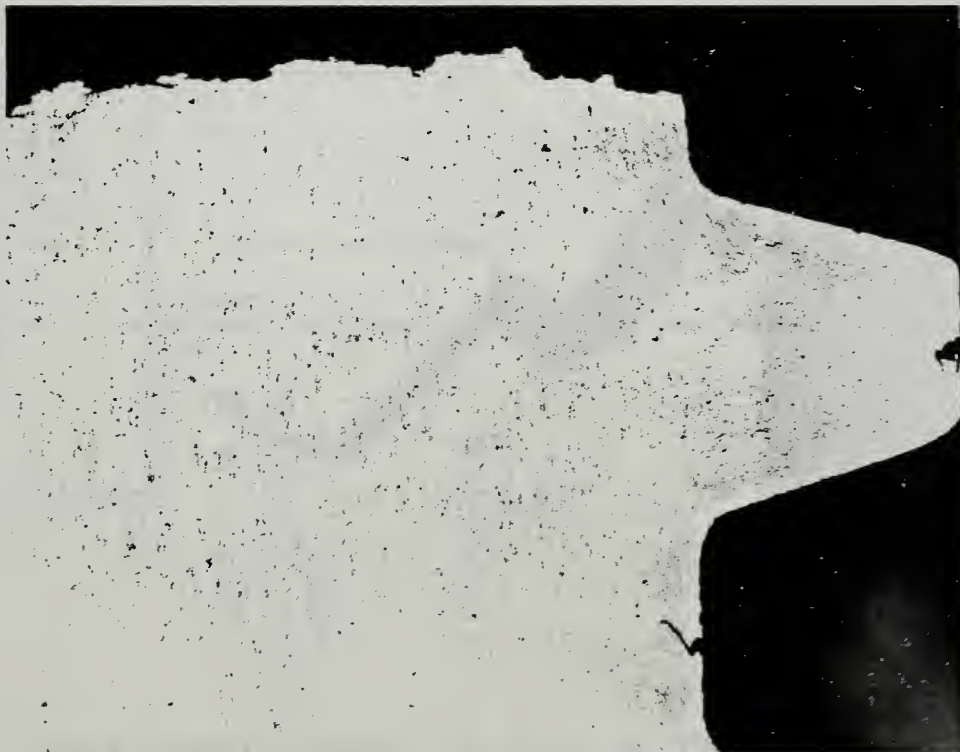
Figure 5.5.6 Fracture profile of jack rod, left, first thread adjacent to fracture (Sample NBS 11-2) (x 9)

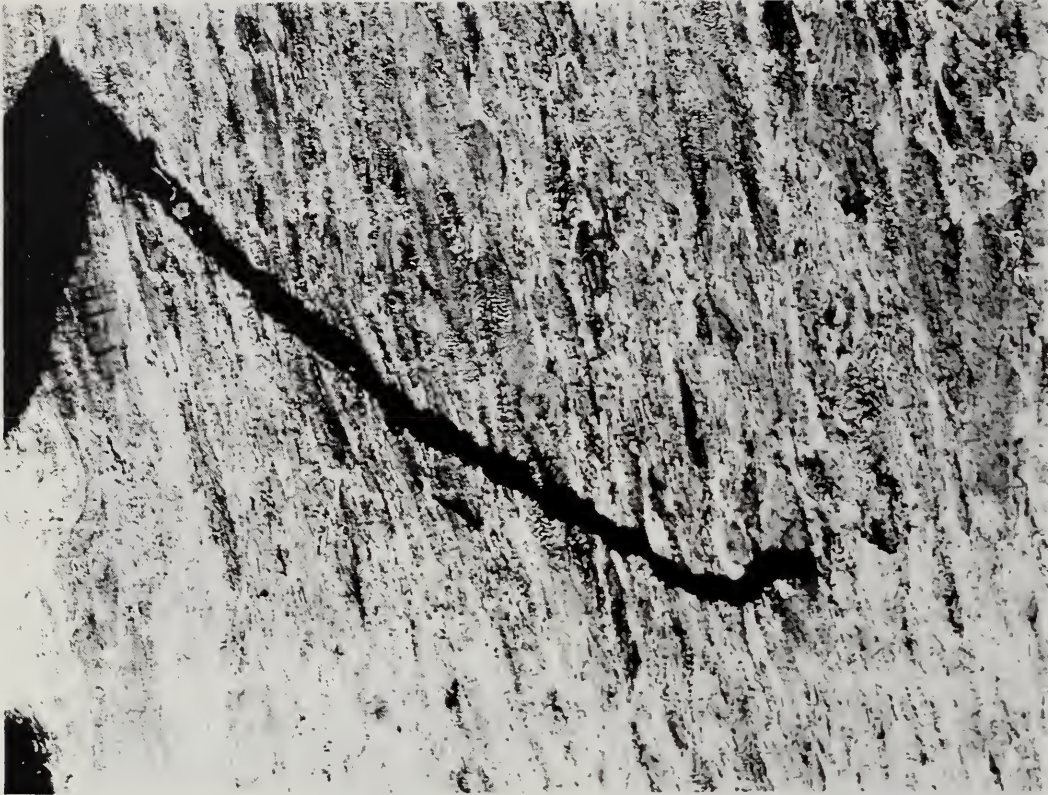
Figure 5.5.7 Lap seam at root of first thread removed from fracture of jack rod (Sample NBS 11-2) (x 500)

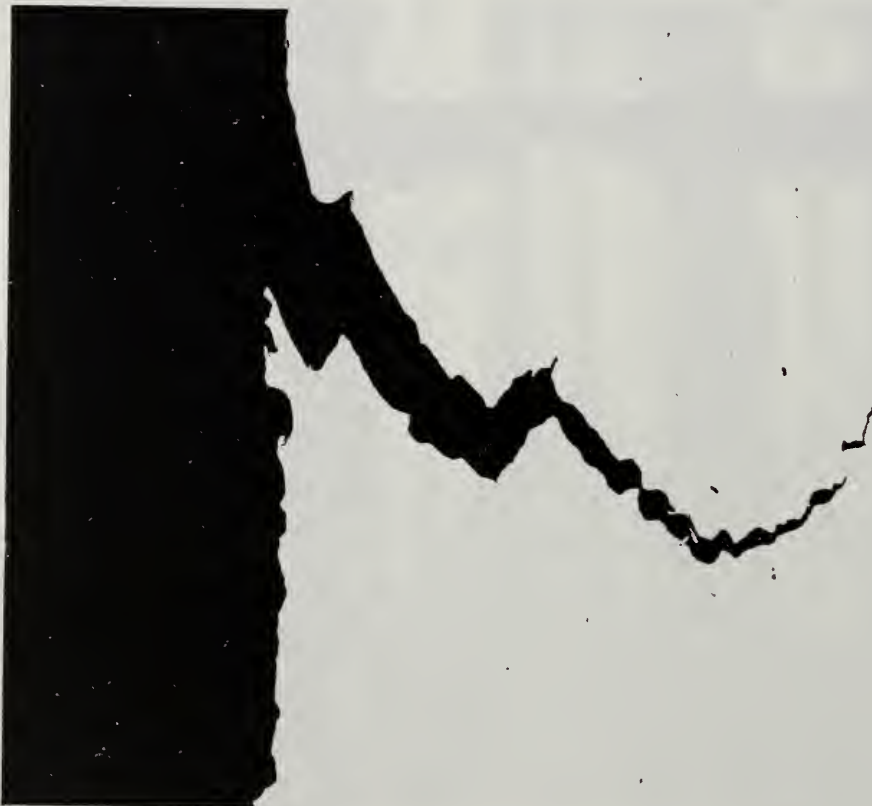
Figure 5.5.8 Lap seam at root of second thread away from fracture of jack rod. As polished (x 40)
