# Investigation of L'Ambiance Plaza Building Collapse in Bridgeport, Connecticut

Center for Building Technology  
National Engineering Laboratory  
National Bureau of Standards  
Gaithersburg, MD 20899

Issued September 1987

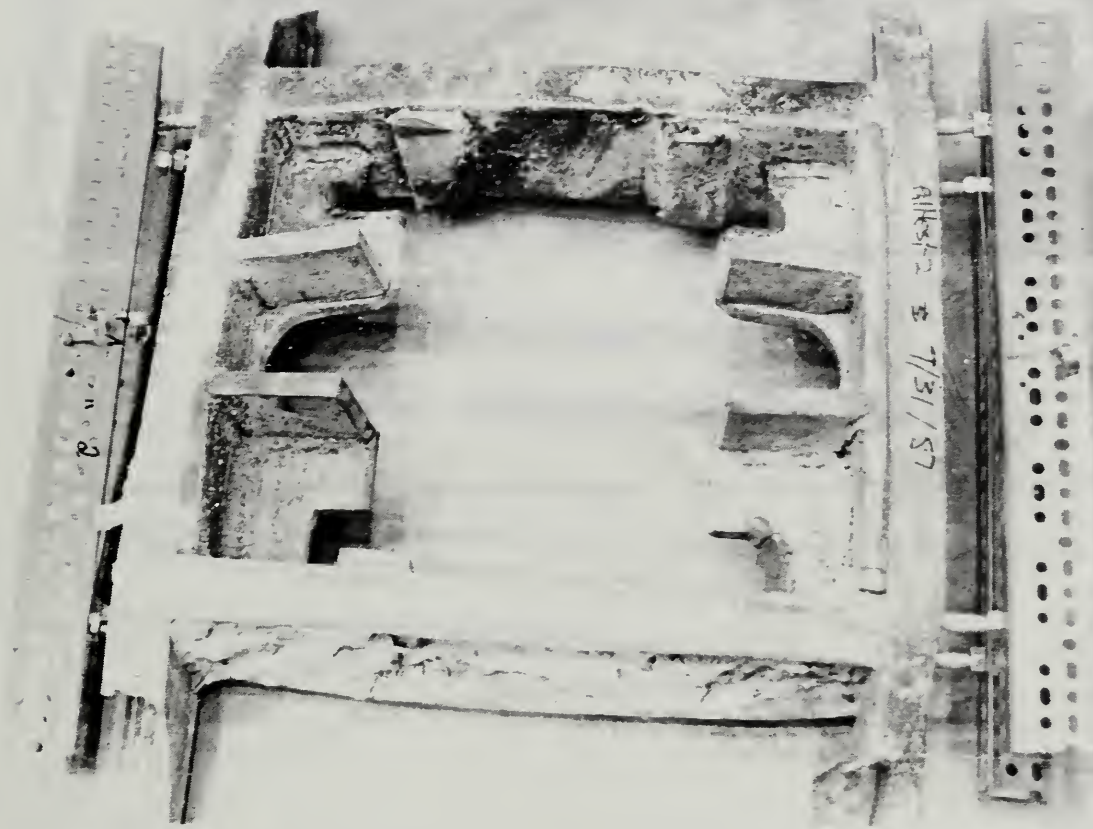
Figure 5.5.17 Shearhead No. 2 after failure showing rotation of lifting angles

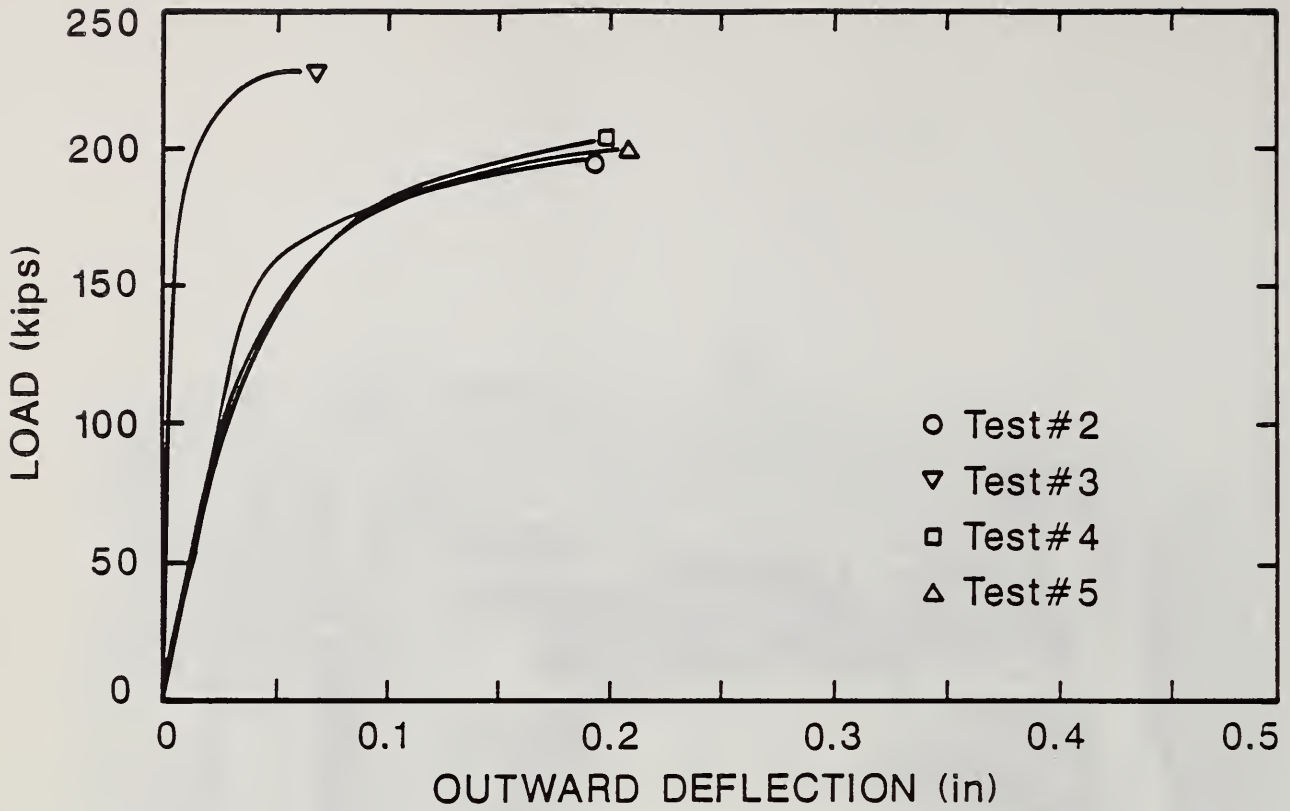
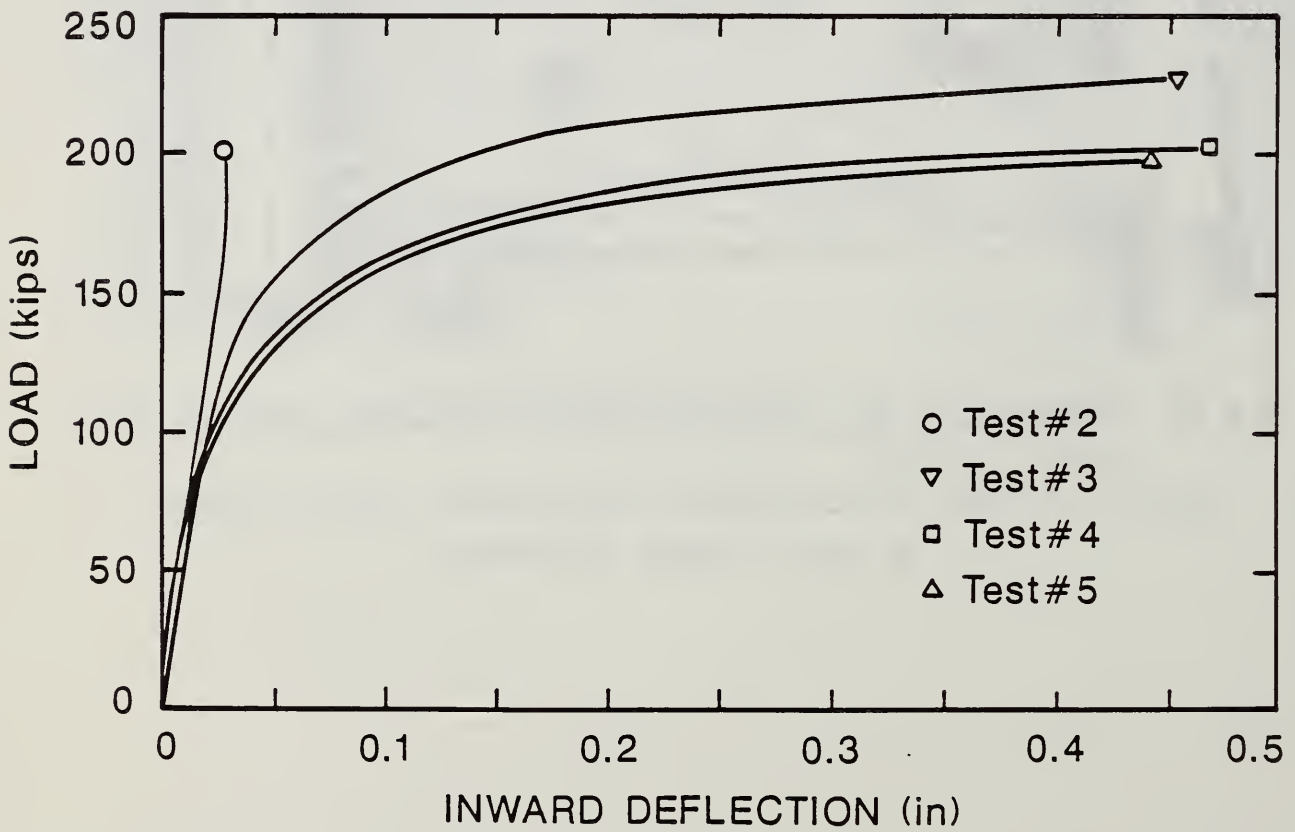
Figure 5.5.18 Lateral deformation of shearhead - failure side
