NBSIR 73-264

Examination of Failed One Inch Black Iron Pipe Natural Gas Service Line, Iowa Public Service Company, Eagle Grove, Iowa

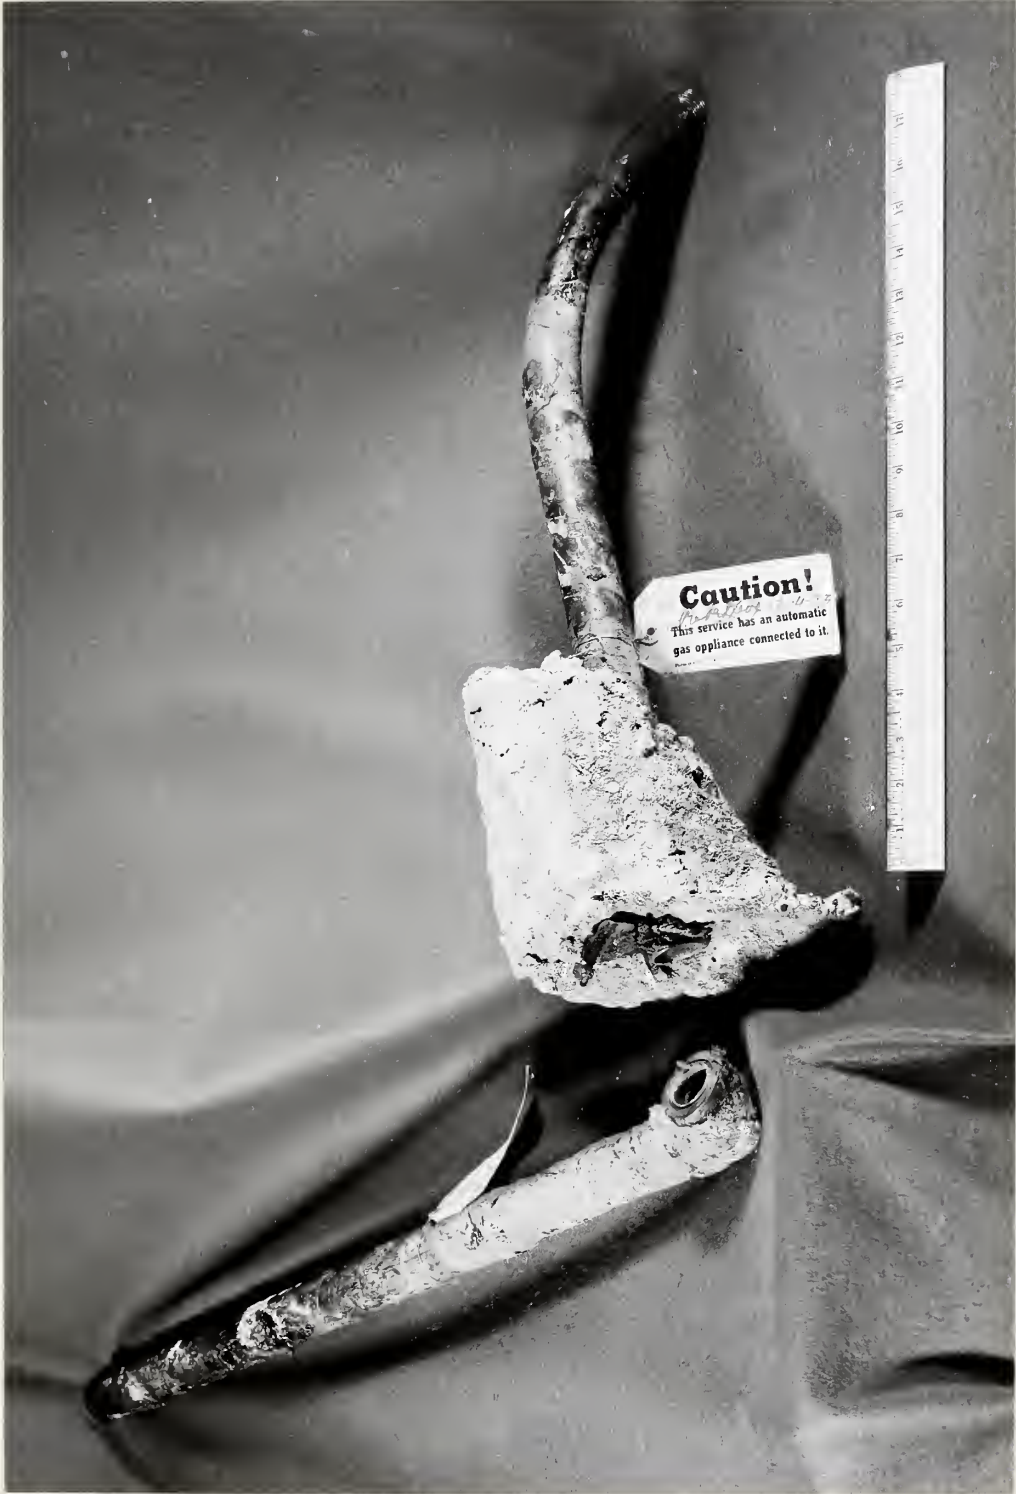
Figure 1. Submitted failed natural gas service line pipe parts as received. ~ X 1/4

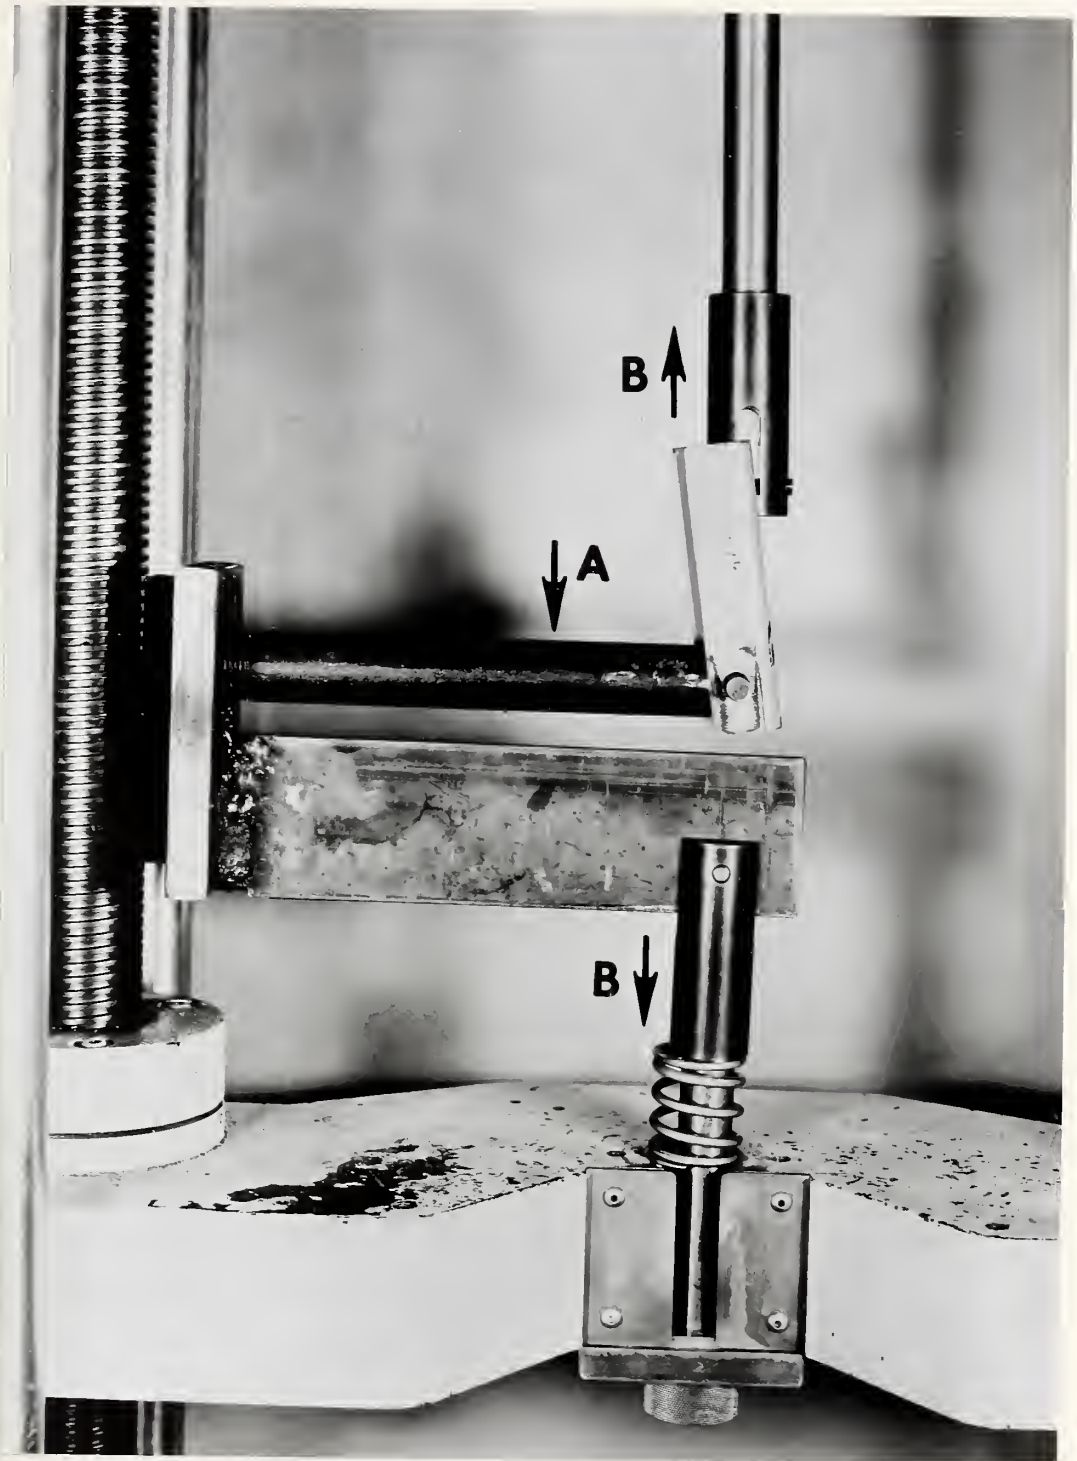
Figure 2. Setup for bend test of pipe length. Pipe specimen is indicated by arrow A. Arrows B indicate the direction of load application. The specimen is threaded on the left end.

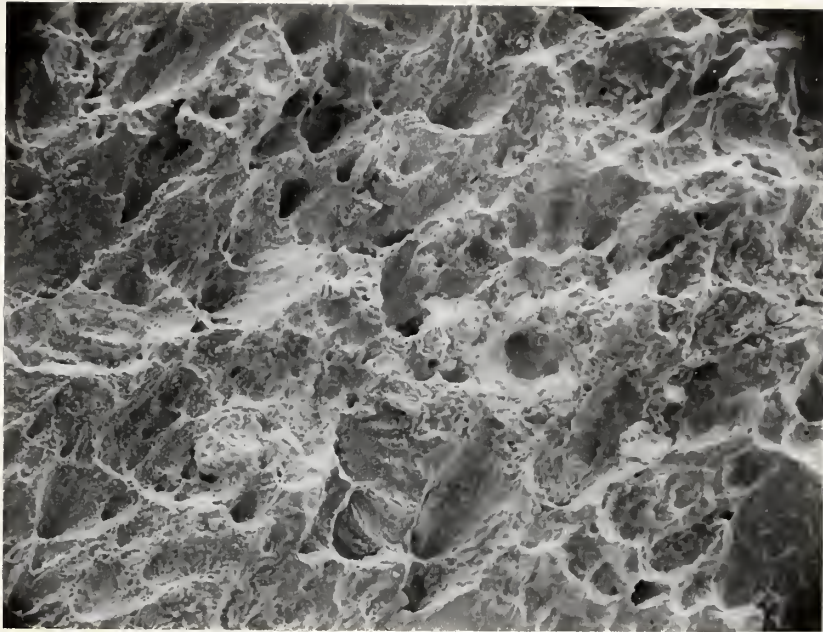
Figure 5. SEM of the fracture surface of the submitted failure in the area of densest rust (area A, figure 4b) showing dimpled rupture. X 650

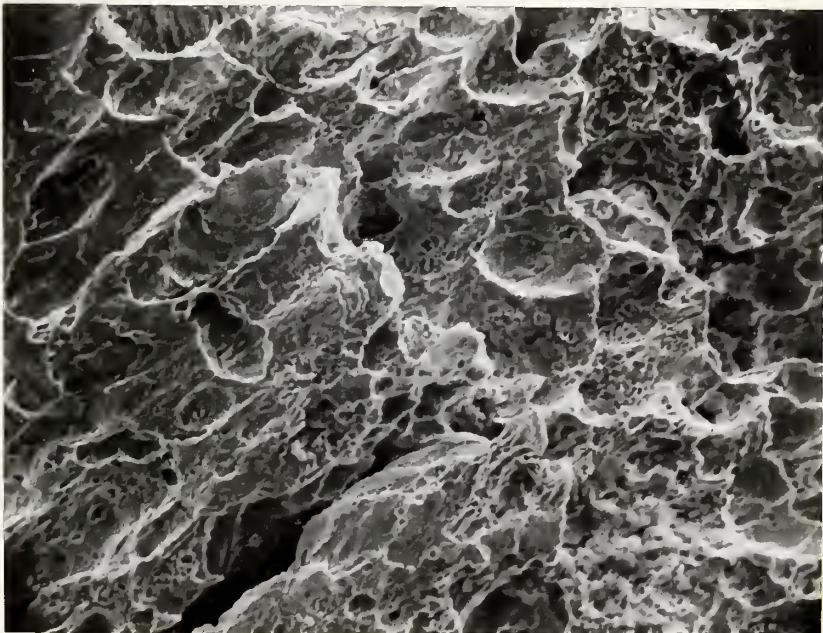
Figure 6. SEM of the fracture surface of the submitted failure in the area of densest rust (area A, figure 4b) showing dimpled rupture. A secondary crack can be seen in the lower left portion of the figure. X 1300

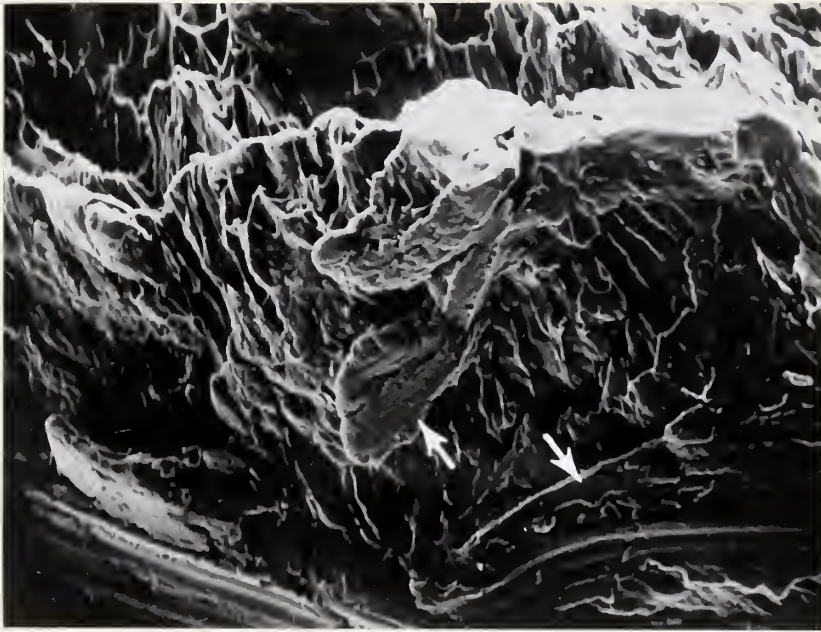
Figure 7. SEM of the fracture surface of the submitted failure in area B, figure 4b, showing mechanical damage (arrows) and dimpled rupture. Edge of thread root can be seen at lower left. X 550

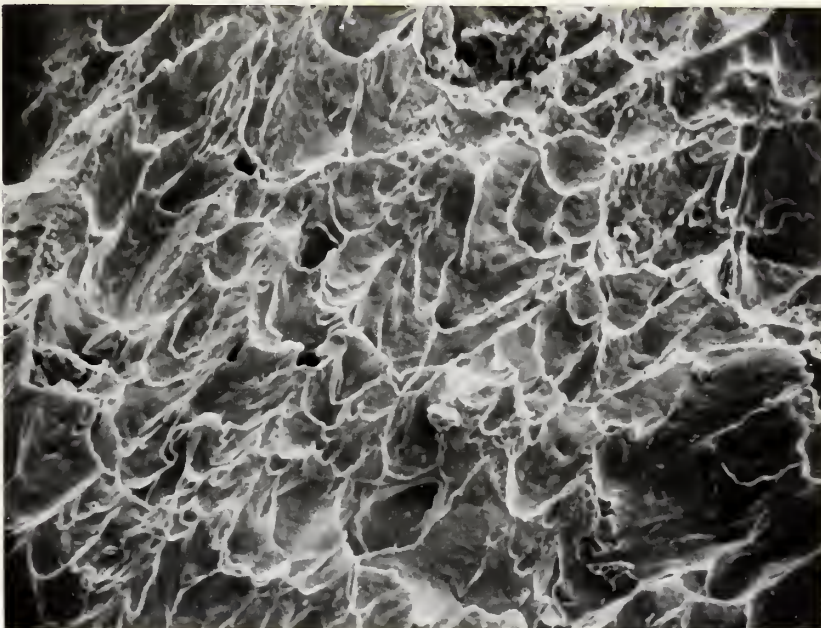
Figure 8. SEM of the fracture surface of the submitted failure in an area away from that containing the densest rust showing dimpled rupture. X 1100

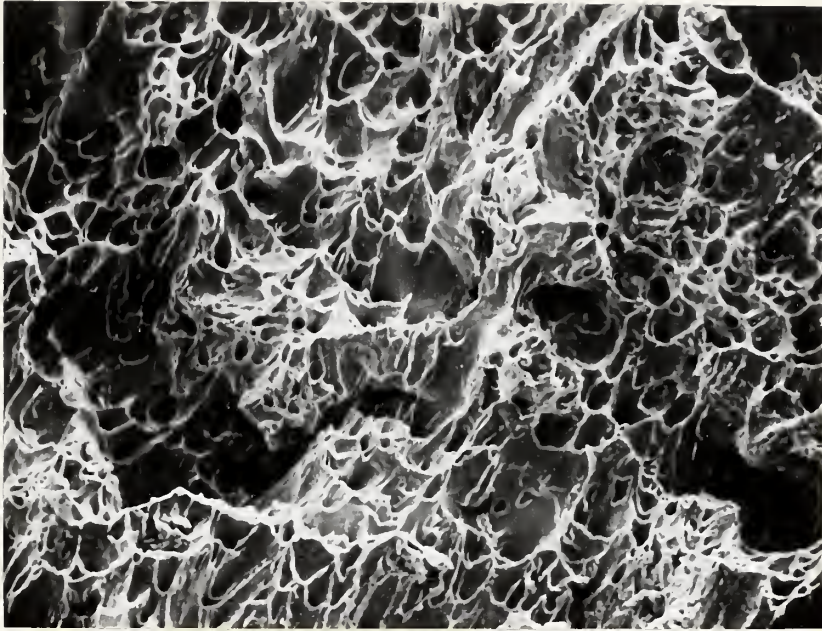
Figure 9. SEM of the fracture surface of the submitted failure in an area away from that containing the densest rust showing dimpled rupture. X 600

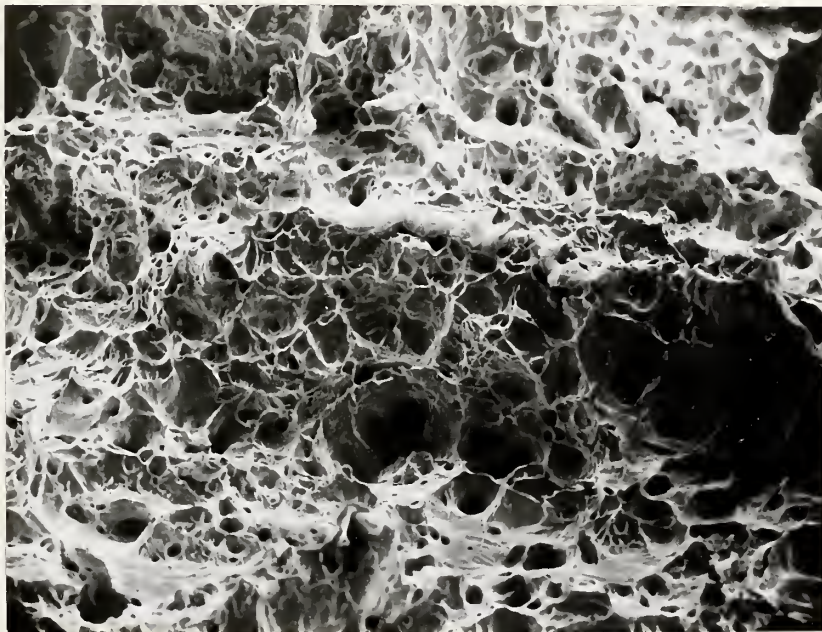
Figure 10. SEM of the fracture surface of the NBS produced bend test (test B) showing dimpled rupture. X 550

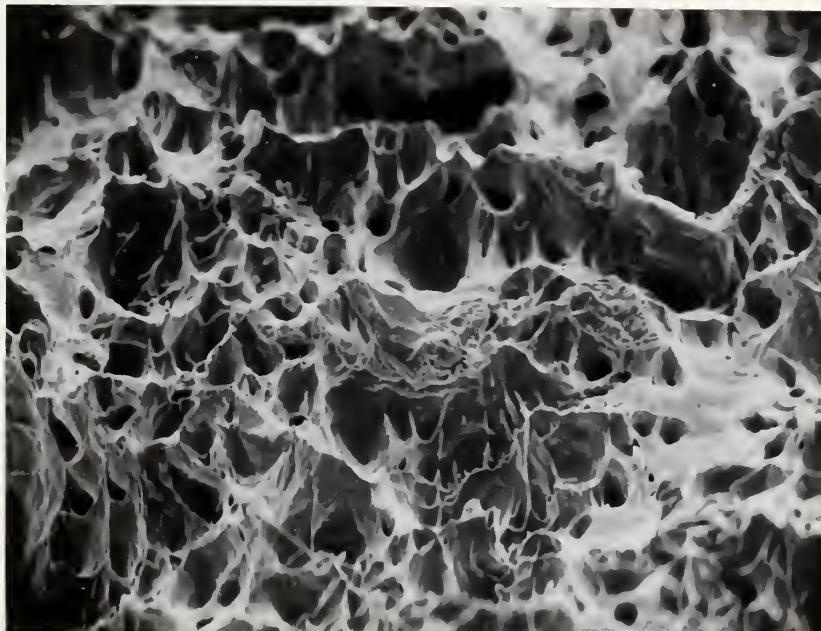
Figure 11. SEM of the fracture surface of the NBS produced uniaxial tensile test of material from the submitted failure (test D) showing dimpled rupture. X 750

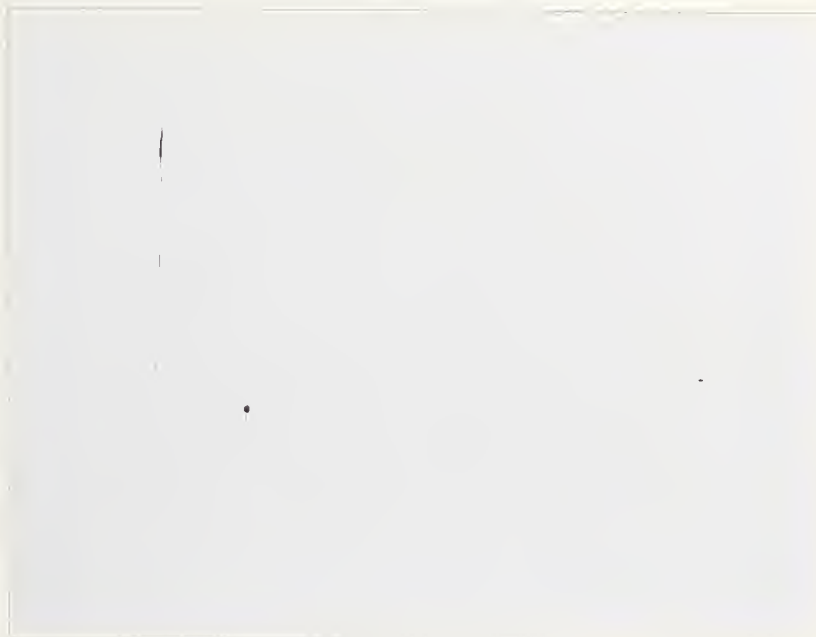
Figure 12. Unetched longitudinal cross section through the submitted failed pipe showing the representative inclusion content. X 100

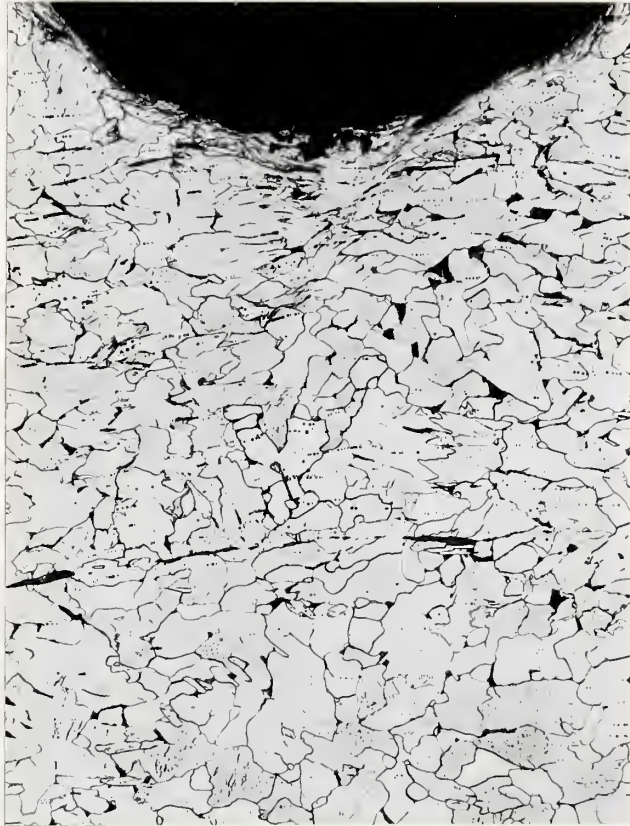
Figure 14. Etched longitudinal cross section through submitted fractured pipe showing deformation at and near the root of the thread one thread removed from the fracture. Etch: ammonium molybdate. X 100

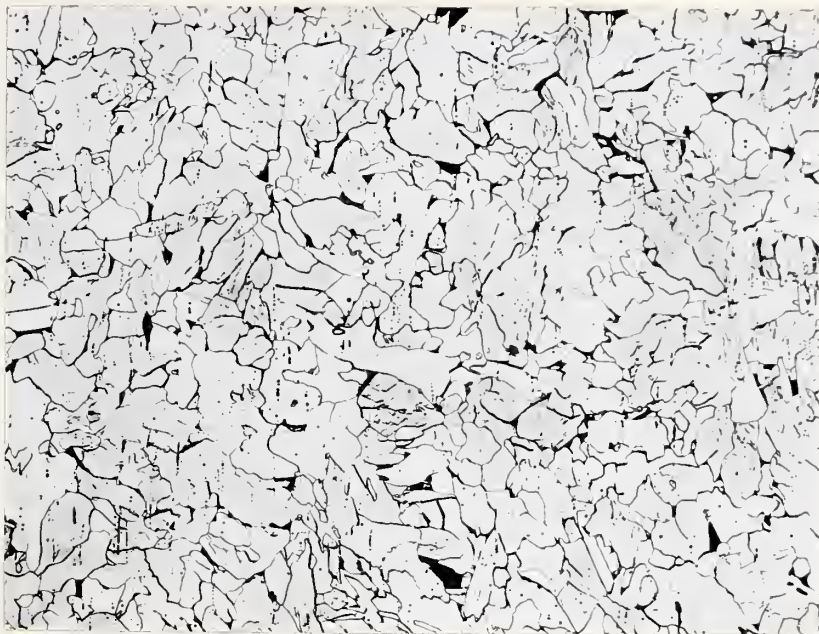
Figure 15. Etched longitudinal cross section through submitted failed pipe showing representative microstructure which consists primarily of ferrite (white) and a small amount of pearlite (dark patches).
Etch: ammonium molybdate. X 100

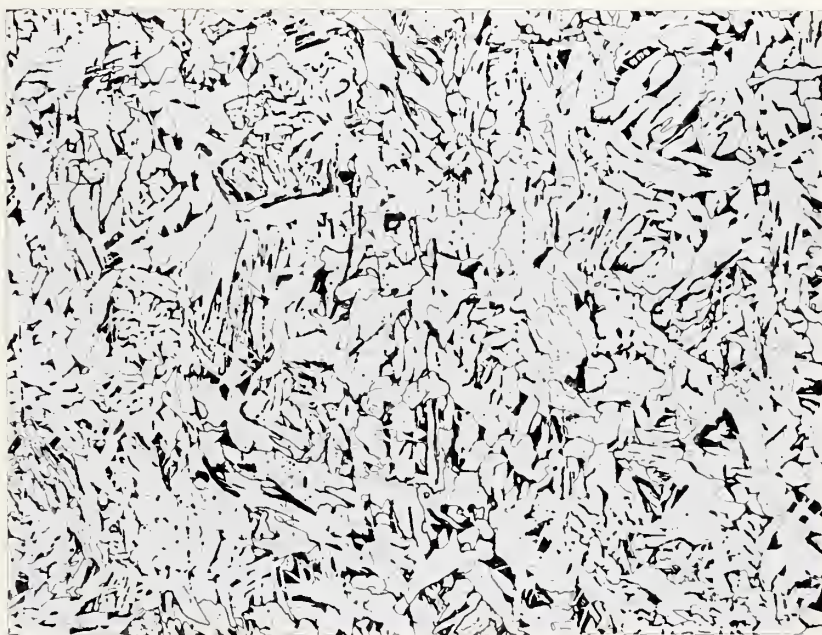
Figure 16. Etched representative longitudinal cross section through stock standard weight black iron pipe used for tests A and C. The microstructure consists of ferrite (white) and pearlite (dark patches). There is some evidence of a Widmanstätten structure.
Etch: 3% Nital. X 100
