Metallurgy of the *RMS Titanic*

Tim Foecke
Metallurgy Division
National Institute of Standards and Technology

Abstract

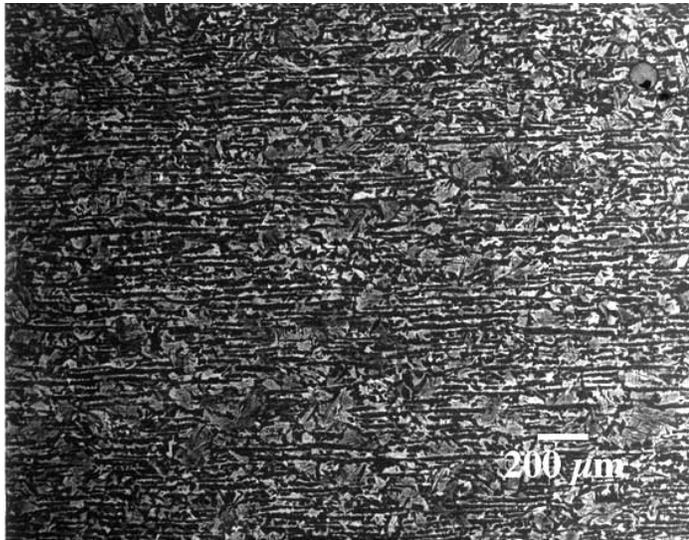
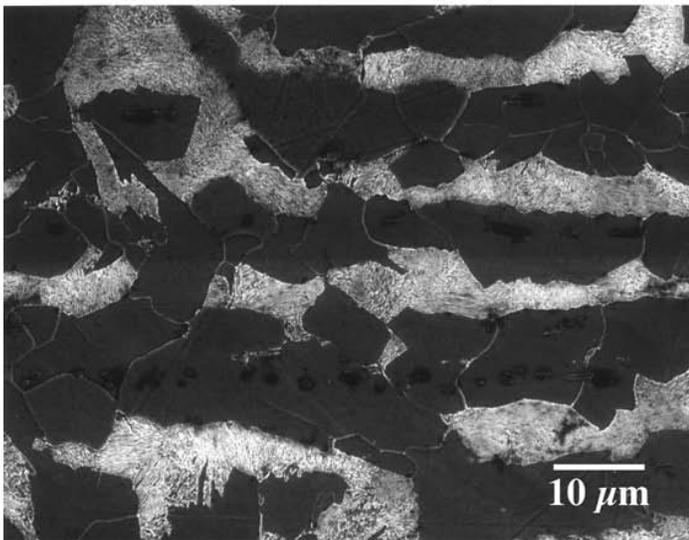
AISI 1018 25mm (1") Plate

A comparable modern steel grade is AISI 1018, which has a similar chemistry and does not possess a specialized microstructure. Micrographs of a modern 1018 steel show a finer grain size, much finer pearlite, and smaller and less numerous rare-earth doped MnS particles. This microstructure is typical of that produced in a modern high-speed mill, followed by a quench and normalization treatment.

Figure 1: Scanning electron microscope image of the polished and etched longitudinal sections of steel from the hull of the *Titanic*, and for comparison a modern hot-rolled 25 mm (1") AISI 1018 plate. Note the differences in grain size, pearlite lamella spacing, and MnS particle sizes.

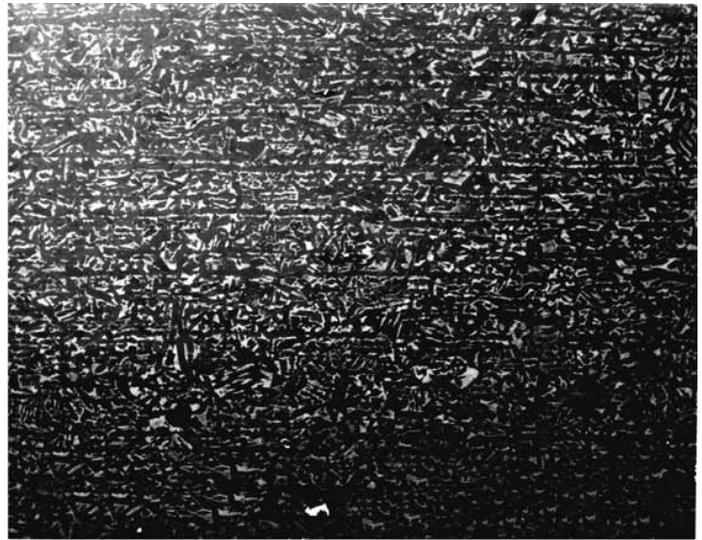
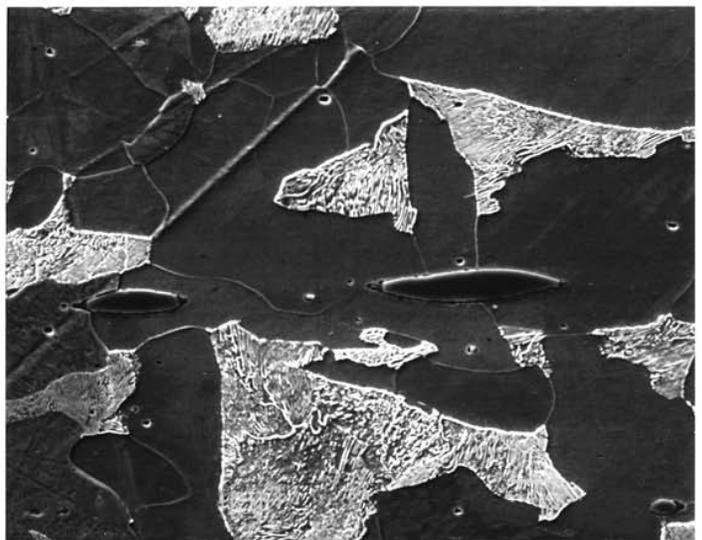
Titanic Hull Plate

Steel samples of all three orientations orthogonal with respect to the rolling plane were polished and etched to reveal the microstructure. A ferrite-pearlite microstructure was seen, with large ferrite grains (ASTM number = 4-5, 100 μm to 130 μm equivalent diameter) and large, coarse pearlite colonies (roughly 0.2 μm lamella thickness, but quite variable). The microstructure shows a large amount of banding in the rolling direction. MnS and oxide particles are evident throughout the material, and were quite large, occasionally exceeding 100 μm in length. The MnS particles were deformed into lenticular shapes instead of being melted into stringers. Given the lack of rare-earth additions to increase the sulfide melting point (see table 2), this indicates a low rolling temperature. The large grain size and coarse pearlite are consistent with air-cooling of the rolled

plate, with no evidence of quenching or normalization treatments evident. All of this evidence is consistent with the production of this plate in a low speed rolling mill, as was the norm in turn-of-the-century Ireland.

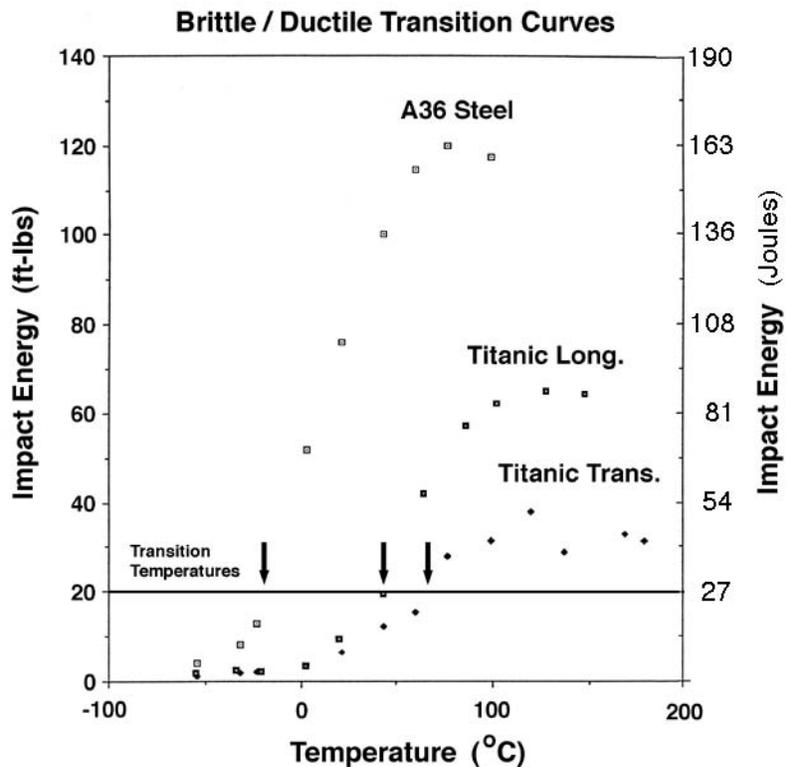
The data produced from tensile tests performed on steel recovered in 1996 [5] and 1991 [2] is shown in Table 1. The uncertainty in this data is unknown. These values are consistent with the design requirements of “15-20 tonnes per inch squared” as specified by Harland and Wolff (the shipbuilder who constructed *Titanic* in Belfast in 1911 [4]). Two groups of Charpy specimens were prepared such that in one group the long direction of the specimens were parallel to the longitudinal direction of the hull plate (LS) and in the second group the long axis of the specimen was parallel to the transverse direction (TL). The adjoining figure compares the experimental results from the Charpy impact test of the *Titanic* hull steel for the longitudinal and transverse rolling directions with a modern ASTM A36 mild steel [7]. Unfortunately for the purposes of a direct correlation of properties and microstructure, the comparison of mechanical behavior was made versus A36 steel, which is chemically nearly identical to AISI 1018 used in the microstructural comparison, but has a more specialized microstructure. Using 20 ft-pounds (27 J.) for the determination of the ductile-brittle transition temperature, the author [5] obtains a transition temperature of -15°C for the modern A36 steel, while the *Titanic* specimens yielded transition temperatures of $+40^{\circ}\text{C}$ for specimens in the longitudinal direction and $+70^{\circ}\text{C}$ for the transverse direction. The transition temperatures for the *Titanic* steel are much above the water temperature of -2°C at the time of the ship-iceberg collision [1].

Figure 2: A plot of the impact energy measured by the Charpy test versus temperature for two different orientations for the *Titanic* hull steel, as well as modern A36 (which is chemically and microstructurally very similar to AISI 1018). The transition temperature is marked for each series of samples, and is defined as that temperature where the sample exhibited 20 ft-lbs (27 J.) of energy. Data from reference [5]. The uncertainty in the data is unknown.

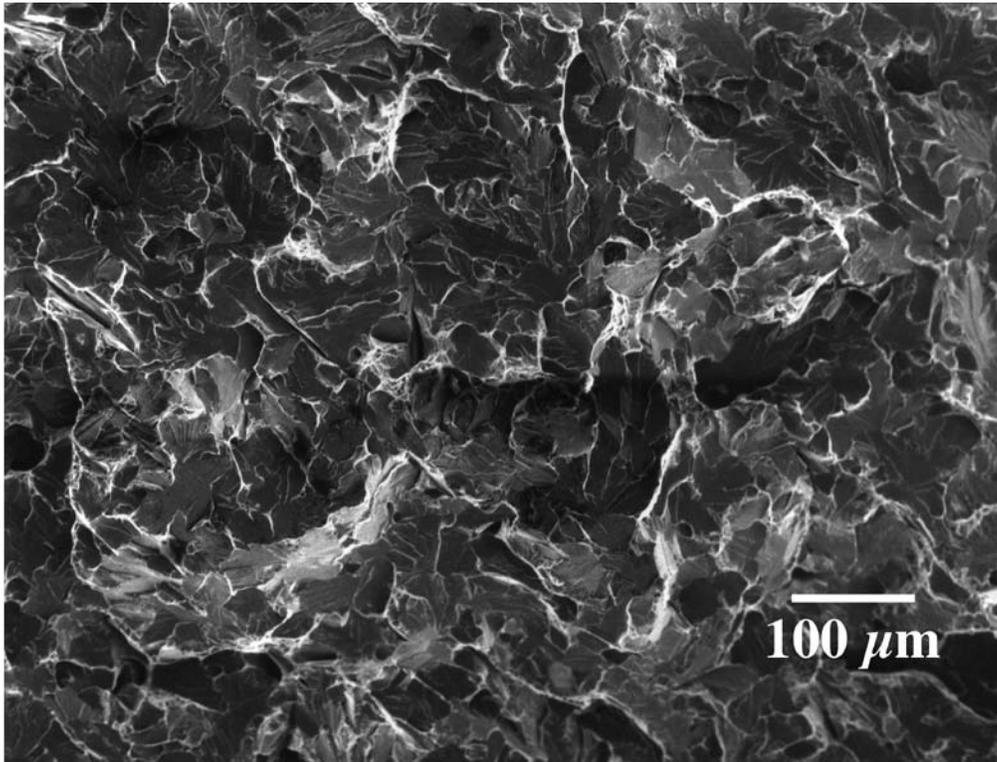
Fracture surfaces cut from the Charpy test specimens tested from the 1996 plate were examined in the scanning electron microscope. Fracture was entirely transgranular (figure 3), with no evidence of fractured grain boundaries. This is significant, in that if the cause of limited fracture ductility of the steel (as evidenced by the absence of microvoids) had been sulfur embrittlement, we would expect sulfur segregation to the grain boundaries and intergranular fracture facets. At ice-brine temperatures, the fracture was nearly entirely brittle, with the ductile portion of the fracture surface estimated to be less than 5 percent (figure 4). Cleavage patches on the surface, made up of 4 to 15 cleaved grains, were seen to originate at fractured MnS particles, as evidenced by tracing river lines on the facets. This indicates that in some cases the MnS particles acted as initiators, but the incidence of these nucleated patches amounted to less than 10% of the surface area of the Charpy bar fracture surface.

Figure 3: SEM fractograph of Charpy bar fracture surface (LT) from a sample fractured at 0° C. Note the presence of cleavage facets and absence of fracture grain boundaries. One or two cleavage patches nucleated by MnS particles can be identified in this image.

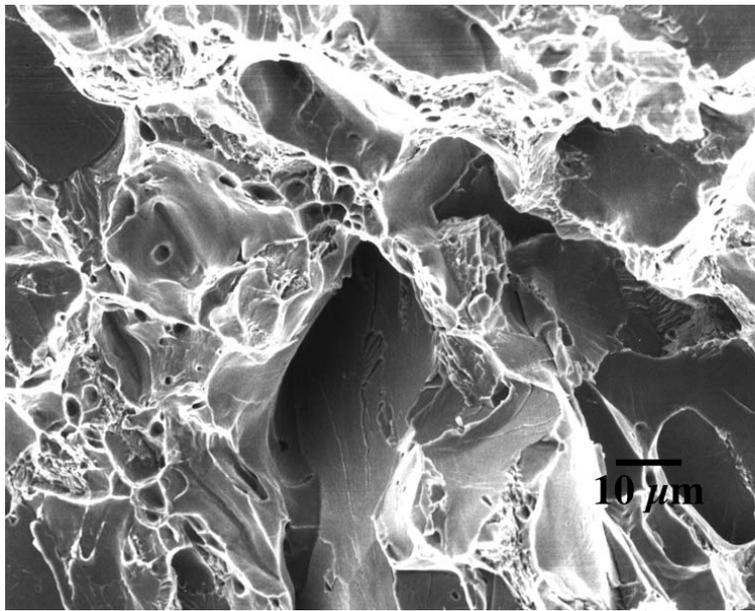
Figure 4: SEM fractograph of Charpy bar fracture surface from a sample fractured at 0° C. Note presence of ductility along ridges. This micrograph contains the largest amount of plasticity observable on the surface in one area of the fracture surface of this sample.

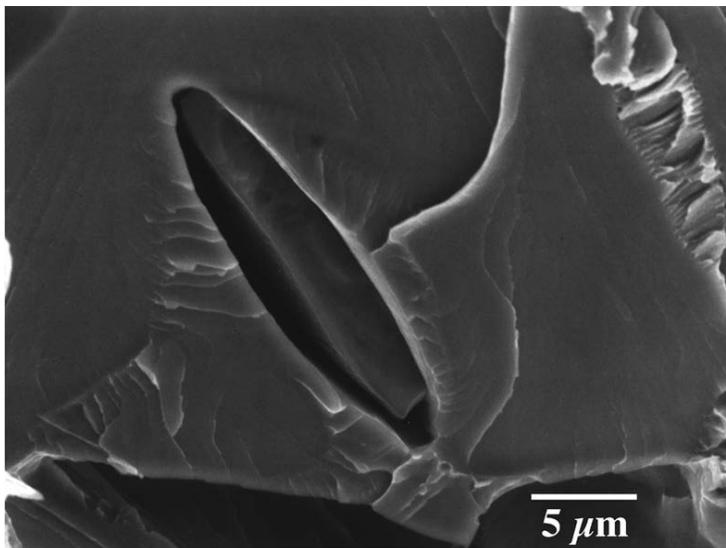
Figure 5: SEM fractograph showing the MnS particle that fractured and nucleated a patch of 15 cleaved grains. This was determined by tracing river lines within the patch. Note the lenticular shape of the particle, the cleavage river lines emanating from the particle, and the fractured course pearlite colony in the upper right corner.

The presence and large size of the MnS particles are considered deleterious to fracture resistance, as they act as crack initiators within the steel at temperatures near the lower shelf [19]. It was seen that the plate recovered in 1996 exhibited 5% ductile fracture during Charpy tests at ice-brine temperatures, and that MnS particles, upon examination of the fracture surface, nucleated a few patches of cleavage. However, the plate recovered in 1991 was 100% brittle even at room temperature [20], placing it firmly in, not near the lower shelf regime. Thus MnS particles would have little to no effect on toughness in this plate. The presence of MnS particles and their effect on crack growth have been found to be much more important at high temperatures than lower temperatures. Their effect on the fracture behavior of both the material in this study as well as the 1991 study [2] are considered negligible. Although cleavage patches have been identified on the fracture surface as having come from the fracture of a MnS particle, and thus the formation of a process-zone would have begun, the occurrence of this was relatively rare. It is believed that the fracture mechanism that controlled at -2°C would have been weakest-link [18], where the first fractured microstructural feature would have precipitated failure. And as the population of large carbides, in the form of thick pearlite lamella, is many times that of large sulfides, it is more likely that a fractured carbide would precipitate failure.

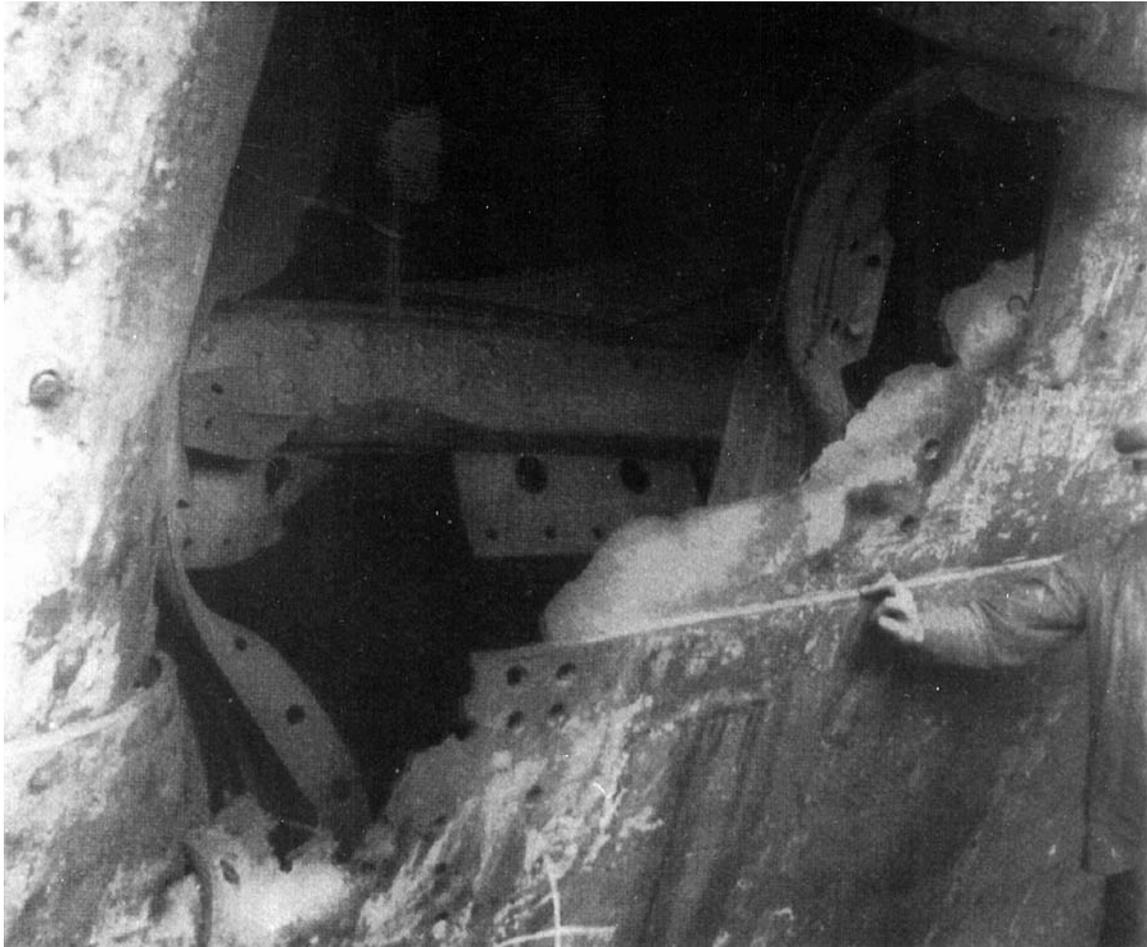
ship with the iceberg at 20+ knots would have occurred at strain rates more in line with a Charpy impact test. At this rate, the steel would exhibit more brittle behavior. Additional evidence comes from photographs of damage to the *Titanic*'s sister ship, *RMS Olympic*, after collision in Belfast harbor with a Royal Navy cruiser, *HMS Hawke* [25] (figure 5). A close examination of the photos show considerable bending of the plates around the hole, while reports of the physical damage include a mention of a triangular piece of hull that fractured into the ship. This would be consistent with a high strain rate impact causing fracture, and then progressively slower deformation as the two ships pressed together, causing bending instead of cracking.

Figure 6: A close-up of the damage to the *RMS Olympic* due to collision with the *HMS Hawke* in the Solent in 1911. Note the man for scale. A considerable amount of plasticity in the hull plates is indicated by the bending and twisting seen in the picture. Note missing rivets. Photo from [25].

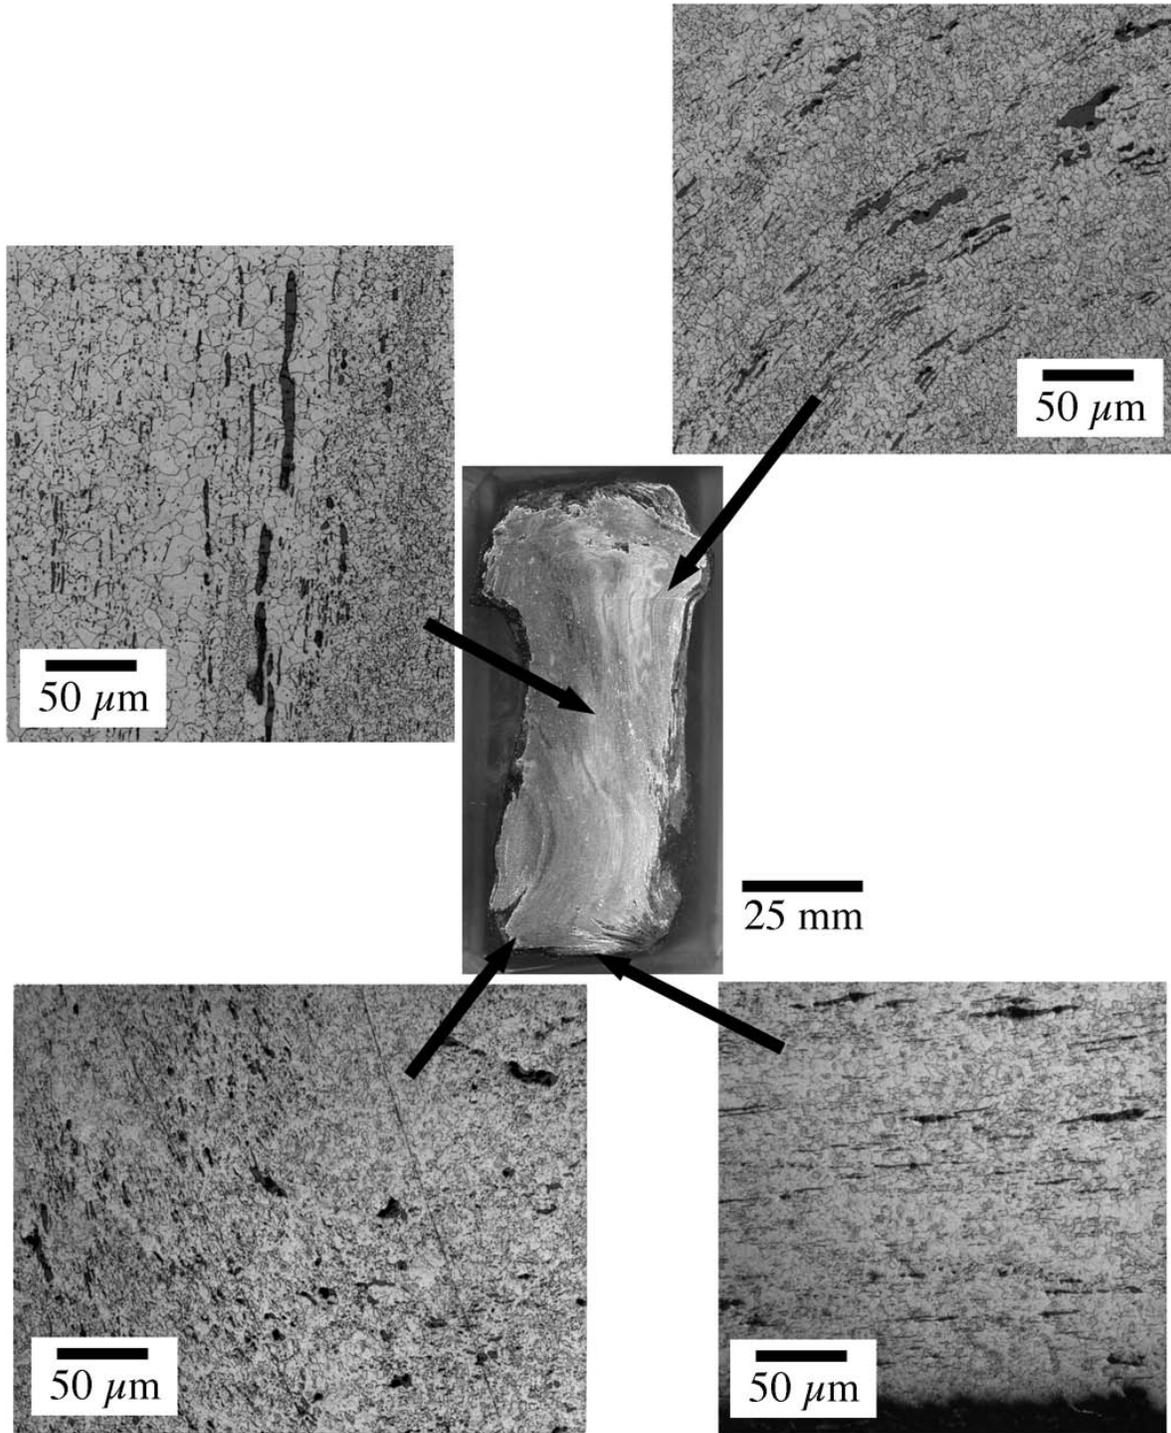
These rivets were made of wrought iron, which consists of a relatively pure iron matrix containing 2-3% (by volume) iron silicate slag. A micrograph of the structure can be seen in figure 7. Quantitative metallography was performed on a cross-section of a hull rivet that had been cut and polished. This showed that this rivet contained 9.3% +/- 0.3% slag on average, which is more than 3 times the amount normally expected in wrought iron [27]. This slag had an almost bimodal-type distribution of sizes, ranging from a large amount in very long stringers (>200 μm long) to a large number of small oblate spheroid particles (1 μm to 5 μm diameter).

The two hull rivets in possession have been sectioned and examined. Both exhibit the above-mentioned orientation distribution of slag stringers within the rivet, an increased amount of incorporated slag, and are both missing the inner head. These metallurgical factors would have degraded the mechanical performance of the rivet. If additional samples are obtained during an expedition planned for August of 1998, further work will be performed to determine if this was a major factor in the sinking of the ship. Rivets from an intact section of a lap joint will be sectioned to see if rivets that did not fail contain elevated slag levels and transversely-oriented slag stringers. It is important to reiterate that only two rivets have been sectioned to date, out of 3,000,000, some minority percentage of which held the hull together.

Figure 7: Montage of micrographs showing the orientation of silicate slag at various locations within a cross-section of a *Titanic* hull rivet. Note that in the upper pre-formed head (formed onto a hot rod of wrought iron prior to cutting the rivet to length), the slag spreads out evenly into the head like the branches of a tree. At the bottom, where the inner head popped off, very near the fracture surface the stringers are oriented perpendicular to the tensile axis. This occurred presumably when the inner head was formed.

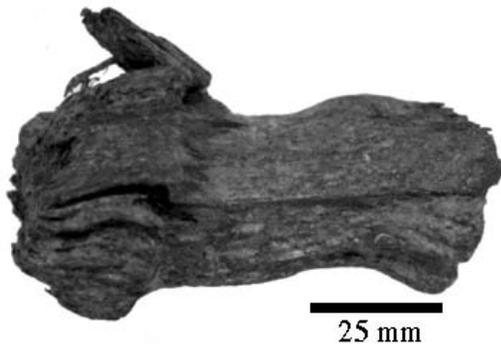
material. This represents a smaller amount of deflection of the hull plate applying the stress through leverage against the supporting rib inside the ship. High residual stresses would increase the tendency of rivets to “pop” during collisions. The presence of high residual stresses in *Titanic* rivets can be seen in a badly-corroded bulkhead rivet, seen in figure 9. The head of the rivet has exfoliated and the slag stringers have spread, driven by residual stress during stress corrosion cracking and dissolution of the ferrite.

Figure 9: Bulkhead rivet from RMS Titanic. Note the portion of the head that exfoliated during corrosion of the ferrite matrix of the wrought iron, under the influence of the residual stress in the rivet.
