Metallurgy of the *RMS Titanic*

Tim Foecke
Metallurgy Division
National Institute of Standards and Technology

Abstract

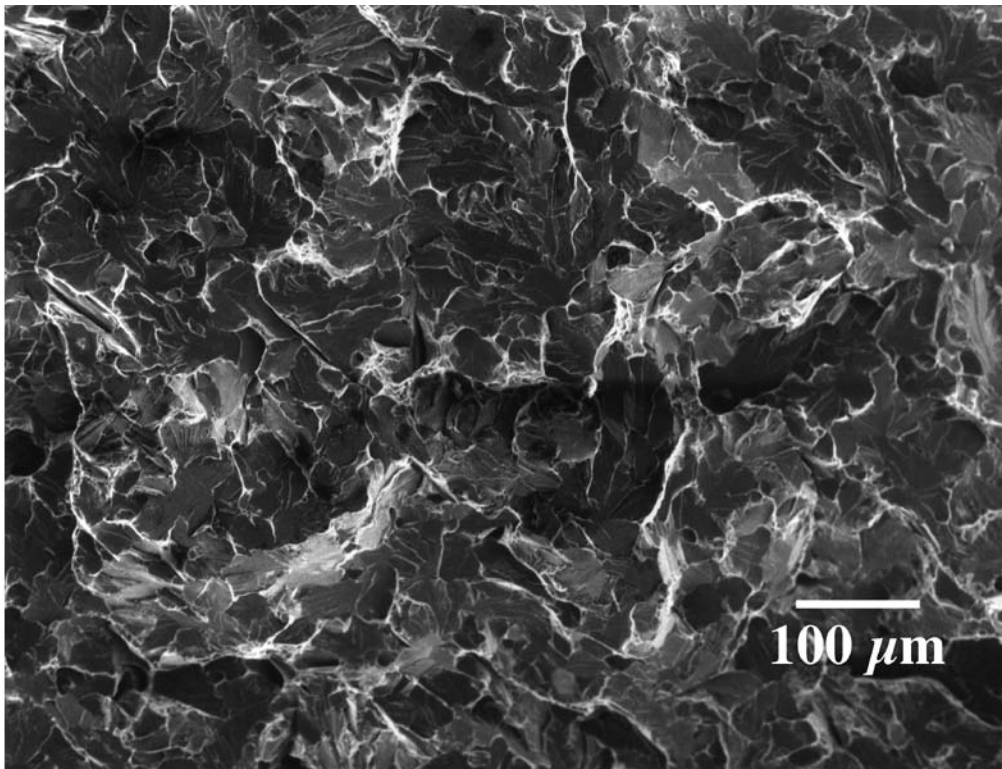
Fracture surfaces cut from the Charpy test specimens tested from the 1996 plate were examined in the scanning electron microscope. Fracture was entirely transgranular (figure 3), with no evidence of fractured grain boundaries. This is significant, in that if the cause of limited fracture ductility of the steel (as evidenced by the absence of microvoids) had been sulfur embrittlement, we would expect sulfur segregation to the grain boundaries and intergranular fracture facets. At ice-brine temperatures, the fracture was nearly entirely brittle, with the ductile portion of the fracture surface estimated to be less than 5 percent (figure 4). Cleavage patches on the surface, made up of 4 to 15 cleaved grains, were seen to originate at fractured MnS particles, as evidenced by tracing river lines on the facets. This indicates that in some cases the MnS particles acted as initiators, but the incidence of these nucleated patches amounted to less than 10% of the surface area of the Charpy bar fracture surface.

Figure 3: SEM fractograph of Charpy bar fracture surface (LT) from a sample fractured at 0° C. Note the presence of cleavage facets and absence of fracture grain boundaries. One or two cleavage patches nucleated by MnS particles can be identified in this image.

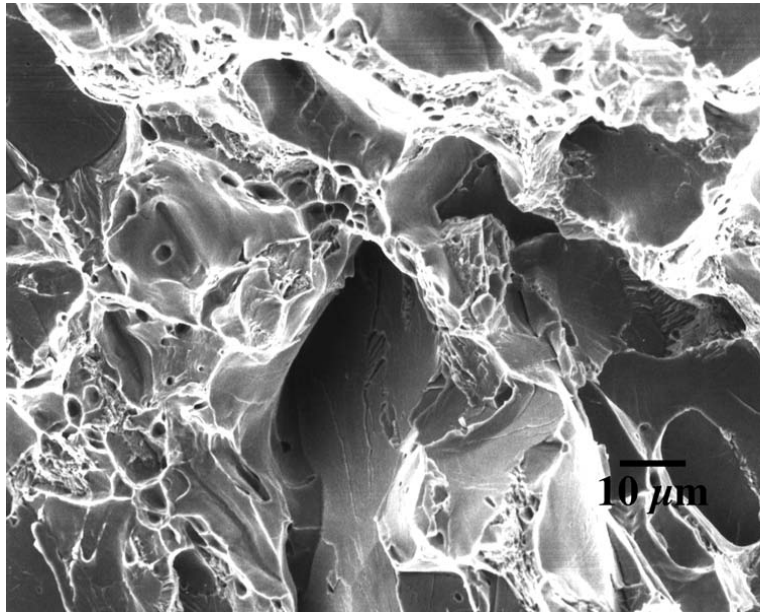
Figure 4: SEM fractograph of Charpy bar fracture surface from a sample fractured at 0° C. Note presence of ductility along ridges. This micrograph contains the largest amount of plasticity observable on the surface in one area of the fracture surface of this sample.
