# 2011 Wildland Urban Interface Amarillo Fires Report #2 – Assessment of Fire Behavior and WUI Measurement Science

**NIST Technical Note 1909**

February 2016

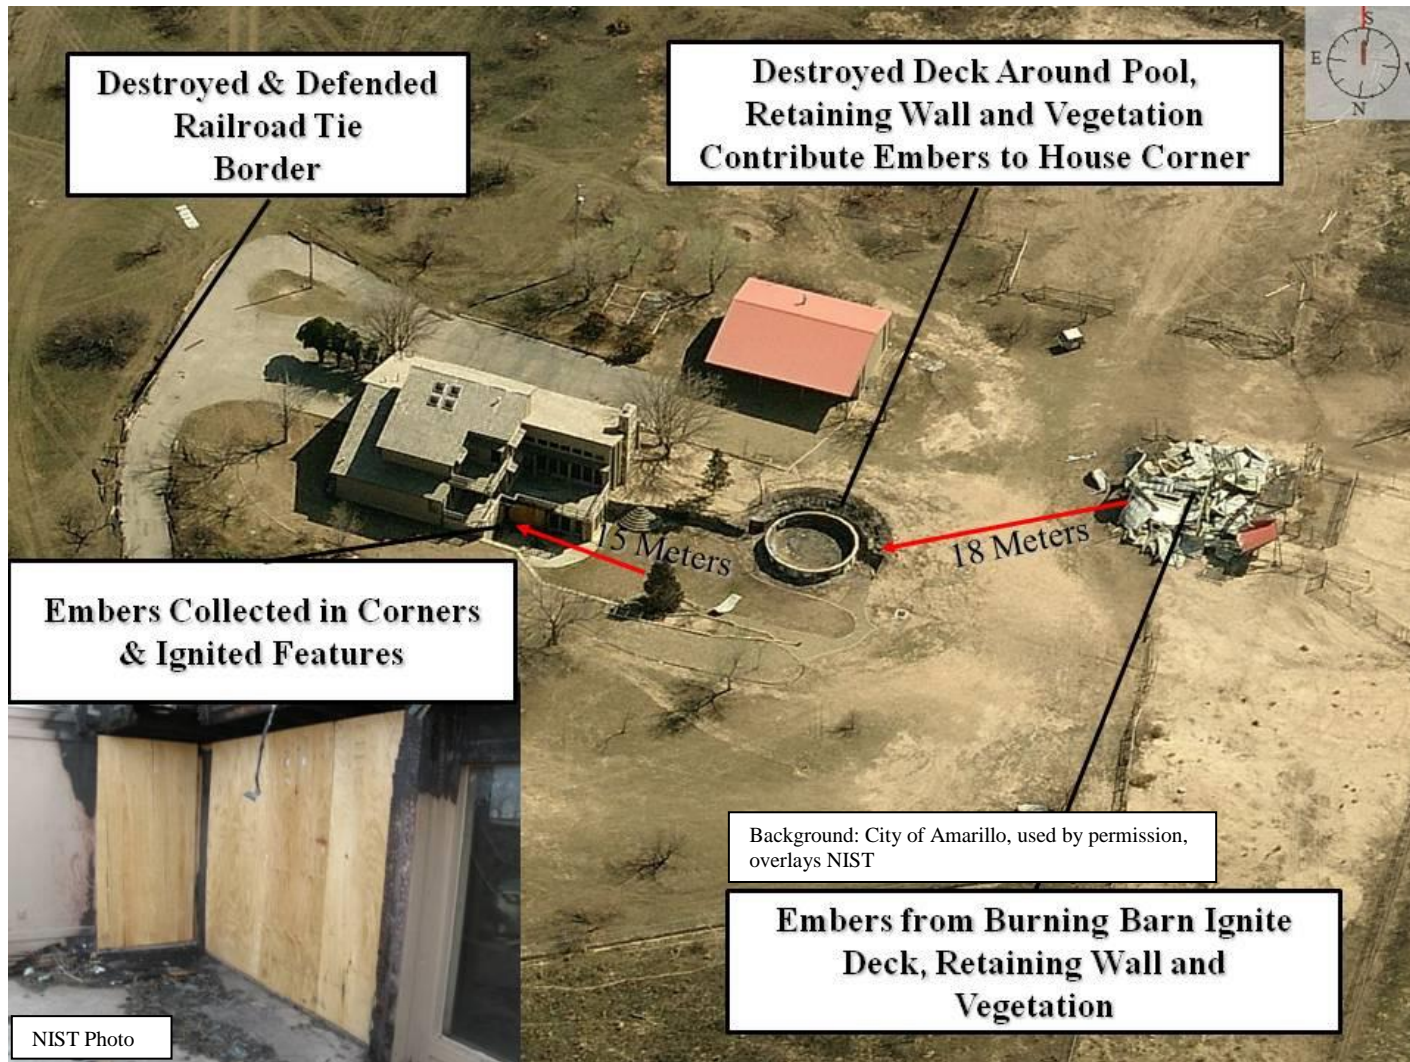
Figure 11 shows destroyed combustibles around 411 Roberts Drive.

**Figure 11 Ignition mechanisms in and around 411 Roberts Drive, close to the fire origin. Structure was defended.**

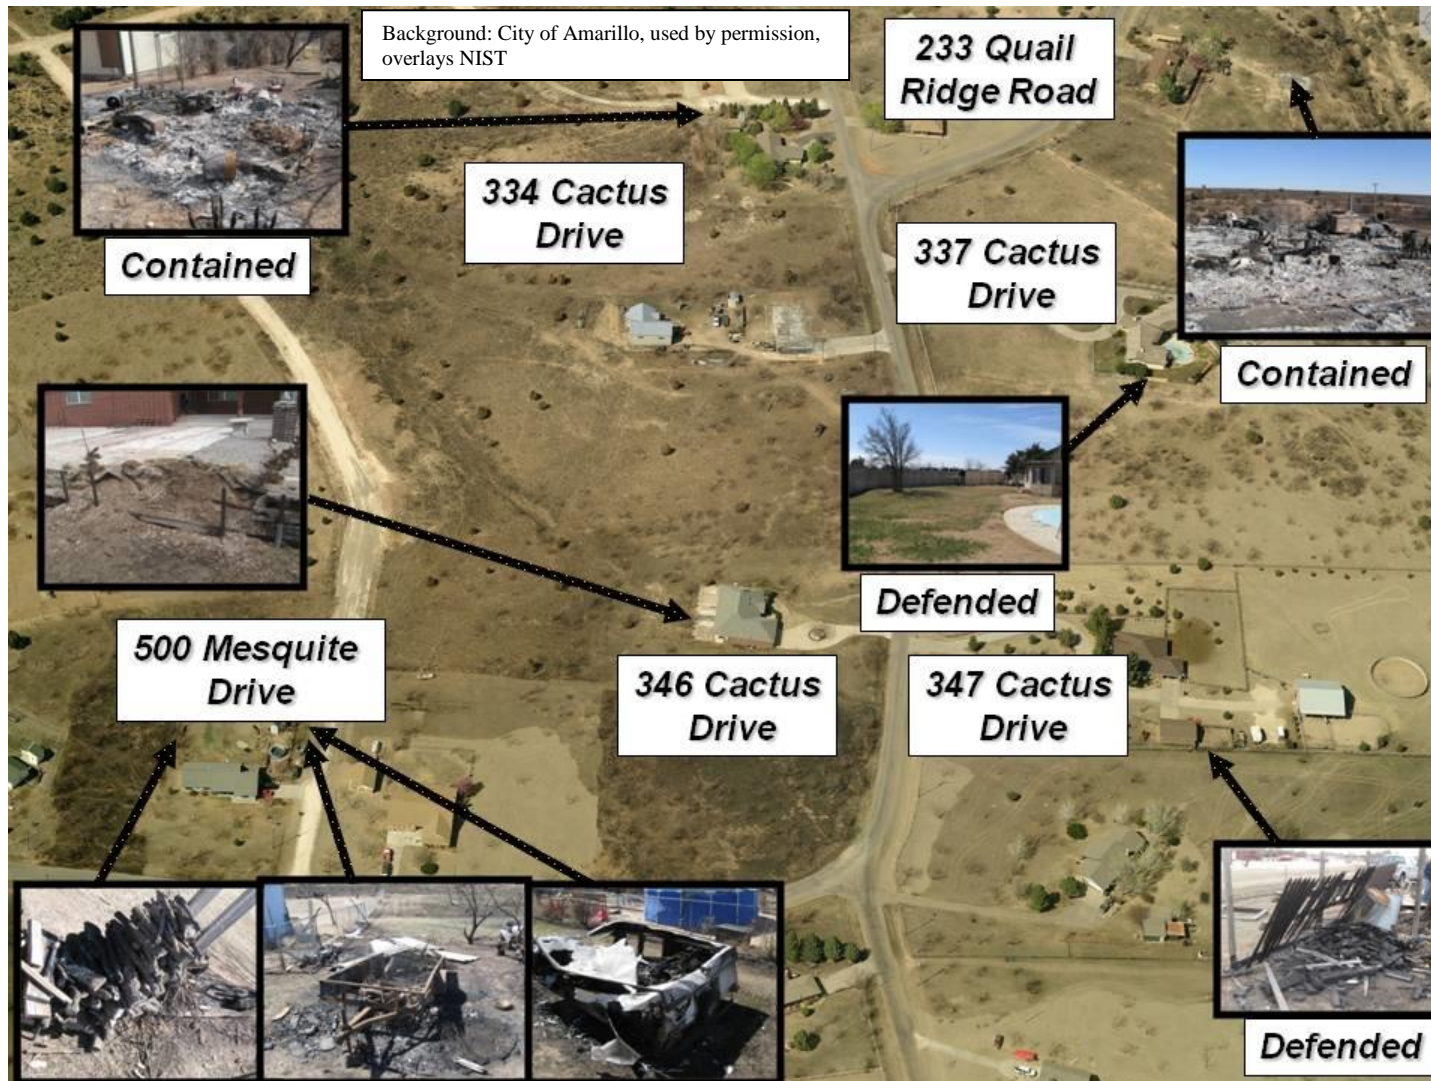
Figure 12 Ignition mechanisms around non-damaged or non-destroyed residential structures in Timber Creek Canyon, NIST photos.

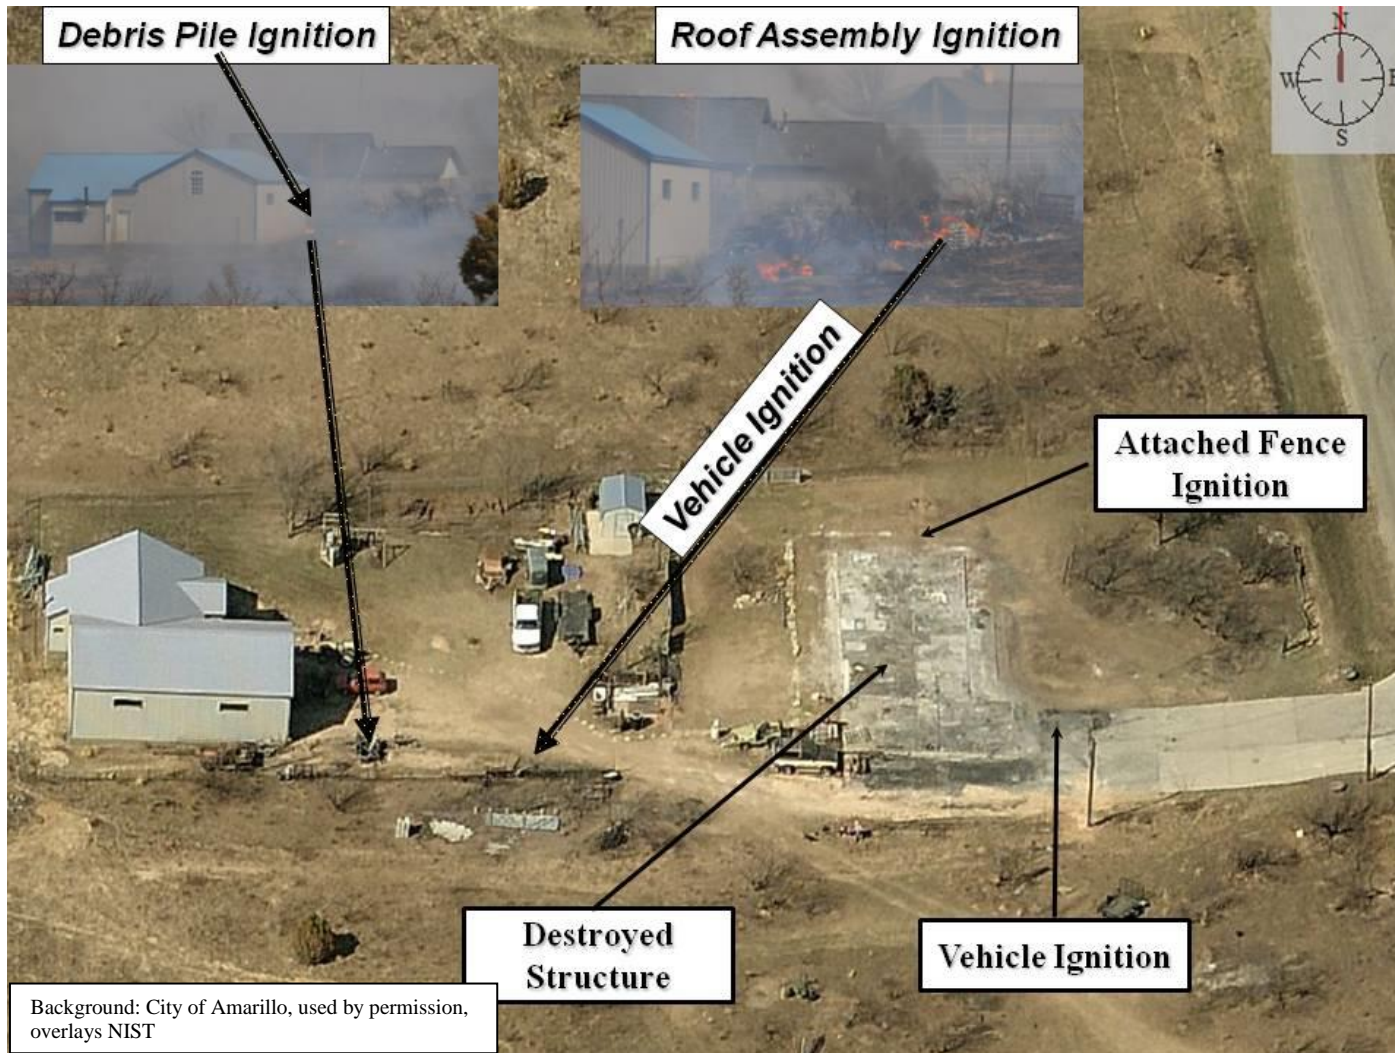
**Figure 13 Structural element ignition mechanisms at 338 Cactus Drive. Structural elements portrayed are known or suspected to be ignited prior to residential structure ignition. Fire direction was from southeast to northwest and the attached fence was on the north of the destroyed home, NIST photos.**

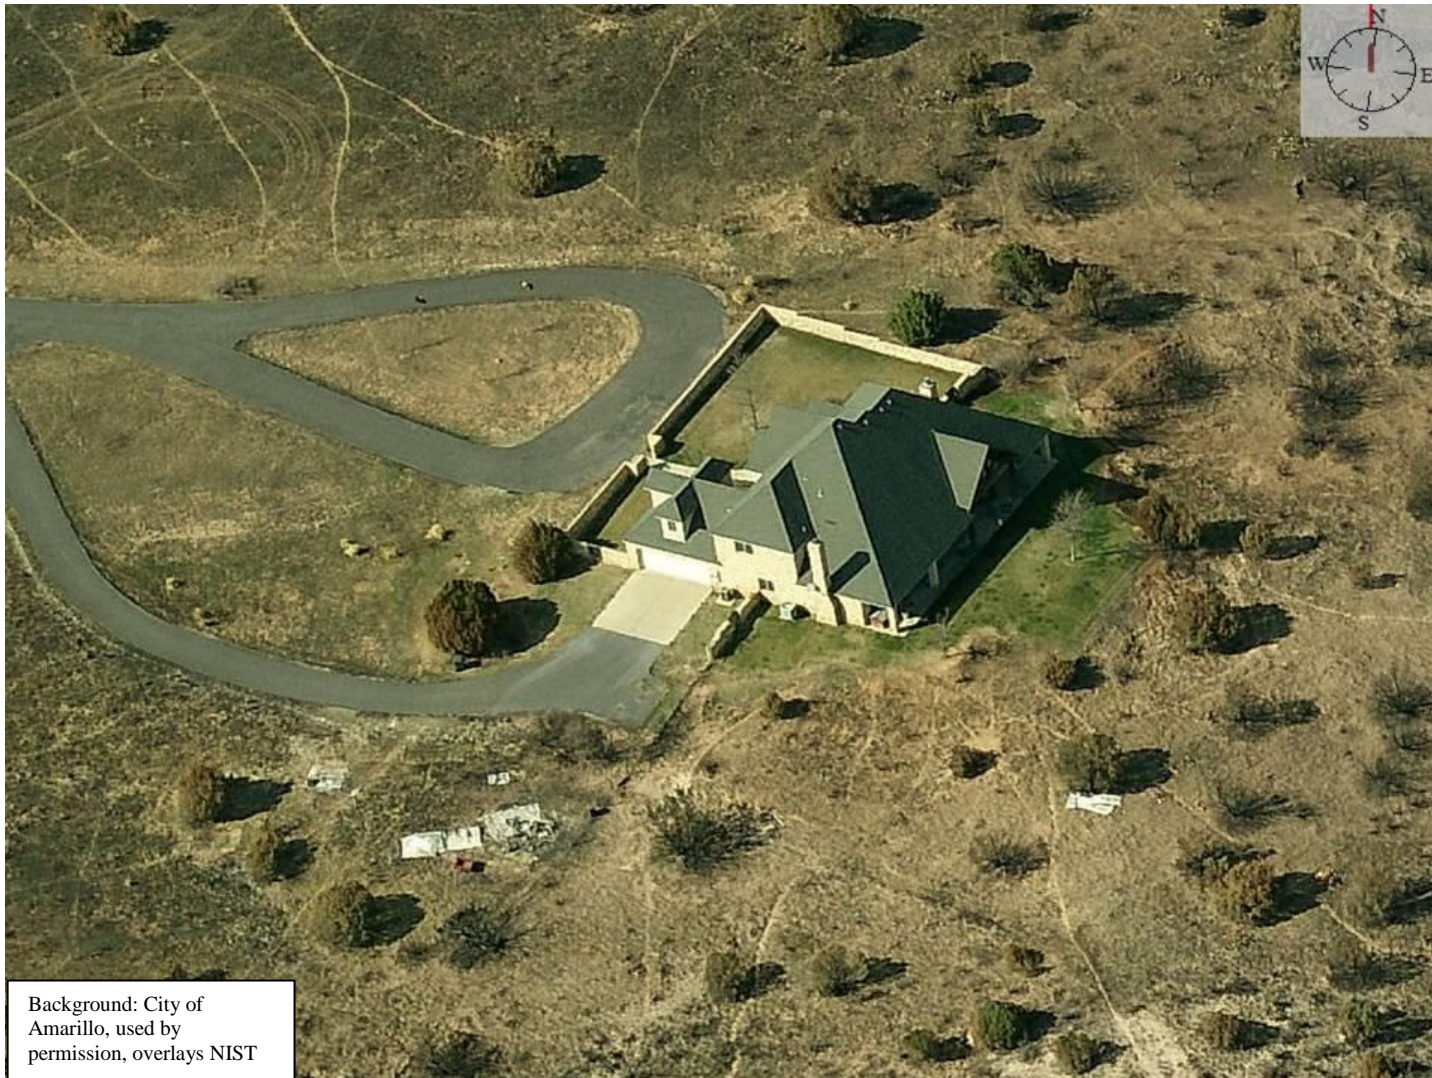
**Figure 20 Treated vegetation around 209 Quail Ridge Road that might have helped to stop fire from contacting house. Exact contributions of defensive actions are unknown.**

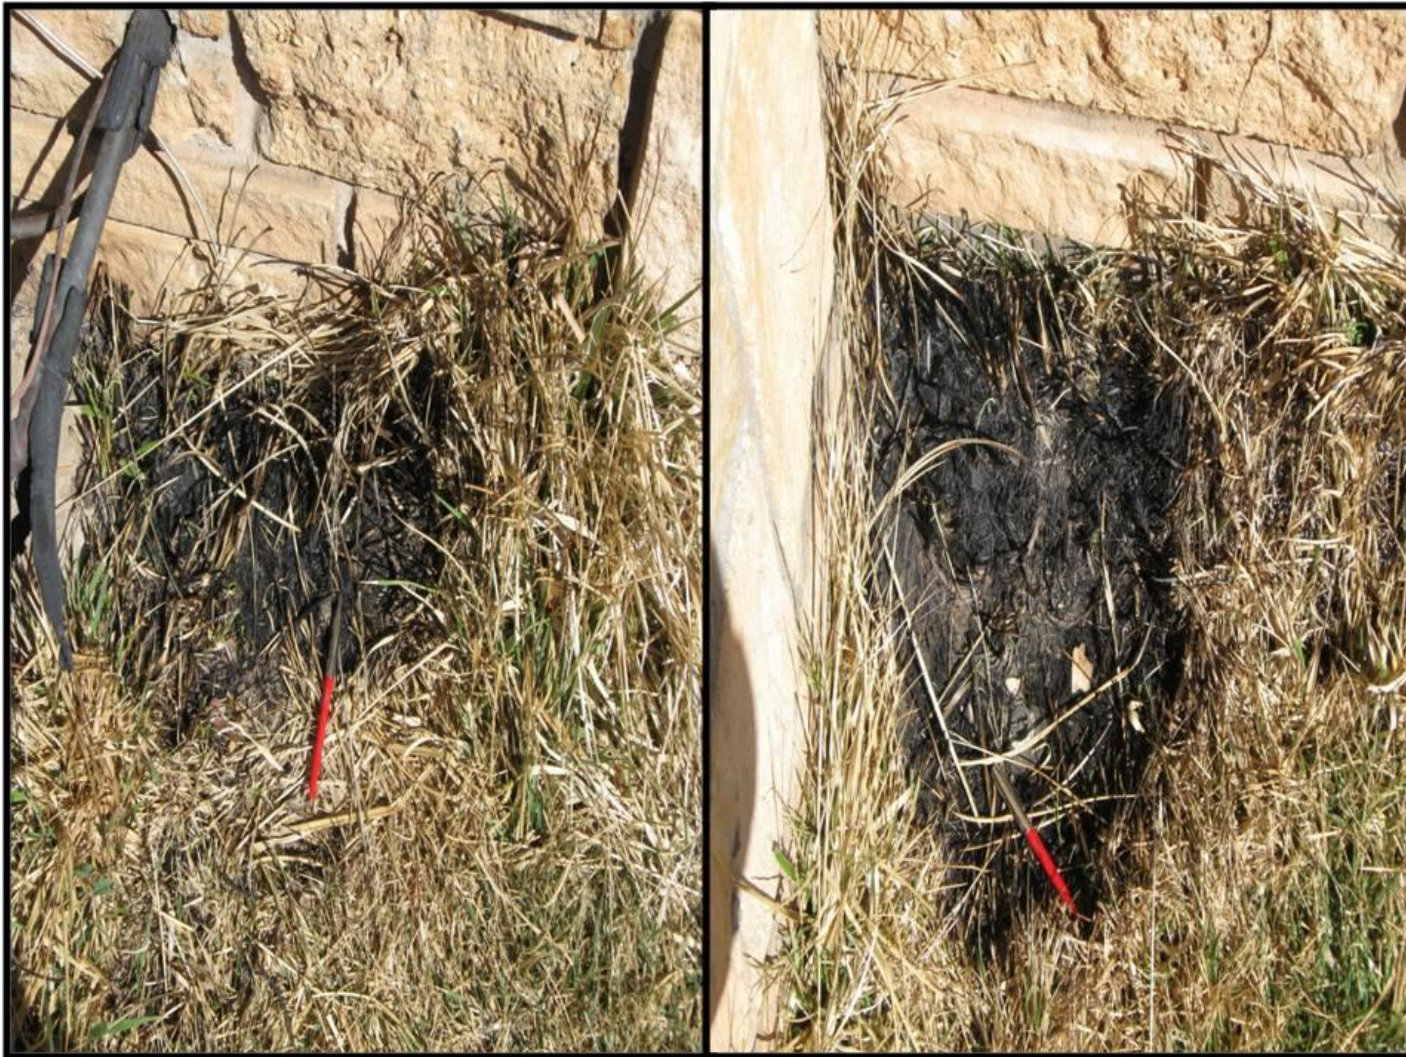
However, field assessments at 209 Quail Ridge Road identified small areas of vegetation burning adjacent to noncombustible sections of the house as shown in Figure 21. It is not known if these areas were extinguished through manual intervention or if they extinguished independently. These burned areas were in the direction of the fire front and might have ignited due to ember accumulation against the wall possibly combined with the non-mowed grass directly adjacent to the house.

**Figure 21 Two distinct vegetation ignitions adjacent to structure at 209 Quail Ridge Road. Red feature is 15 cm (6 in) long ballpoint pen, NIST photos.**

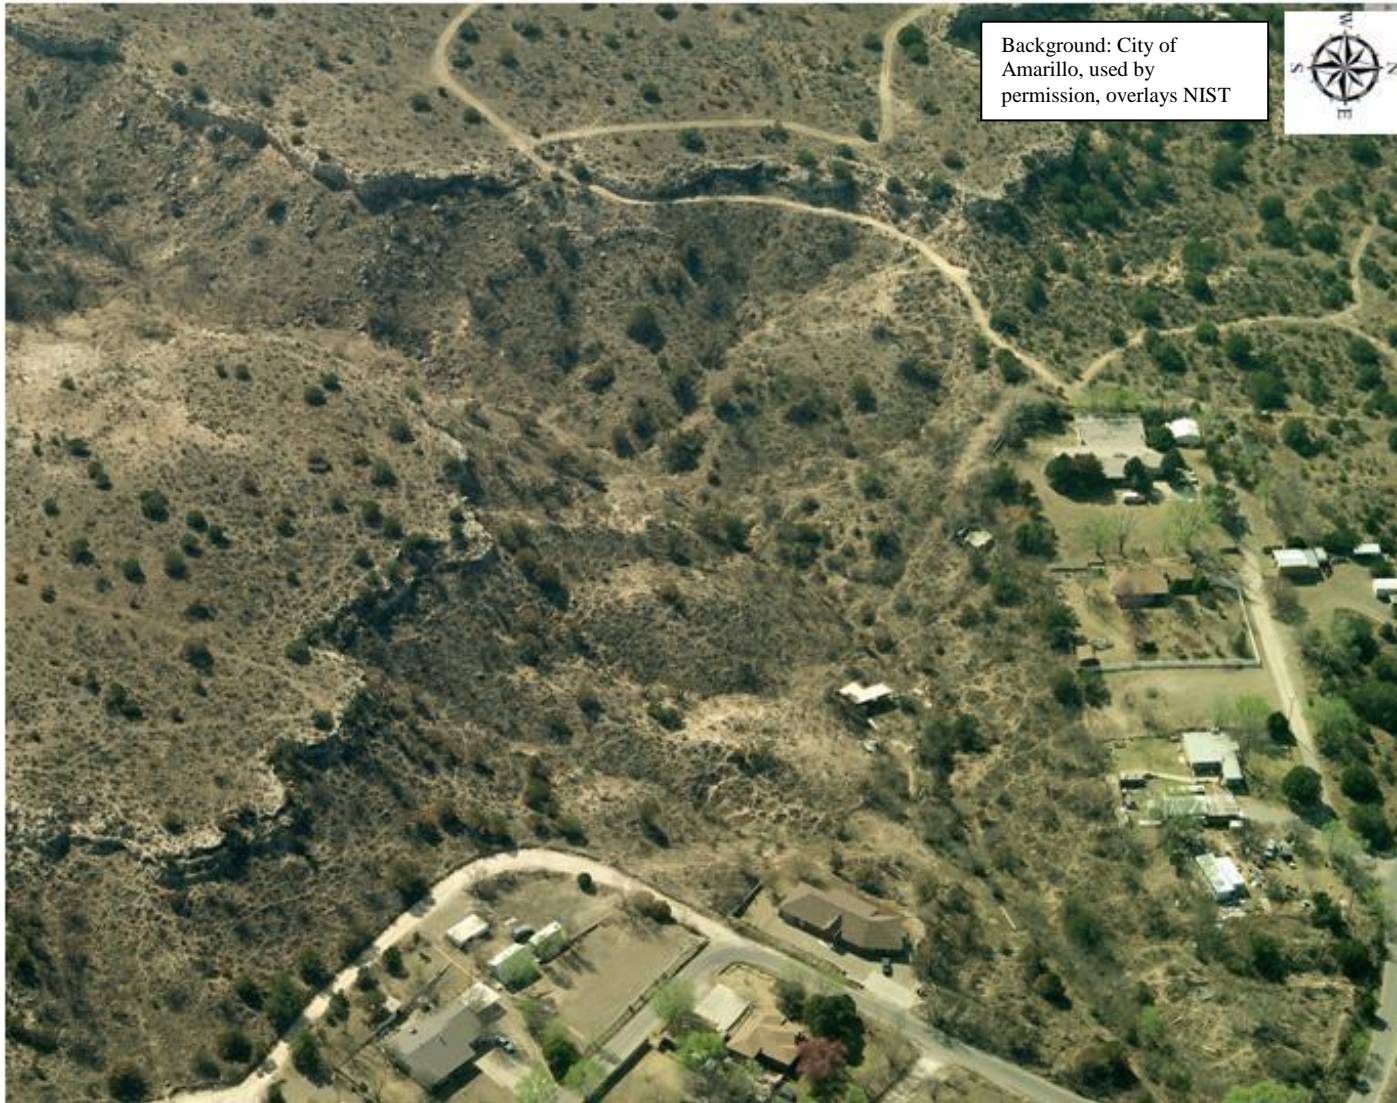
**Figure 26 Post-fire south facing oblique imagery showing results of higher intensity fire on the southeastern side (northeast facing) of the canyon compared to the northwestern side.**

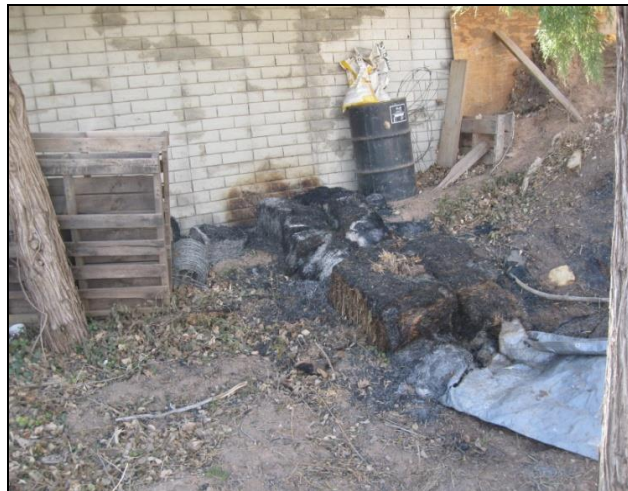
**Figure 33 Burned hay bales leading from destroyed secondary structure to primary structure causing scorching on the brick siding. Categorization of defensive actions is unknown, NIST photo.**

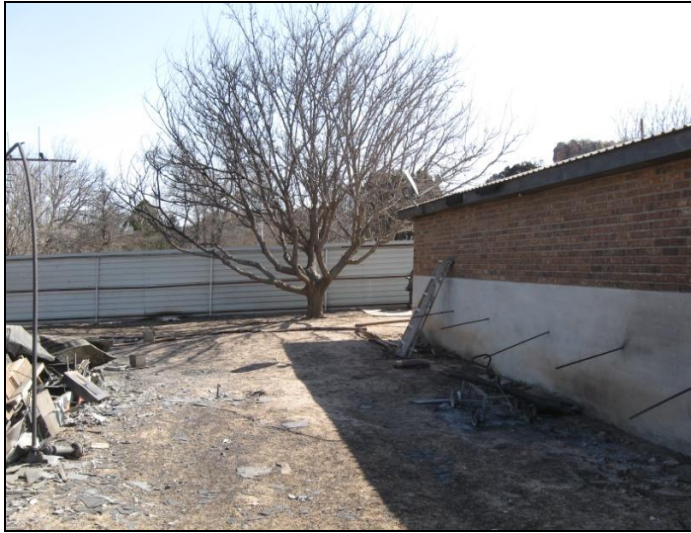
**Figure 34 Unidentified burned features adjacent to the northern side of the residential structure at 102 Gary Drive. These features are believed to be ignited by the burning mobile home to the north of the brick residential structure, NIST photo.**

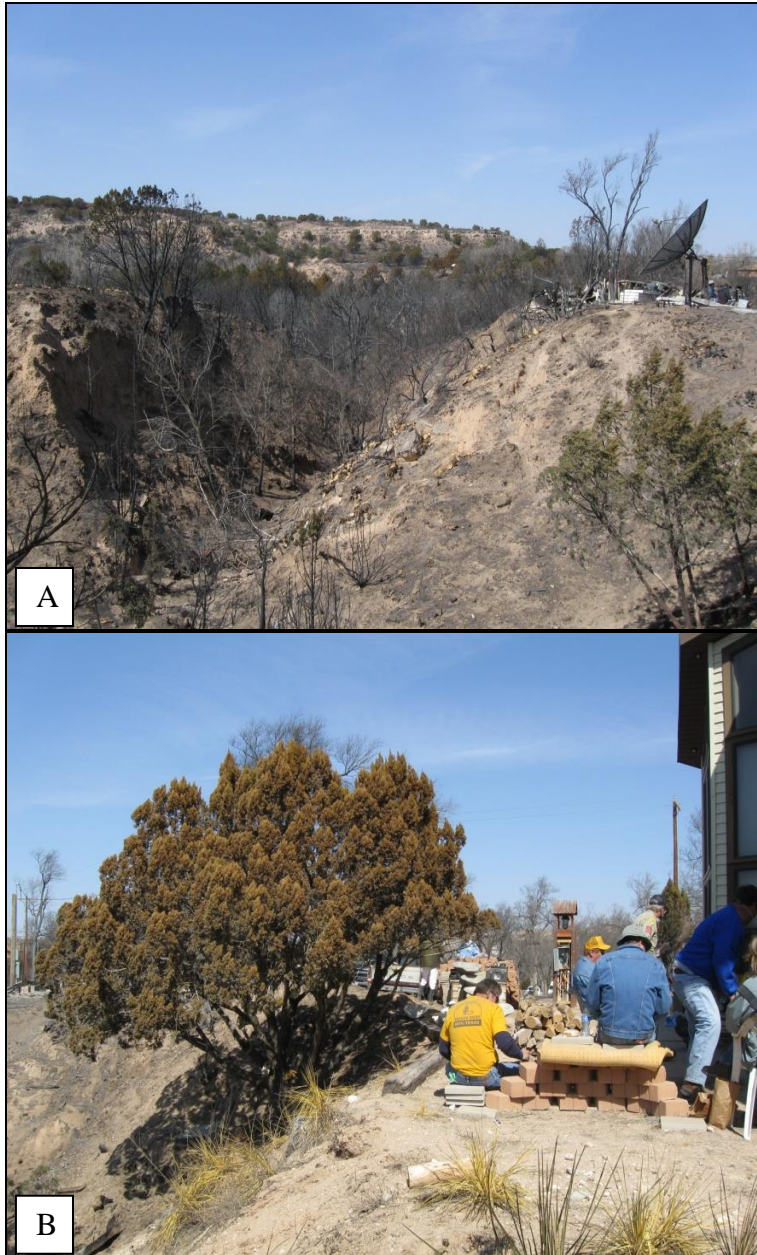
**Figure 35 A: Stand replacing fire in the canyon to the west of 102 Gary Drive. B: Vegetation and building features with minimal damage at the top of the canyon, indicating topographically influenced fire behavior. Image taken from the south side of 102 Gary Drive looking north, NIST photos.**

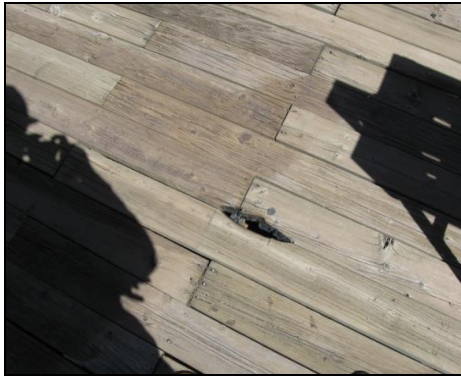
**Figure 44 Ignited deck, which was extinguished by homeowners, NIST photo.**

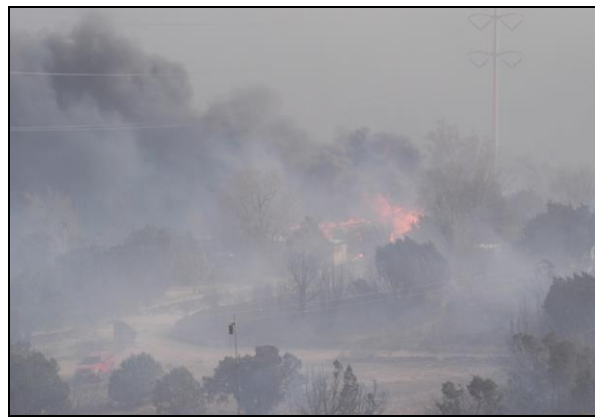
**Figure 45 Fully involved residential structure at 128 Exmoor Road igniting residential structure at 130 Exmoor Road, Photo Gordon Ivy, used by permission.**

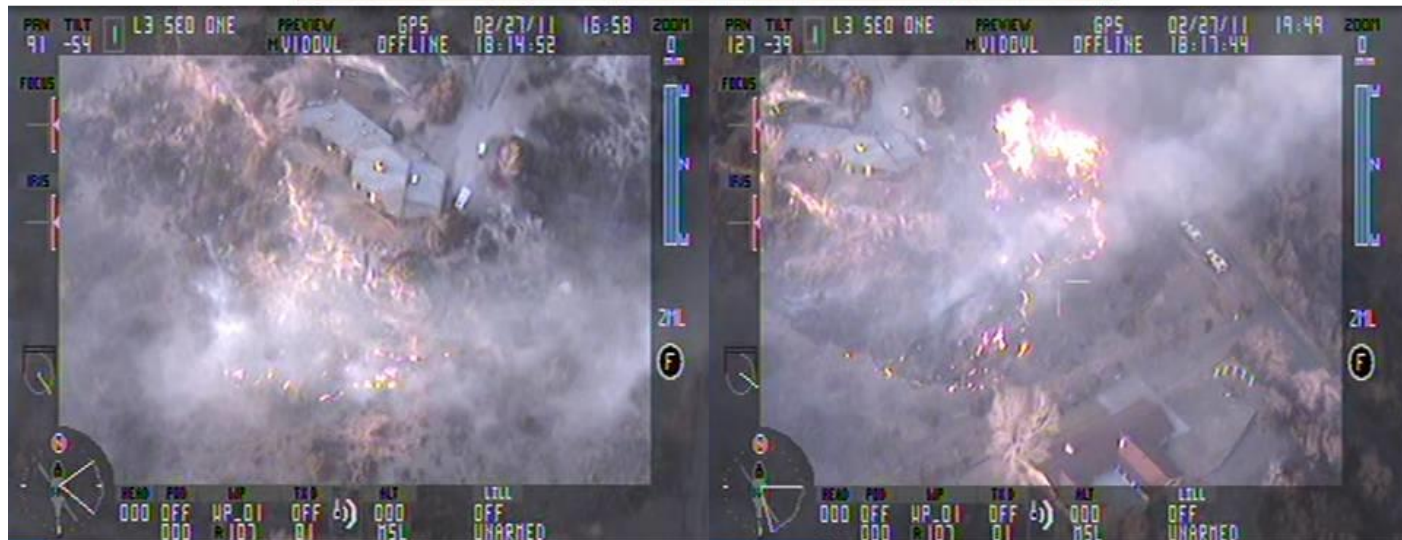
Figure 50 Fire behavior changes coincident with topography. Side directly exposed to wind (left) saw limited scorching and no torching of trees in post-fire imagery, and a low intensity ground fire during Amarillo Sheriff Helicopter flight. Side not facing wind (right) exhibited scorching and torching of trees in post-fire imagery, and a high intensity crown fire during helicopter flight was observed.

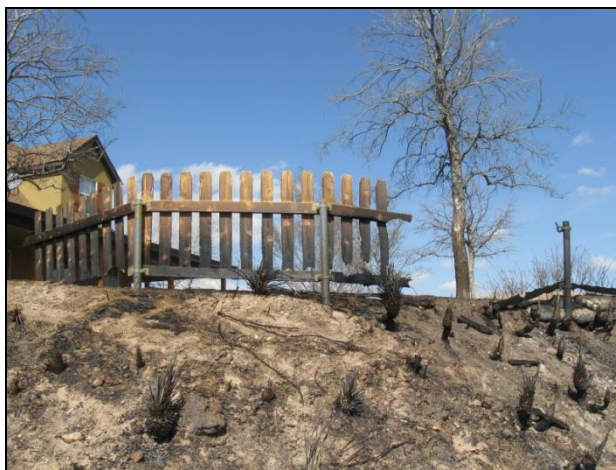
**Figure 54** Partially destroyed fence at 100 Camino Alto, NIST photo.

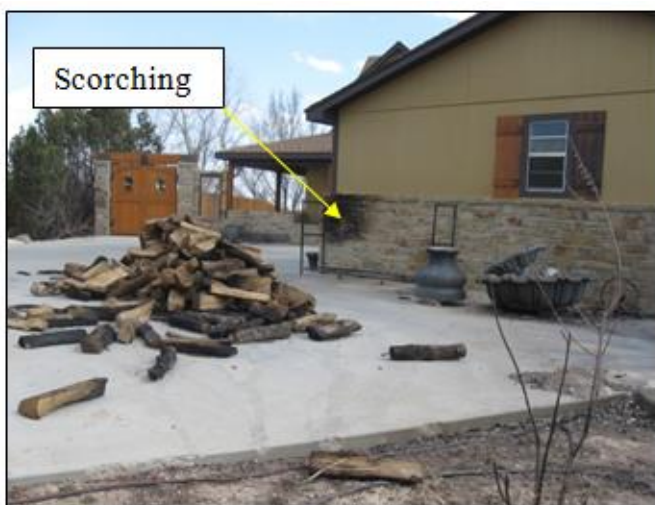
**Figure 55** Defended firewood pile at 100 Camino Alto, NIST photo.

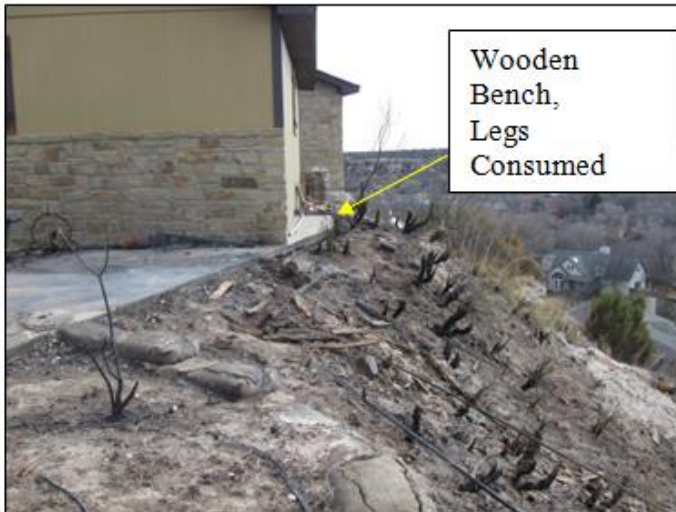
**Figure 56 Damaged wooden bench and burned and unburned vegetation on west side of 100 Camino Alto, NIST photo.**

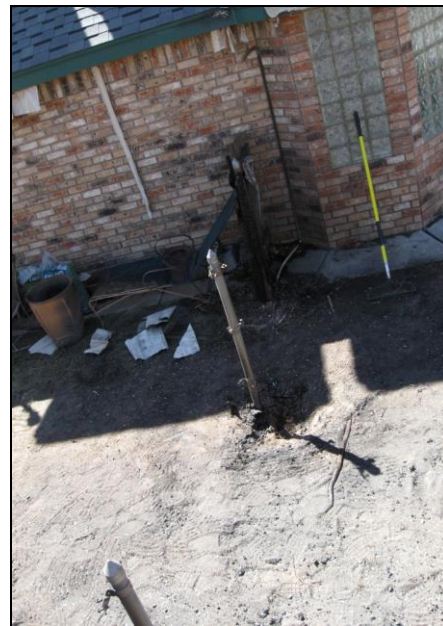
**Figure 57 Partially destroyed wood fence, which caused scorching to brick siding and melting of vinyl soffit, NIST photo.**

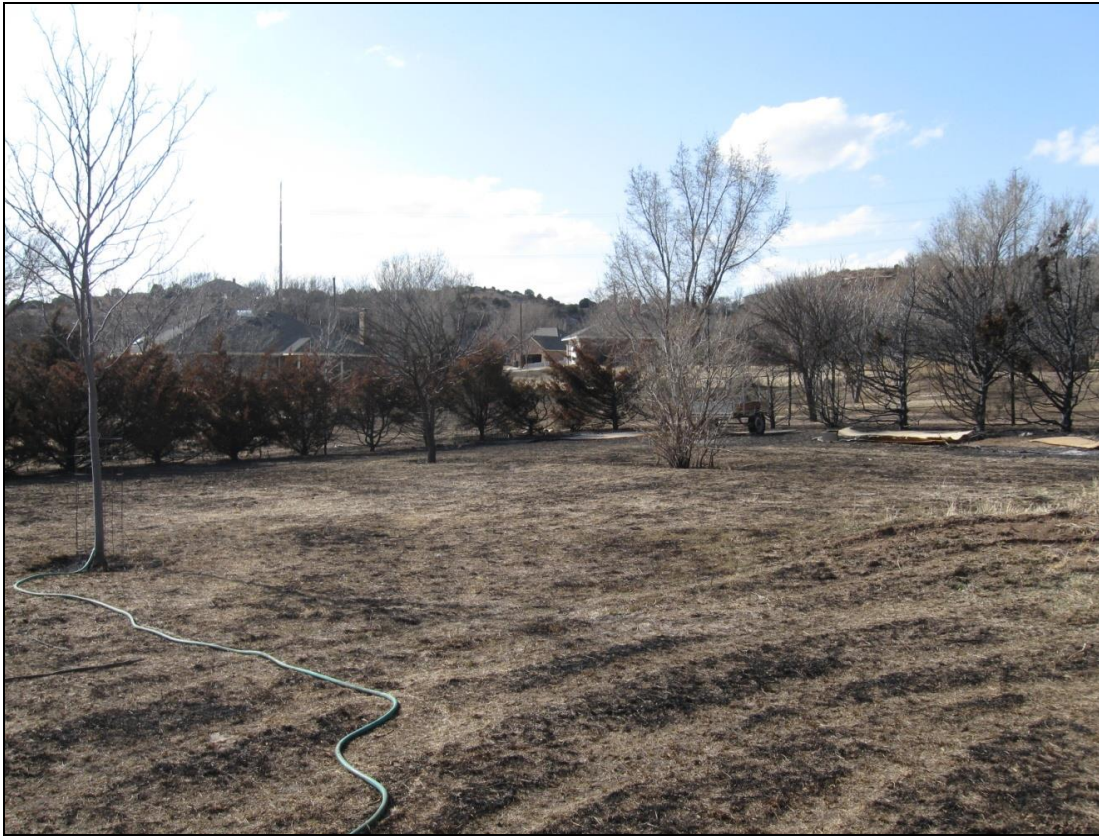
**Figure 58** Burnt hedgerow and Buffalo grass that facilitated fire spread to destroyed secondary structure at 105 Port-O-Call Drive, NIST photo.

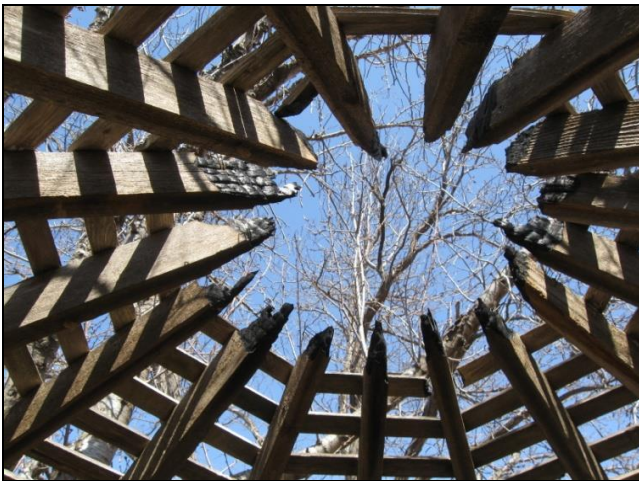
**Figure 60 Damaged pergola roof ignited by embers, NIST photo.**
