NBSIR 84-2858 (R)

Report No. 11

Observations of the April 8, 1979 Railroad Accident at Crestview, Florida

April 1984

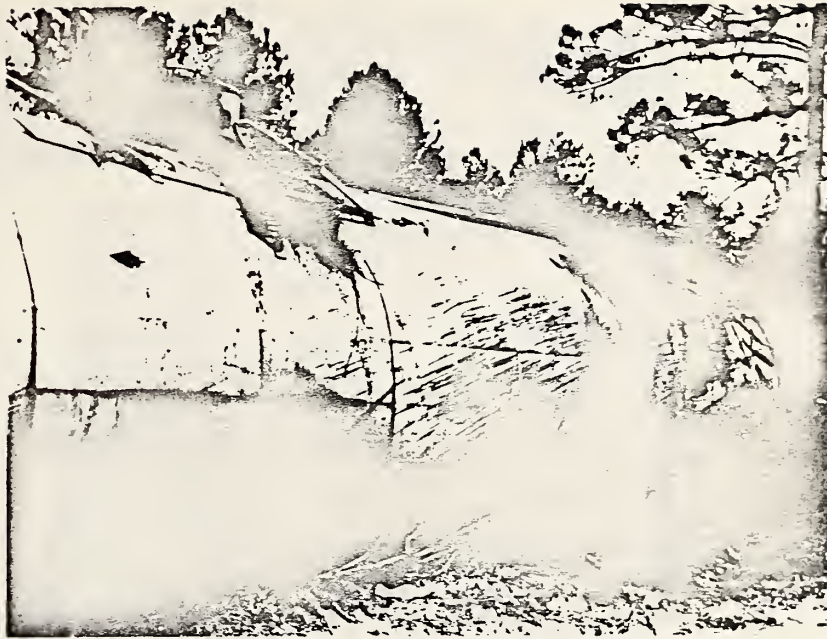
Jacket: No Jacket _____ or Describe: Photos show badly wrinkled jacket with a fracture of 2 3/4 inches by 12 inches in the 7th course from the A head. No significant damage to jacket on either A or B-heads.

Photo 1-1: Tank-car GATX 49258 showing rumpled jacket and fracture in the 7th jacket course from the A head.

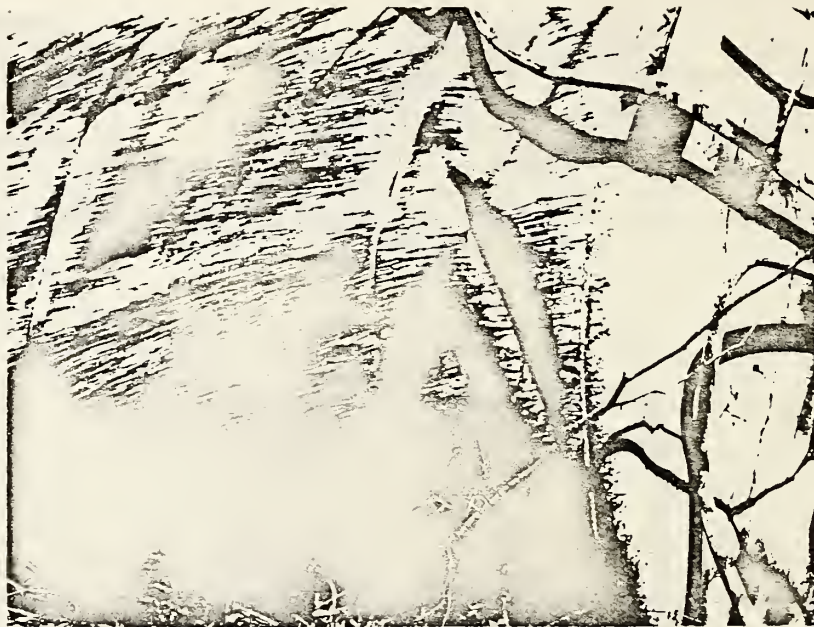
Photo C1-8: Close-up of rumpled jacket at the A end of tank-car GATX 49258.

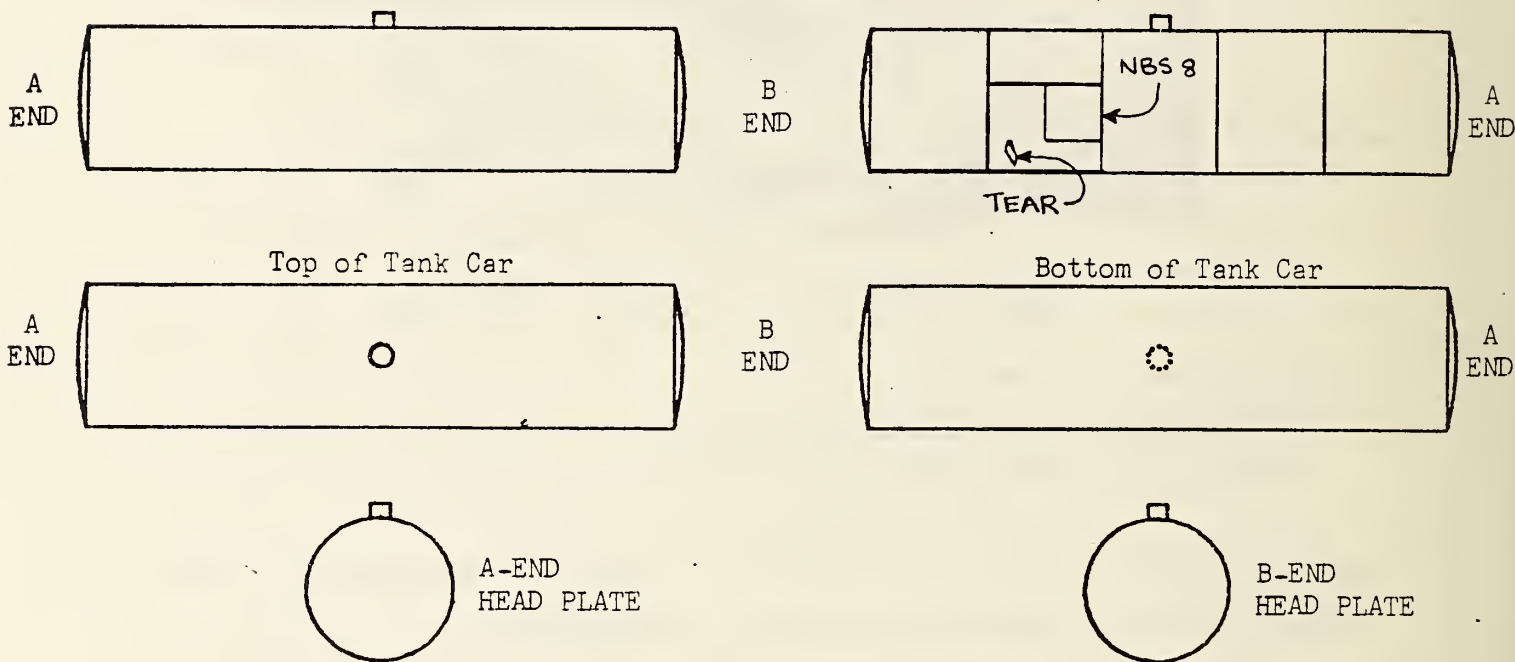
Shell and Head Plates: This very badly damaged car had only one fracture (in course 4). It was 17" long in a shell plate at a region of very high strain. NBS 8 contains course 4 and the weld to 3. The A-head contained a dent at the edge.

SAMPLE IDENTIFICATION NUMBER	OTHER SAMPLE IDENTIFICATION MARKINGS	LOCATION OF SAMPLE ON CAR
NBS 8		Shell course 4.

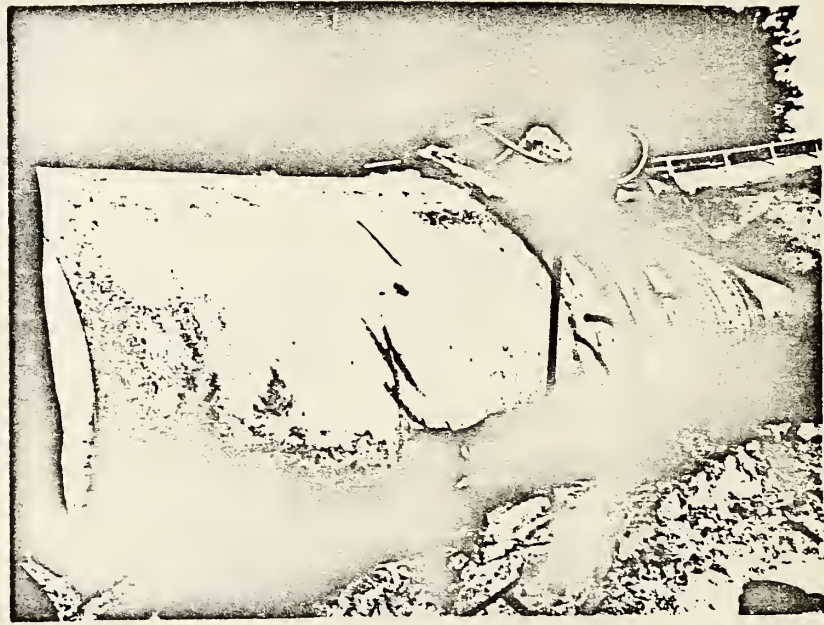
Photo 2-6: Tank-car GATX 44019 showing a 17 inch fracture.

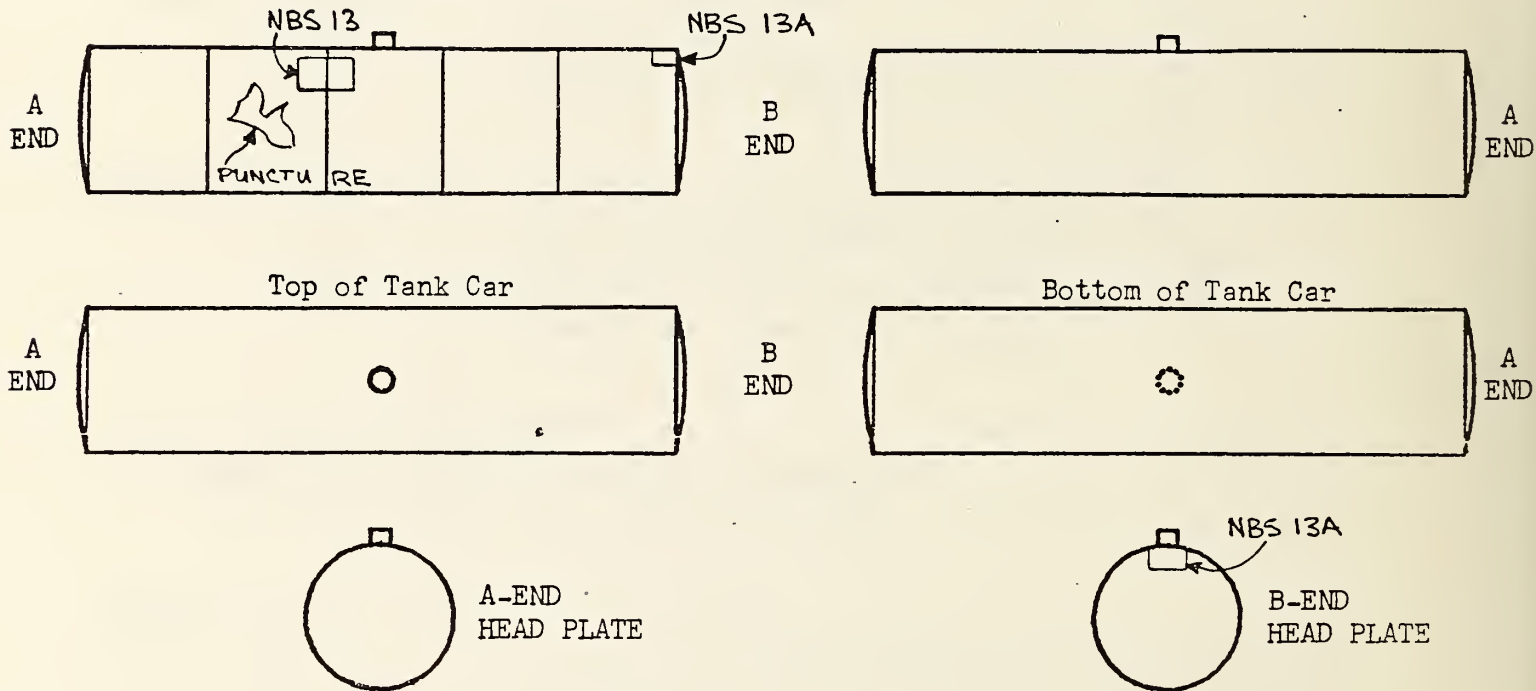
The tank has a banana shape. The 63" rupture is generally lying in the girth weld direction away from the girth weld.

NBS 13 is located in two shell courses (one contains 63" rupture); NBS 13A is located in the severely dented head plate, but it is in a relatively undeformed part of this head plate.

SAMPLE IDENTIFICATION NUMBER	OTHER SAMPLE IDENTIFICATION MARKINGS	LOCATION OF SAMPLE ON CAR
NBS 13		Shell courses 2 & 3, near puncture.
NBS 13A		Shell course 5 & B-head plate.

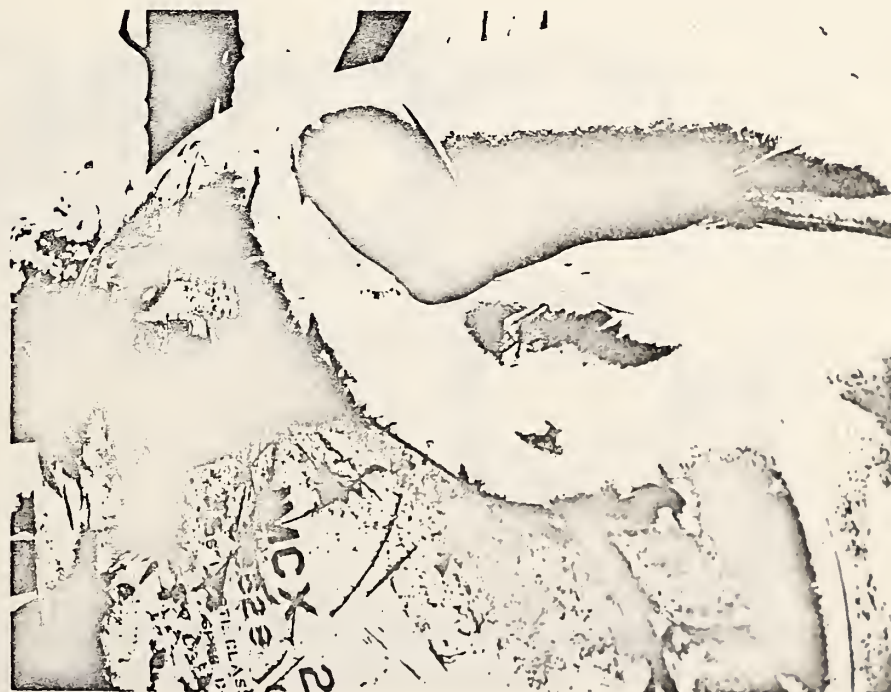
Photo C2-12: Dent in head plate of the north side tub (B-end) of tank-car IMCX 2513.

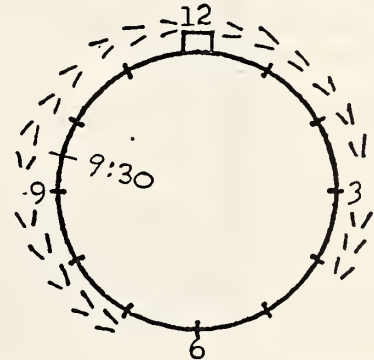
Location Fracture on B-end.
Shell course 2.

Brittle

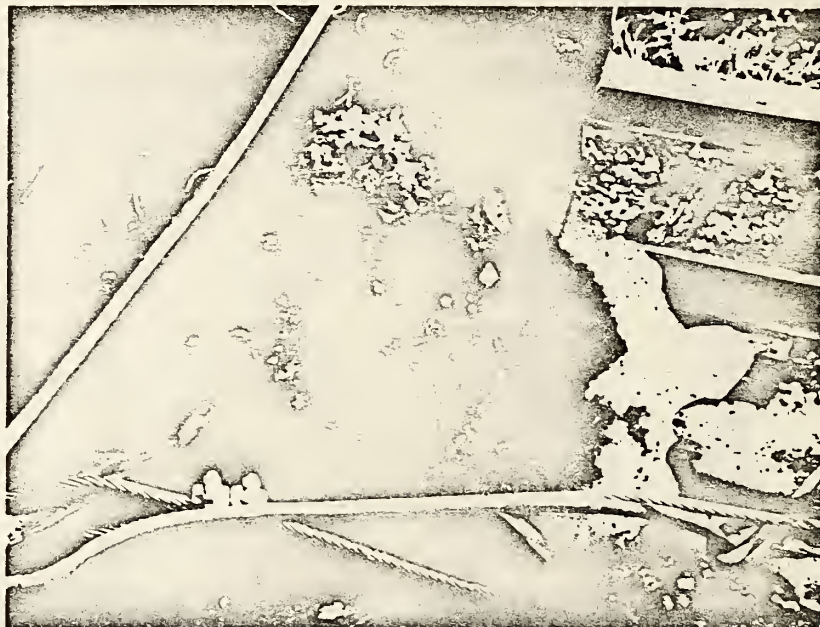
and was not found during clean-up of accident site. Chevron marks were recorded on this, a largely brittle, fracture. See photo 2-8. Sample NBS 12 does not contain this characteristic fracture, except on NBS 12 extended.

Photo C4-4: North side tub (B-end) of tank-car
IMCX 2827 showing the area of sample
NBS 12, the probable fracture origin.

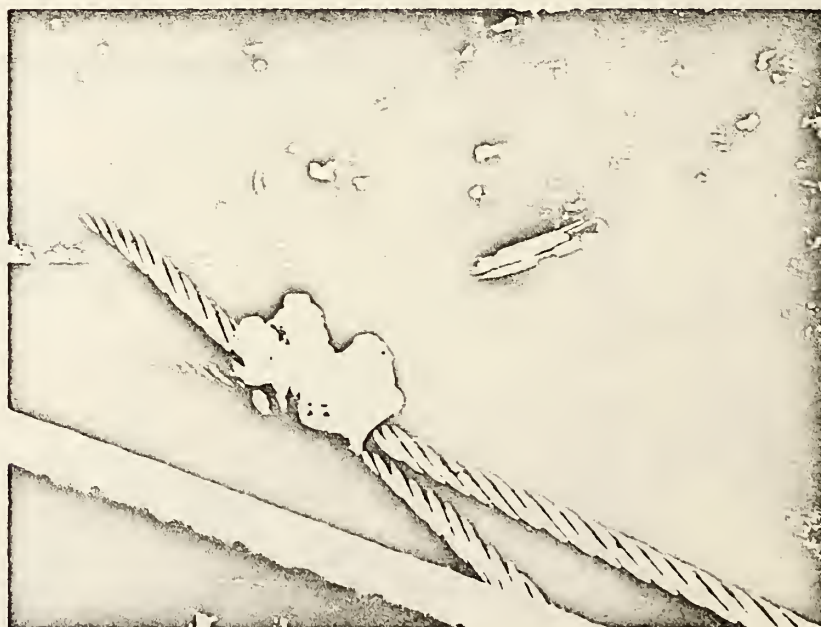
Photo C4-3: Close-up of the probable fracture origin
of the north side tub (B-end) of tank-
car IMCX 2827.
