# NATIONAL BUREAU OF STANDARDS REPORT

REPORT  
OF  
EXPERIMENTS TO DETERMINE THE FIRE RESISTANCES  
OF  
TWO PREFABRICATED WOOD WALLS

J. V. Ryan  
Fire Protection Section  
Building Technology Division

U. S. DEPARTMENT OF THE AIR FORCE  
Headquarters U. S. Air Force  
Washington 25, D. C.

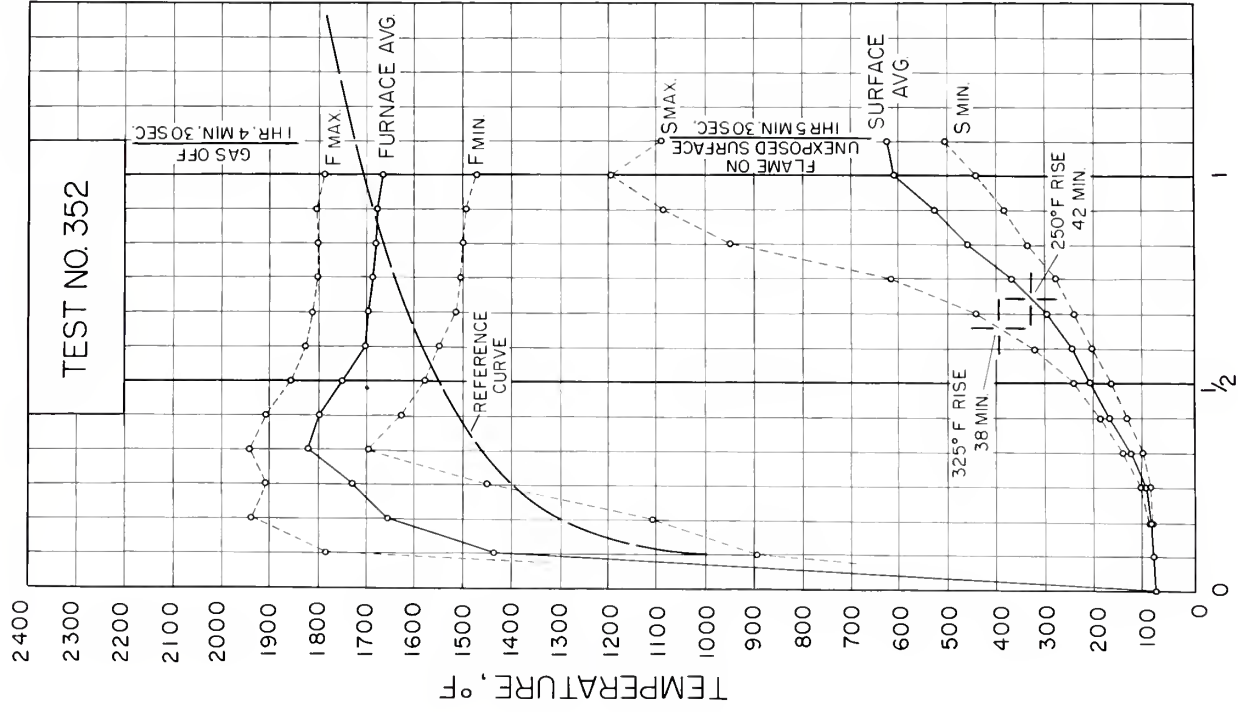
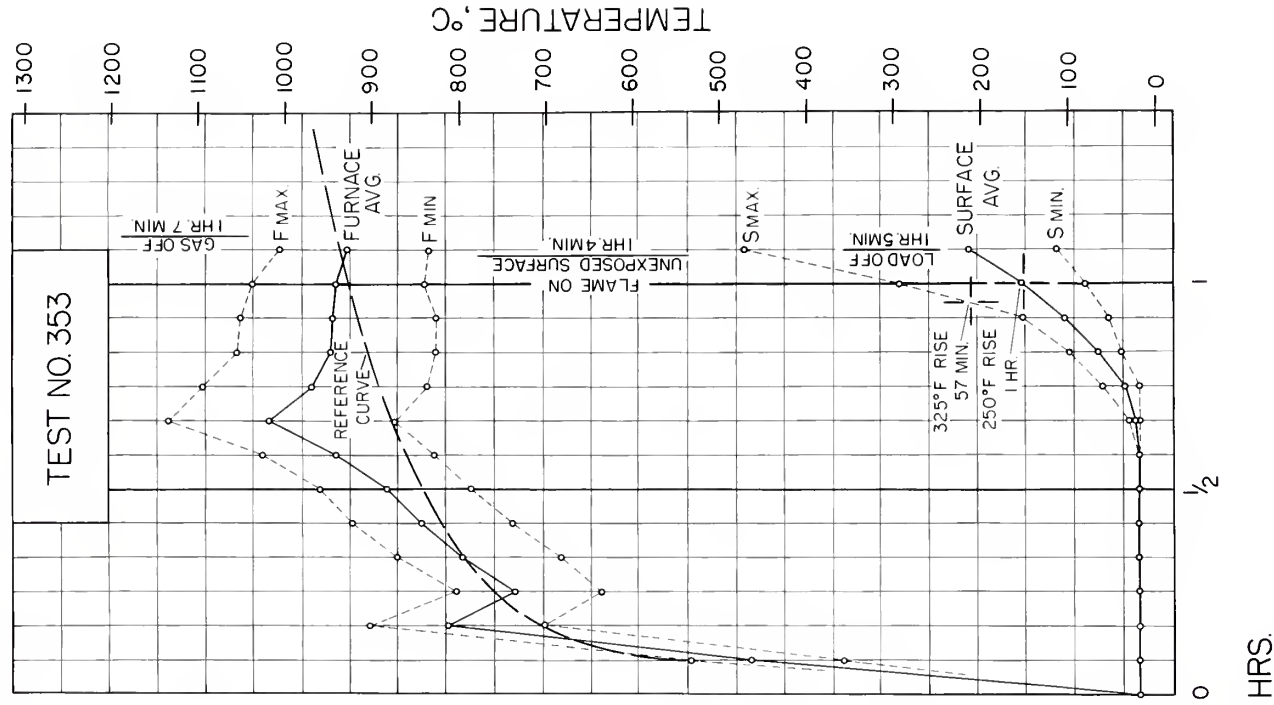
FIG 2 TEMPERATURES OBSERVED DURING FIRE-ENDURANCE TESTS

The temperatures observed during the experimental test are represented in figure 2. The temperature at one thermocouple on the unexposed surface had risen 325 degree F above the initial temperature at 38 min and the average on the unexposed surface had risen 250 degree F above the initial temperature at 42 min. The average furnace temperatures were higher than those of the standard time-temperature curve during most of the test. The fire exposure severity, defined as the ratio of the area under the curve of average furnace temperature to the area under the standard time-temperature curve, was 121 percent. Therefore, a correction of +6 min was applicable to the 36 min limiting time, making the corrected fire endurance of the experimental specimen 44 min.

The temperatures observed during the experimental test are represented in figure 2. The temperature at one thermocouple on the unexposed surface had risen 325 degree F above the initial temperature at 57 min and the average at all the thermocouples on the unexposed surface had risen 250 degree F above the initial average at 1 hr. The average furnace temperatures were somewhat higher than those of the standard time-temperature curve during part of the test. The fire exposure severity was 105 percent. A correction of +2 min was applicable to the 57 min limit, making the corrected fire endurance of the experimental specimen 59 min.

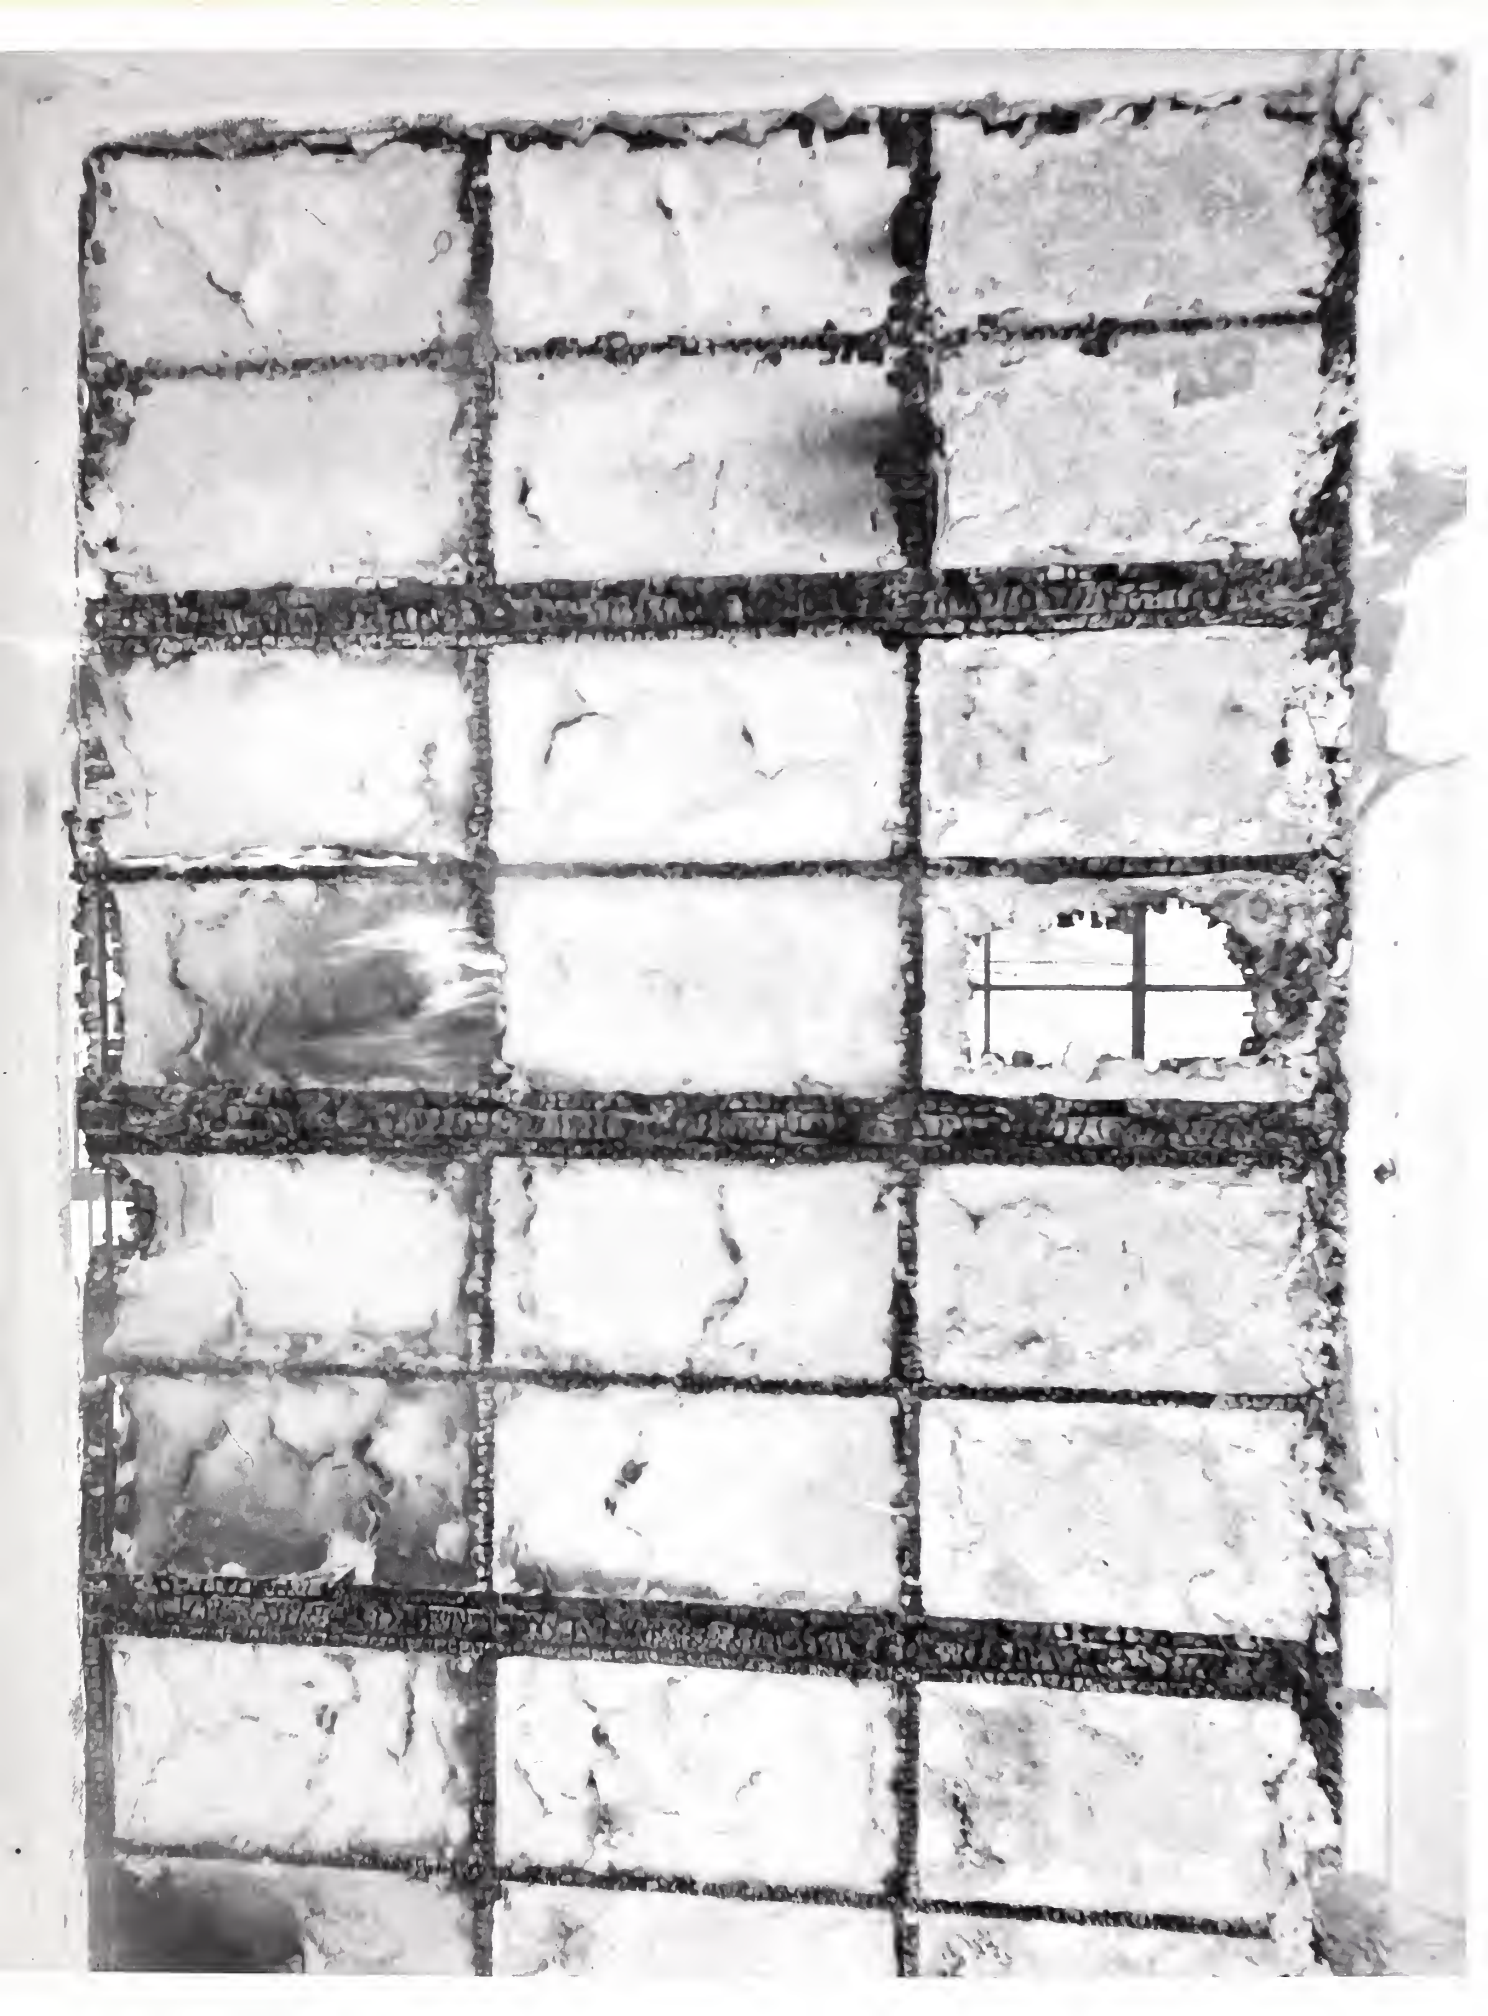
Figure 4. Exposed surface of fire-break wall  
as flames started at 1 or 2 m of  
fire entrance to it.

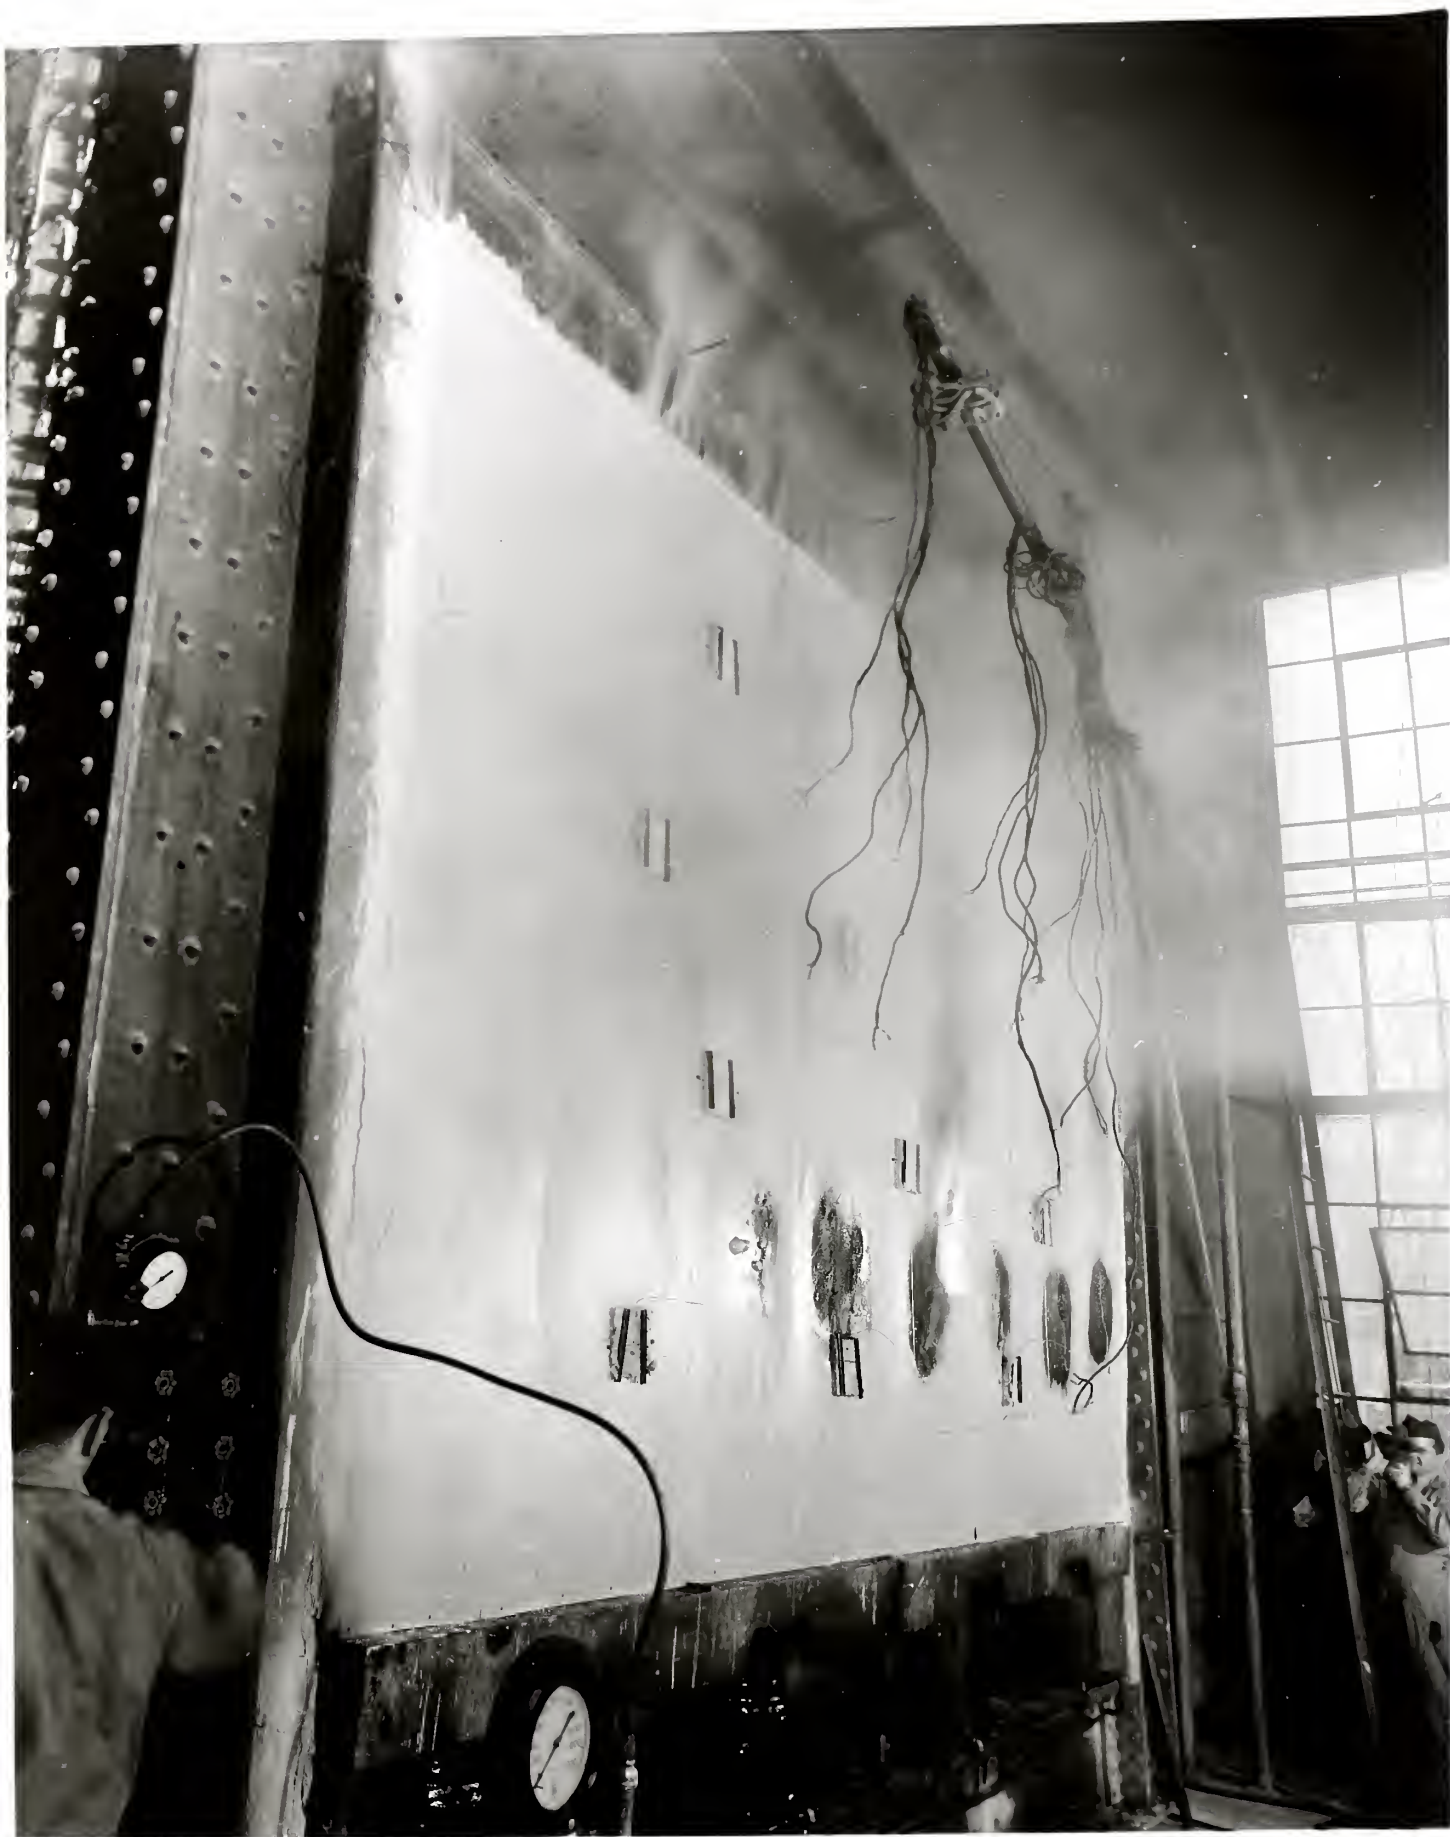
E-68976

The specimen and flame were removed from before the furnace and a water stream played on from exposed side. The panels that had made up the exposed side of the wall were almost completely gone. The plywood was burned from the inner faces of the panels that made up the unexposed side of the wall and the glass fiber insulation was white and matted. Over some areas, it had a granular texture in place of the original fibrous texture.

Figure 5. Section of fire-break wall from fire  
side after test 11.
