# Investigation into the Ashland Oil Storage Tank Collapse on January 2, 1988

# **Investigation into the Ashland Oil Storage Tank Collapse on January 2, 1988**

Issued June 1988

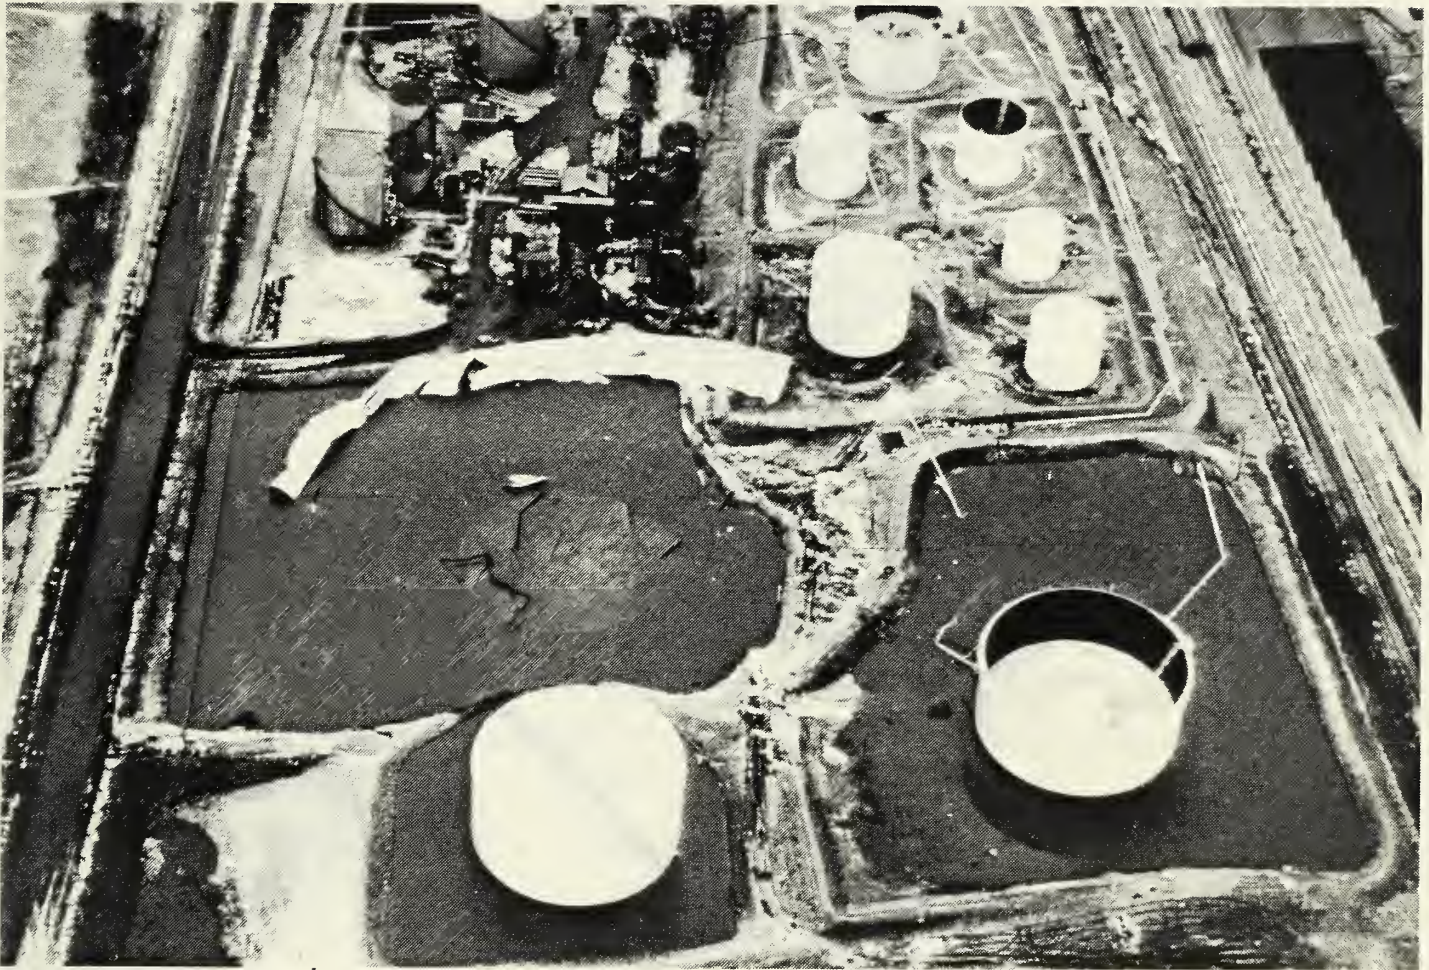
Figure 1.1 - Aerial View of the Ashland Tank Collapse, January 4, 1988.  
(Photo Courtesy of Vince Musi -- Pittsburgh Press/SIPA)

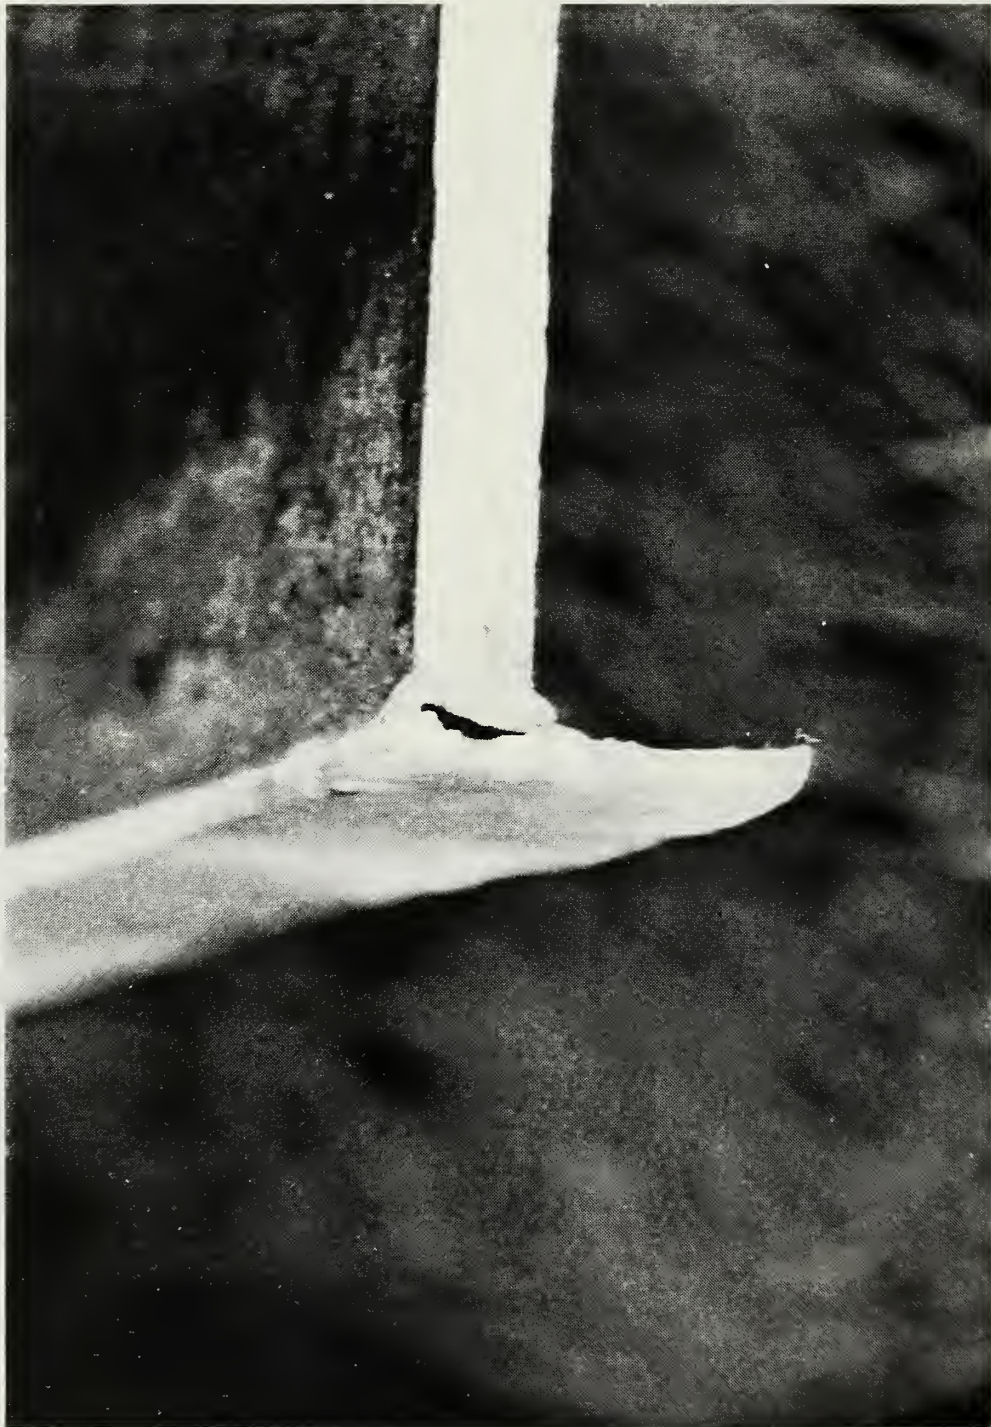
Figure 3.6 - Tear in Tank Bottom at Inside Fillet Attaching First Shell Course and Bottom Plate

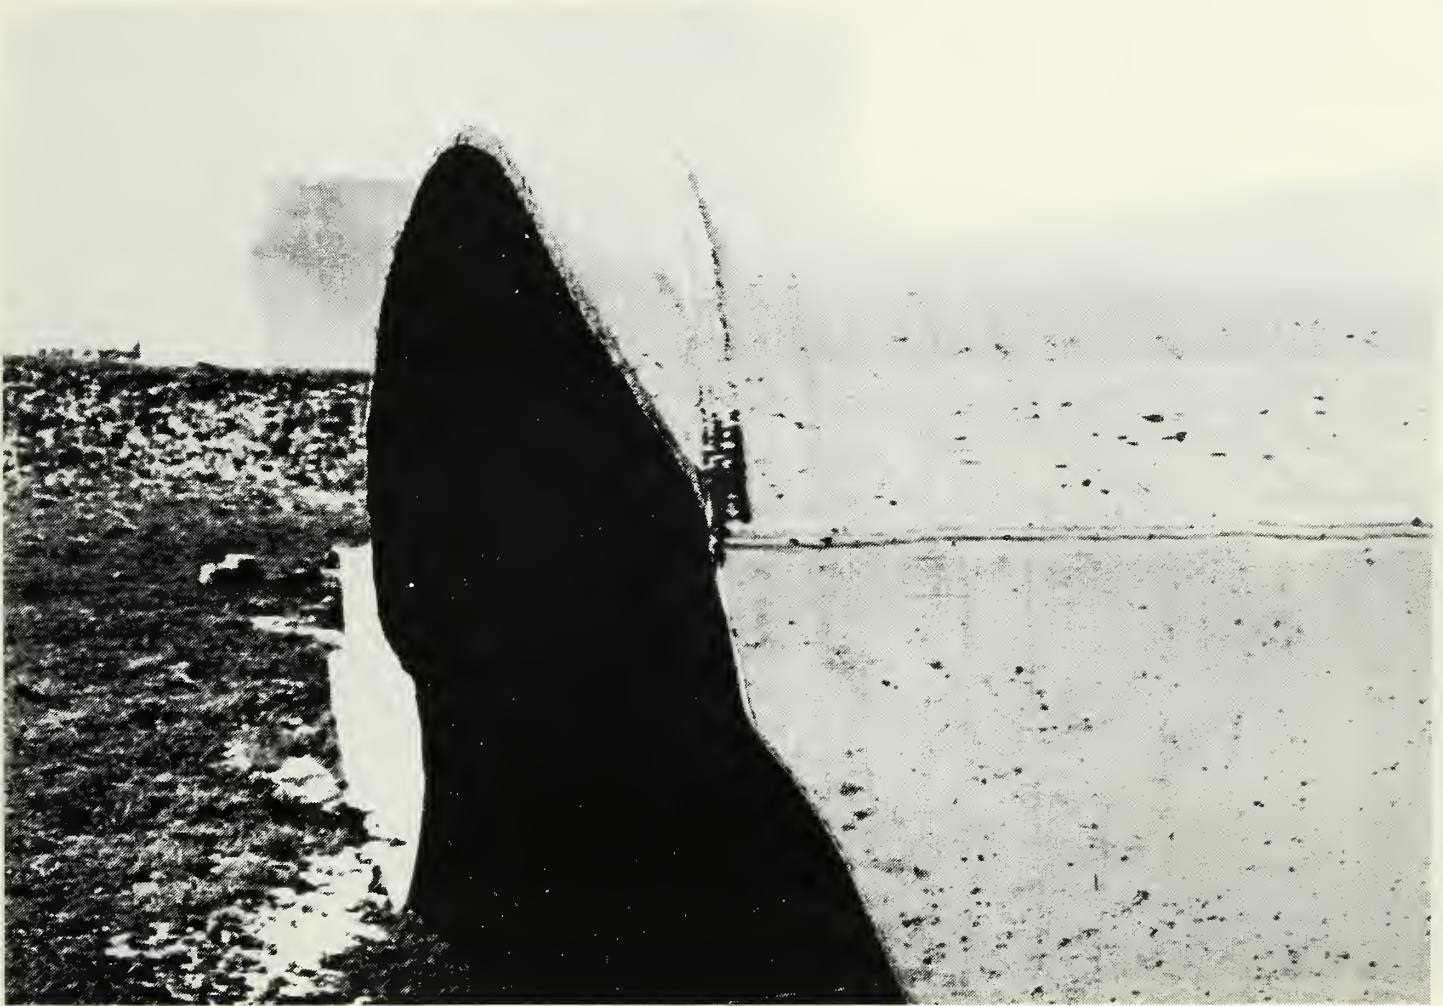
One side of the fracture in the tank wall came to rest inside the dike area near Tank No. 1366. It is shown in Figure 3.9. The fracture surface was flat and perpendicular to the tank wall indicating that it was a brittle fracture. Chevrons were evident on the fracture surface (see Figure 3.10). The chevrons pointed to a dark area extending about two-thirds of the way through the plate thickness (see Figure 3.11). The location of this dark area is just below the horizontal weld, between the first and second shell courses, and just to the left (looking from the outside of the tank) of a vertical seam in the second course. The fracture was believed to have initiated at this point and extended to the top and bottom of the tank wall. A diagram showing the path of the fracture is shown in Figure 3.12. Note that the fracture neither started nor propagated in the welds.

Figure 3.9 - Right Side of Fracture

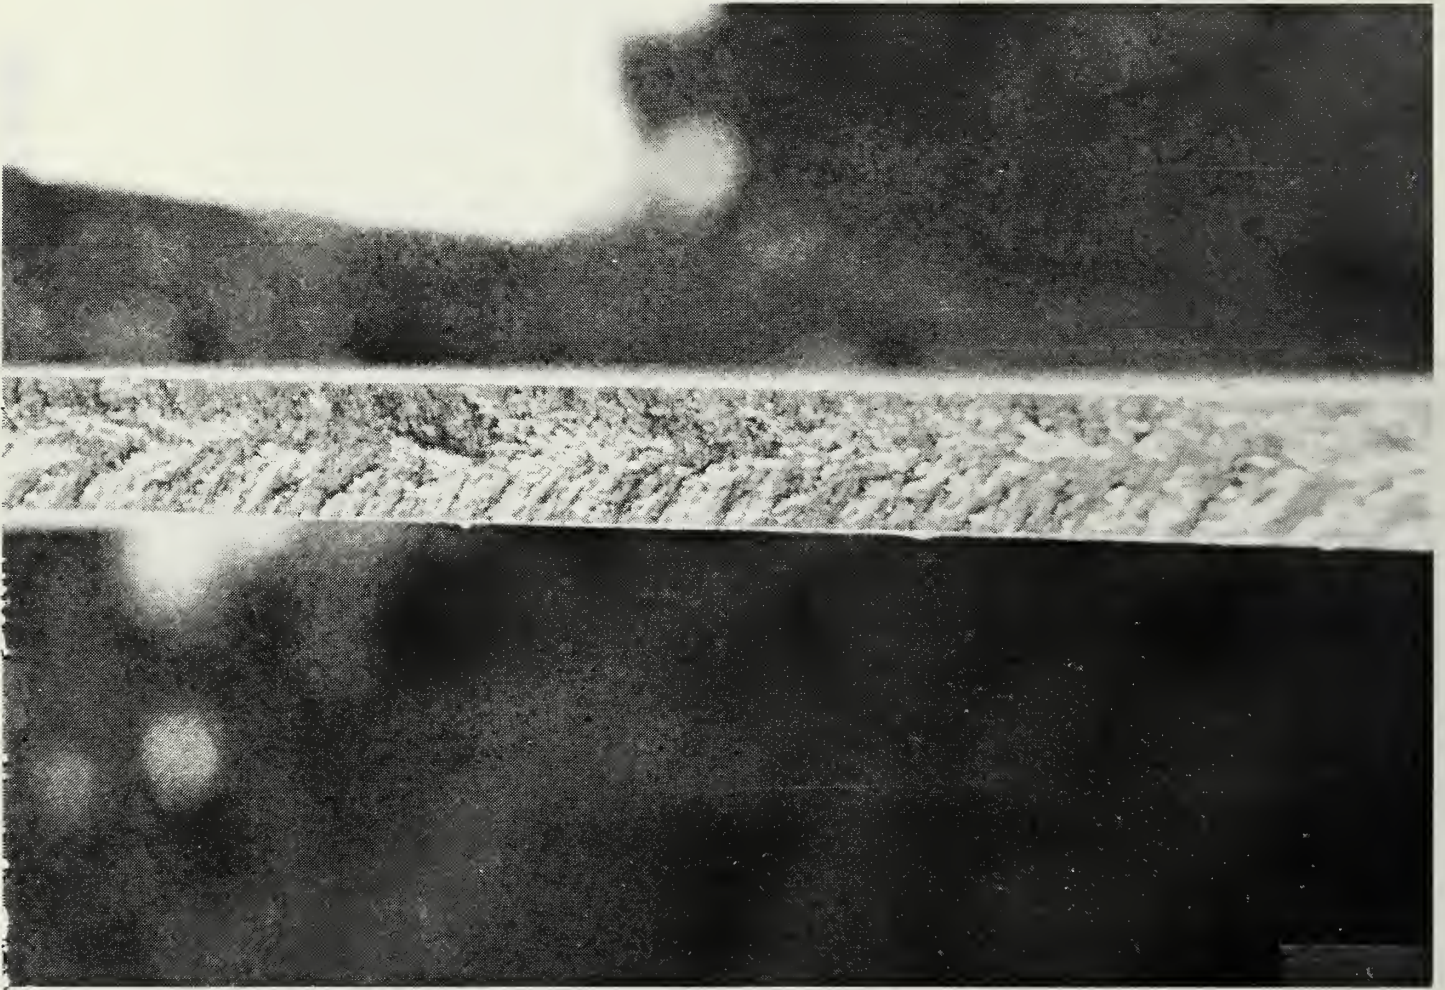
The flat surface of the fracture of the shell indicated that it was a result of brittle fracture. Chevron-like markings were evident on the fracture surface. These pointed to a flaw extending about two-thirds of the way through the plate thickness and located about 8 ft above the base of the tank, just below the horizontal weld between the first and second shell courses, and just to the left (looking from the outside of the tank) of a vertical seam in the second course. The chevron markings, pointing to the flaw from above and below, are convincing evidence that the fracture of the shell initiated at this flaw.

Figure 3.10 - Chevrons in Fracture Surface

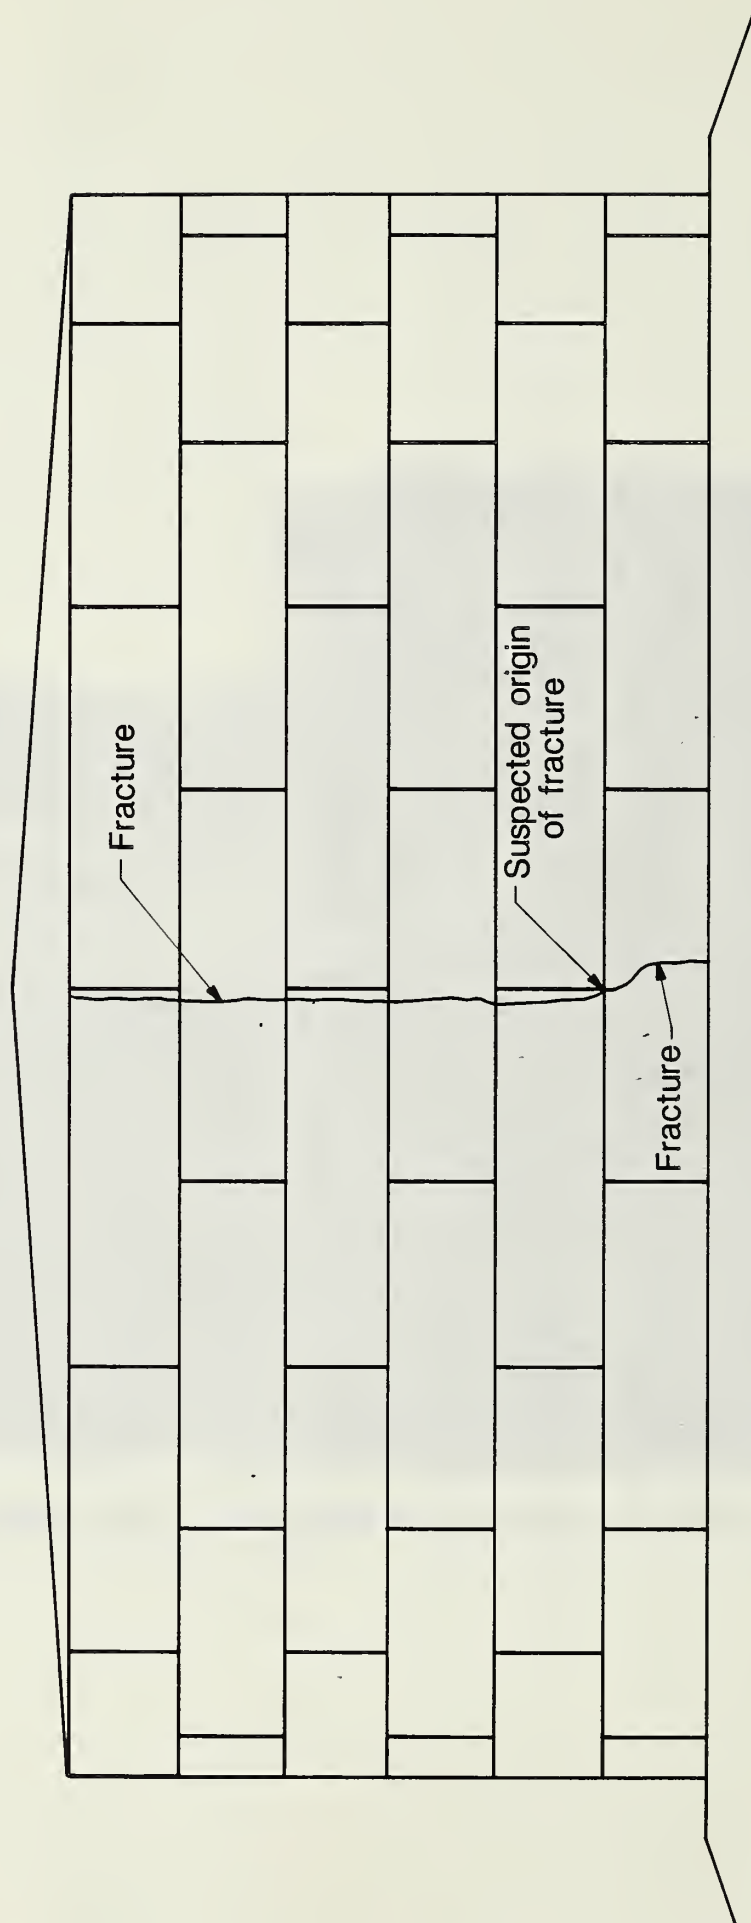
The failure of the tank was caused by a brittle fracture that initiated at a flaw in the tank shell about 8 ft above the base and just below the horizontal weld between the first and second courses of steel. The fracture propagated to complete rupture of the tank shell because the steel lacked sufficient toughness to arrest a propagating fracture at the temperature and stresses existing in the tank shell.

Figure 3.12 - Approximate Path of Fracture in Tank Wall

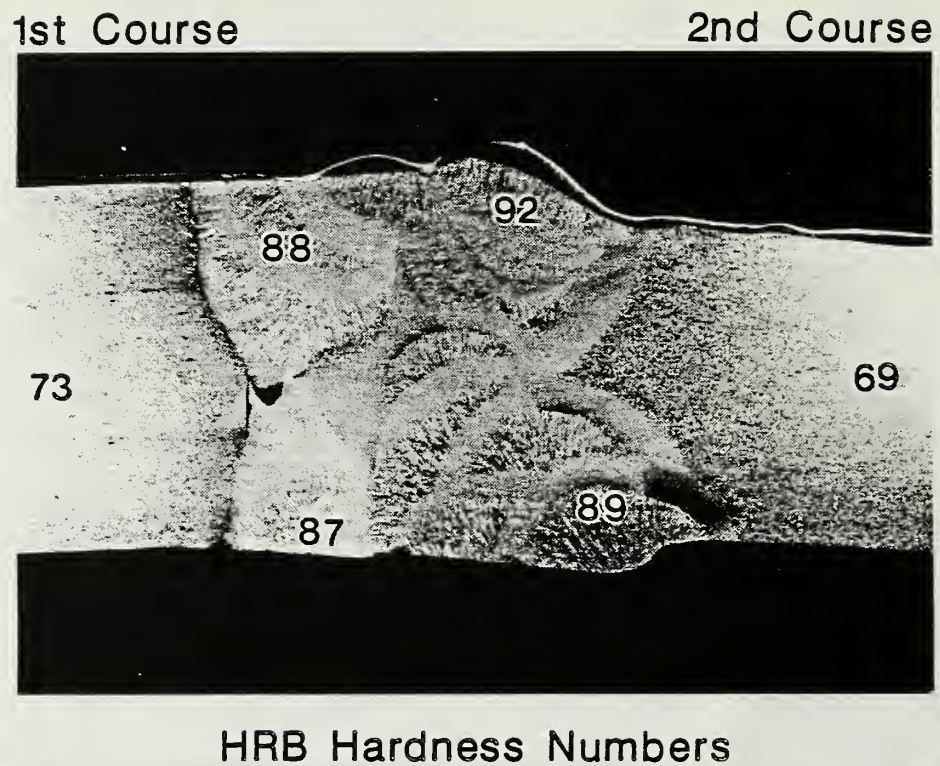
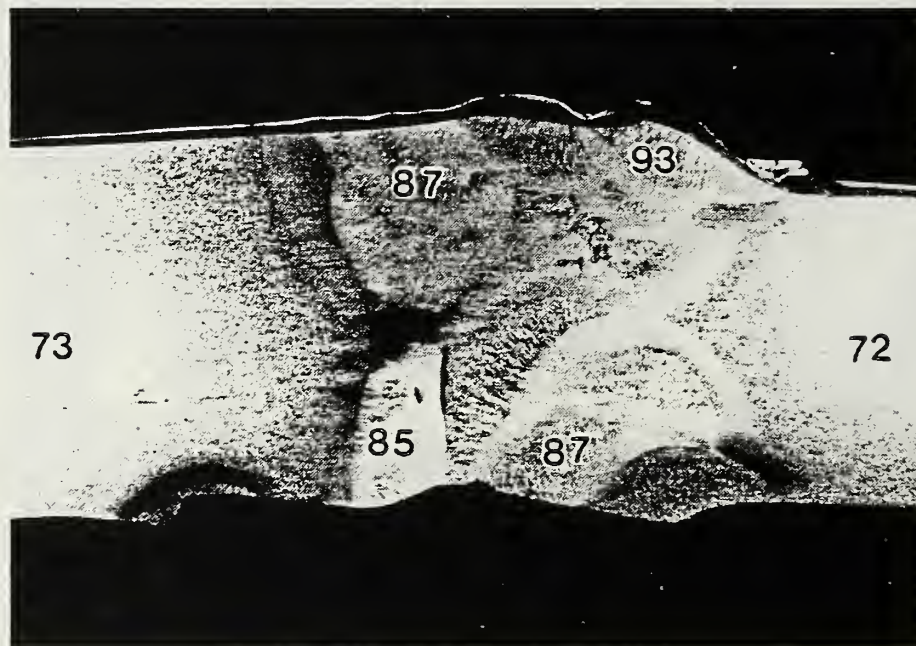
Although the weld quality did not conform to API 650, the weld quality was not a contributing factor in the initiation or propagation of this fracture. However, welding adjacent to the flaw contributed to embrittlement of the metal.

Figure 7.18 - Defects in Horizontal Weld Metal

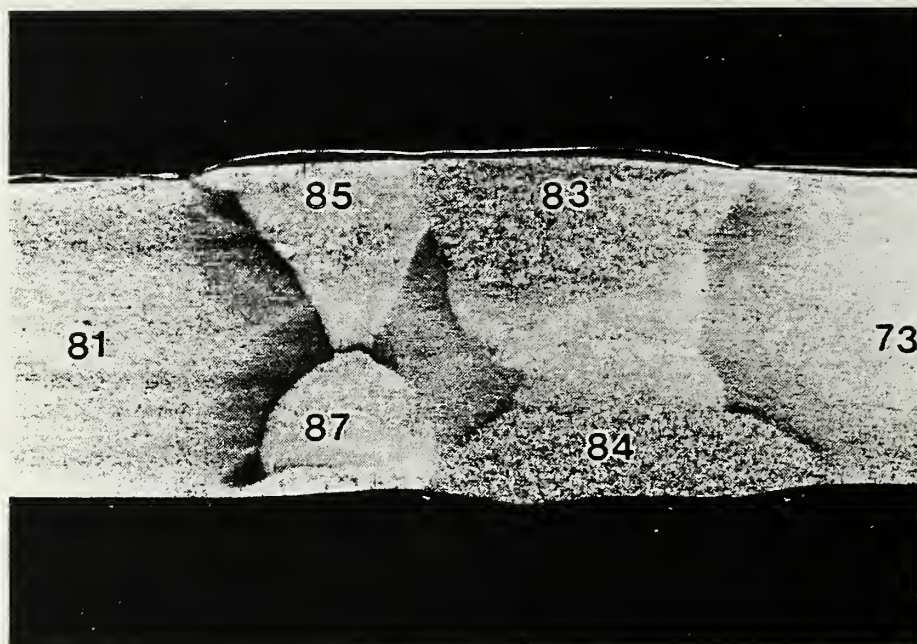
Figure 7.20 - Defects in Vertical Weld Metal

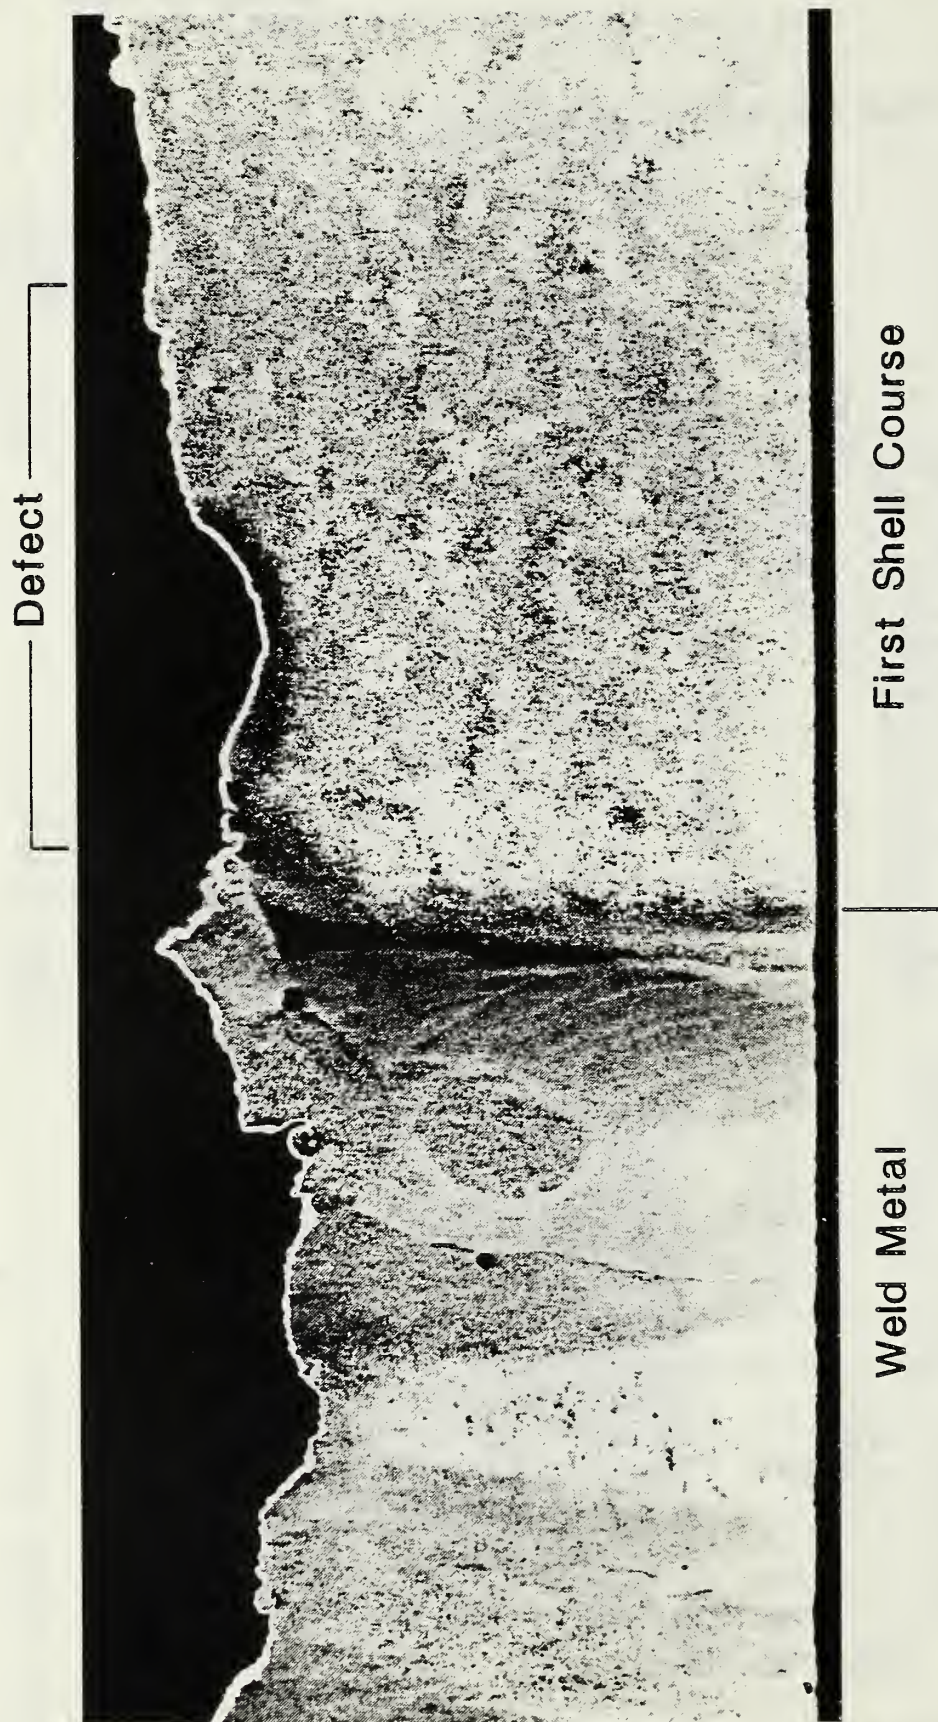
Figure 7.26 - Transverse Section of Fracture Surface Defect Showing Exact Location of Defect
