NATIONAL BUREAU OF STANDARDS REPORT

9026

DWELLING UNIT BURNOUT TESTS

PRATT INSTITUTE TEST BUILDING

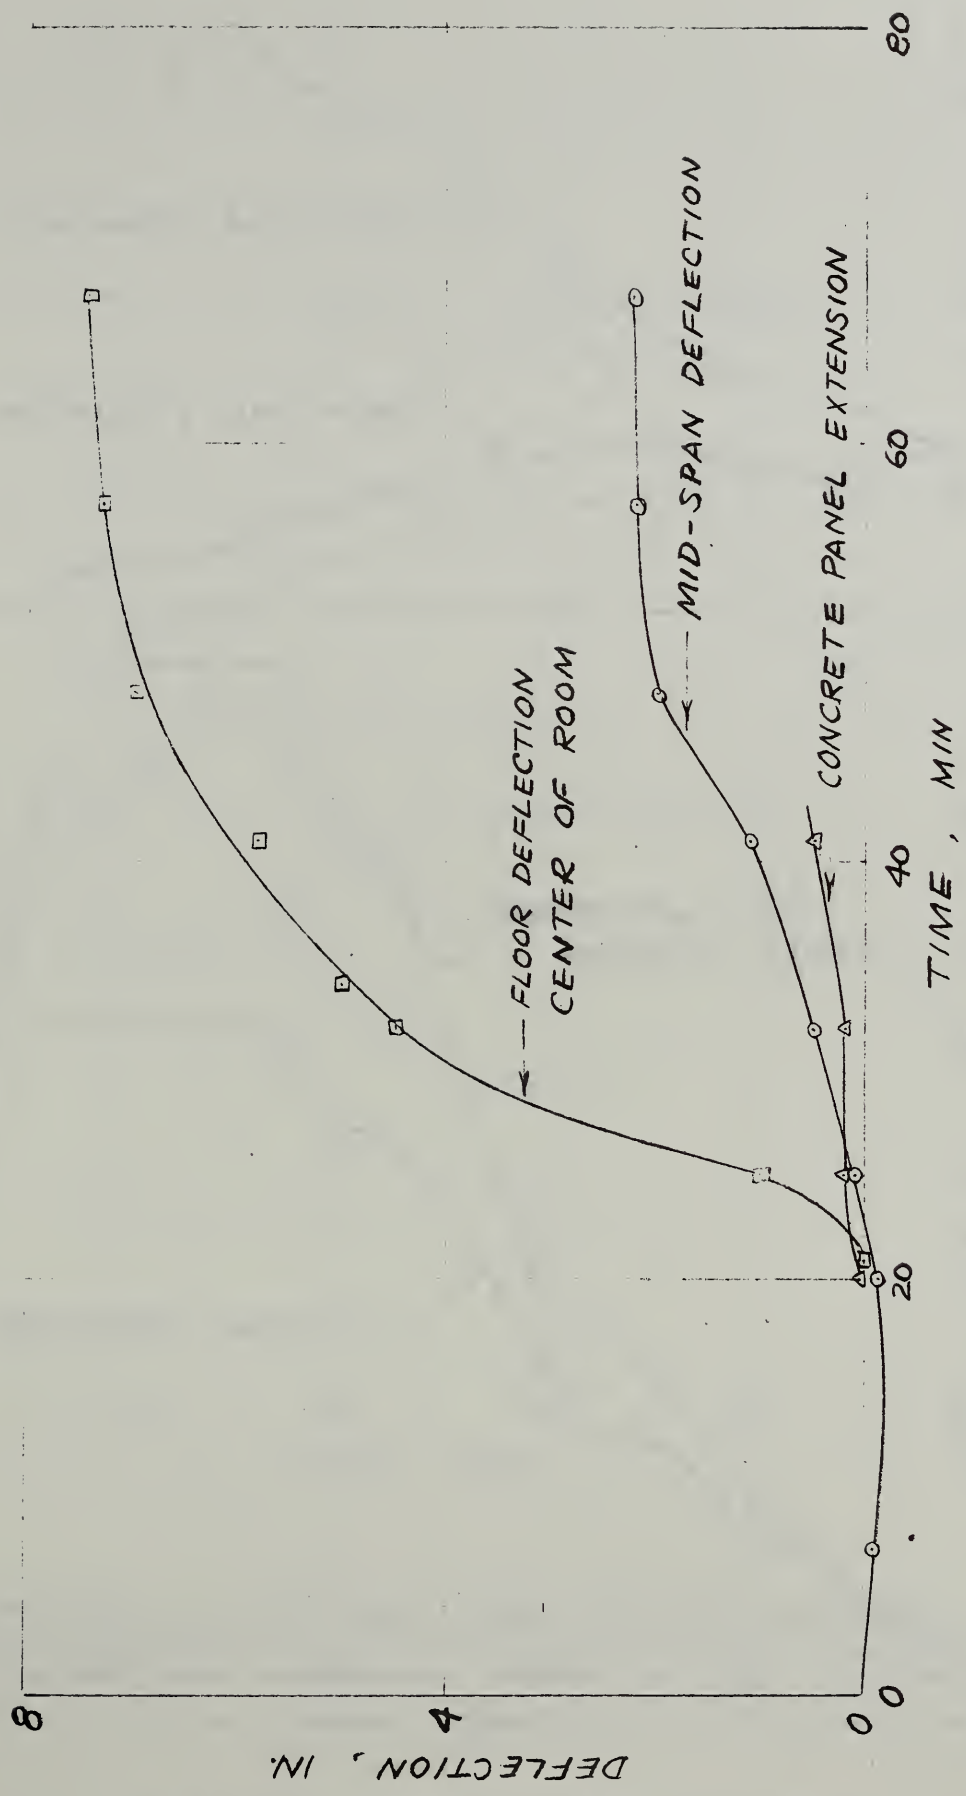
FIG.12 DEFLECTIONS , TEST 1

Vertical and lateral deflection measurements are shown in Fig. 12. Rapid deflection of the floor at the center of the room followed shortly after the ceiling dropped and all structural members became directly exposed to fire. The maximum deflection observed was 7.4 in., with a permanent sag of about six in. after cooling. At the mid-span of the joists, the maximum deflection observed was 2-1/4 inches.

Whereas, in a laboratory fire test, the entire span length L is loaded and fire-exposed, in these tests only one-half the span was exposed to fire. Taking $L = 10$ ft and d (the depth of the joist) = 1 ft, load failure was arbitrarily considered to have occurred in Test No. 1 at 26 minutes. It should be noted, however, that the structure continued to support the 40 psf design load without collapse throughout the test.
