# NATIONAL BUREAU OF STANDARDS REPORT

CONTROL OF LEAKAGE THROUGH JOINTS  
IN CAST-STONE MASONRY AT  
THE NATIONAL NAVAL MEDICAL CENTER

Progress Report No. 1  
by  
A. Hockman, E. J. McCamley and  
E. W. Krussell

To  
District Public Works Office  
Potomac River Naval Command  
Bureau of Yards & Docks  
Department of the Navy

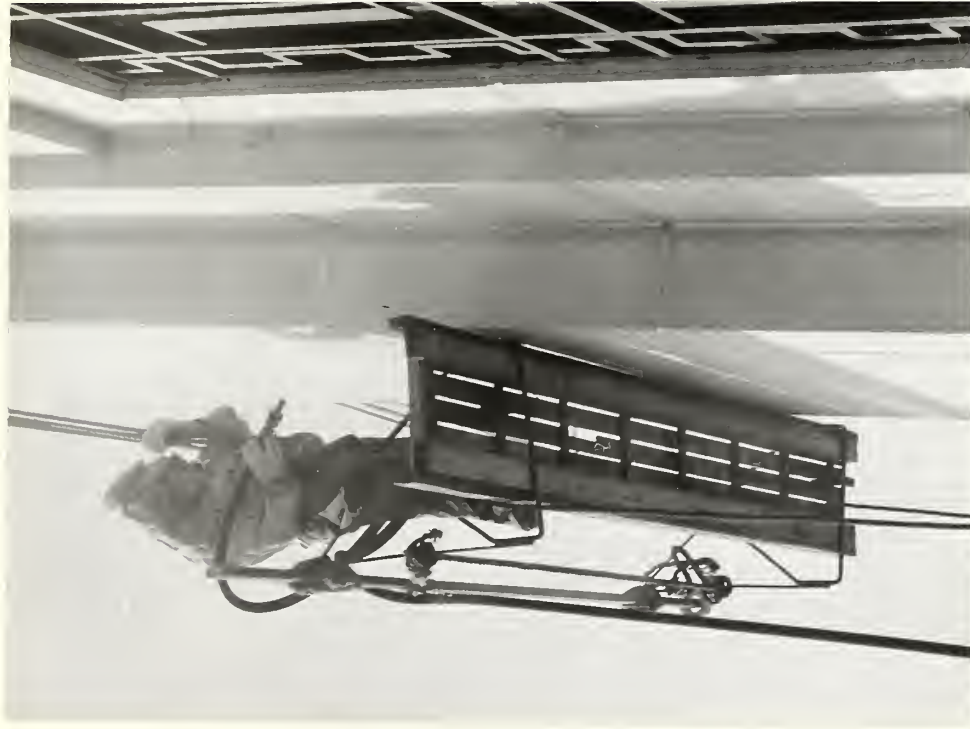
A.

The contractor started the job by brushing the joints clean of dirt and dust which was followed by the application of 1 1/2 in. of masking tape to both sides of all joints. The joints were then sandblasted to remove old calking compound and dirt from the surface and sides of the joints, and at the same time exposing the faces of cracks between the panels and the mortar (see figure 1-A).

Fig. 1. Application of waterproofing to the mortar joints by contractor. (19th floor level, Building No. 1, Naval Medical Center).  
 (A) Sandblasting to remove old calking from surface of cast stone, and to expose cracks in joints.  
 (B) Applying the cement-sand grout to the joints.

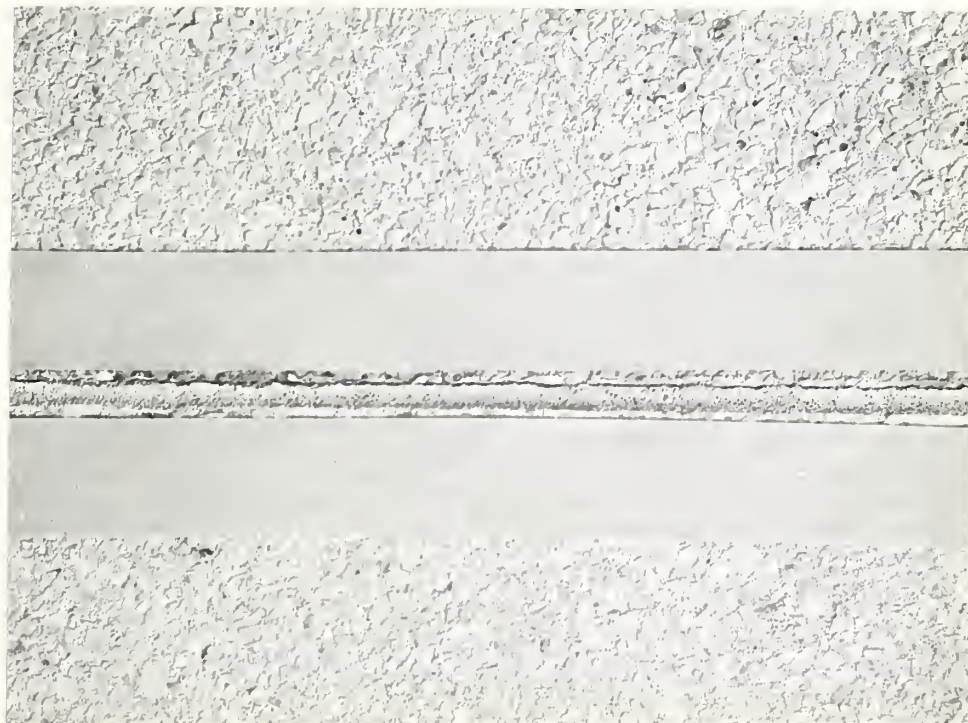
A.

Examination of the masonry at the 19th floor level before the treatment was applied revealed that practically every vertical joint contained cracks. These cracks occurring primarily at the sides of the joints

varied in width from hairline to as much as one tenth of an inch; the latter occurring in some corners. Some of the cracks extended upwards continuously to the top of the building, while others only intermittently. There were a few instances of loose mortar in the vertical joints, the worst cases occurring in the corners. Many of the horizontal joints appeared in good condition up to the 10 ft. level. It was difficult to estimate the condition of the joints above this height. The cast-stone panels appeared to be in excellent condition with the exception of a few hairline cracks barely visible to the naked eye.

Fig. 2. Typical vertical joint as it appeared, (A) before the waterproofing treatment, (B) four days after the treatment.

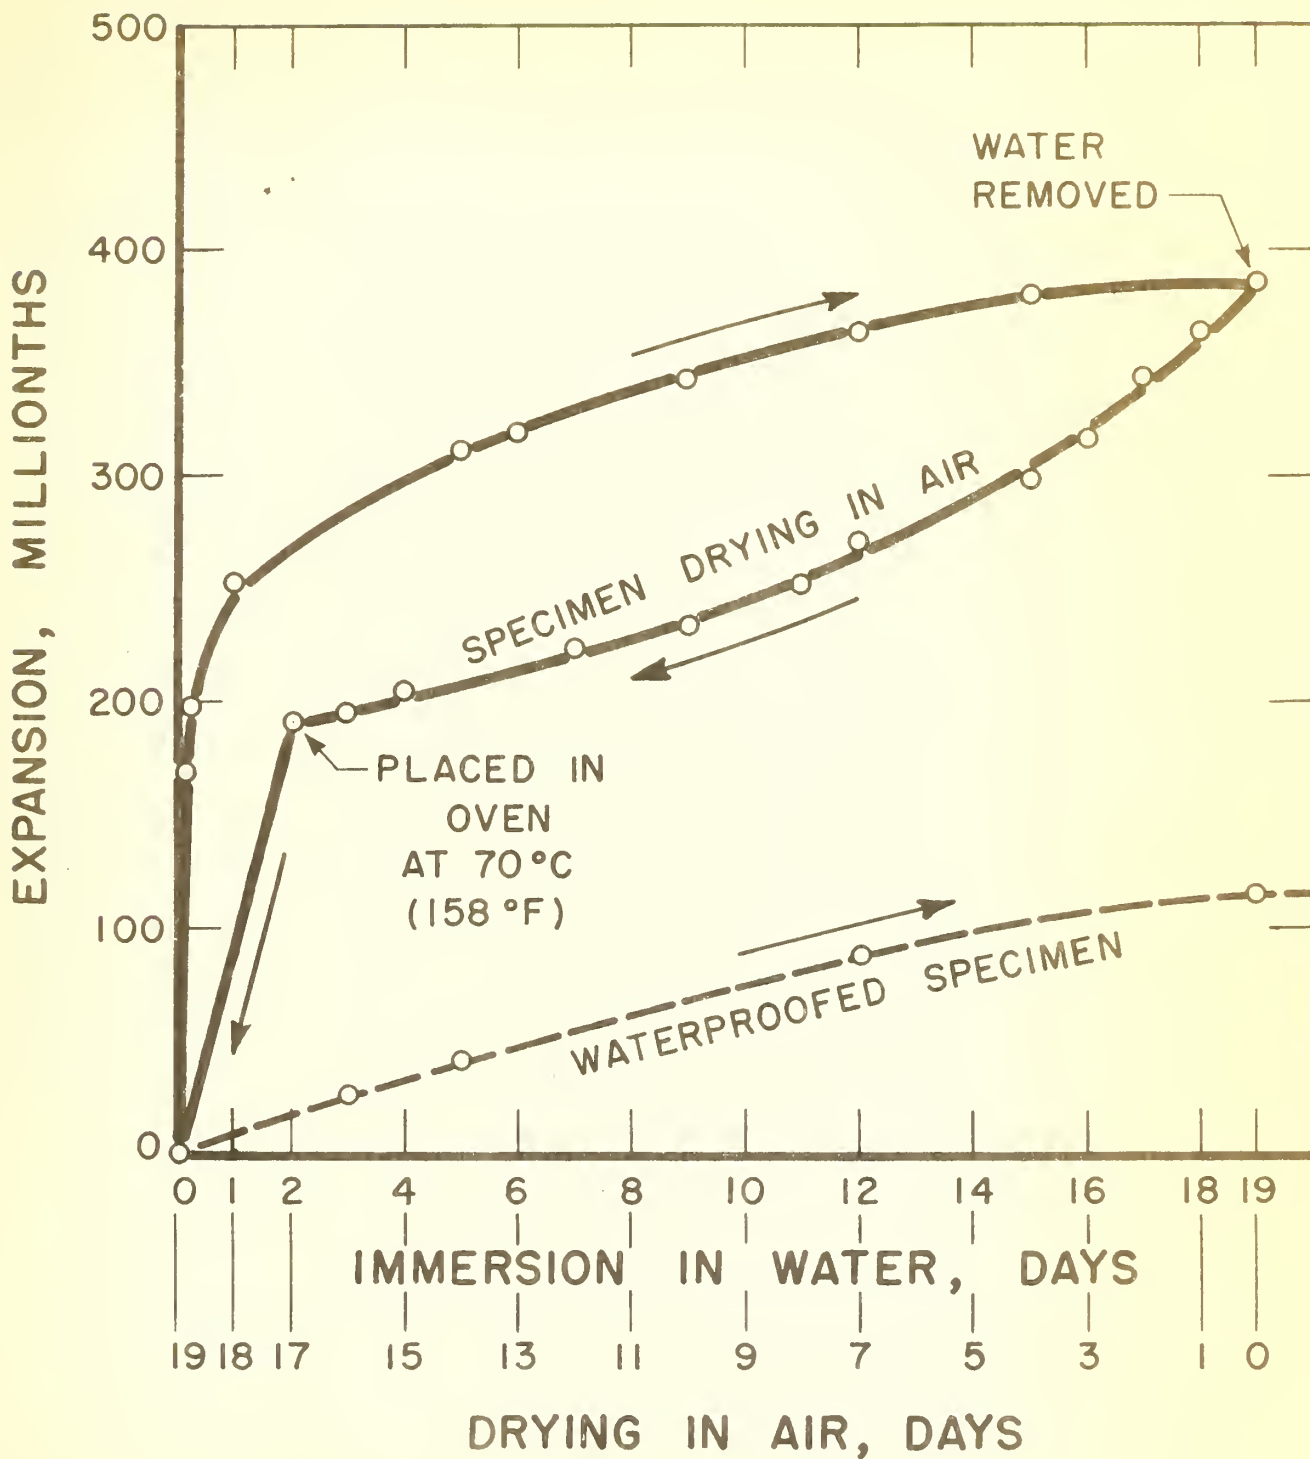
Figure 6 gives the moisture expansion and contraction curves for a sample of cast-stone originally used at the Naval Medical Center. After 19 days immersion in distilled water at constant temperature ( $75^{\circ}\text{F} \pm 2^{\circ}$ ) the specimen expanded 385 microinches per in. or 0.0385 percent. The expansion curve rises sharply at the start of the test, attaining 15 percent of the total expansion after one hour and 66 percent after 24 hr. immersion. When the water was removed and the specimen allowed to dry, contraction proceeded at a comparatively slow rate. After 17 days of drying at room temperature, the specimen contracted to 50 percent of the amount it expanded when immersed. A heating of the specimen at  $160^{\circ}\text{F}$  for two days brought it back abruptly to its original length.

Figure 6, lower portion, shows the moisture expansion curve (dashed lines) of the waterproofed specimen of cast-stone. After 19 days of immersion, the sample expanded 115 microinches per in. or 0.0115 percent. Unlike that of the non-waterproofed specimen, the curve rises slowly and the expansion proceeds at a fairly uniform rate. Waterproofing of the cast-stone reduced the moisture expansion obtained on the non-waterproofed specimen by 92 percent for 24 hr. immersion and 70 percent for 19 days immersion.

FIGURE NO. 6 MOISTURE EXPANSION AND CONTRACTION CURVES (75°F) OF CAST STONE USED AT THE NAVAL MEDICAL CENTER.

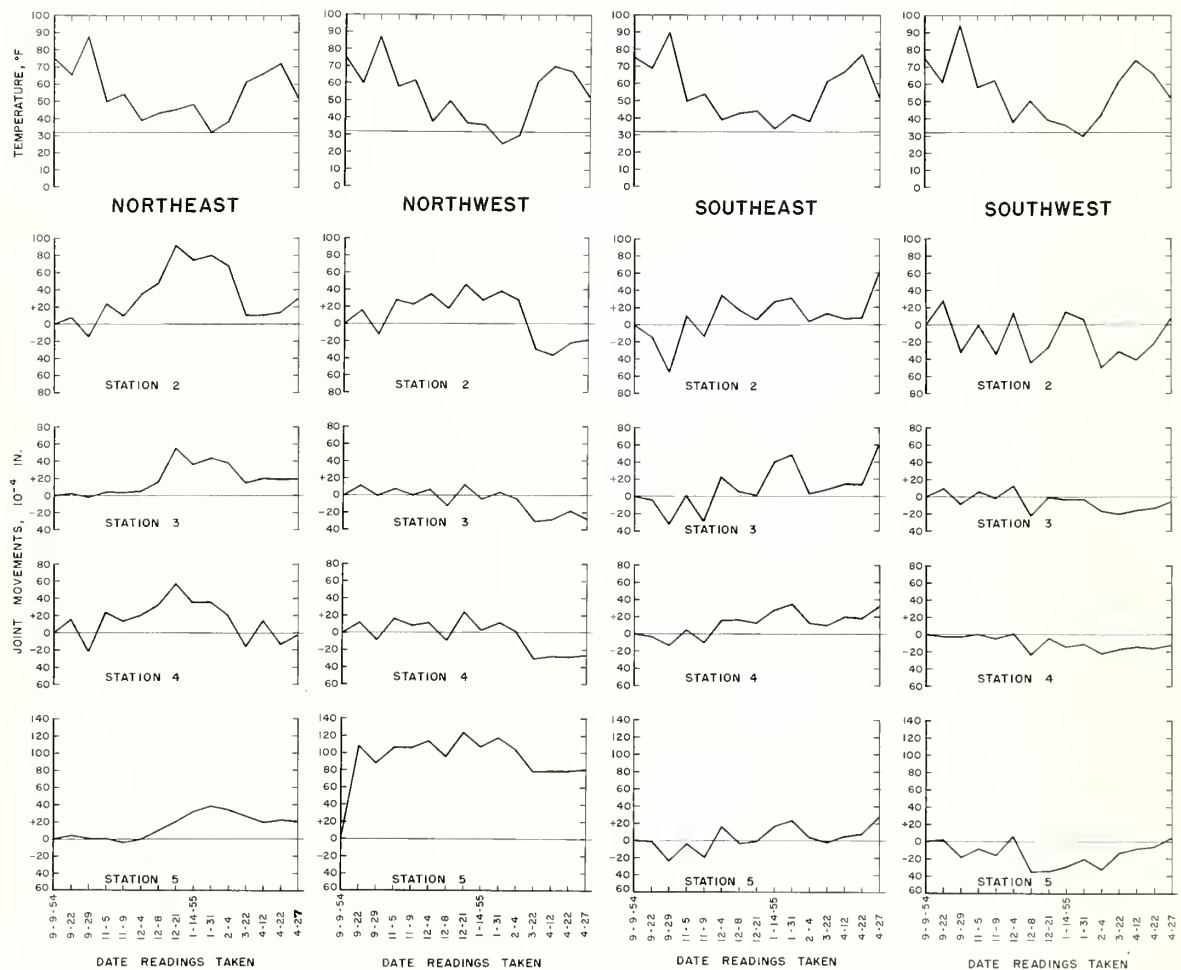
Figure 16 and table 3 give the complete record of joint movements as measured at all 16 gage stations on 15 separate occasions from September 9 to April 27, 1955. In general, the joint movements were directly related to the changes in temperature. A rise in temperature caused the cast-stone panels to expand which resulted in a closing or contraction of the joints. This is illustrated by the September 29 readings, when the temperature rose to 90°F and the joints contracted in most instances (cast-stone panels expanded). Similarly, a drop in temperature to 39°F on December 4, 1954, caused most of the joints to open or expand (cast-stone panels contracted). Figure 17 shows the correlation between the joint movements and the air temperature recorded at the time of gage readings.

It is probable that joint movements resulting from wetting and drying of the cast-stone, caused by rains, were reduced to a minimum on account of the water-repellent surfaces of the cast-stone. However, it is also probable that movements of the cast-stone panels may have been affected by changing relative humidities - a problem which will be investigated at a later date.

Fig. 16. Complete record of joint movements measured at 16 gage stations on 4 elevations. (19th floor level, Building No. 1, Naval Medical Center). Corresponding air temperatures for each date that readings were taken are plotted along the top of the graph.

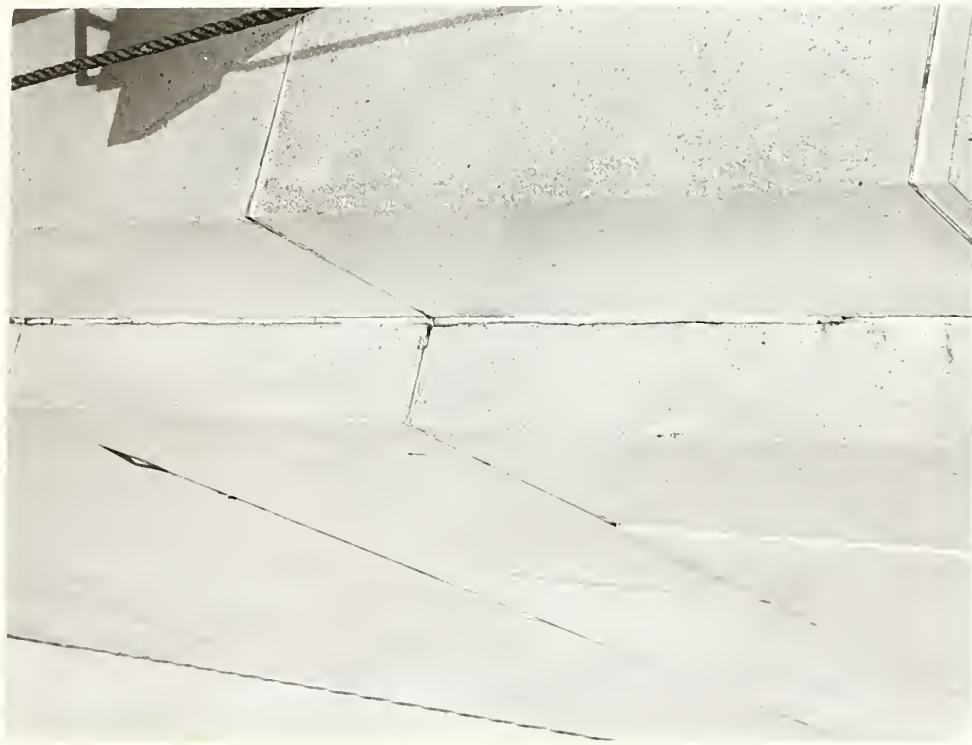
A.

Although the authors have been informed by a representative of the maintenance department of the Medical Center that there has been no leakage of any consequence subsequent to the application of the waterproofing treatment, measurements made with the Whittemore gage indicated joint movements, which averaged 0.0066 in. for all four sides of the building, excluding the corner joints (chapter 5). Figure 18-A illustrates a corner joint (southeast) as it appeared the day before the waterproofing treatment was applied and figure 18-B shows the same corner as it appeared on April 22 approximately 7 months after the treatment.

Fig. 18. Illustration of a corner vertical joint on the southeast side, (19th floor, Building No. 1).  
 (A) Just before waterproofing treatment.  
 (B) As it appeared 7 months after treatment.

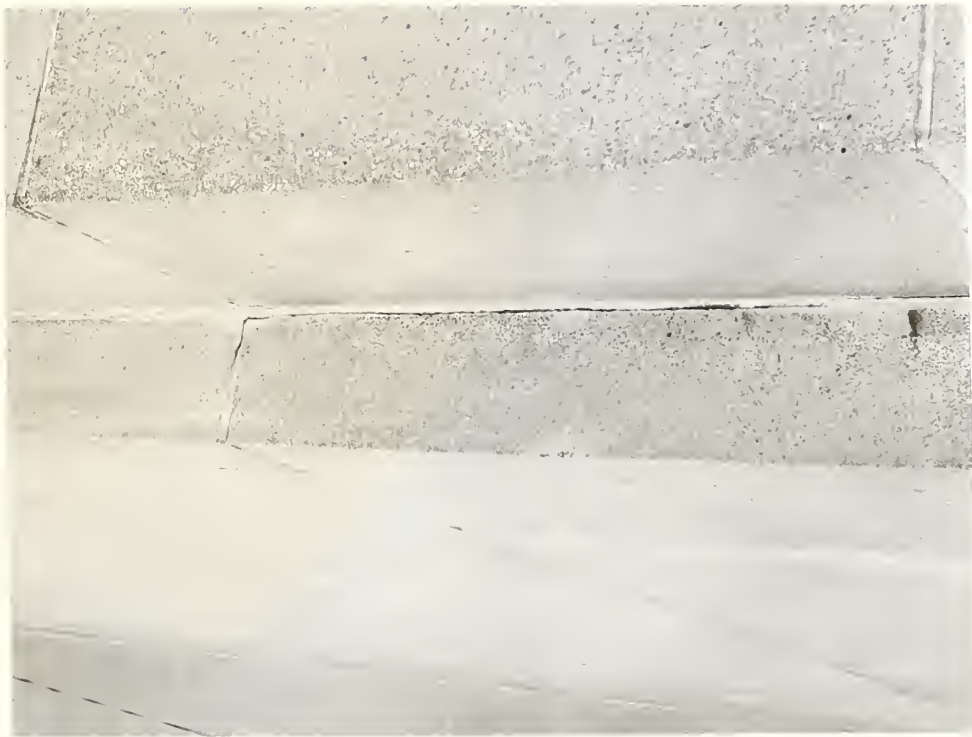
B.

The results of the examination of the joints made on April 22 corroborated to some extent the results obtained with the Whittemore strain gage. As shown in Table 4 joint cracks ranged in width from hairline (less than 0.001 in.) to a maximum of 1/16 in. - the latter in corner joint No. 6 on the southwest side. Except for the hairline cracks and the one large crack (1/16 in.), the average of the openings in the rest of the joints was 0.006 in. This latter figure is practically the same as the average movement of 0.0066 in. obtained with the Whittemore strain gage. However, this similarity appears to be only a coincidence since measurement of cracks on the northeast side made on April 22 revealed no opening greater than hairline (Table 4), whereas, previous strain gage measurements of these same joints showed an average movement of 0.0071 inches. Similarly, joints No. 2 to 5 on the northwest side had average cracks of less than 0.001 in. on April 22, whereas strain gage measurements revealed movements averaging 0.0065 in. for the same joints.

It might be noted here, that during the inspection of the joints on April 22, the senior author could, in many instances and with little effort, flake off, by means of a small knife blade, the thin coating of mortar from the side of a joint, and by so doing, reveal a crack that most likely existed before the grouting was applied. This indicates that, in many instances the cement grout did not penetrate into the opening of the joint, and was merely functioning as a thin shell-like coating over the existing crack.
