NIST Special Publication 901

The January 17, 1995 Hyogoken-Nanbu (Kobe) Earthquake

*Performance of Structures, Lifelines, and Fire
Protection Systems*

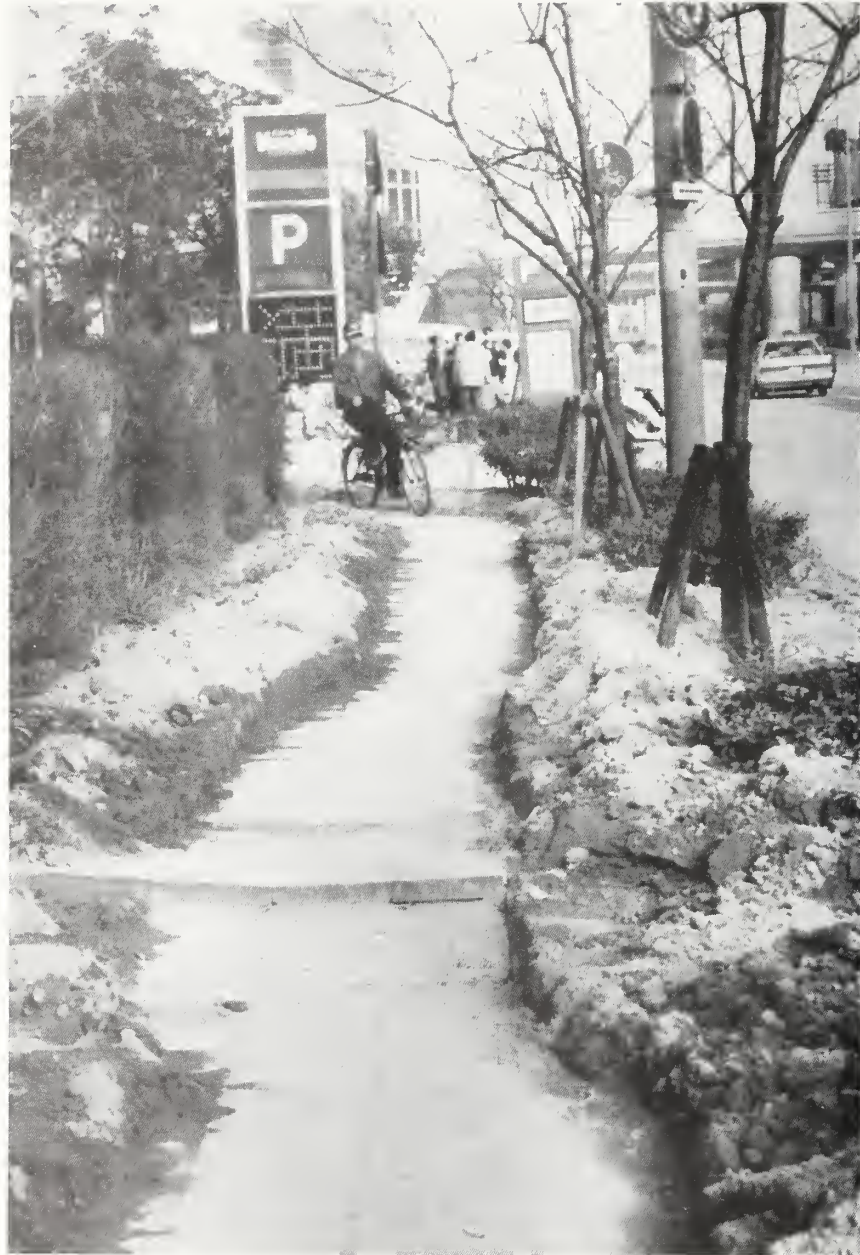
Figure 2.5.1 Path cleared through soil vented by liquefaction that covered sidewalk on Port Island (Photograph by Carol S. Prentice, USGS).

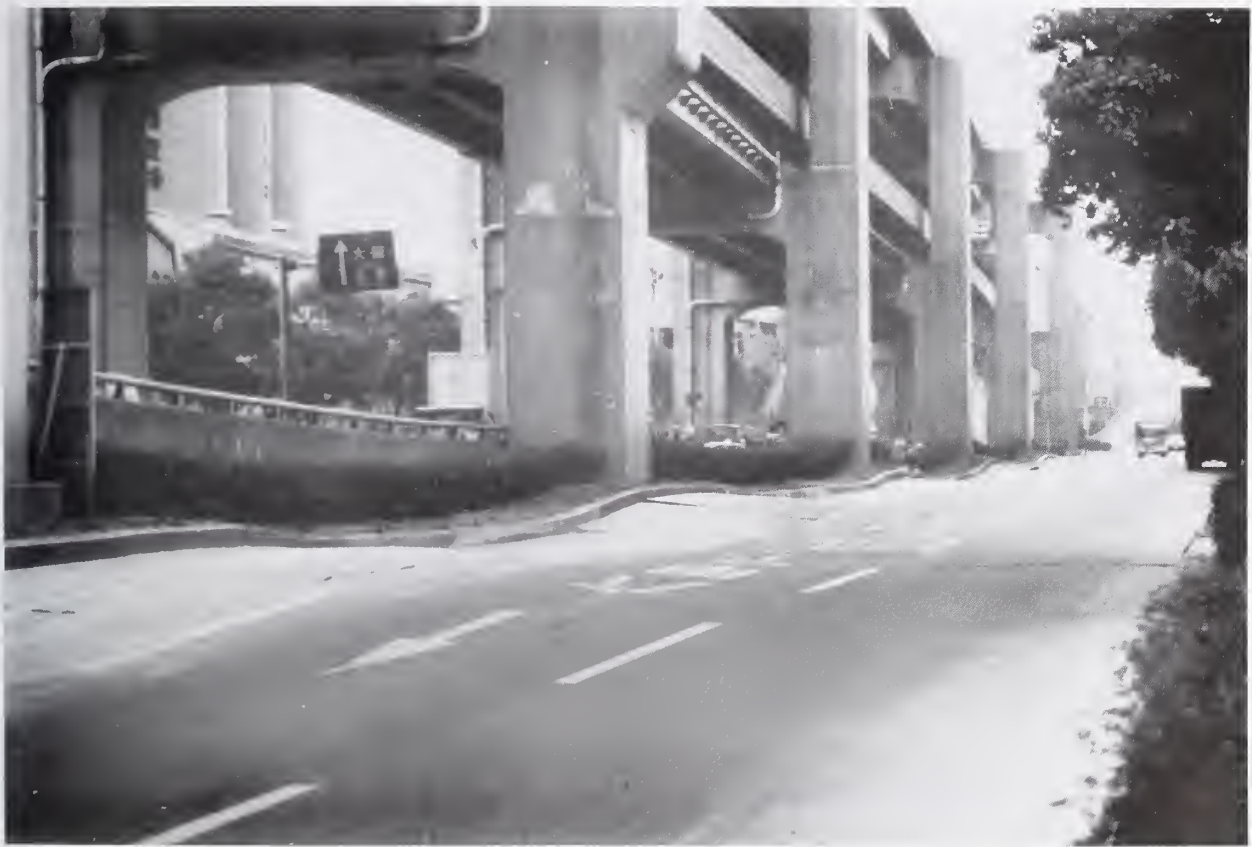
Figure 2.5.4 Differential ground settlement in artificial fill along the Harbor Freeway. Post-liquefaction consolidation cause ground to settle between bridge columns. Columns extend through the liquefied zone. (Photograph by Carol S. Prentice, USGS).

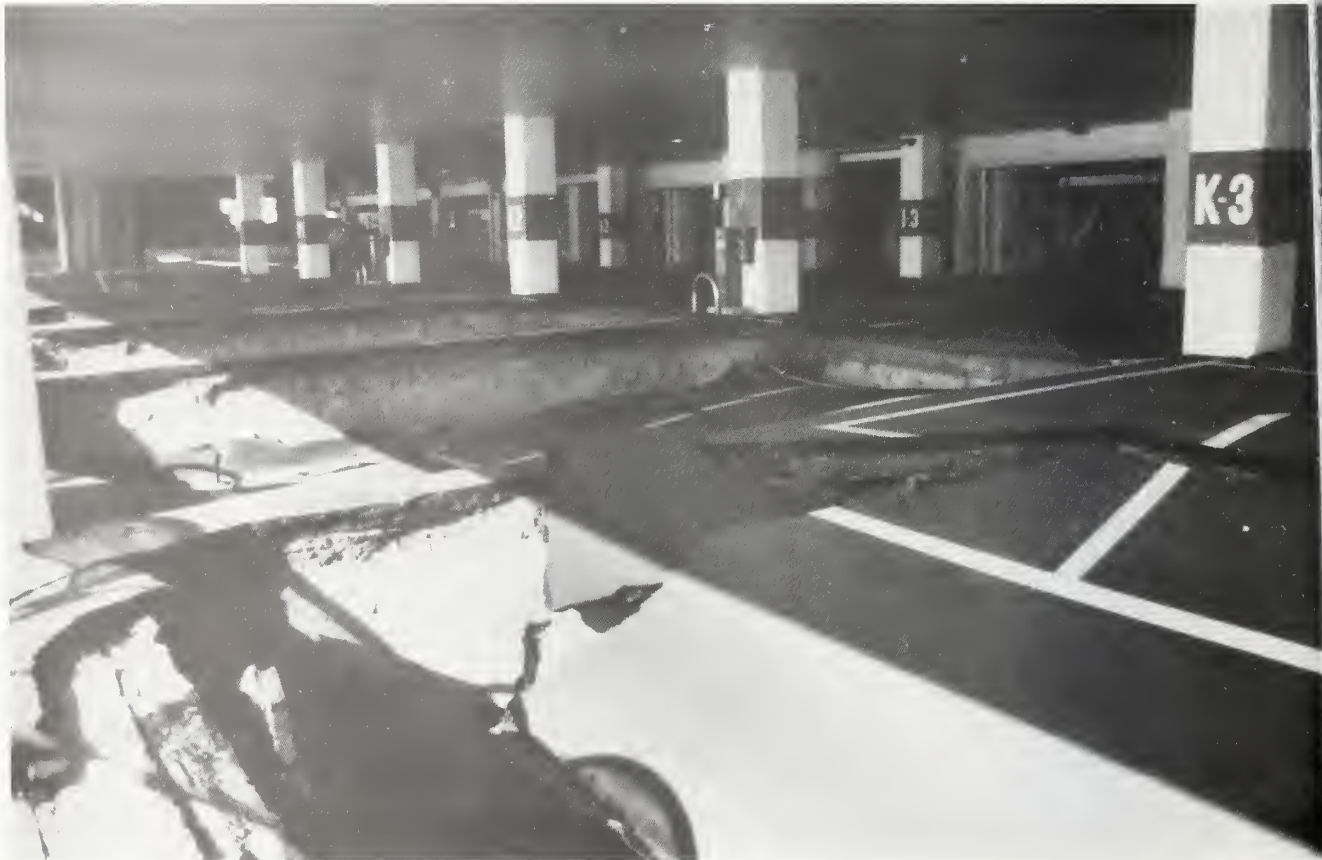
Figure 2.5.5 Differential settlement of about 1 m between columns of parking structure on reclaimed ground near the bridge to Port Island.

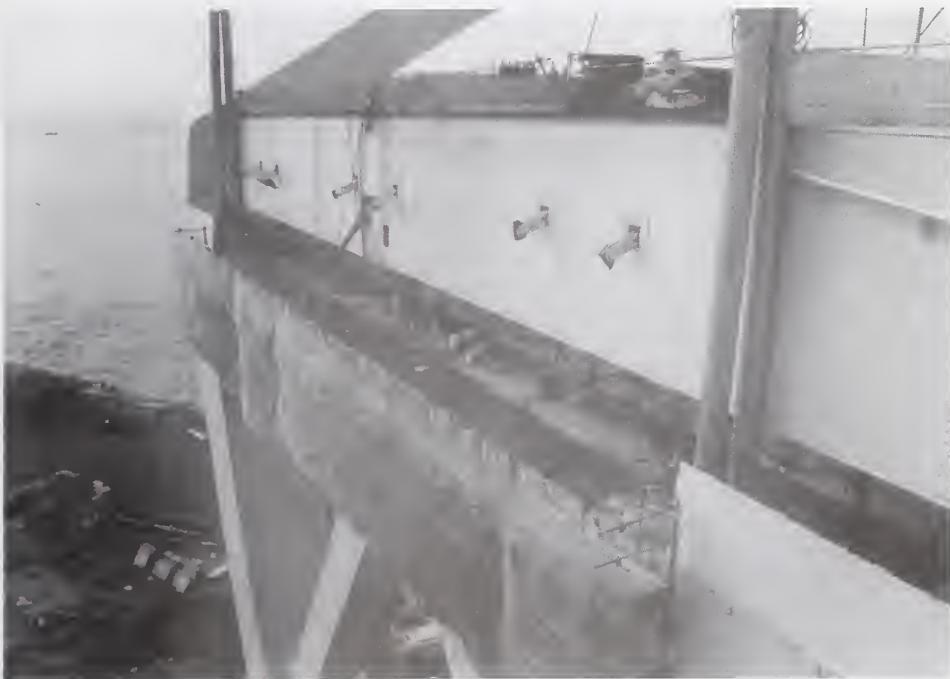
Figure 4.2.4 Cap beam of Pier 111, Nishinomiya-ko Bridge, showing cross-girder of arch and failed restrainers.

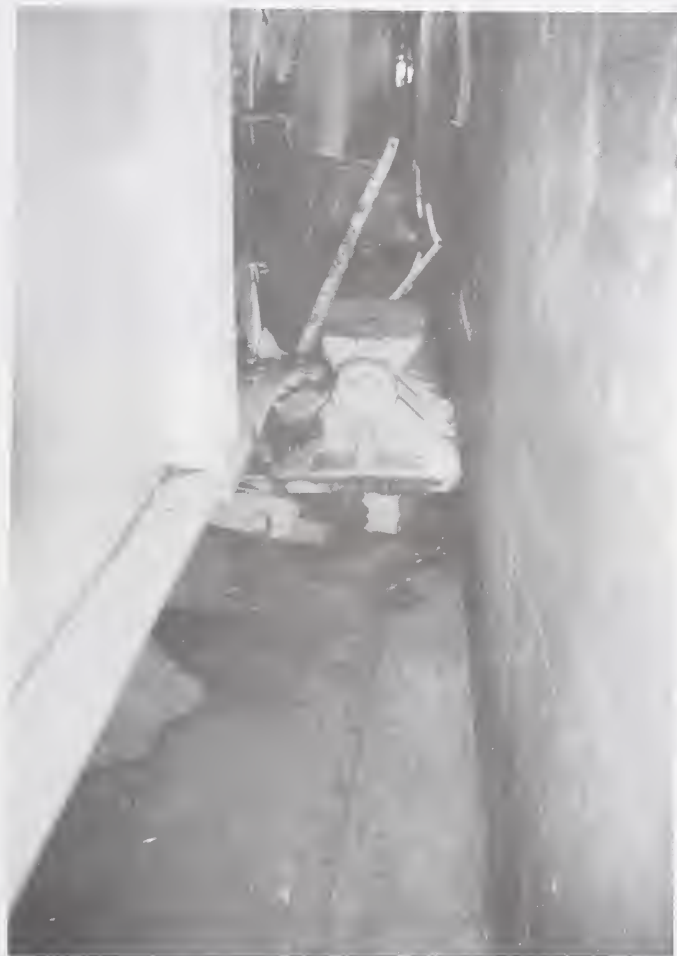
Figure 4.2.10

Bearing and restrainer damage at abutment A1, Mukogawa Bridge, showing distorted guide rails and uncoupled restrainer from abutment backwall.

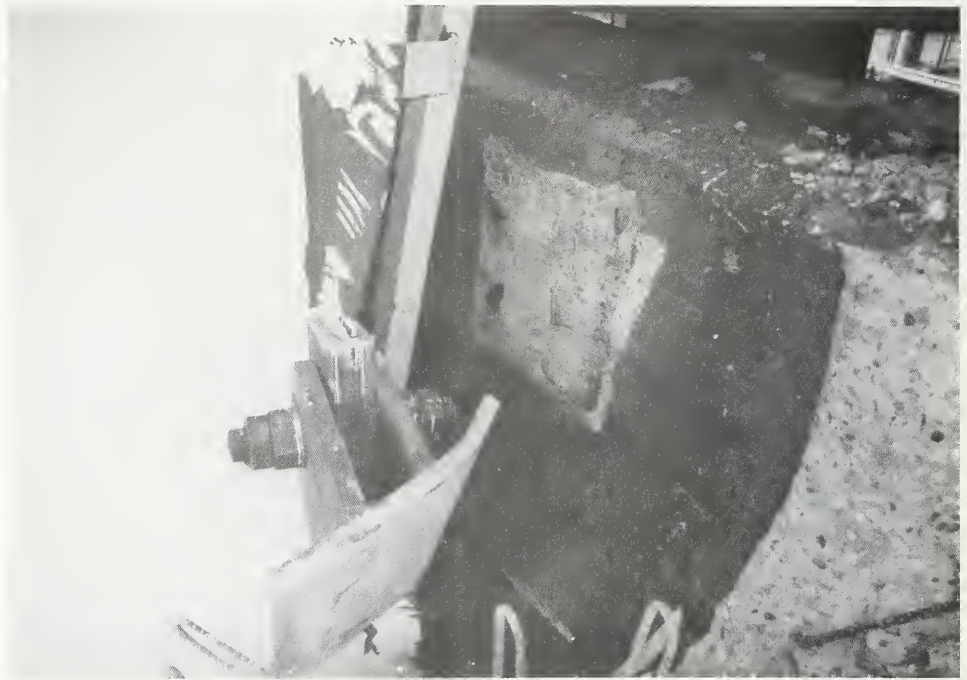
Figure 4.2.11 Damaged restrainer at Abutment A1, Mukogawa Bridge, showing failure of anchor bolts and distortion of web of main girder.

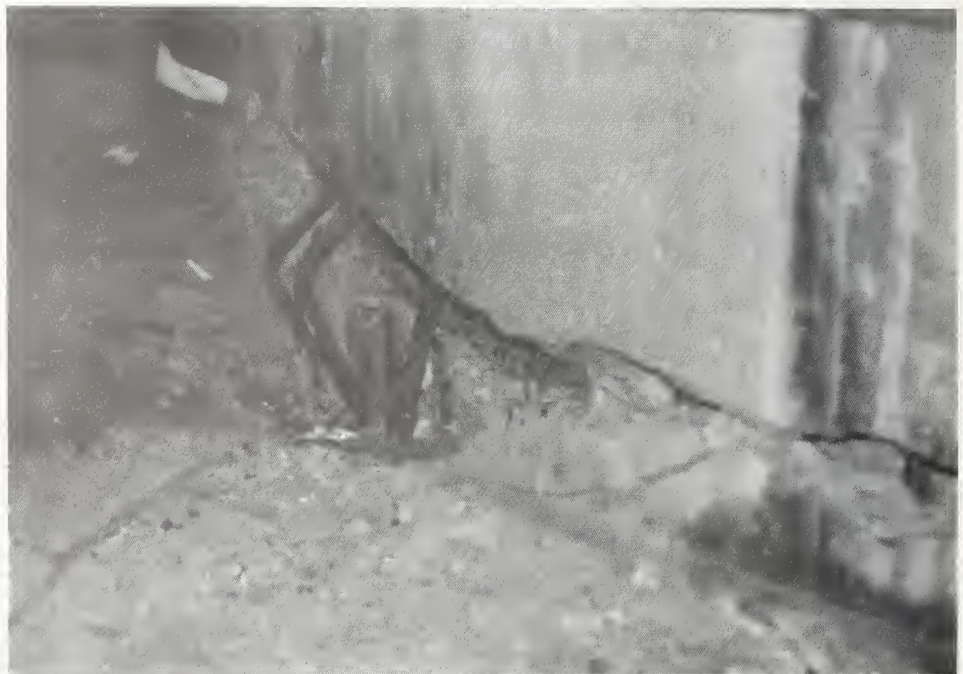
Figure 4.2.12 Failure at top of buried column, Pier P1, Mukogawa Bridge.

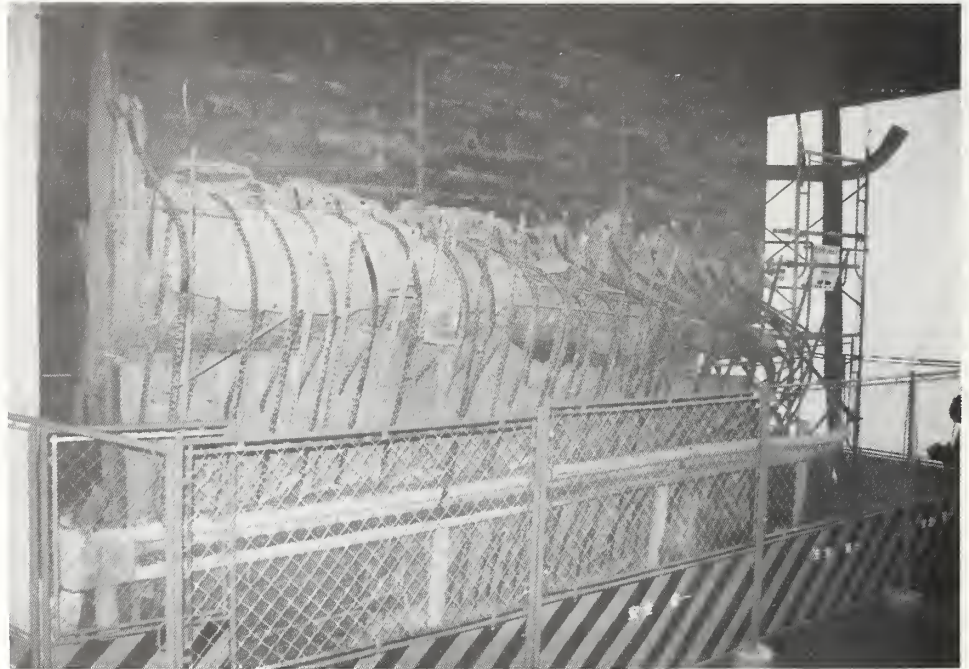
Figure 4.2.24 Shear failure in wall pier (east face), Moribe Viaduct.

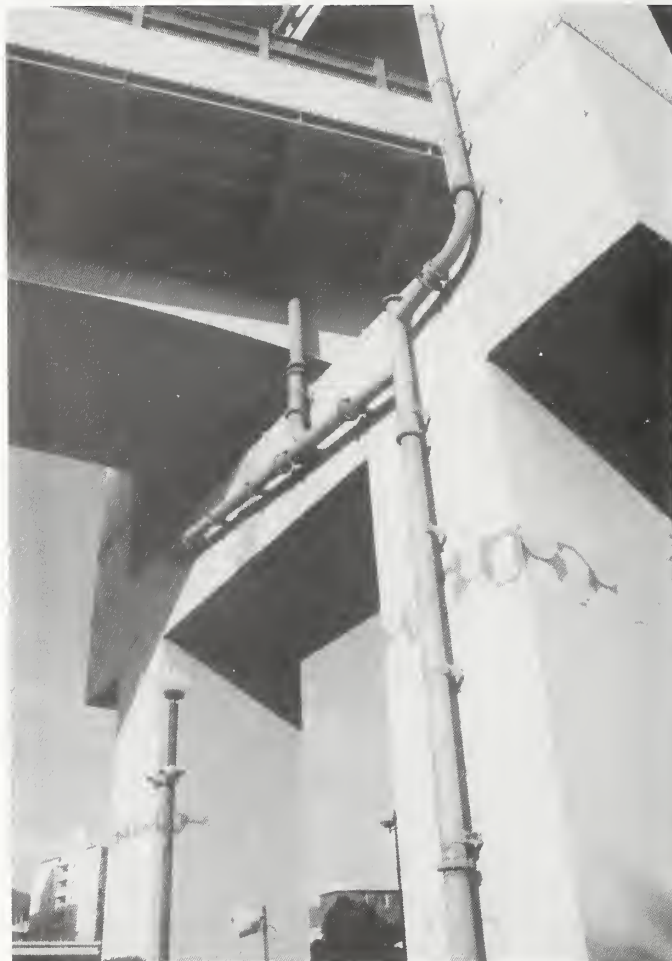
Figure 4.2.39

Local buckling in steel box columns at Pier 41 of the Hamate By-Pass Viaduct.

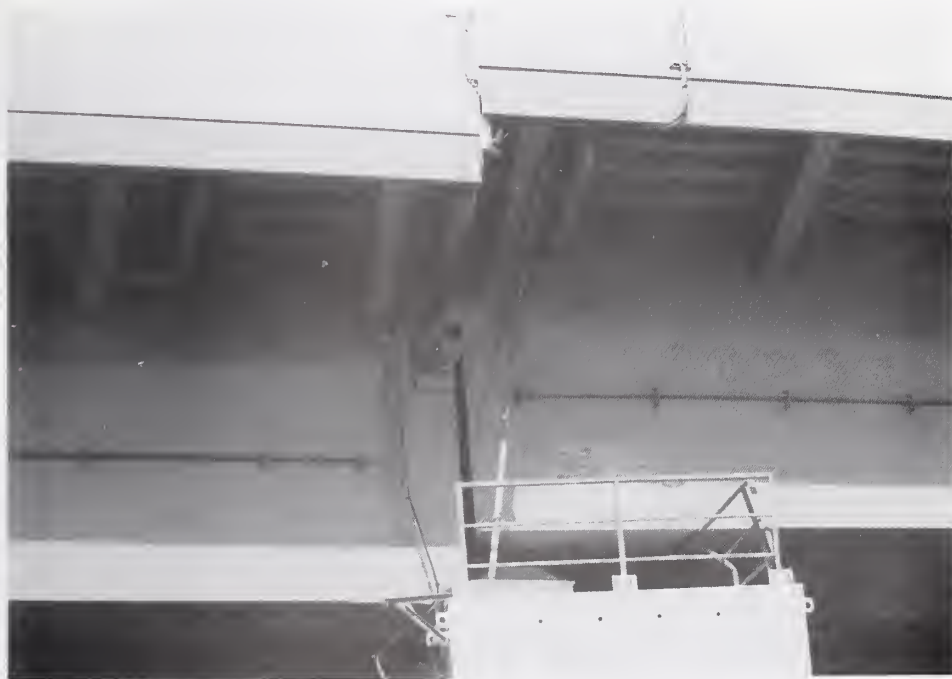
Figure 4.2.44

Approach span at edge of seat at Pier 134 of Shukugawa Bridge due to lateral movement of the pier by about 1 m towards the center of the channel.

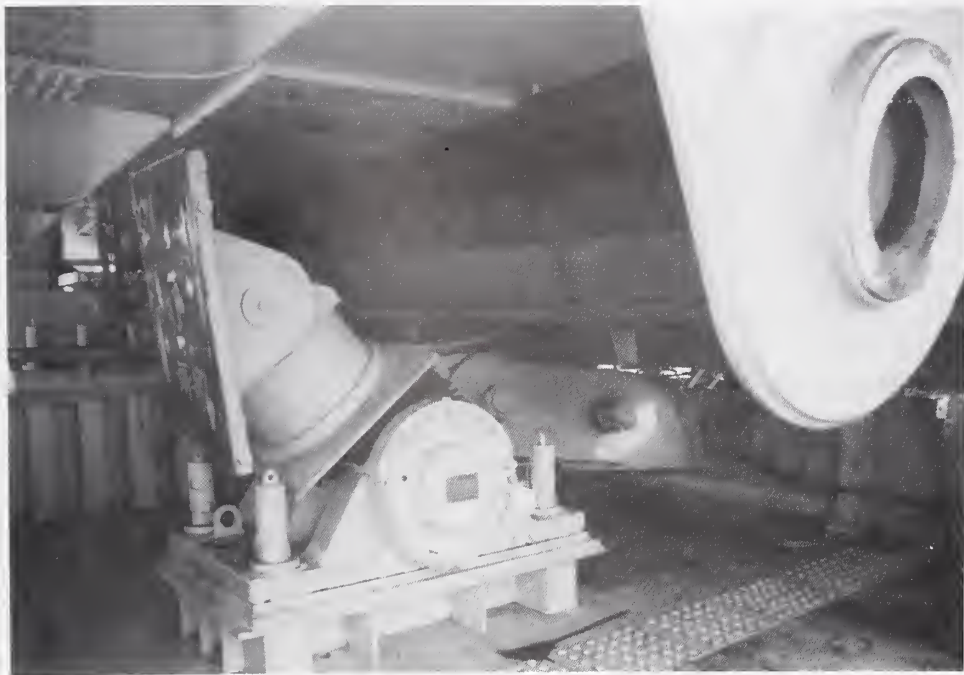
Figure 4.2.49

Failed connection of Vane-type energy dissipator and (at upper right) part of failed dead load tie-down at Pier 187 of the Higashi-Kobe Bridge.

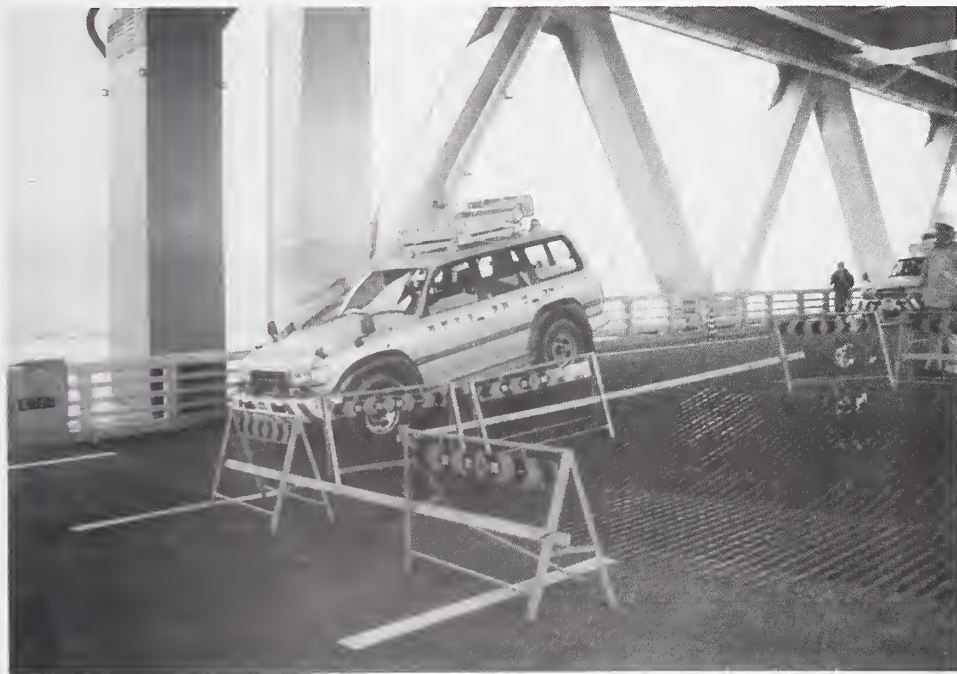
Figure 4.2.50

Uplift at the west end (Pier 187) of the main girder of the Higashi-Kobe Bridge due to failure of the dead load tie-down.

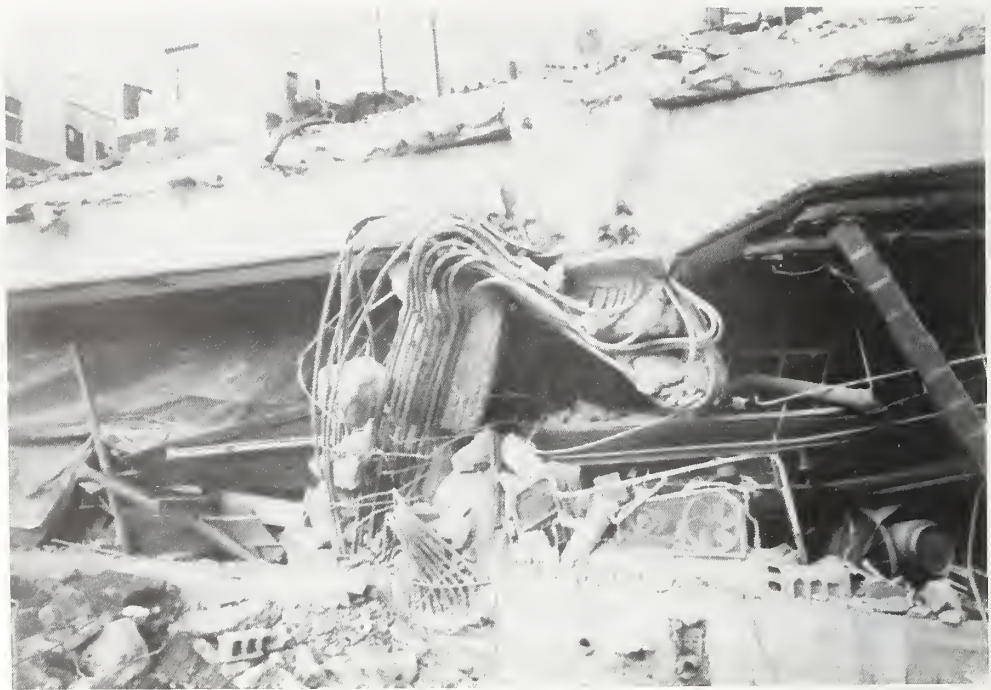
Figure 4.3.9 Failed column at Higashi - Nada - elevated rail yard.

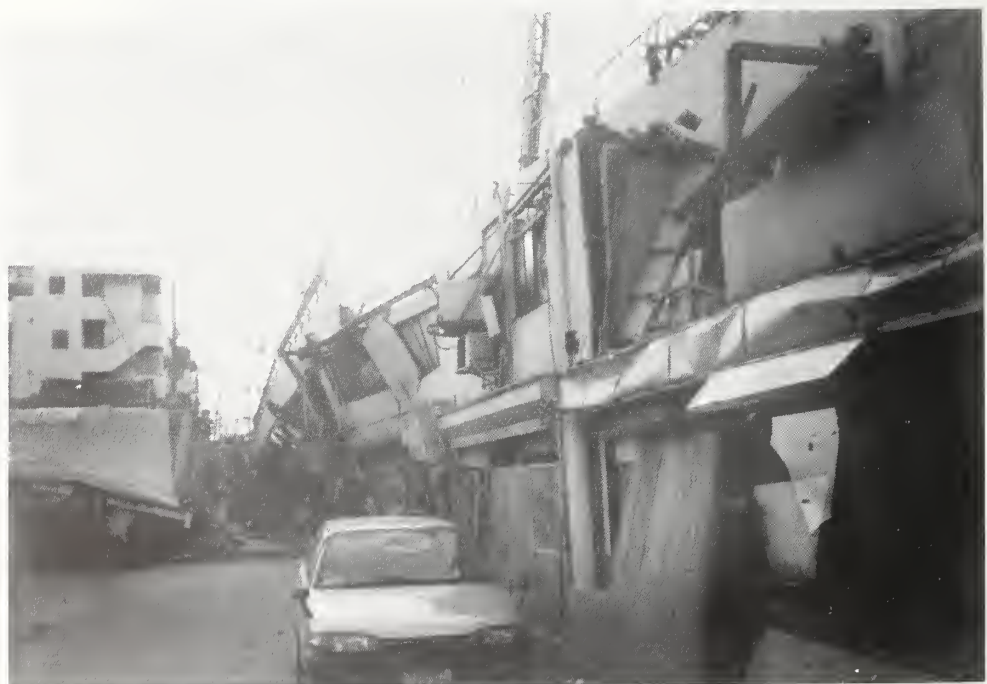
Figure 4.3.10 Collapsed rail yard at Higashi - Nada.

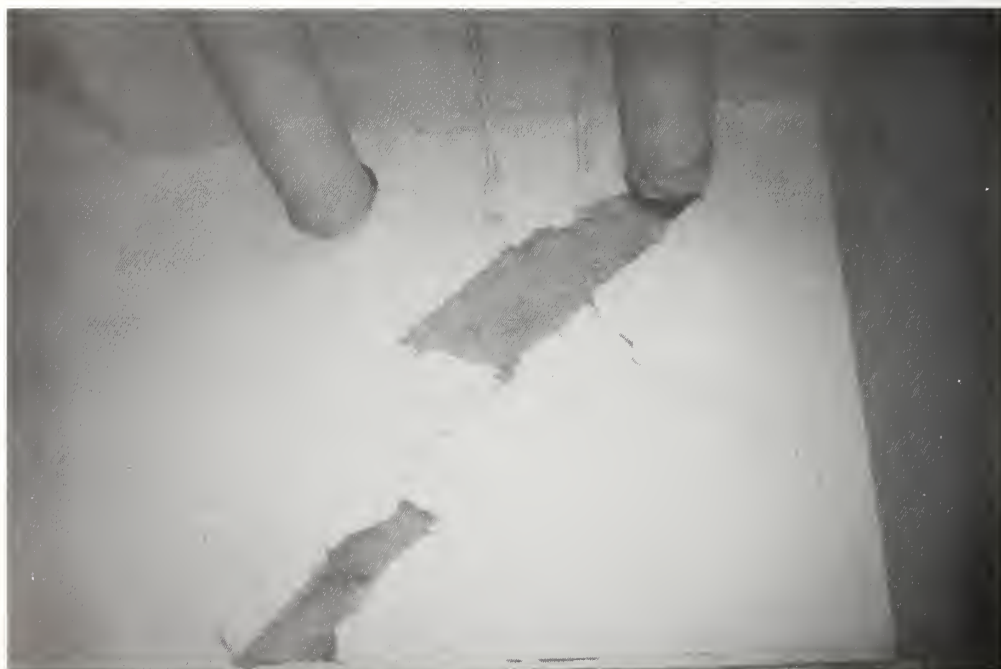
Figure 4.4.27 Cracks in the stair-well shear walls of the Osaka Airport Administration Building.

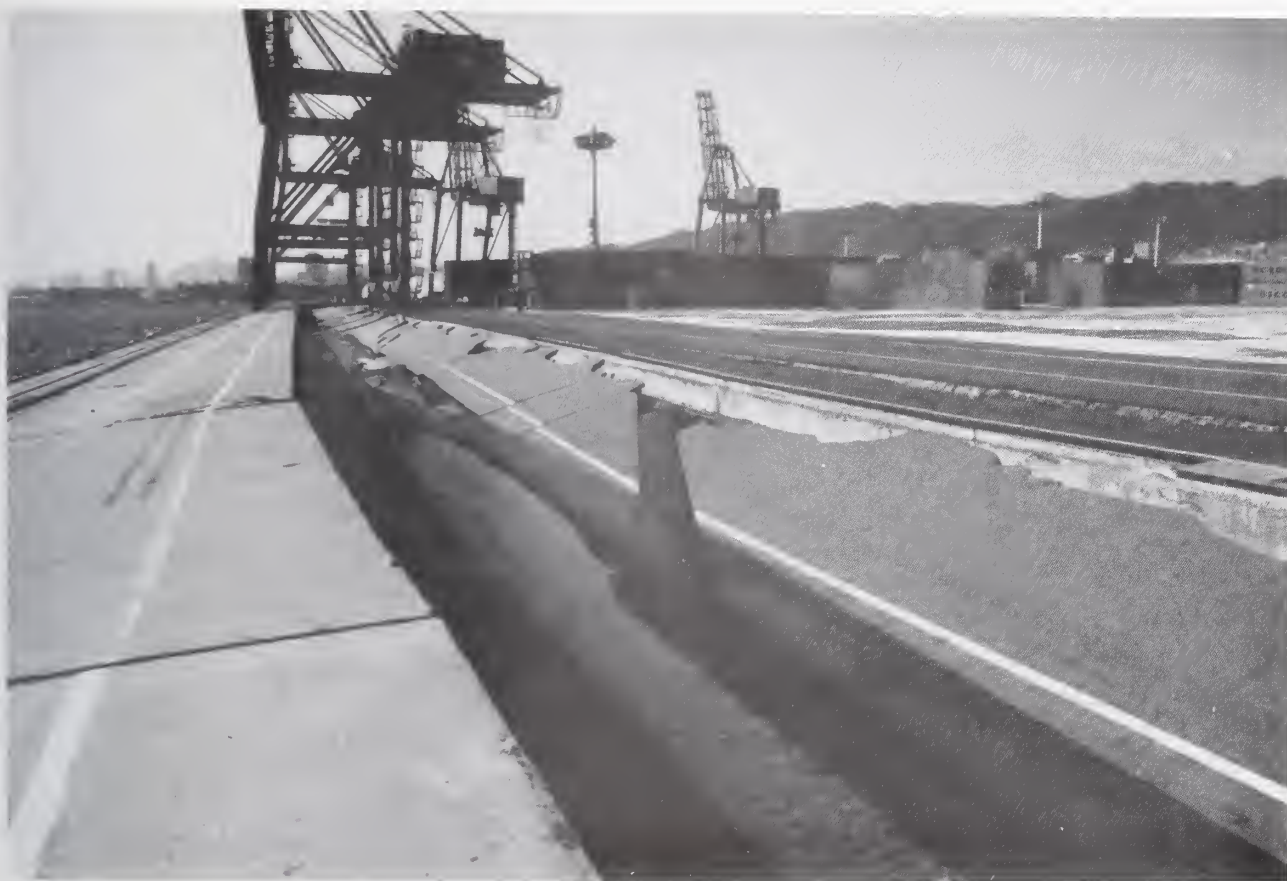
Figure 4.5.5 Damaged to Maya Wharf caused by liquefaction-induced lateral spreading. Downdropped block has formed behind quay wall where land has settled and moved outward. Landward side of block is the pile-supported rear crane rail. Photograph taken February 15, 1995.

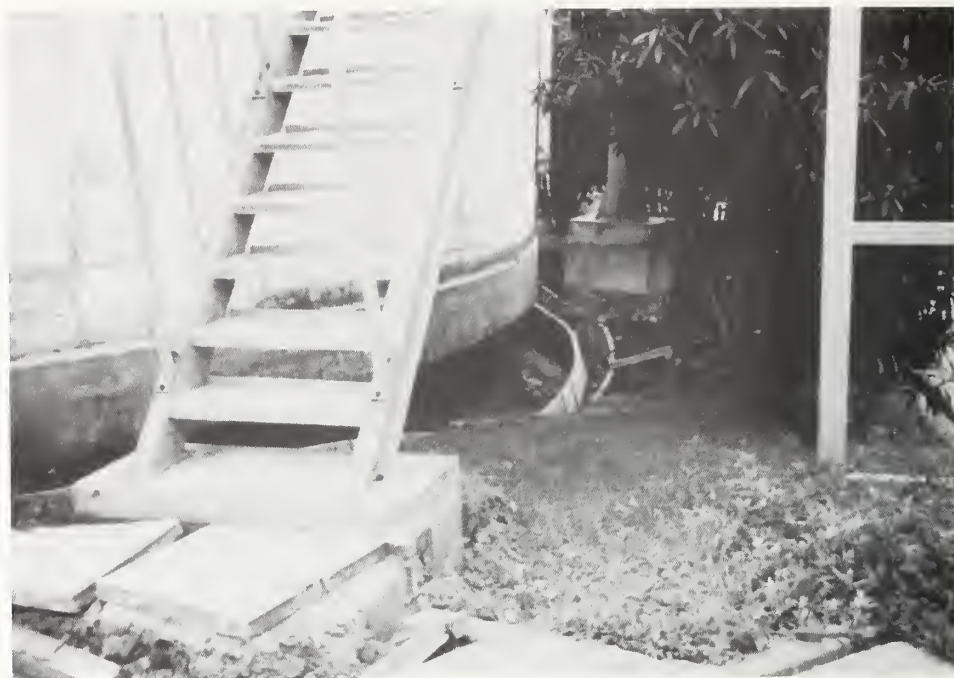
Photo 37 Differential settlement between pipe and non-pile supported structures damaged piping throughout the plant.

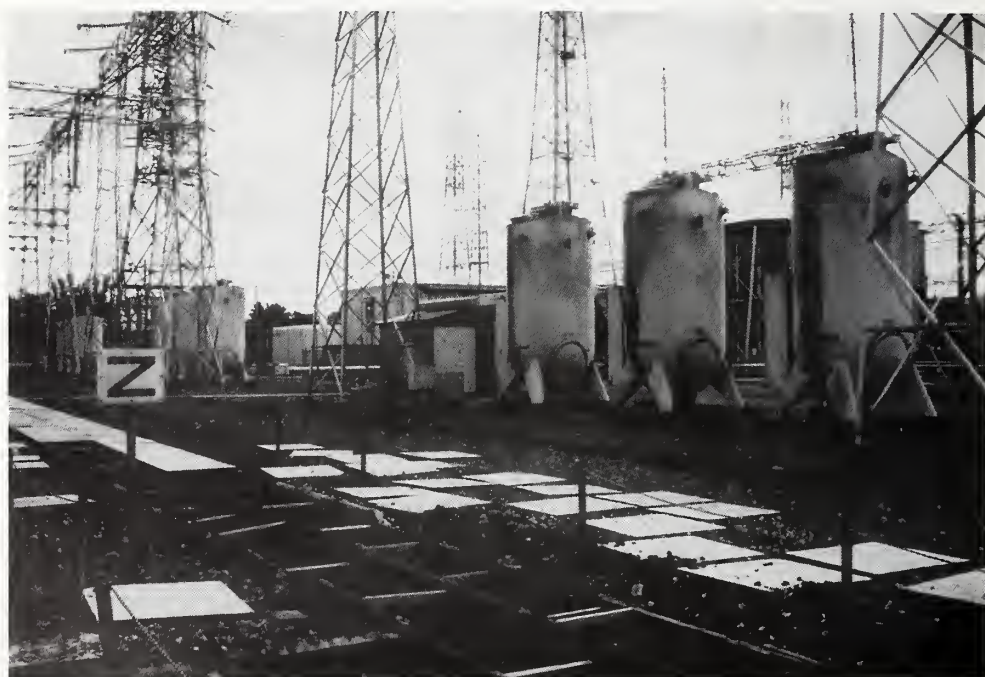
Figure 5.4.26 Bulk-oil circuit breakers with the bushings removed to replace damaged units at other sites.

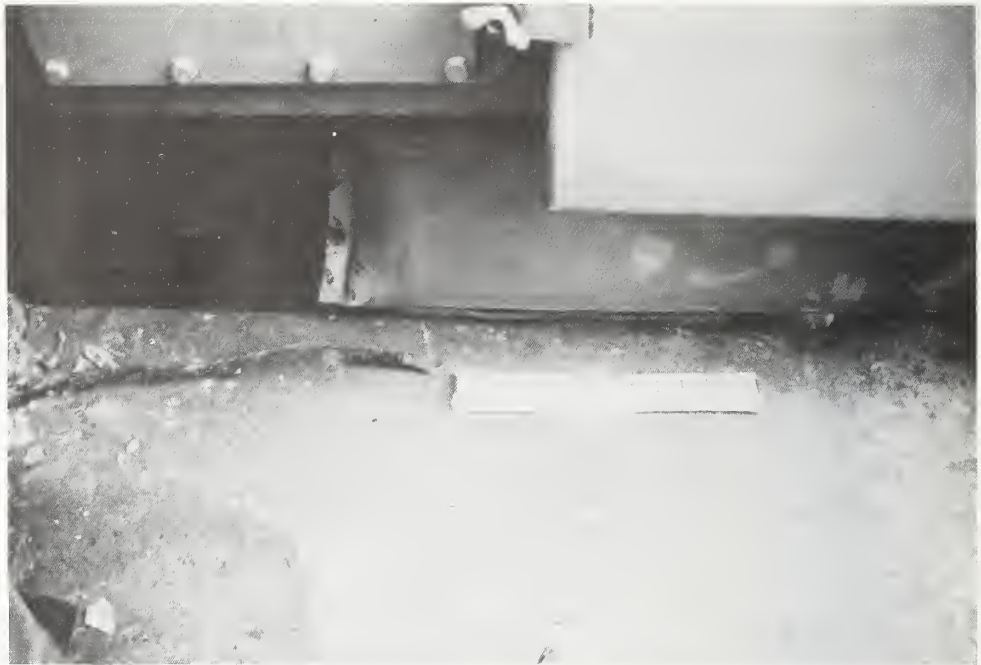
Figure 5.4.35 Transformer control cables were almost sheared off due to movement of the transformer.

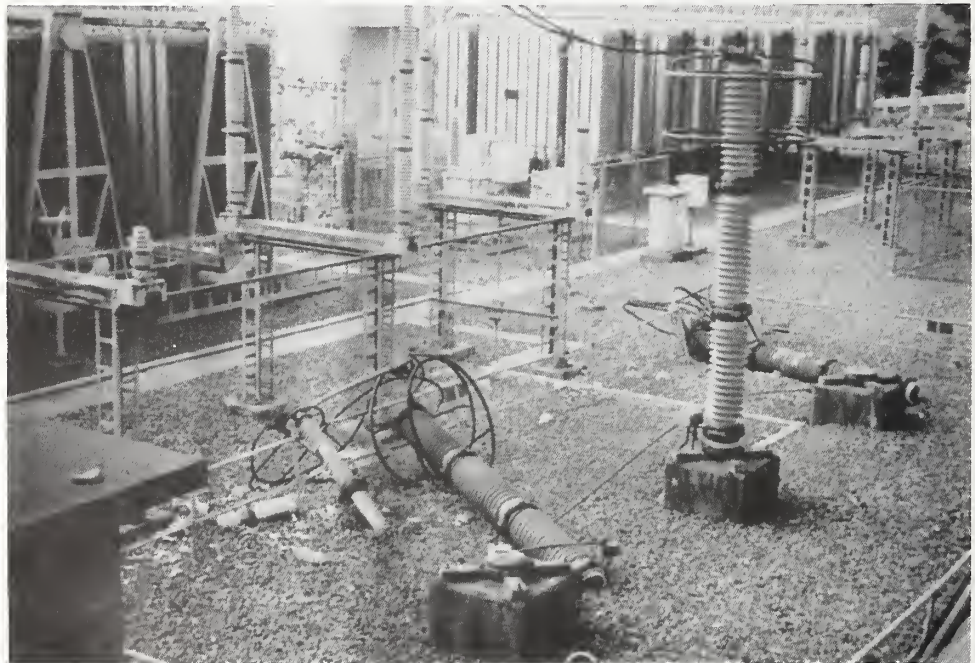
Figure 5.4.55

Lightning arresters failed and probably pulled down adjacent disconnect switched.

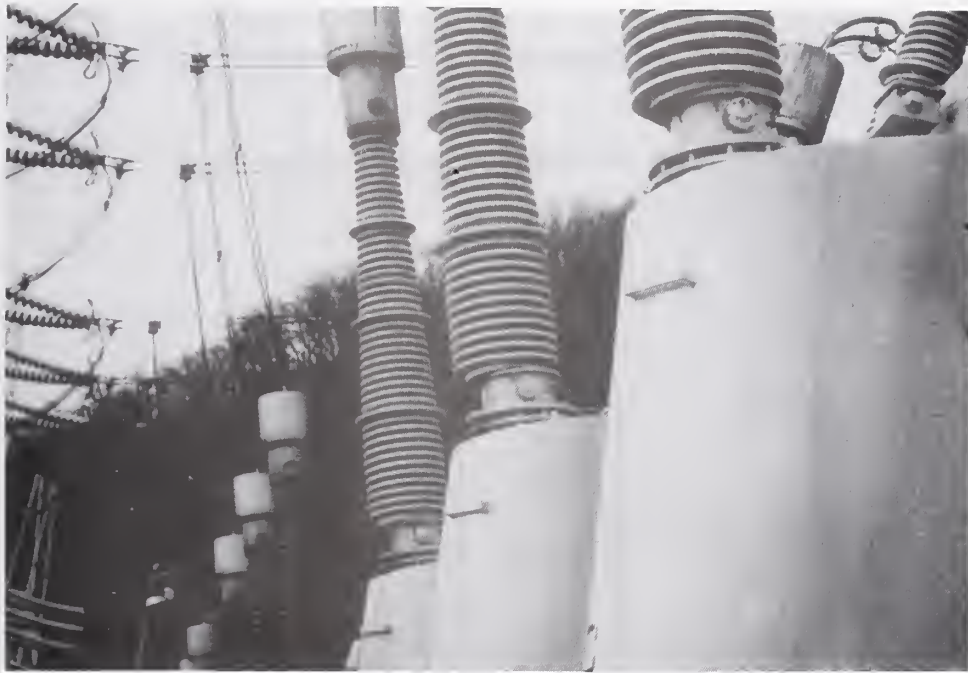
Figure 5.4.56 All three bushings shifted on this 275 kV bulk-oil circuit breaker.

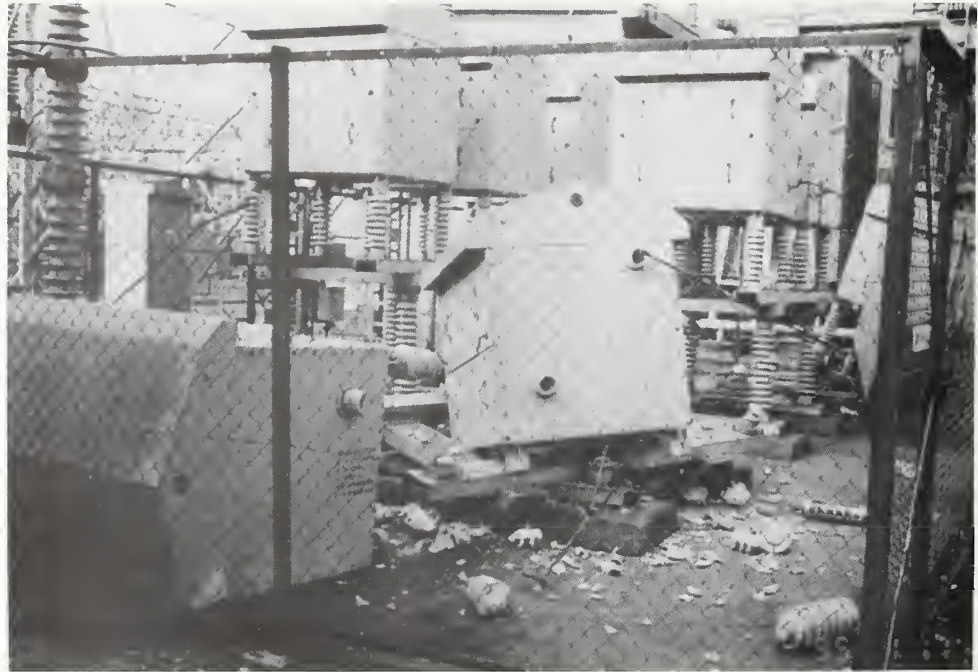
Figure 5.4.58 Neutral resistors failed, a device not used in this configuration in the U.S.

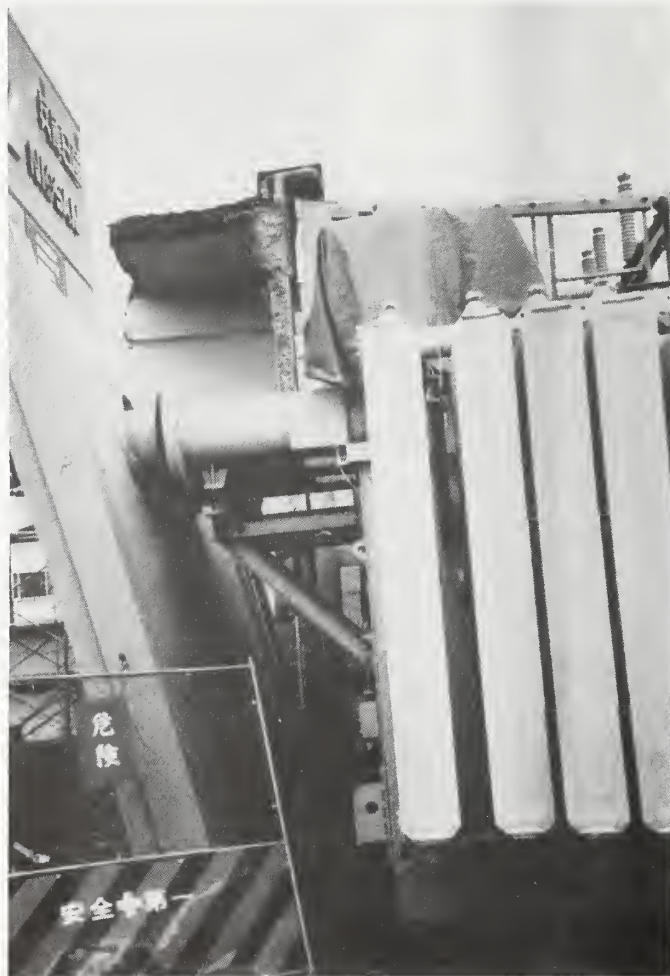
Figure 5.4.61 A transformer pushed over the fire wall after it failed its anchorage.

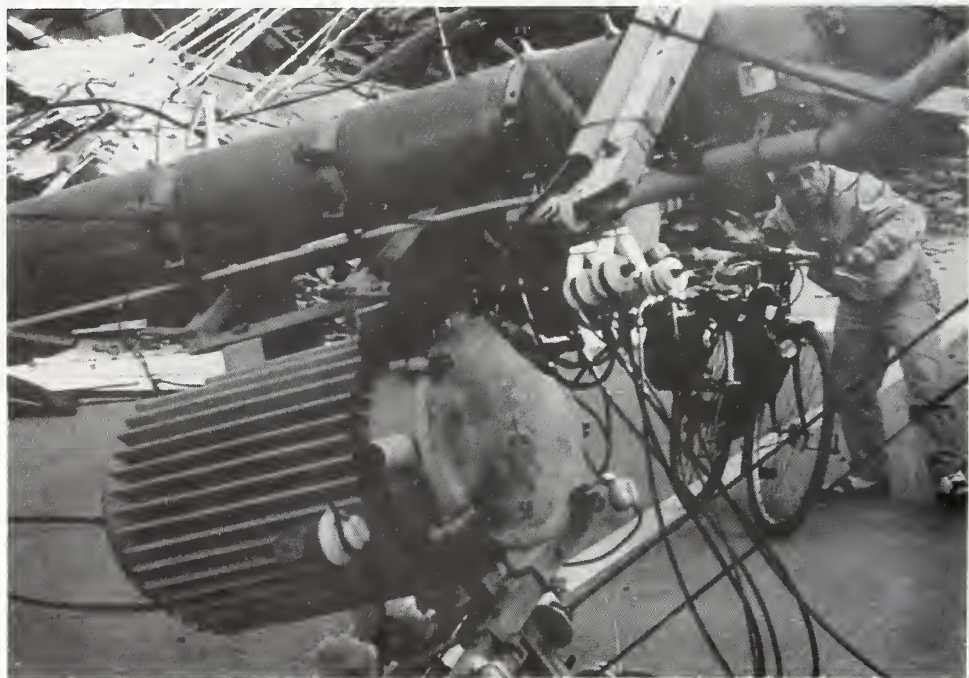
Figure 5.4.70 Fallen poles contributed to the disruption of traffic.

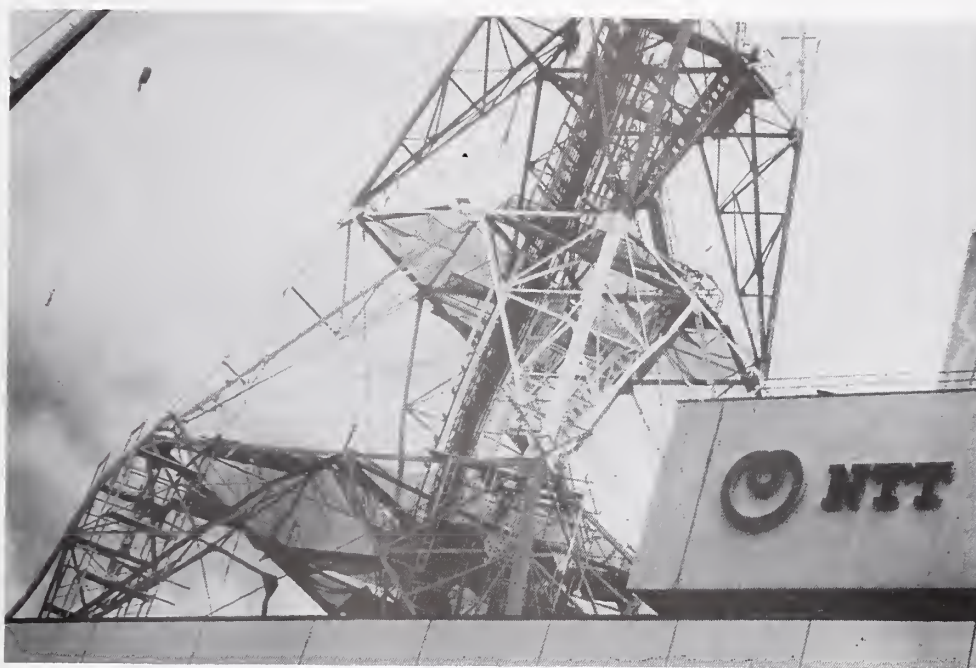
Figure 5.5.1 Microwave tower on top of a central office which was damaged and later removed.

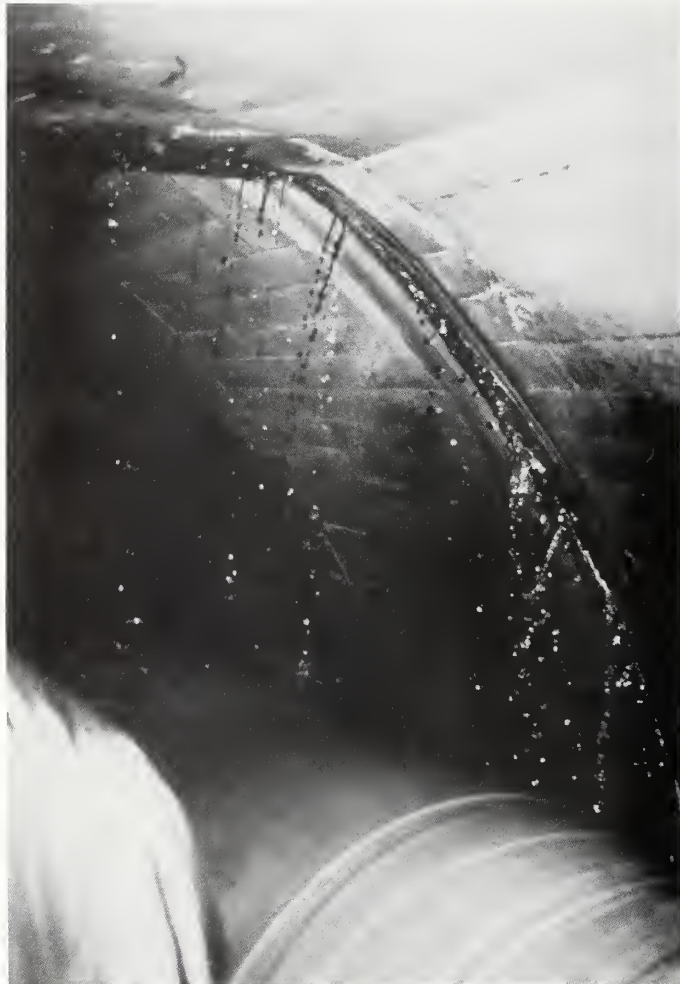
Figure 5.5.3

Slight movement at a construction joint caused a small water leak in a joint utility tunnel.

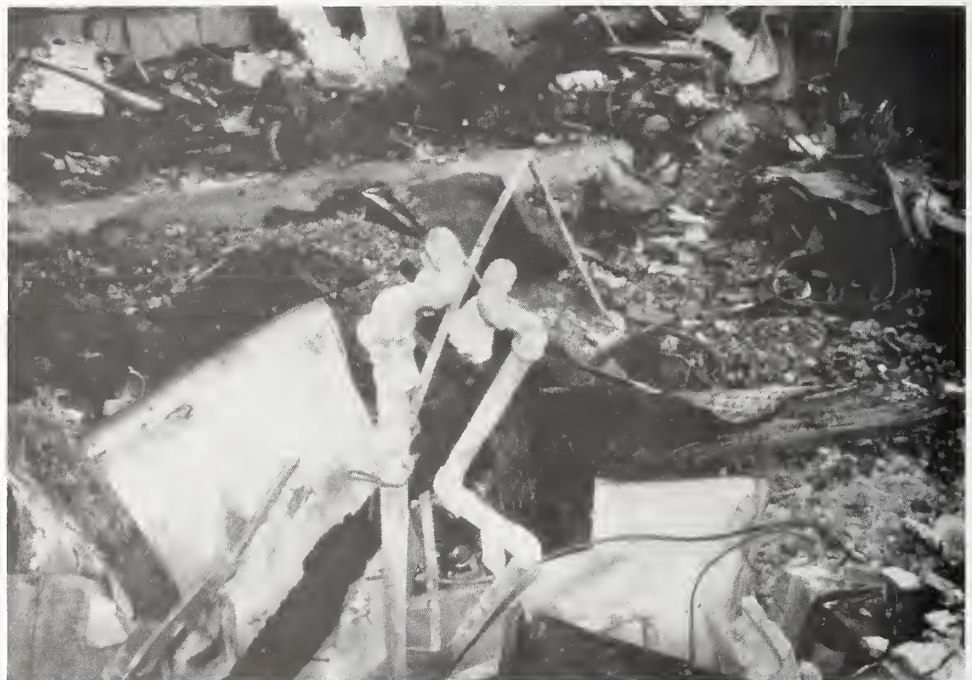
Figure 6.2.4 Broken gas meter connection.
