NBSIR 82-2593

October 1982

**INVESTIGATION OF CONSTRUCTION
FAILURE OF THE RILEY ROAD
INTERCHANGE RAMP, EAST CHICAGO,
INDIANA**

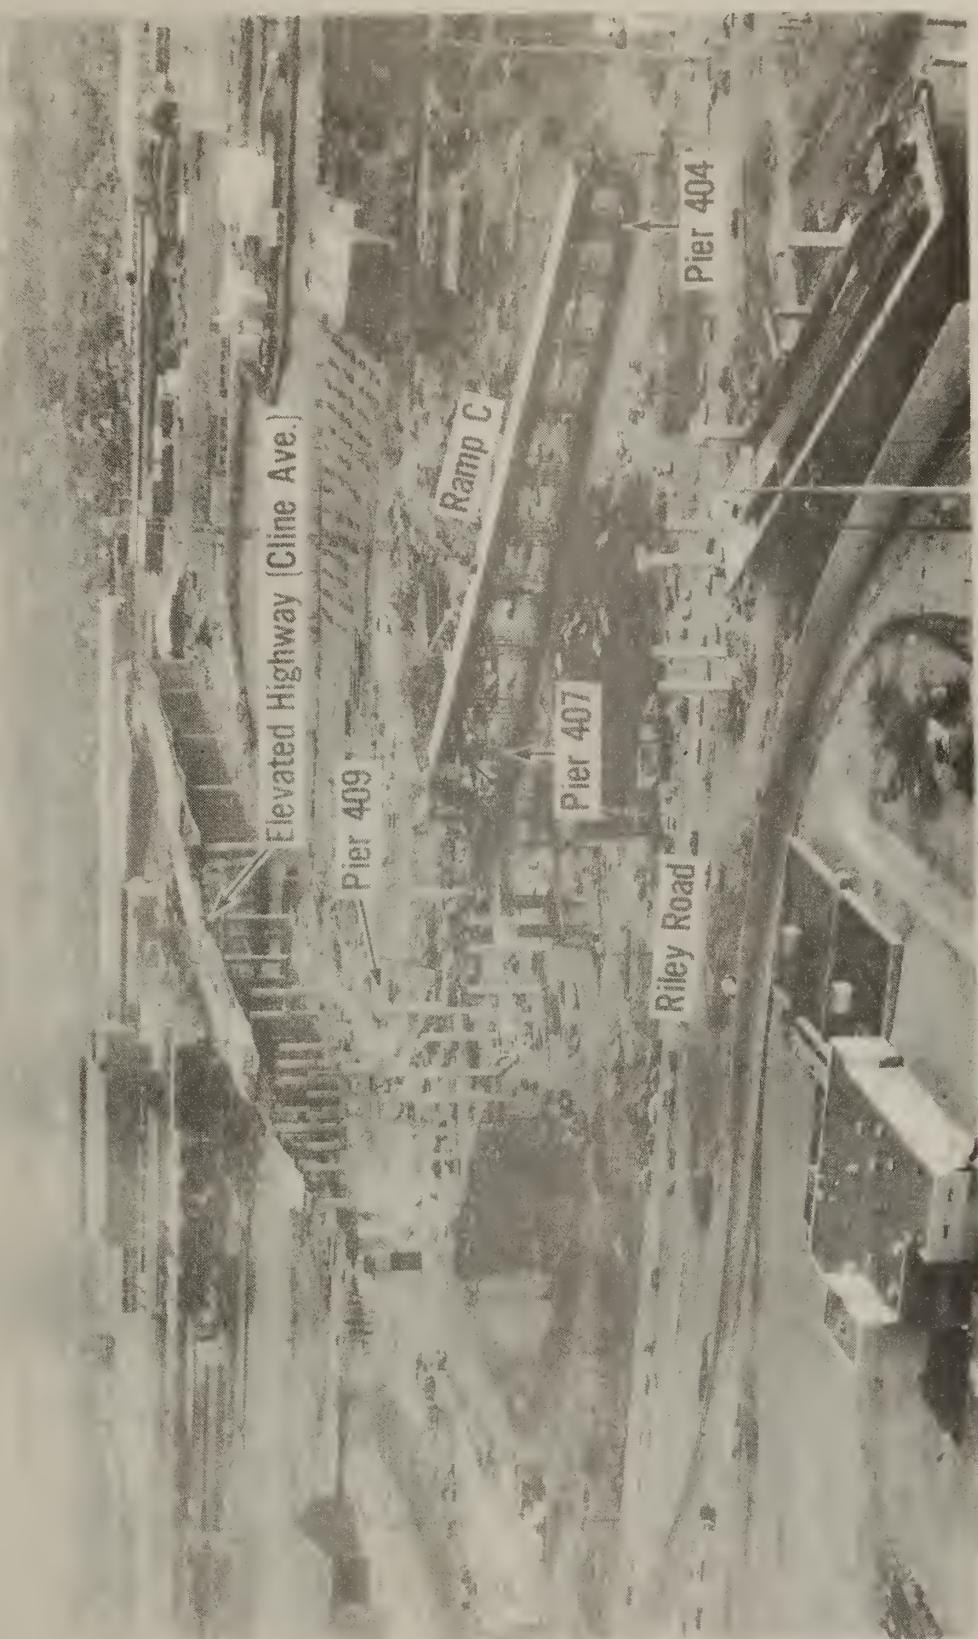
Figure 2.1 Overall view of the collapse site, looking from west to east.
(Courtesy of Post-Tribune, Gary, Indiana)

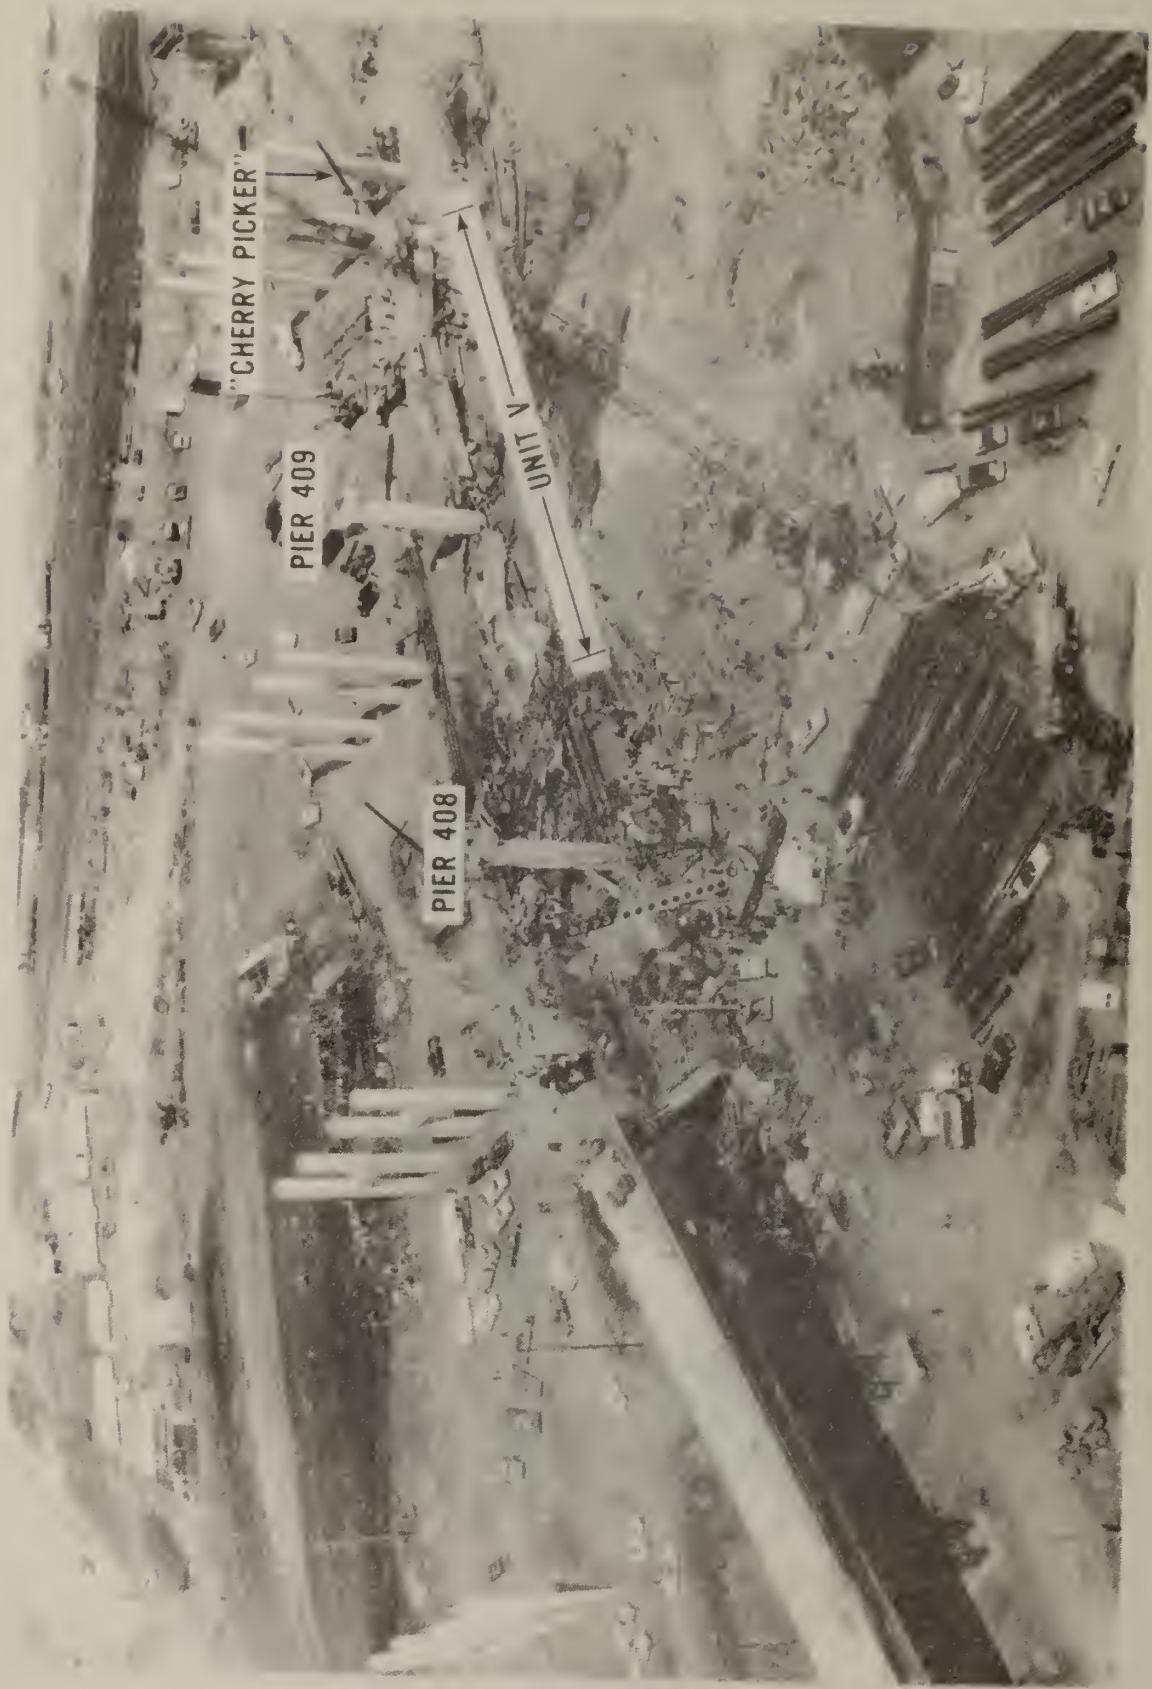
Figures 2.14, 2.15, and 2.16 are aerial photographs taken on the day of the failure. They show the location of the debris before a significant amount of it had been moved for rescue operations.

Figure 2.14 View of collapse as seen from the southwest (courtesy of Post-Tribune, Gary, Indiana)

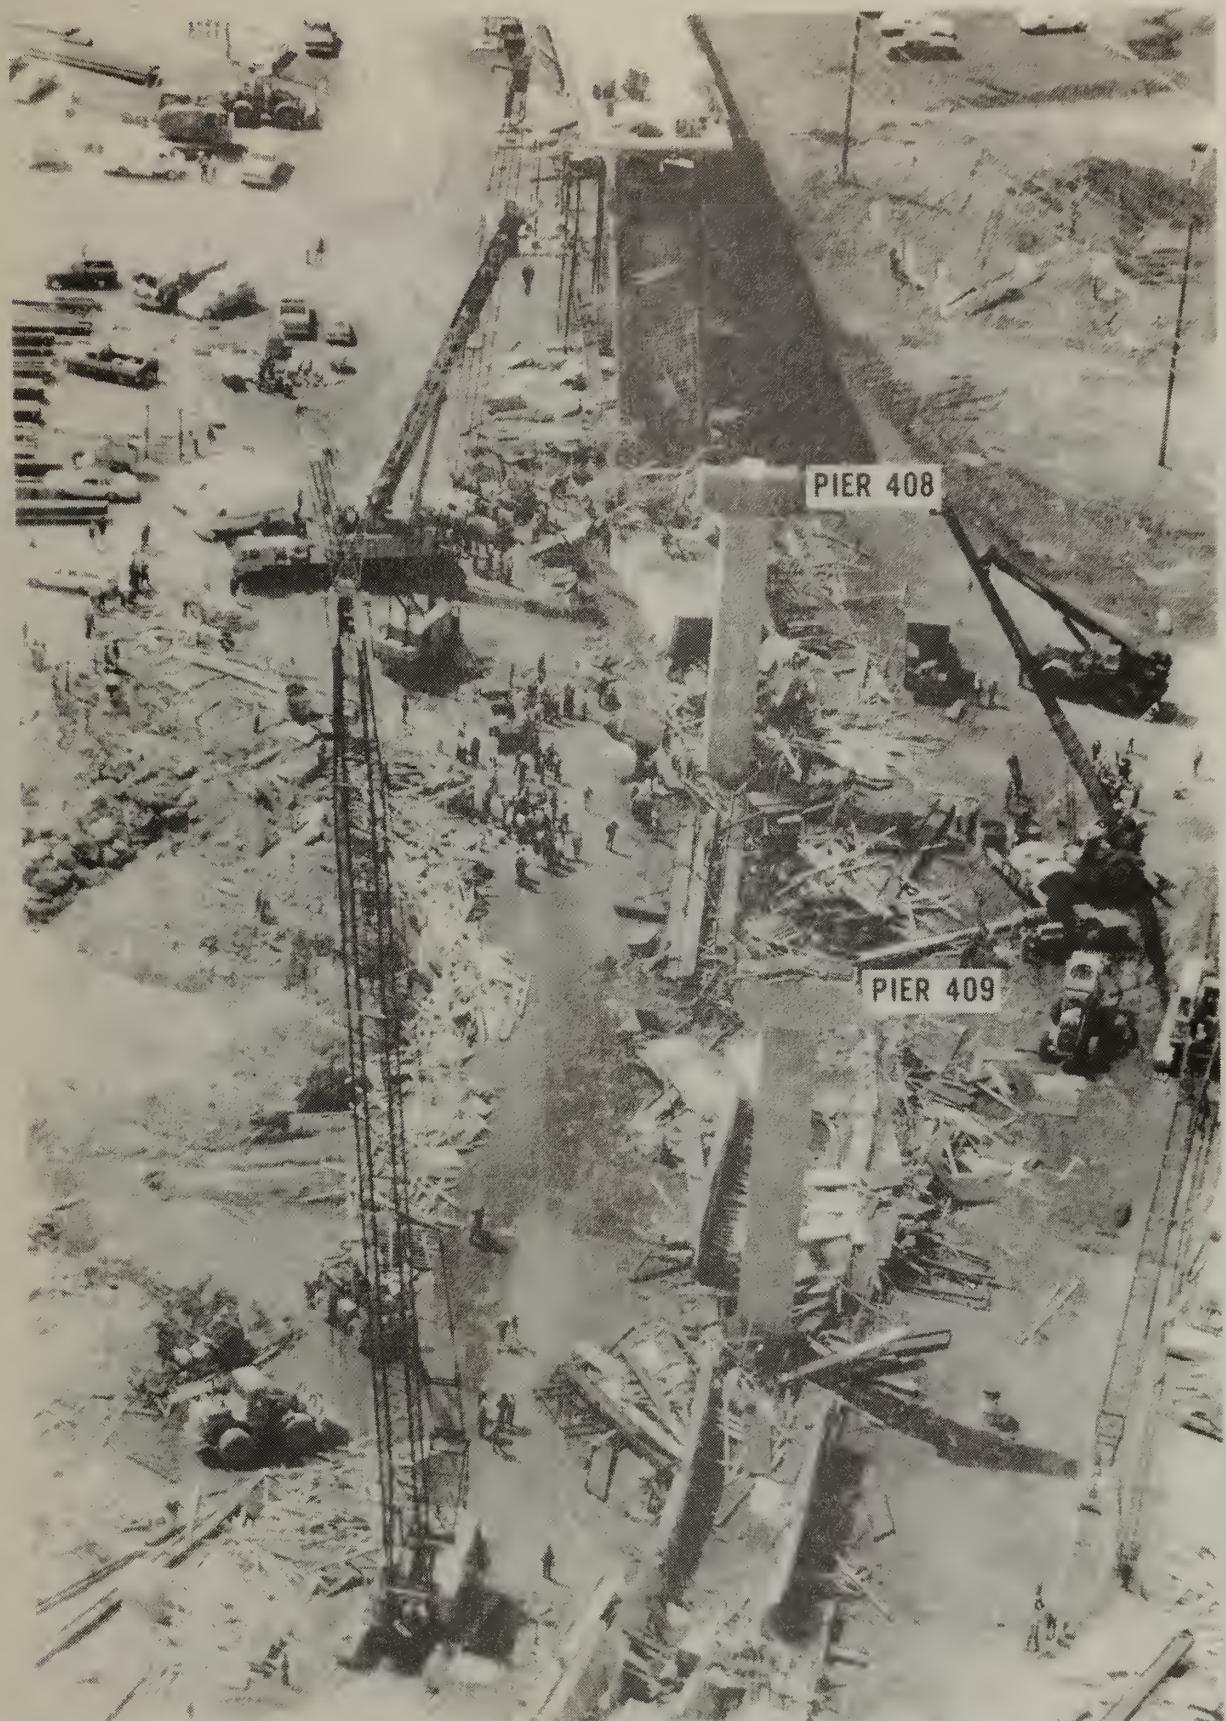
Figure 2.15 View of collapse as seen from the east. (Courtesy of Post-Tribune, Gary Indiana)

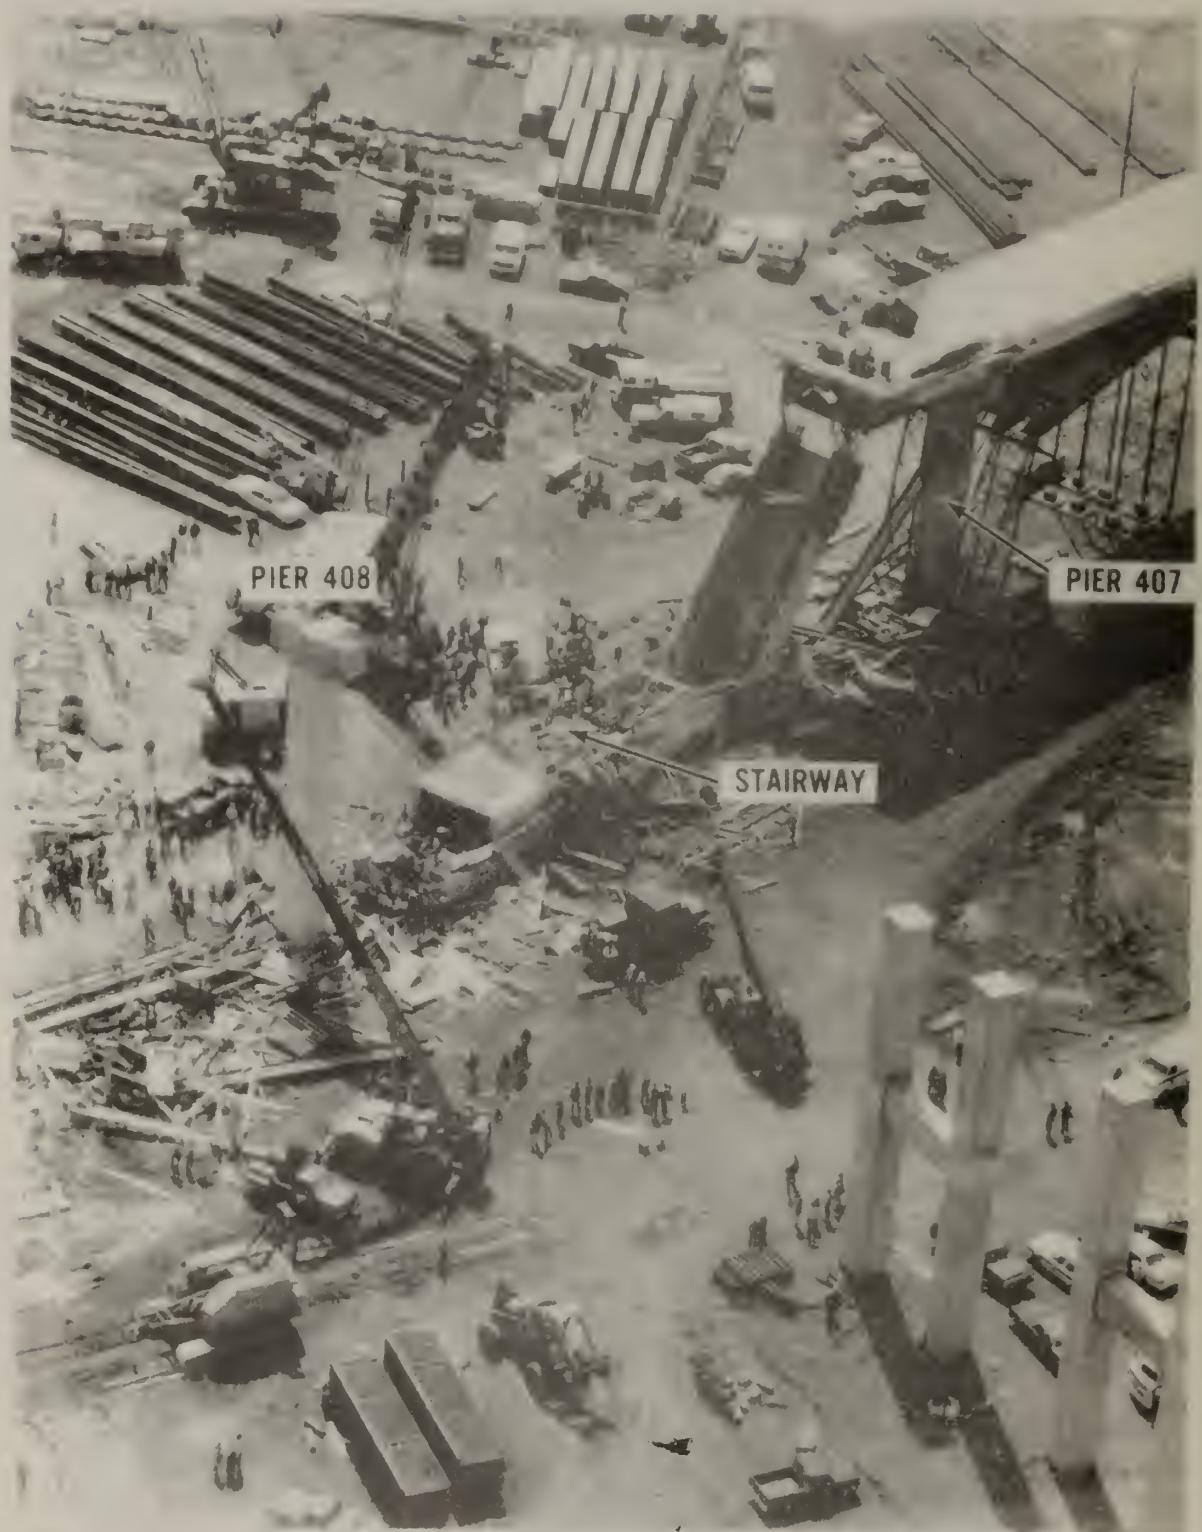
Figure 2.16 View of collapsed unit IV as seen from the northeast. (Courtesy of Post-Tribune, Gary Indiana)

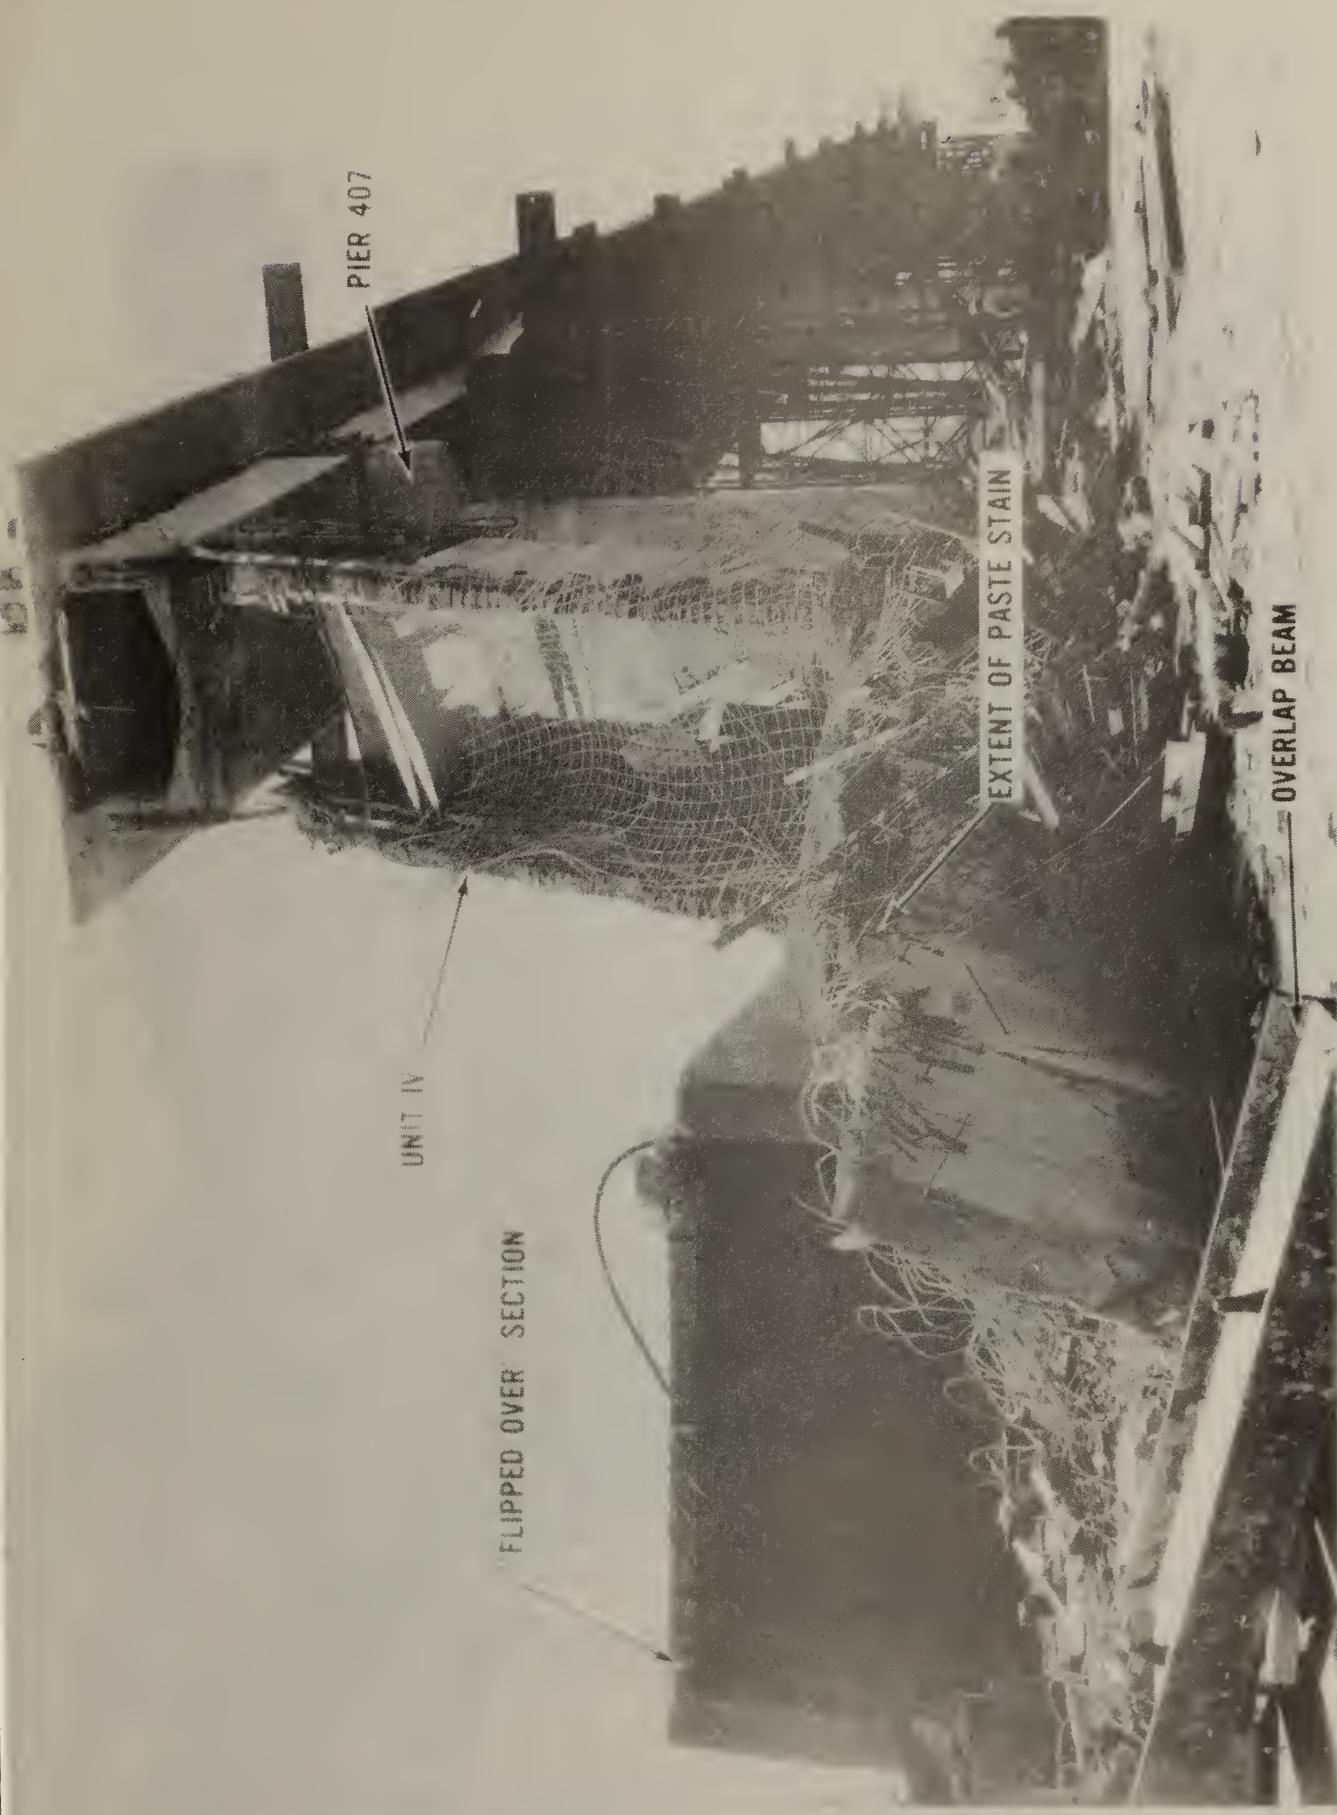
concrete plant, 140 yd³ (107 m³) of concrete had been delivered for the top slab. From field measurements it was found that the diaphragm had been filled to an elevation of about 5 ft (1.5 m), thus it was calculated that the top slab had been placed to a point about 20 ft (6.1 m) west of pier 408, when the collapse initiated. This estimate was corroborated by worker statements and by measurements of the extent of the cement paste stain on the northern side wall of unit IV (see figure 2.17).

Figure 2.17, 2.18, and 2.19 are ground level views of unit IV. Figure 2.17 is a view from the northeast and shows the portions of unit IV that were adjacent to pier 408. Stains due to fresh cement paste can be seen on the northern side wall. The stained region ends at about 20 ft (6 m) from the end of the unit, and this is assumed to indicate how much of the top-slab concrete had been placed. In the foreground of figure 2.17 is seen a short, steel beam that was originally located next to the cap of pier 408. The purpose of this beam is discussed in subsection 3.2.4.

Figure 2.17 Unit IV as viewed from the northeast

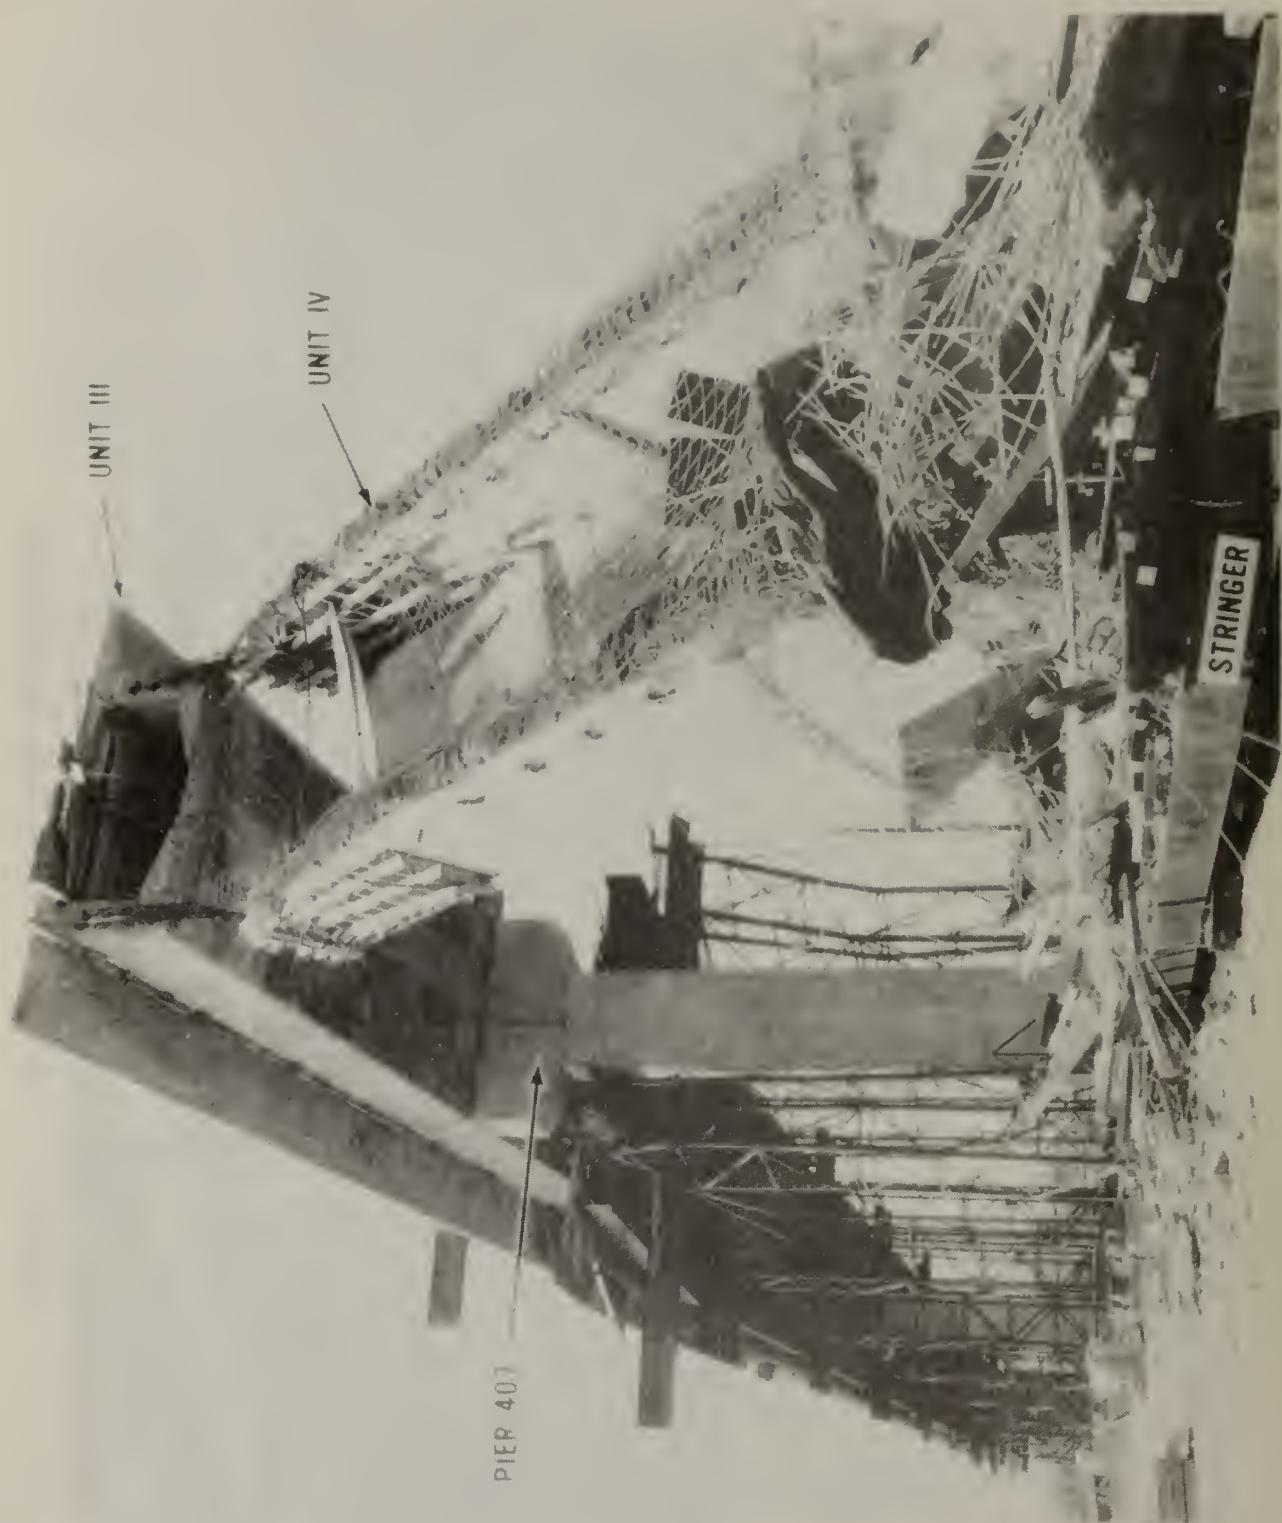
Figure 2.18 Partial view of unit IV from the southeast

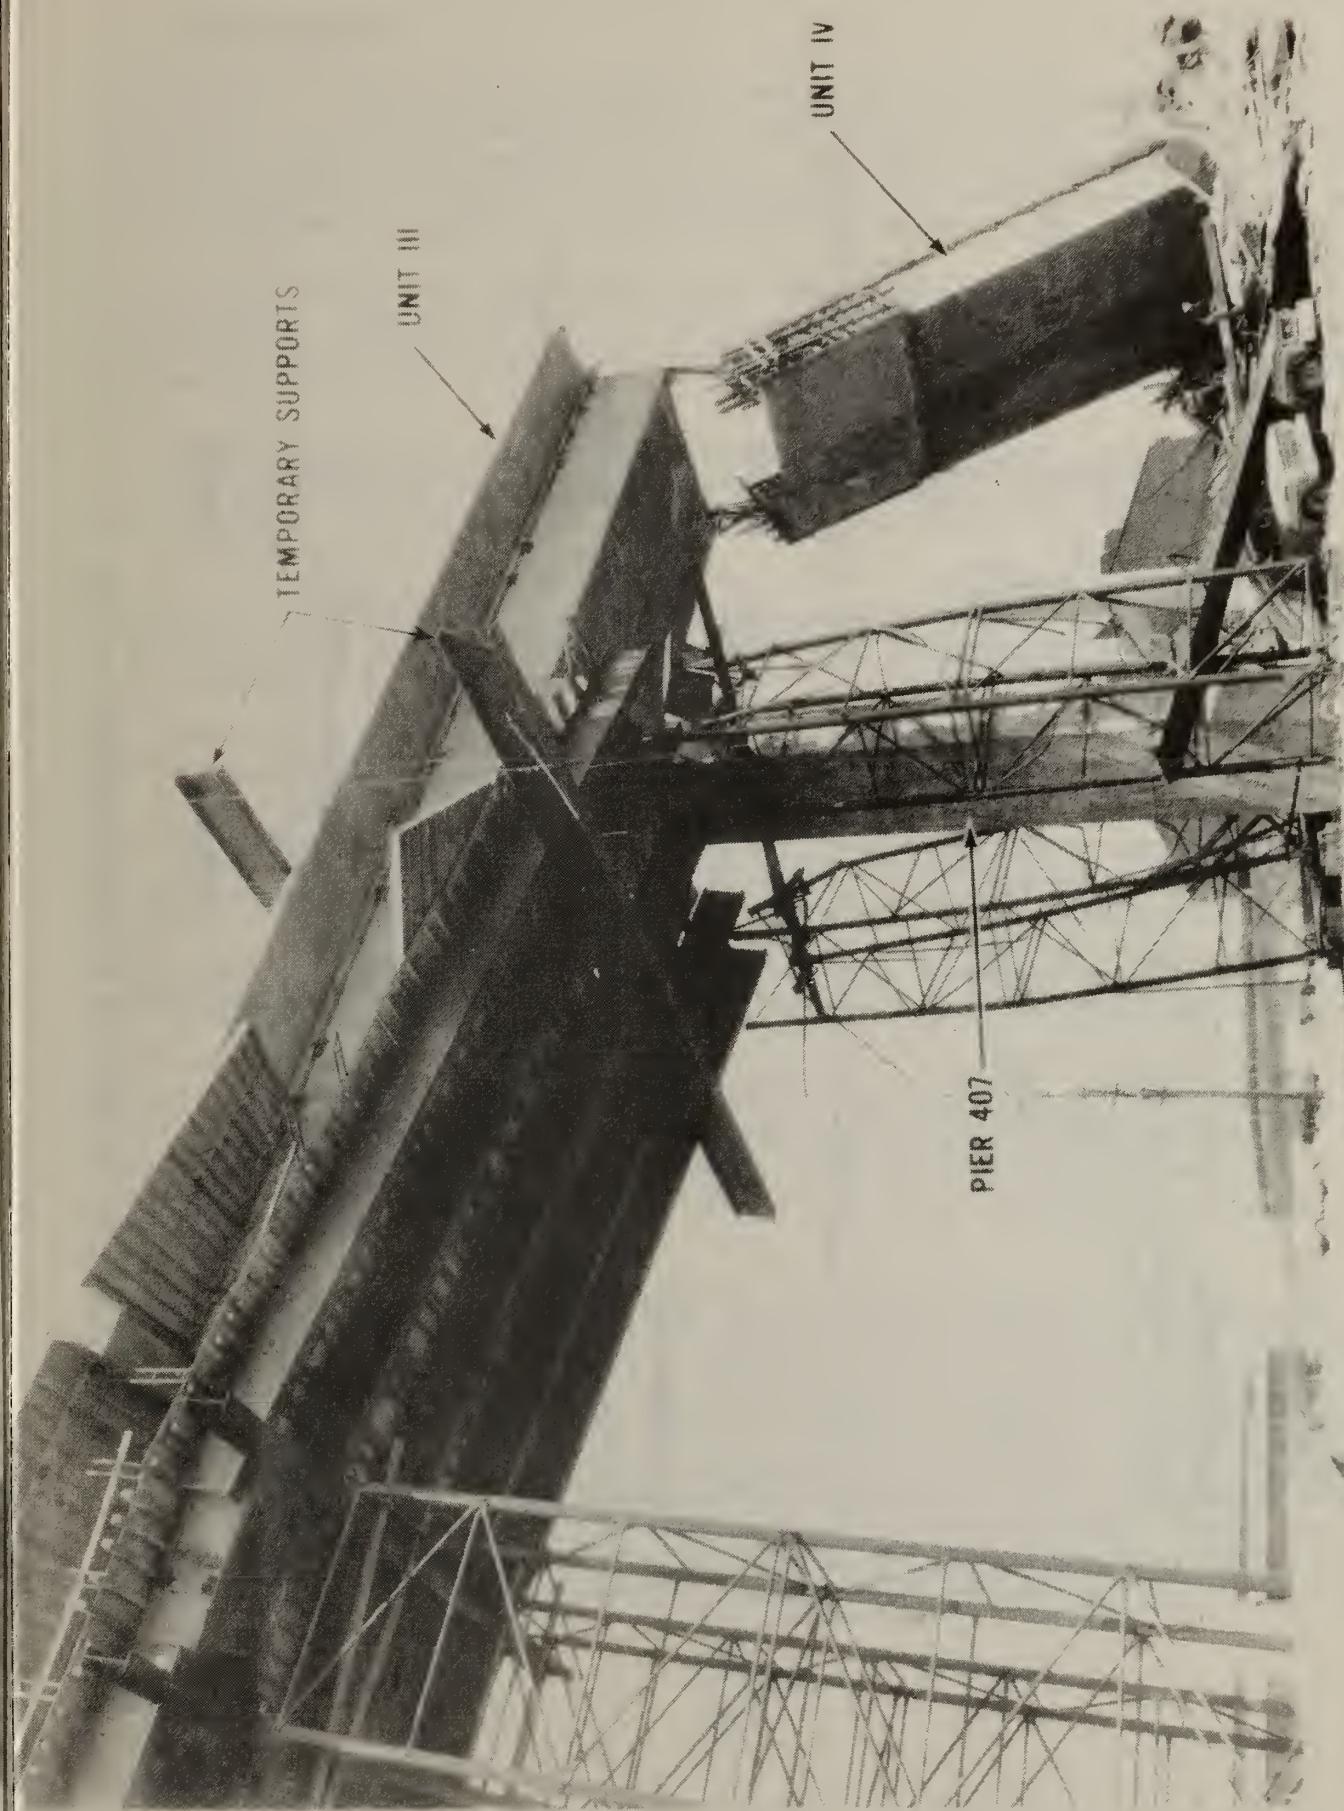
Figure 2.19 is a view of the hanging portion of unit IV as seen from the southwest. The portion of the floor slab that is a lighter shade is the portion cast two days before the failure. Also seen are the damaged shoring towers at pier 407. The two transverse beams on unit III were added after the collapse to help support the stringers which were originally supported by the towers at pier 407. Figure 2.19 also shows some of the falsework details to be discussed in section 3.2.

Figure 2.19 View of the hanging portion of unit IV from the southwest

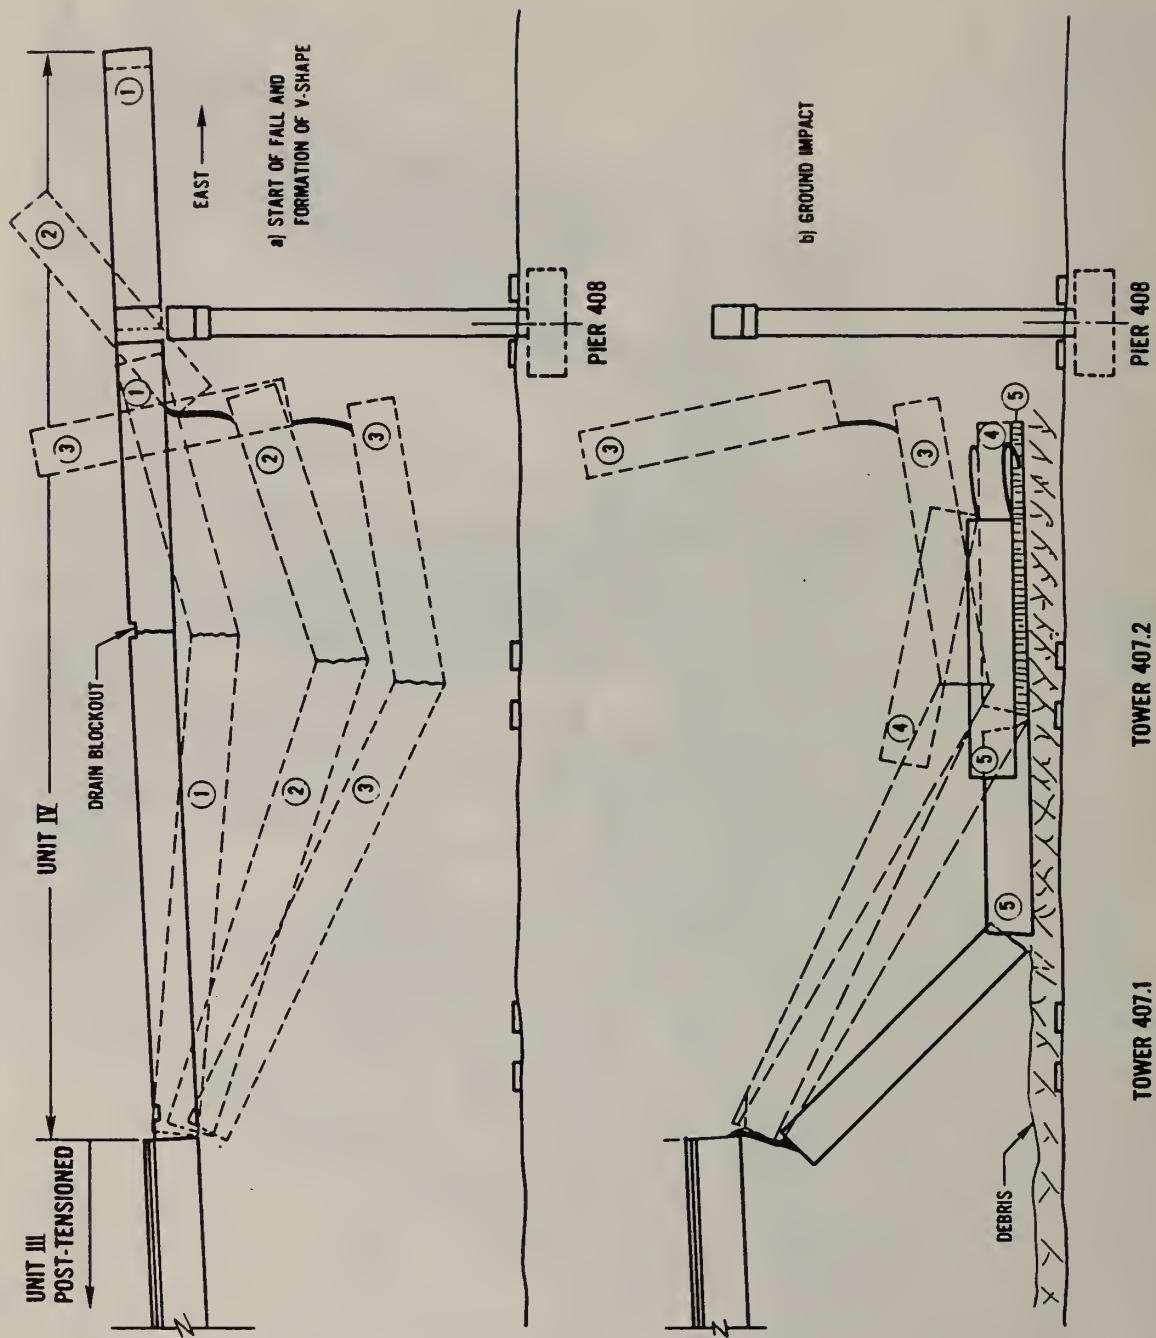
Figure 2.20 is a reconstruction of a possible mechanism of the collapse of unit IV. Field observations after the failure revealed a large gap in the northern wall of unit IV at approximately the same cross section containing the drain blockout on the south wall (see figure 2.9). Thus, it is suggested that unit IV developed initial cracking at the location of the cross-section with the blockout. As the unit fell it dragged with it the portion east of pier 408 (#1)*, because the tendons were wedged in place at the jacking end of unit IV.

Figure 2.20 Possible of collapse sequence for unit IV

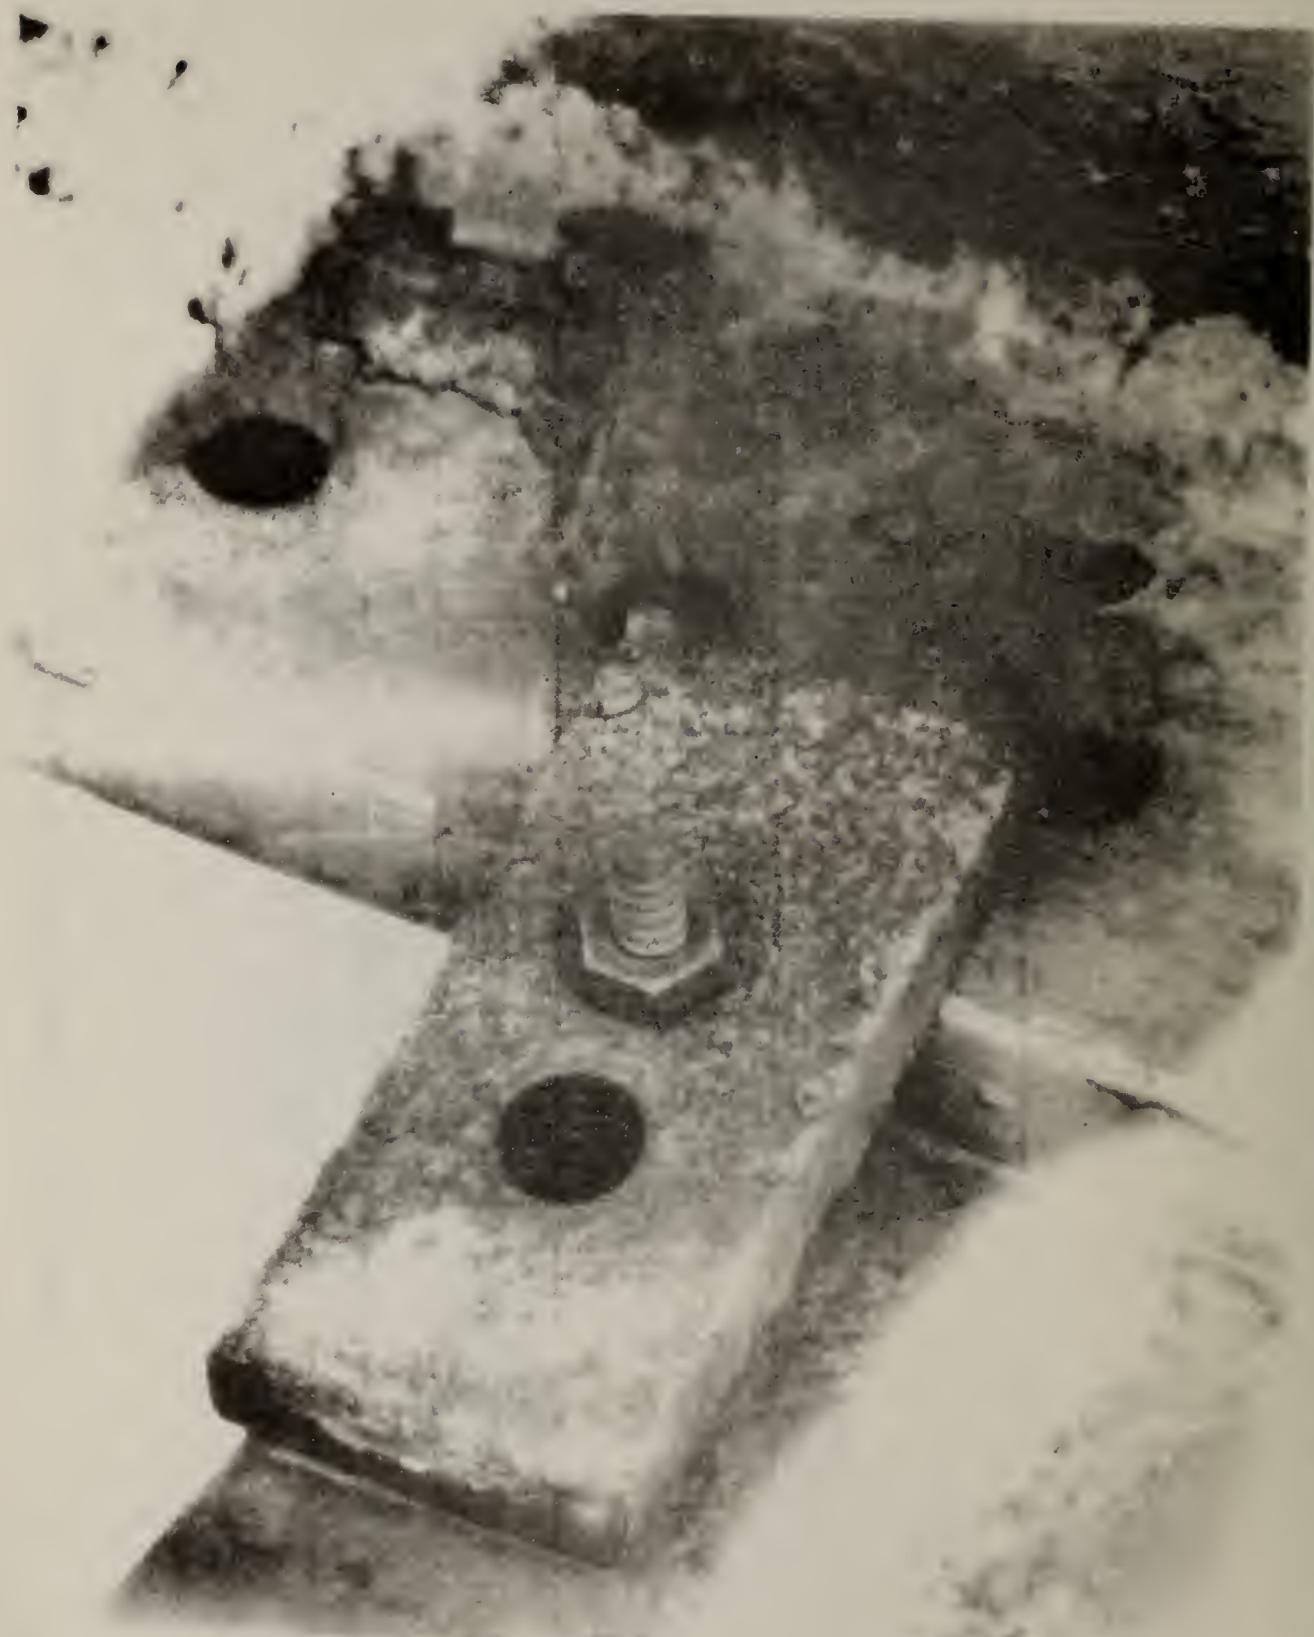
The structural drawings called for 1-in (25-mm) steel bolts to connect certain stringers to the cross-beams. No evidence of these bolts was found during the

field investigation. A frictional clip was used in place of the bolts, but no documentation was found authorizing this substitution. The drawings also specified wedges between crossbeams and stringers to compensate for the slope of the roadway. There was no evidence that wedges were used, and no documentation was found approving their omission. In addition, no calculations were found for the engineering design of the concrete pads, and the construction sequence deviated from that specified in the drawings.

Figure 3.13 Connection detail employed in place of specified bolted connection

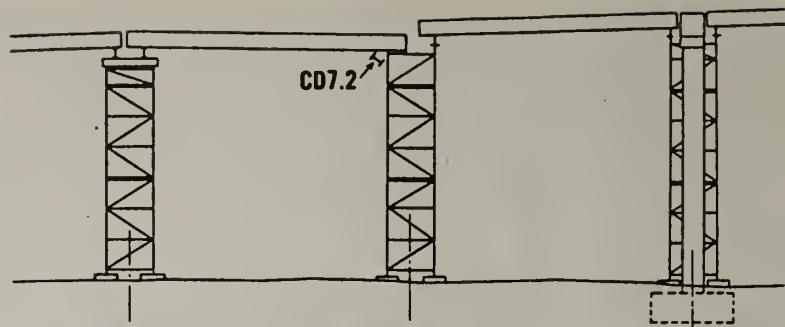
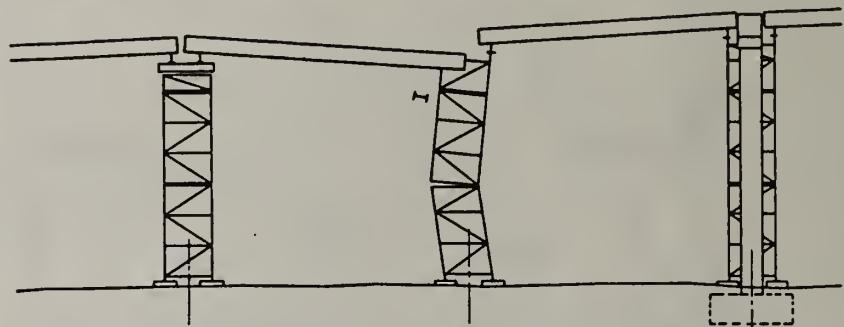
a. Cross-beam CD7.2 falls down, U-heads are broken off.

b. Tower starts to fold.

c. Top portion of north tower begins to separate .

Figure 3.23 Possible collapse sequence of falsework at 407.2

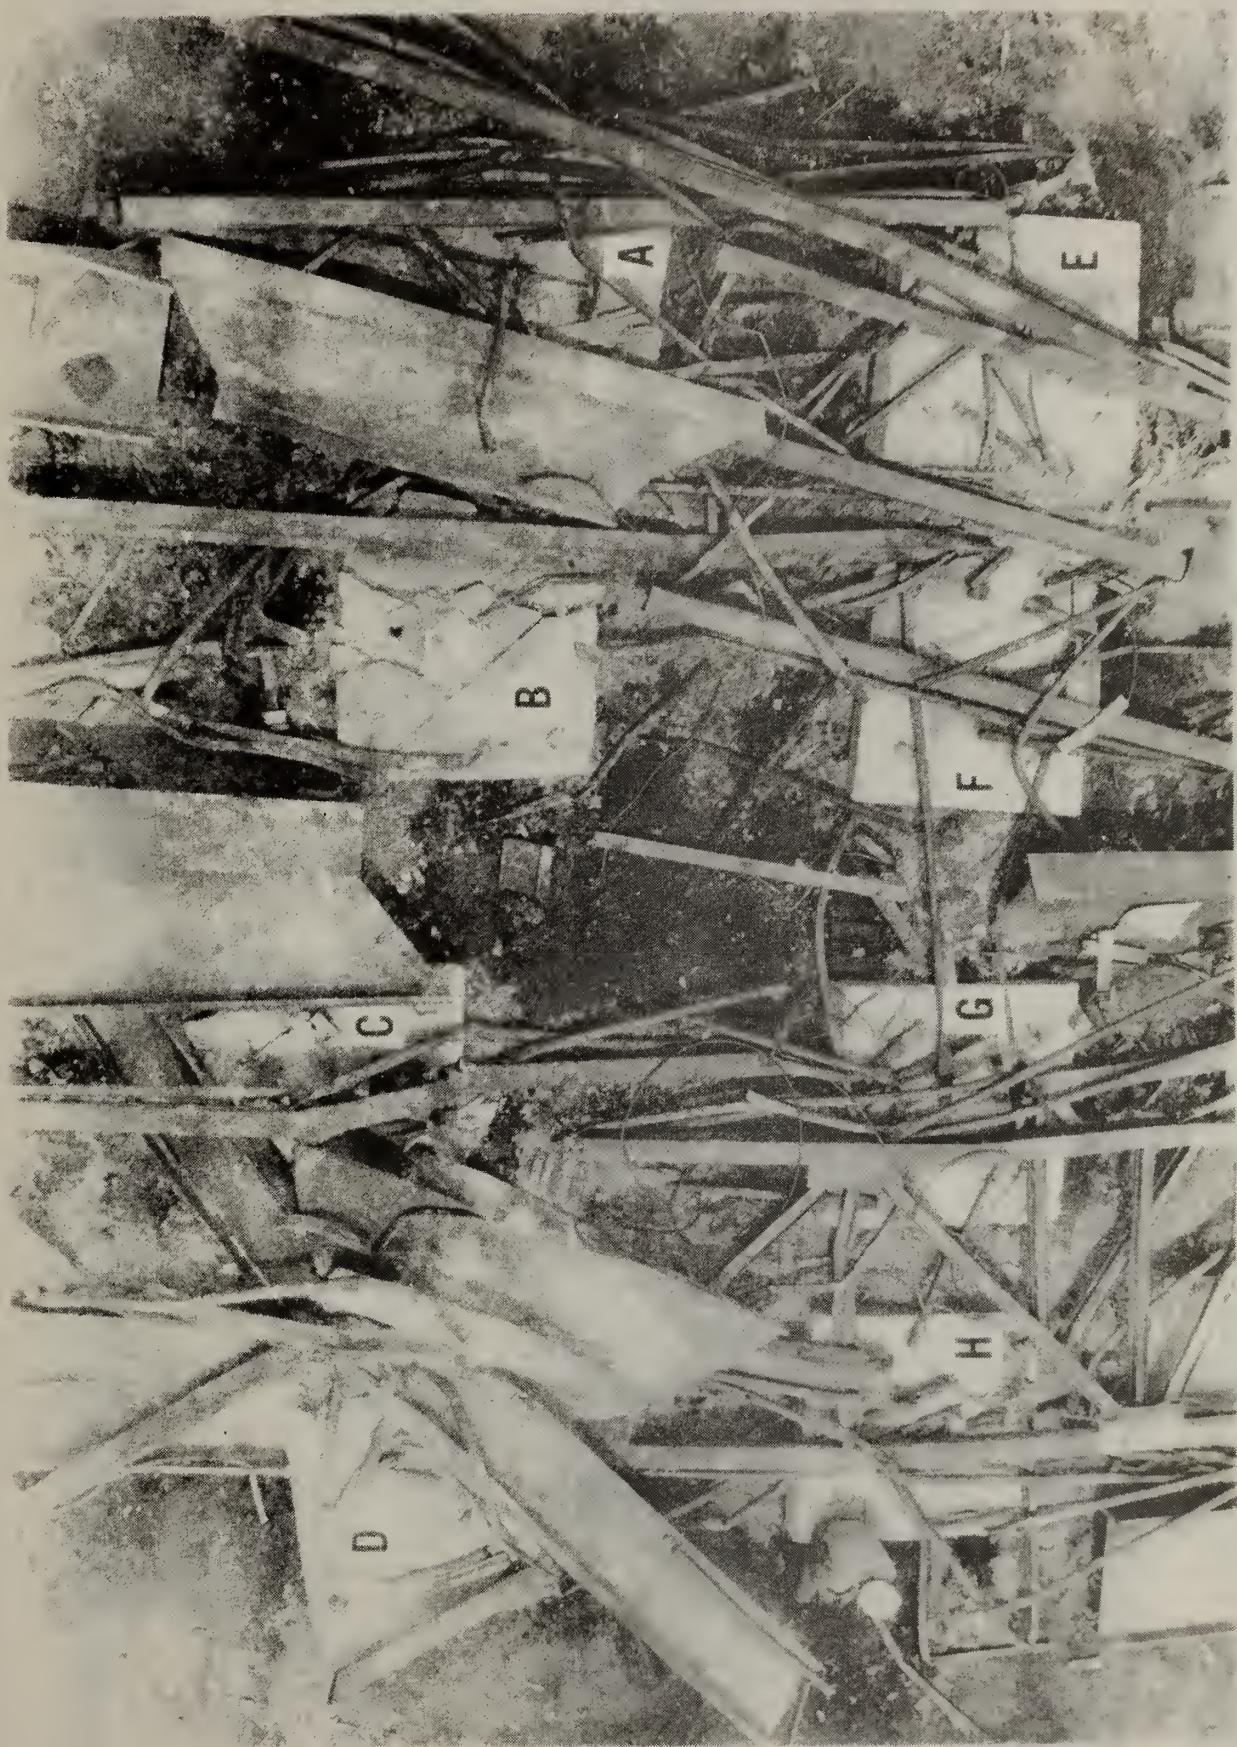
Figure 3.24 Close-up view of cracked concrete pads at tower location 407.2 (north is to the right)
