NBSIR 82-2593

October 1982

**INVESTIGATION OF CONSTRUCTION
FAILURE OF THE RILEY ROAD
INTERCHANGE RAMP, EAST CHICAGO,
INDIANA**

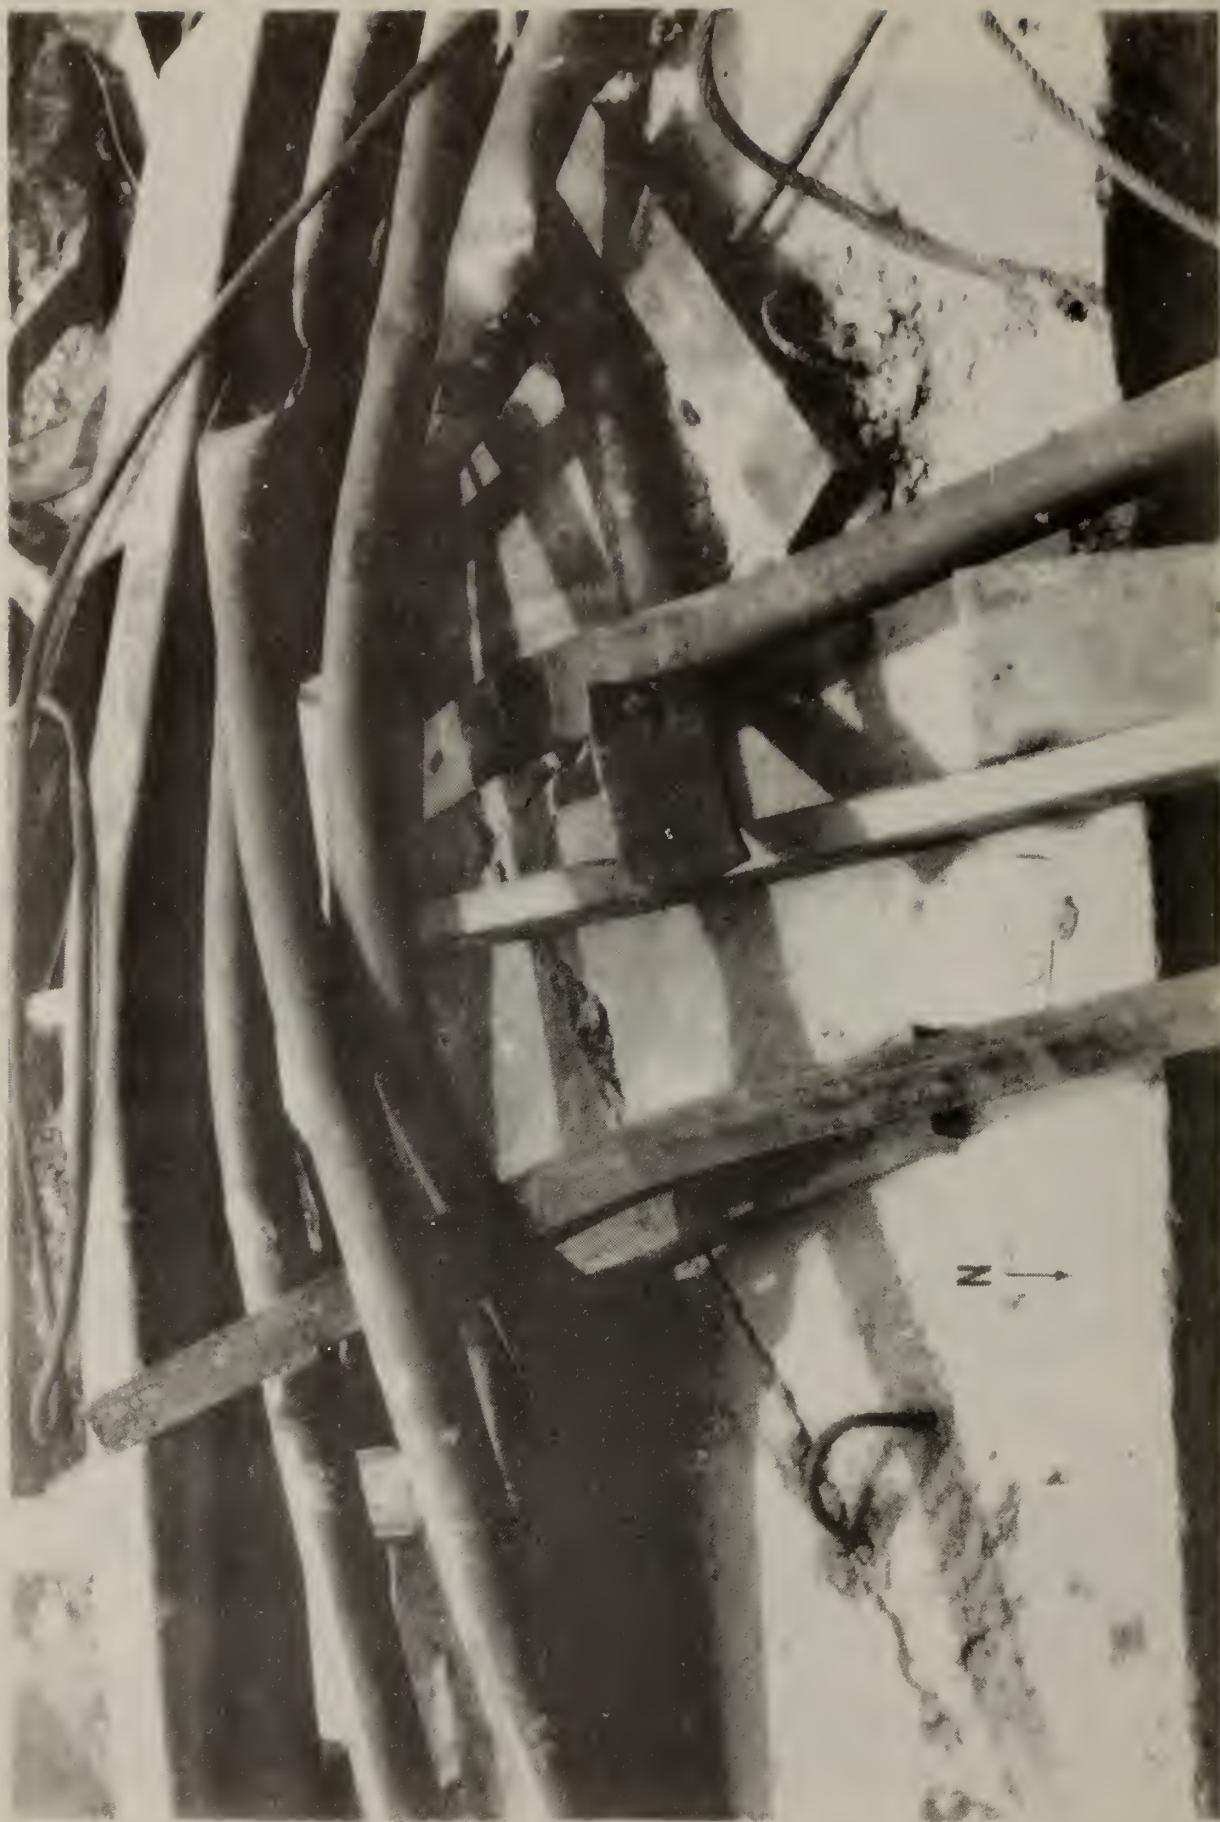
Figure 3.25 Cracking pattern of concrete pad 407.2-G

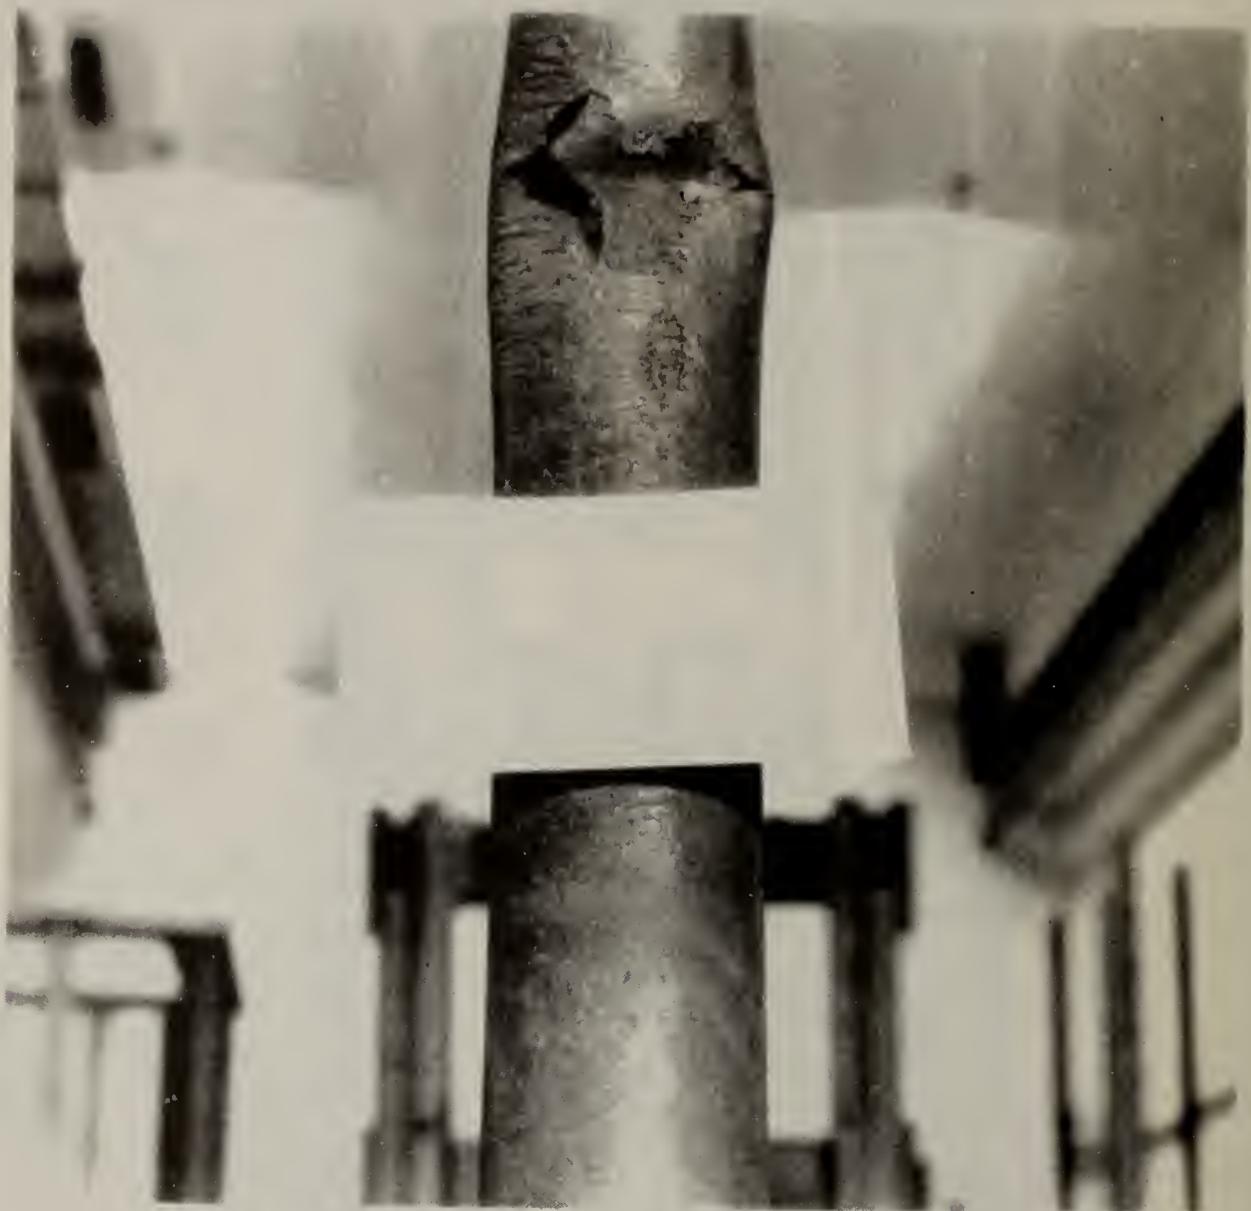
Figure 4.33 Close up view of corroded region near coupler of brace #3

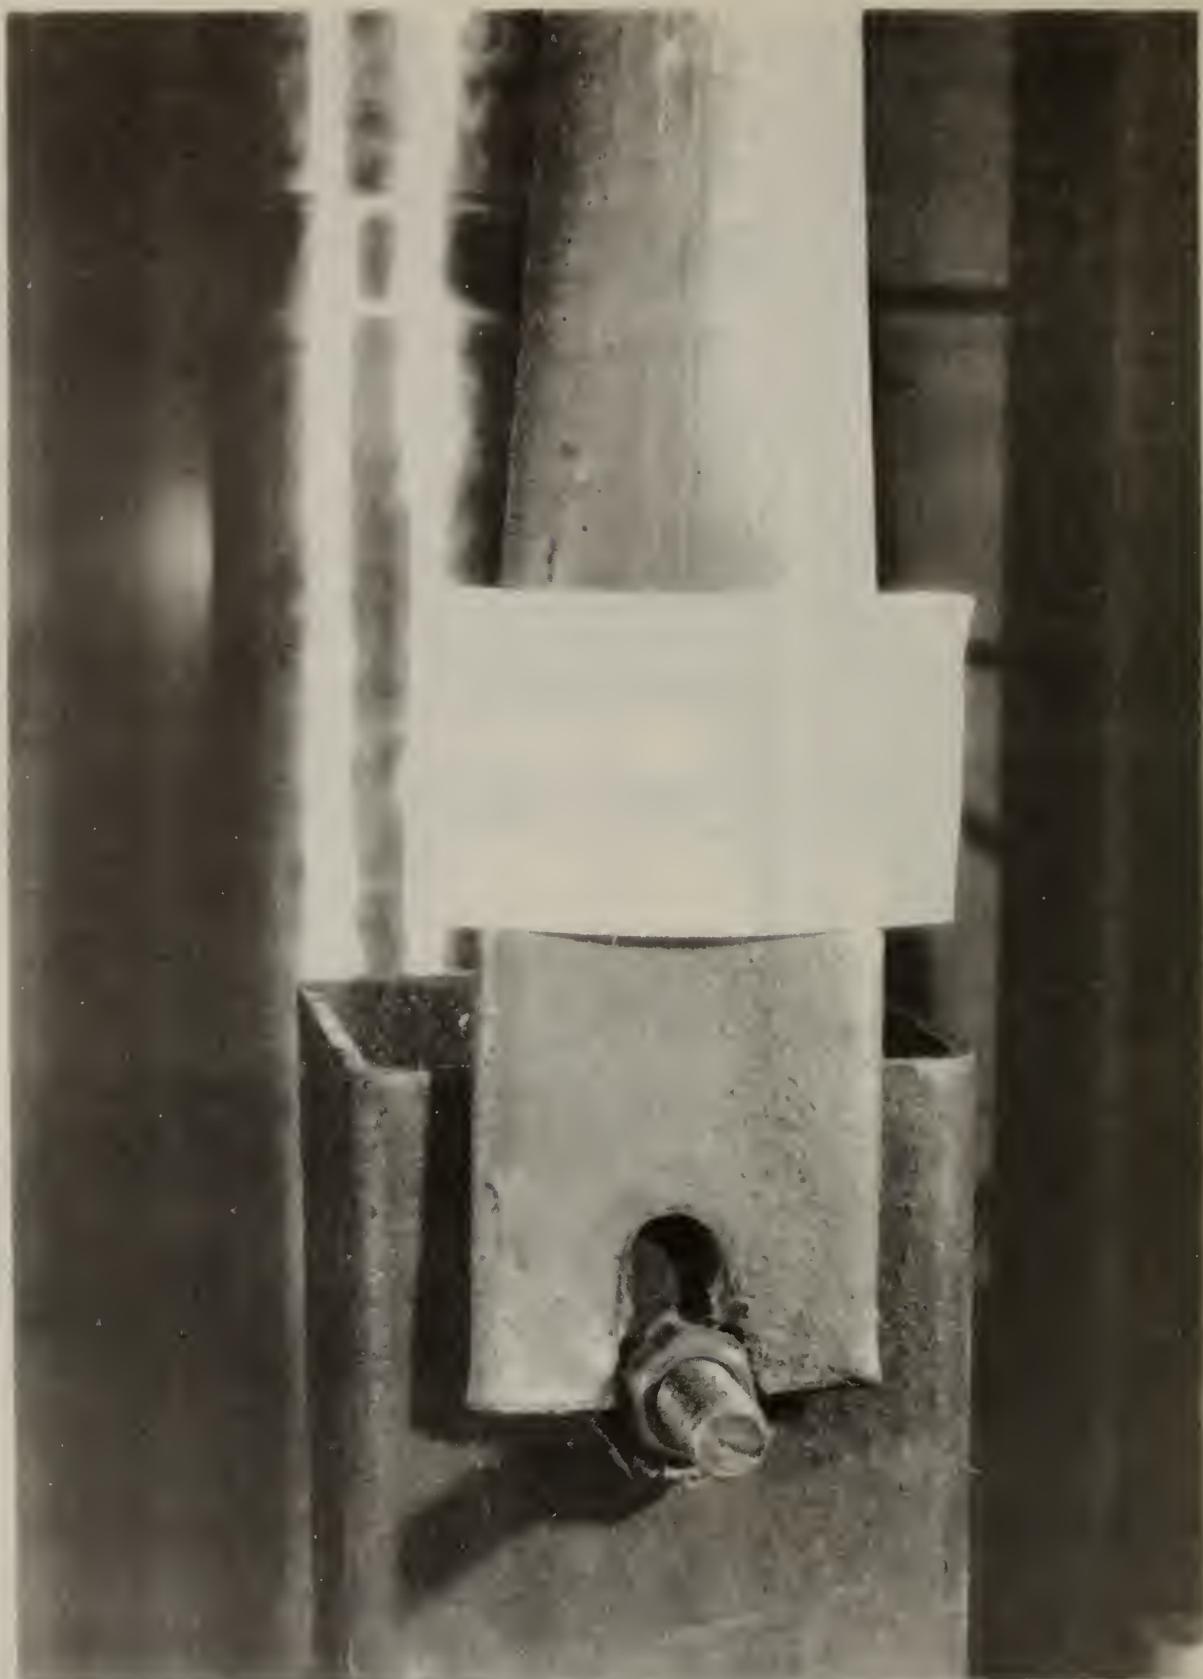
Figure 4.35 Tearing failure at bolt connection of brace #5
