NIST Special Publication 1164

Preliminary Reconnaissance of the May 20, 2013, Newcastle-Moore Tornado in Oklahoma

December 2013

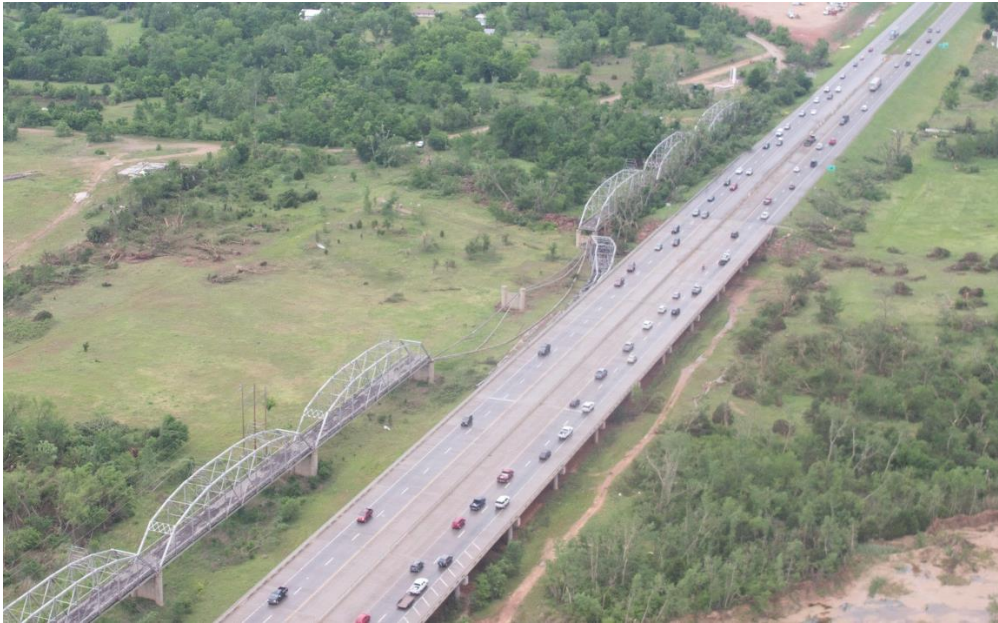
Figure 2-5. Two spans of the historic trestle bridge on US 62 running parallel to I-44 were destroyed. The bridge had been closed to traffic since 1963 but carried water pipes across the Canadian River.

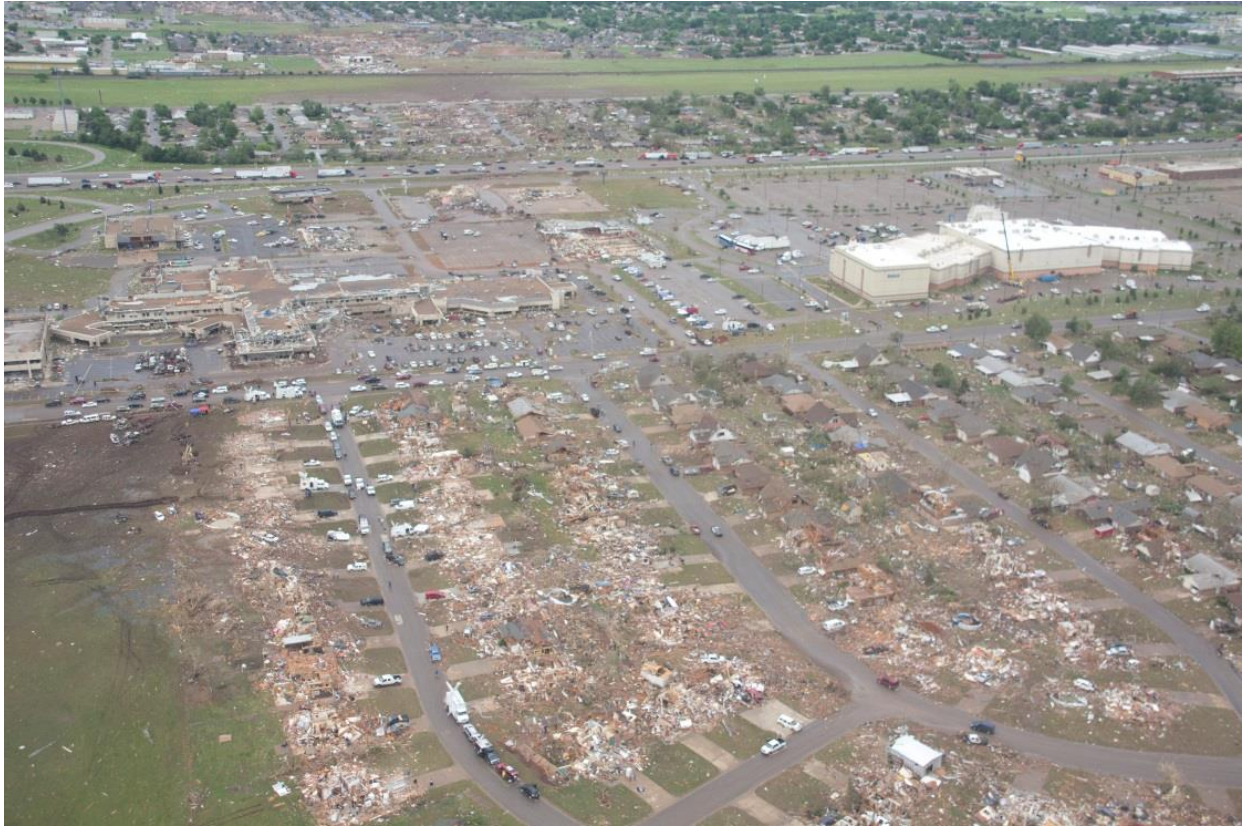
Figure 2-6. Aerial view (facing east) of damage to the Moore Medical Center (upper left), with heavily damaged residential neighborhood immediately west of the Medical Center in the foreground.

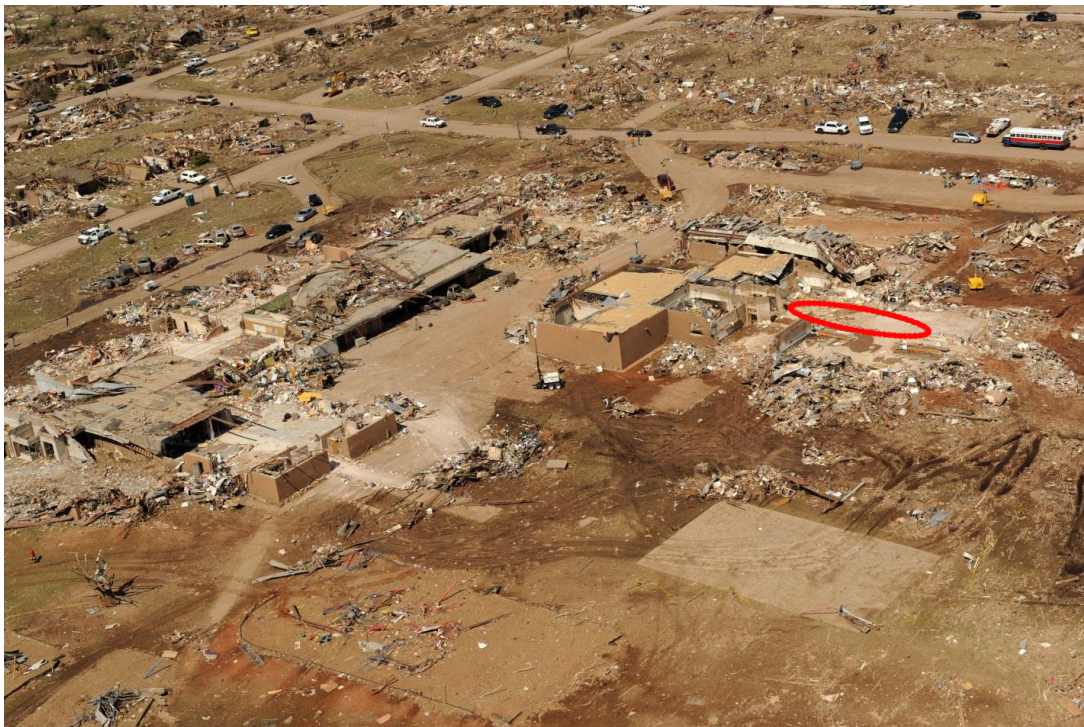
Figure 4-5. Post-tornado aerial view (looking northeast) of the Plaza Towers Elementary School taken May 21, 2013. Much of the debris had already been moved by the time of this photograph as part of the search and rescue operations. The area circled in red shows the approximate location in the hallway of the new main classroom building where the 7 fatalities occurred.

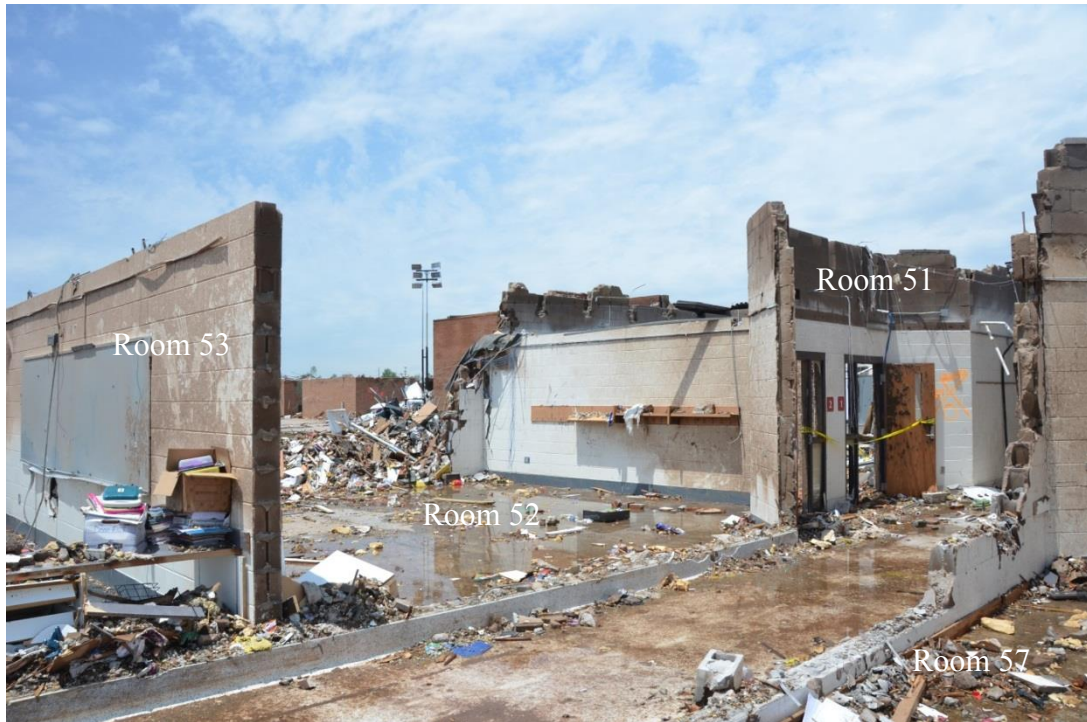
Figure 4-6. Damage to the hallway and classrooms of the new main classroom building (complete loss of roof and many walls) where the 7 fatalities occurred (most of the debris has already been removed). This hallway area was a “designated area of safety.”

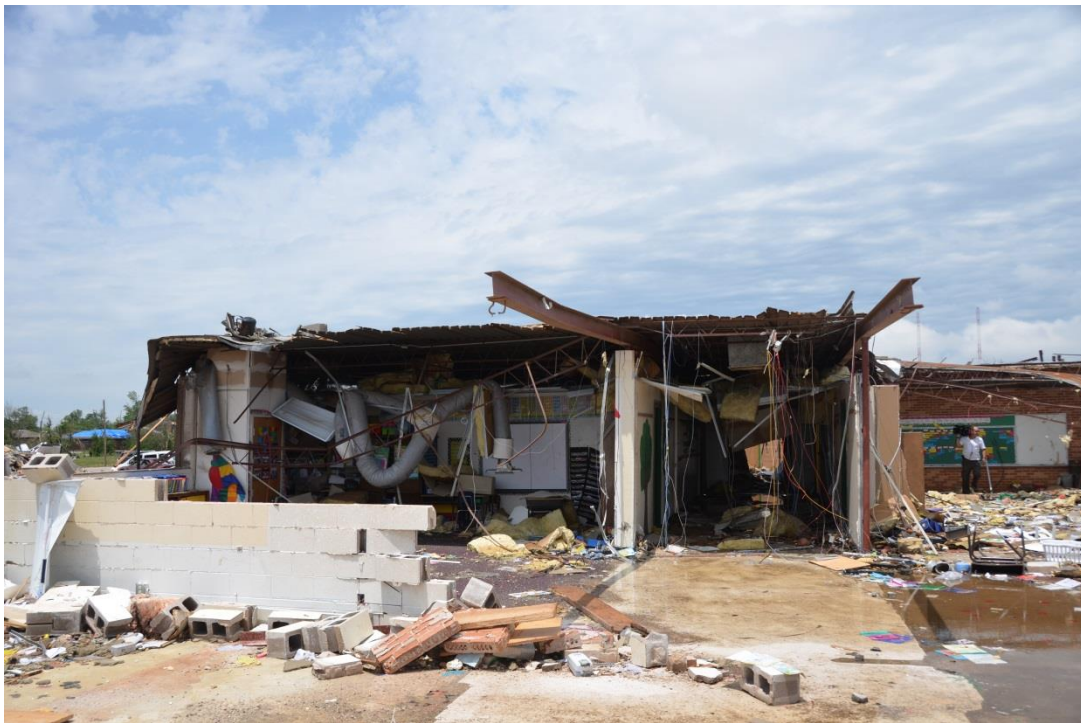
Figure 4-7. Collapsed southwest wing of original main classroom building.

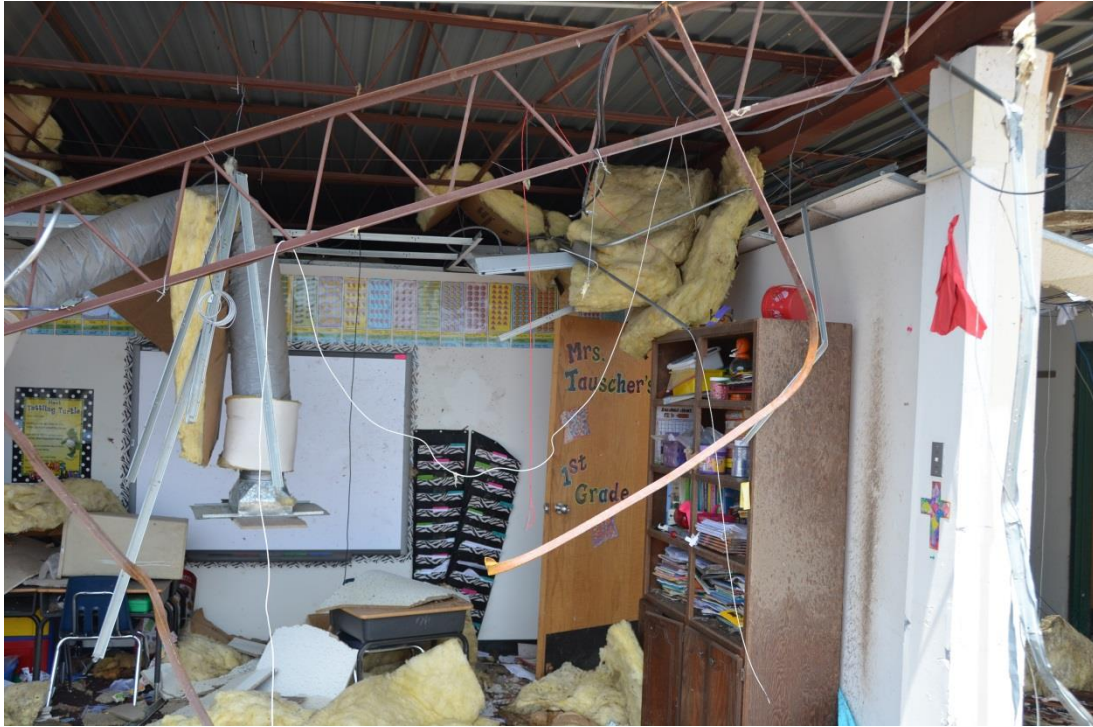
Figure 4-8. Damaged interior of a classroom in the original main classroom building.

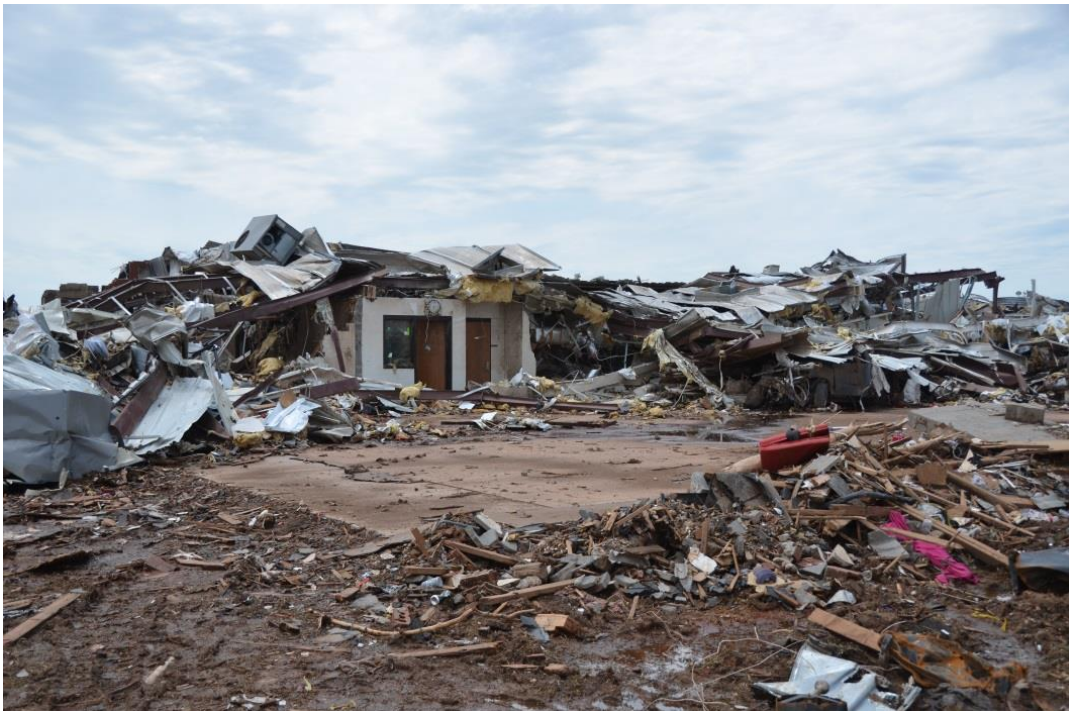
Figure 4-9. Collapsed Gymnasium building (Note the interior Gymnasium Office surrounded by a reinforced CMU wall remained standing).

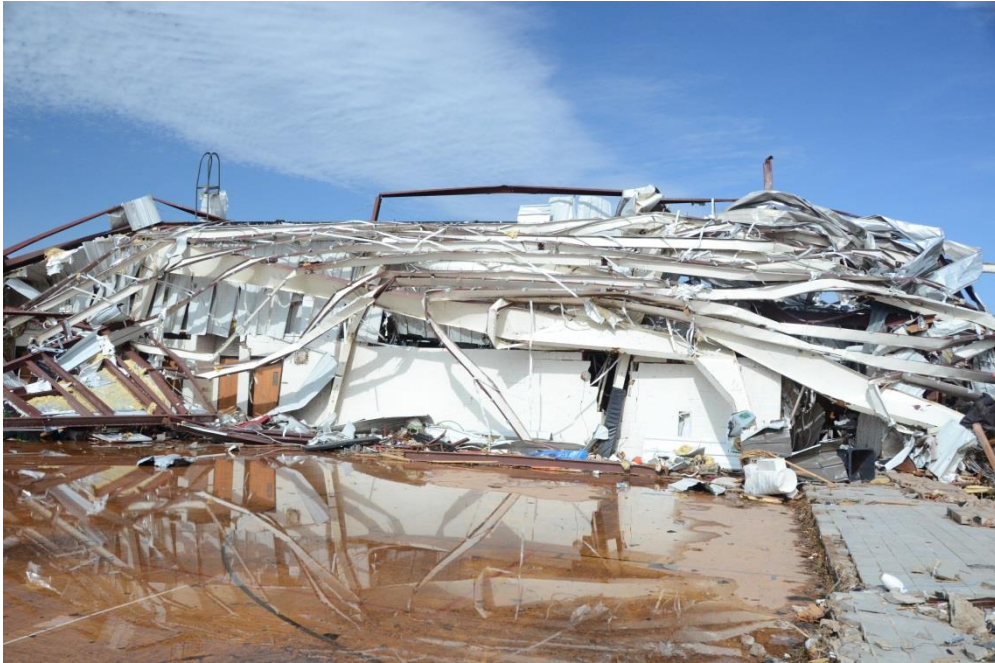
- **Multipurpose Building:** This pre-engineered rigid steel frame building sustained complete structural failure, with the collapse of all the steel frames and three of the four perimeter reinforced CMU walls (see Figure 4-14).

Figure 4-14. Collapsed Multipurpose Building of Briarwood Elementary School.

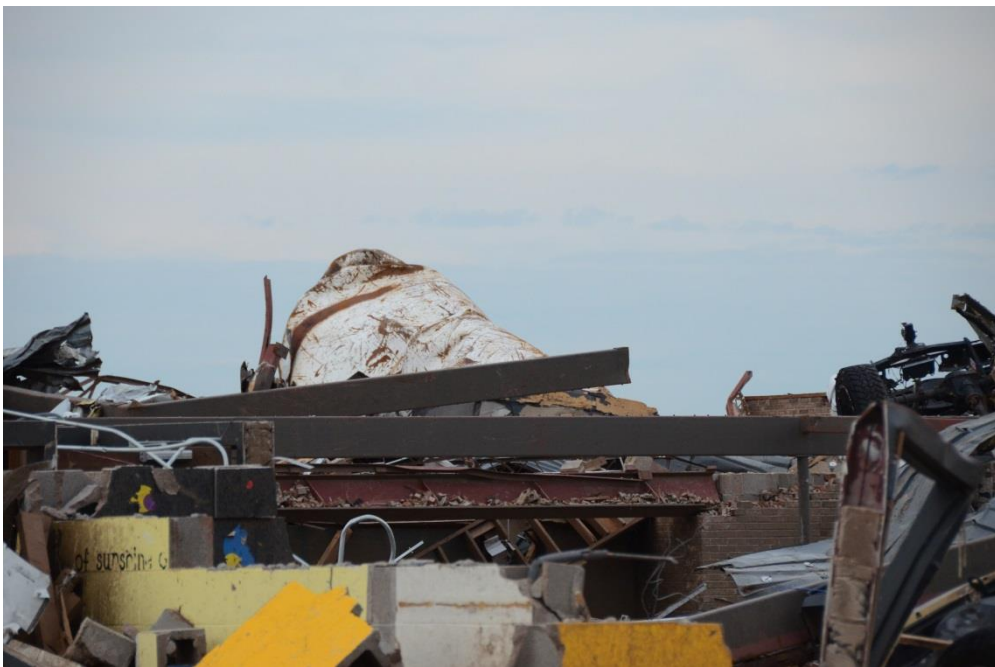
Figure 4-15. Building 300, with propane storage tank (white) that landed on top.

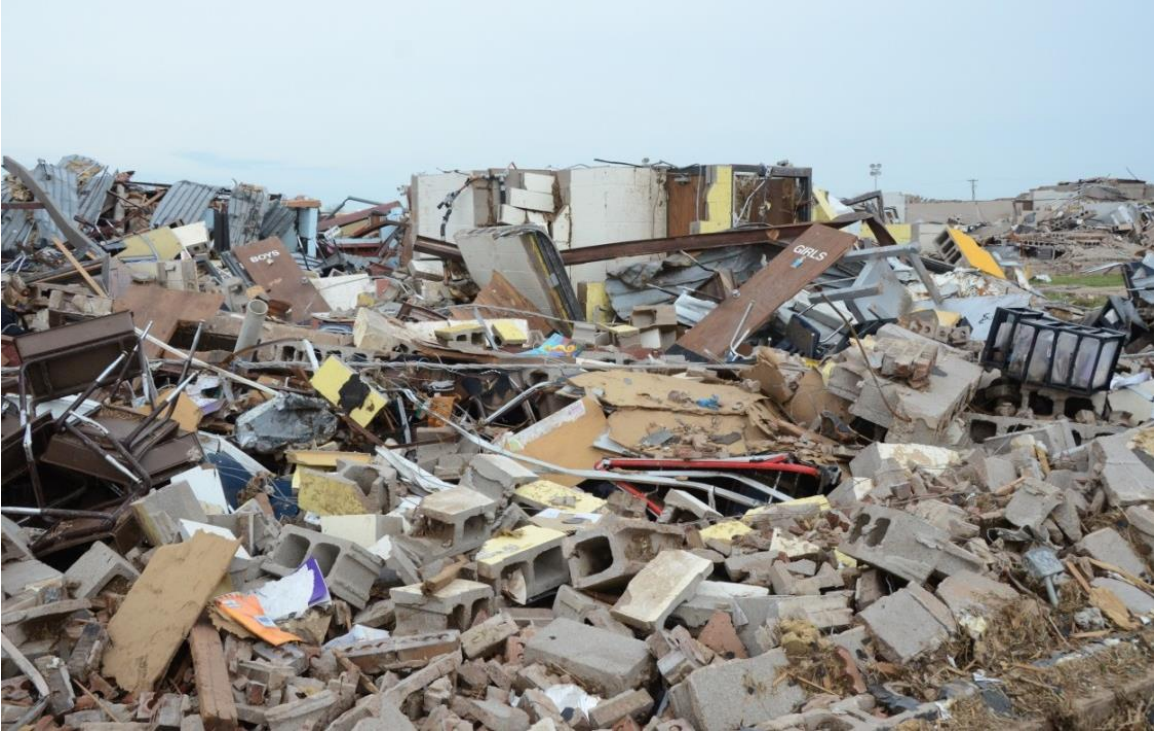
Figure 4-16. Building 200 (completely demolished, with only the boy's and girl's bathrooms remaining standing).

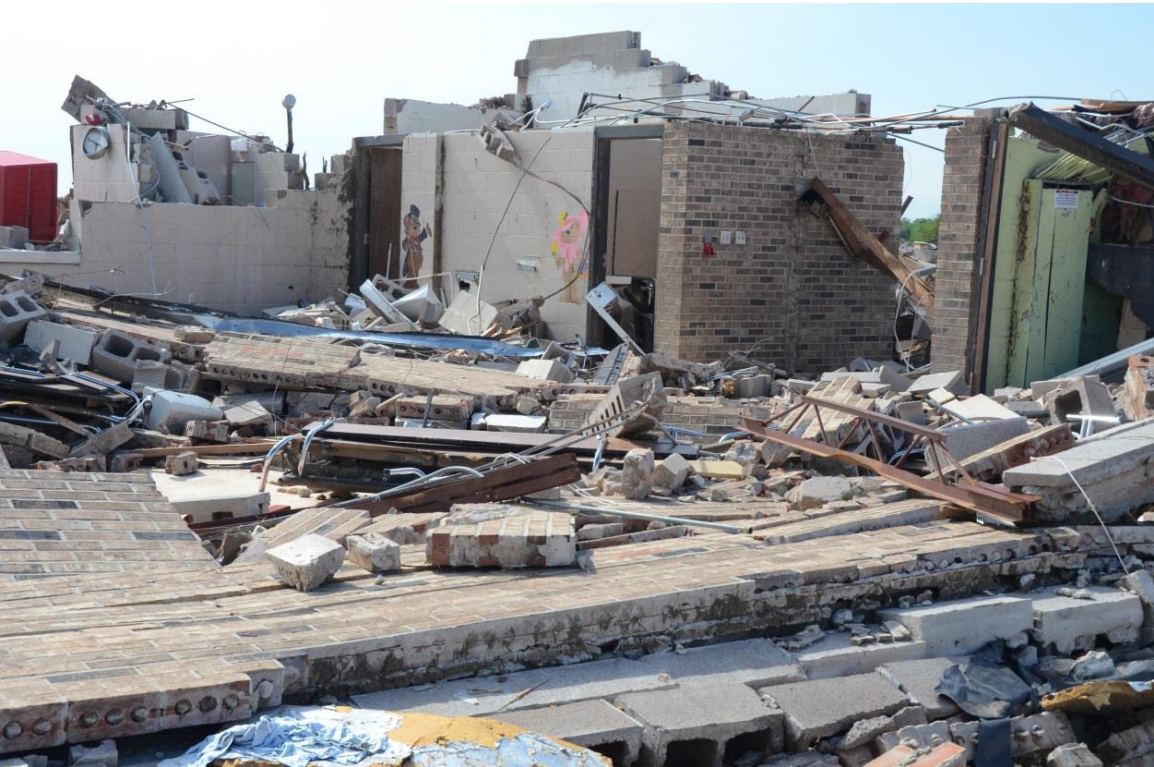
Figure 4-17. Cafeteria. Complete structural failure with only the interior bathroom remaining standing.

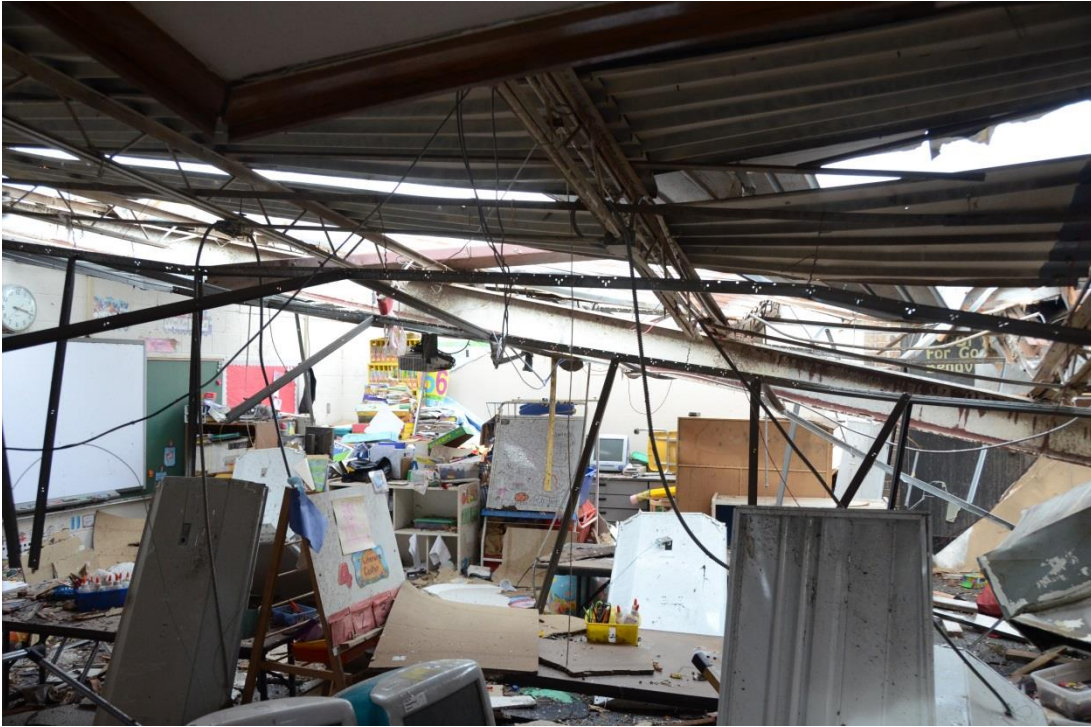
Figure 4-18. An interior view of a classroom in the 400 Building where portion of the building's metal roof system was lost.

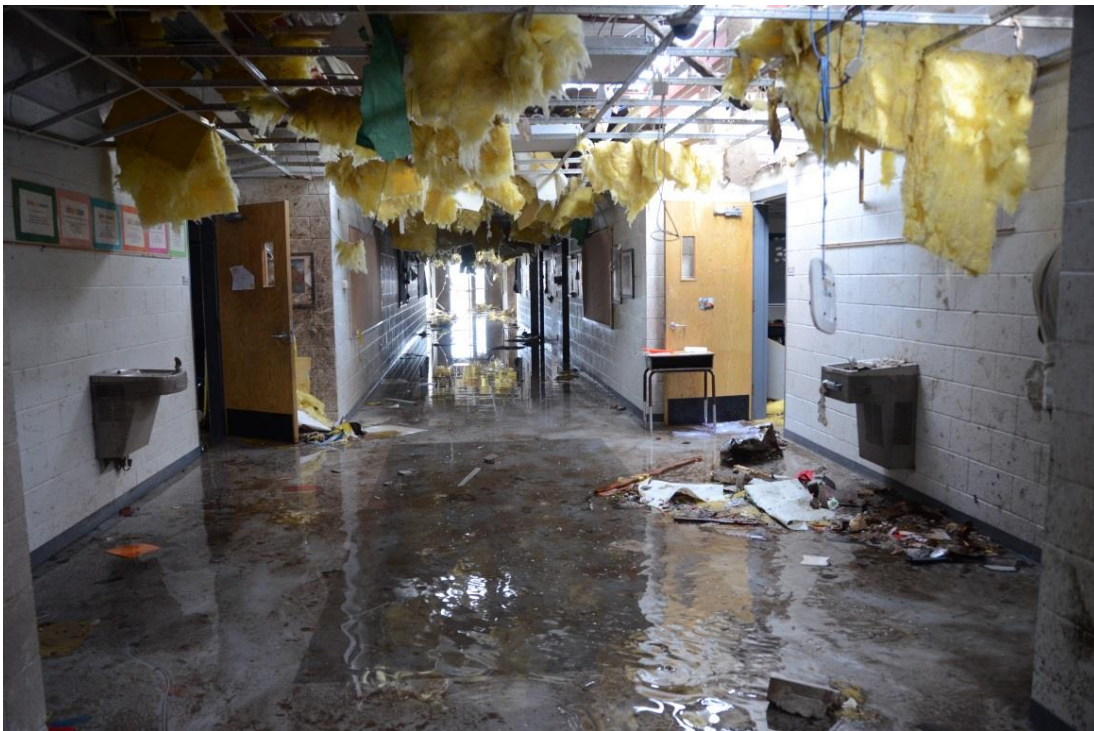
Figure 4-19. Hallway of Building 400 after the tornado (designated tornado safety area and initial location of Building 400 occupants before moving to the bathrooms just before the tornado struck)

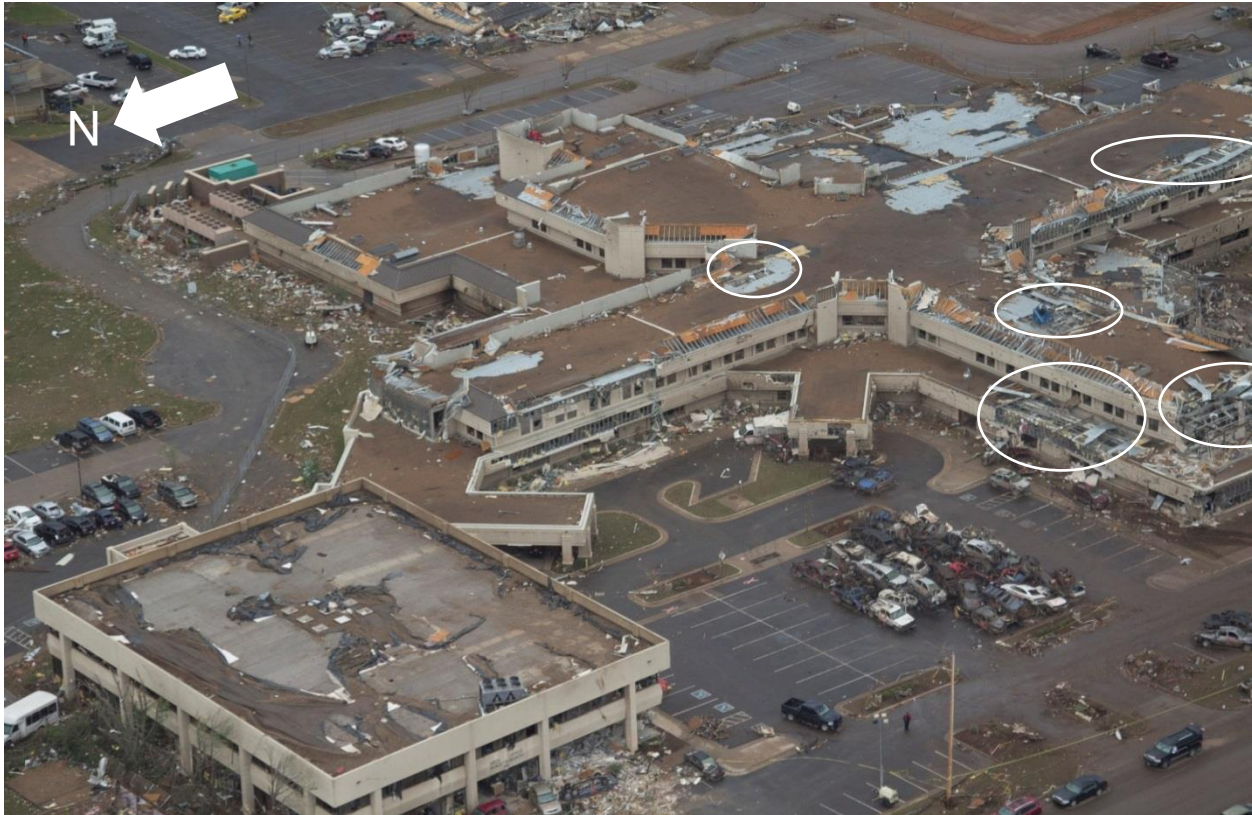
Figure 4-24. Aerial view of the heavily damaged Moore Medical Center (looking south-east). Circled locations indicate areas of roof deck damage.

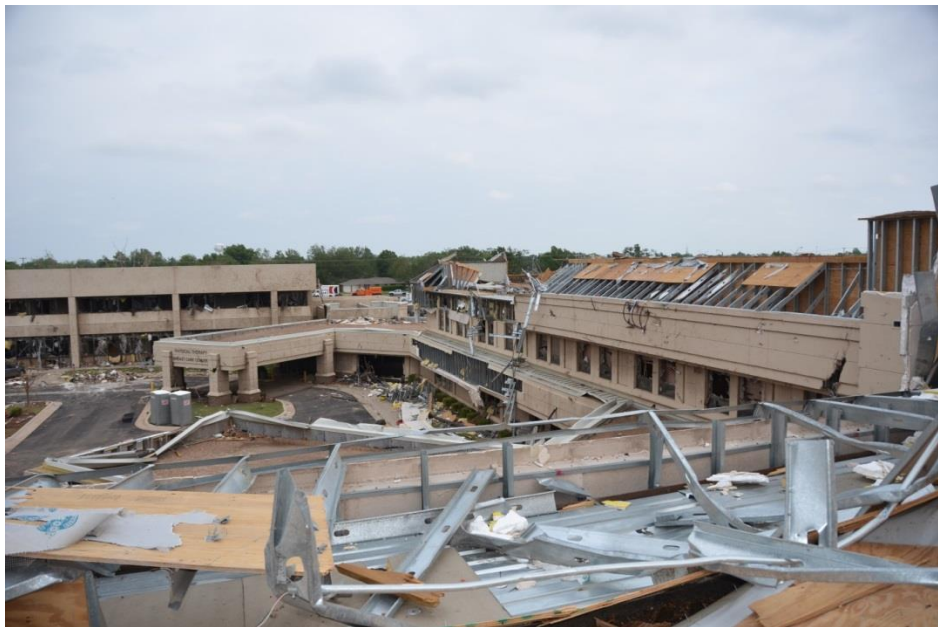
Figure 4-25. Damage to the building envelope and rooftop architectural elements of Moore Medical Center.

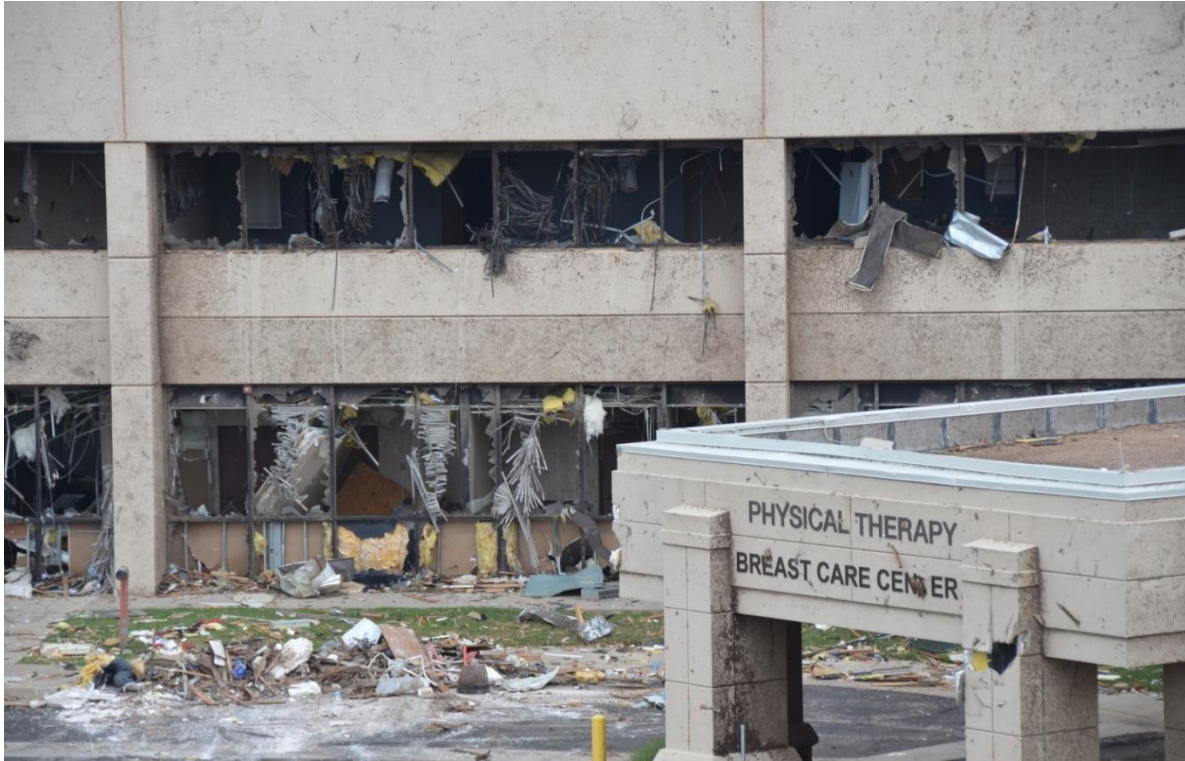
Figure 4-26. Damage to the envelope of Moore Medical Center (glazing).

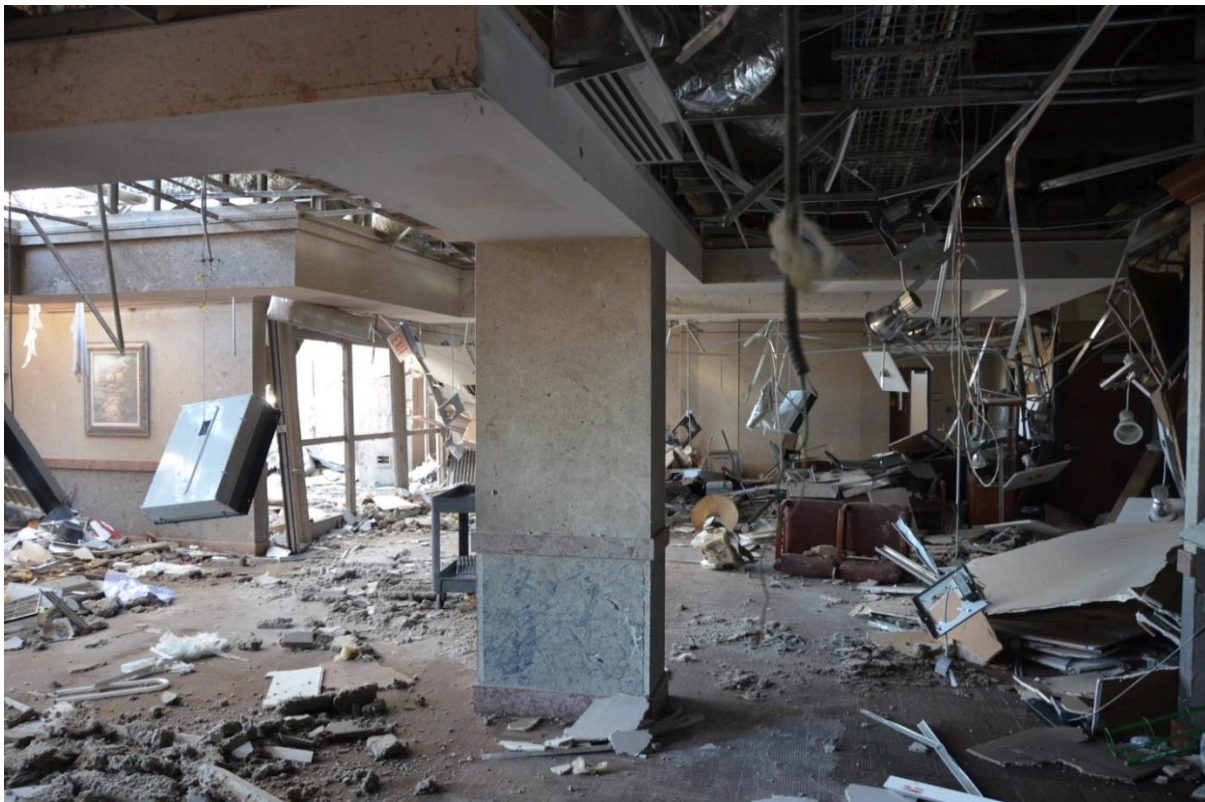
Figure 4-27. Damage to the interior of the Moore Medical Center due to wind and debris infiltration.

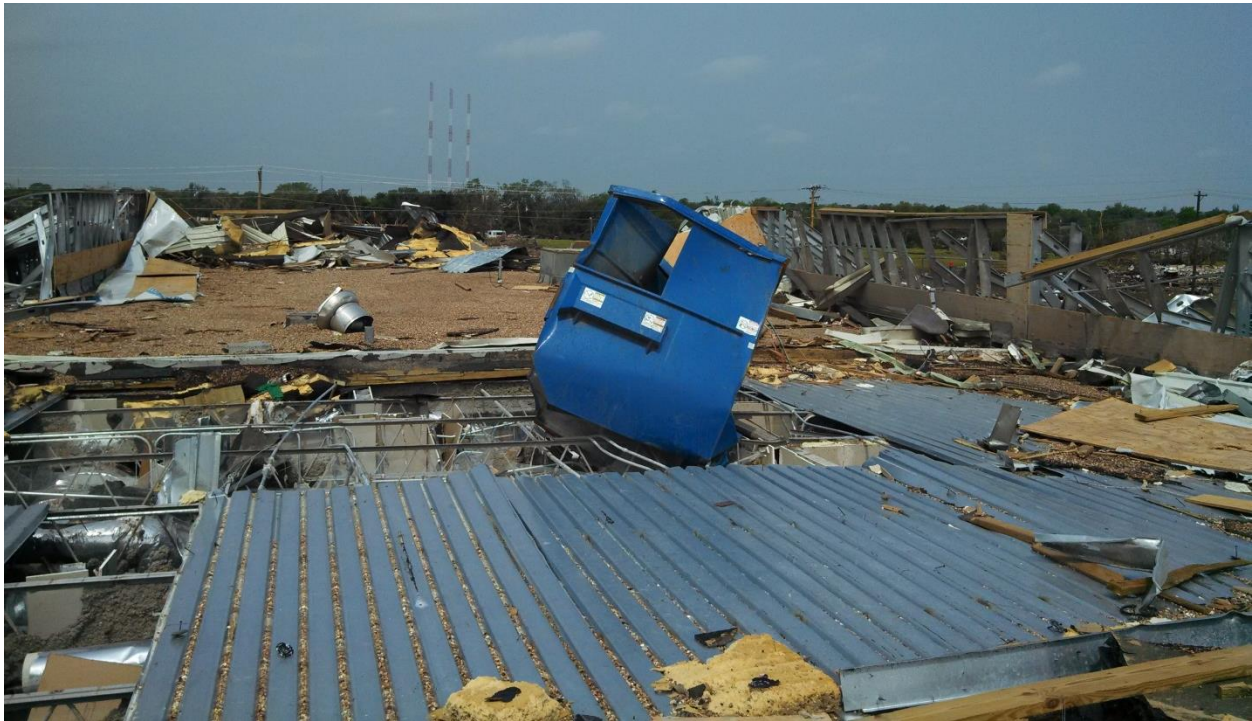
Figure 4-28. Impact damage to hospital roof bar joists from steel trash dumpster, and loss of steel roof decking.

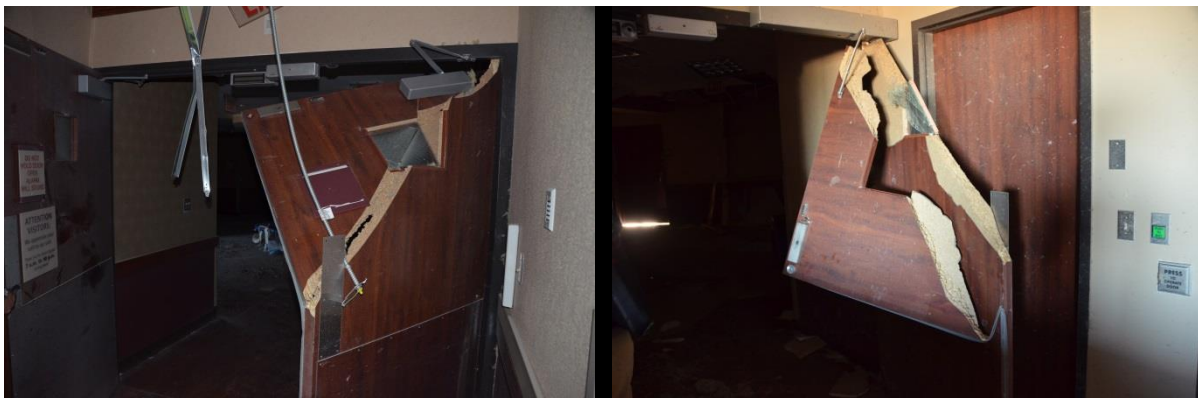
Figure 4-29. Examples of broken interior doors at the Moore Medical Center.
