PERFORMANCE OF ROOFING IN PUERTO RICO

20 April 1962

Organic Building Materials Section  
Building Research Division

Office of the Chief of Engineers  
Department of the Air Force  
Bureau of Yards and Docks

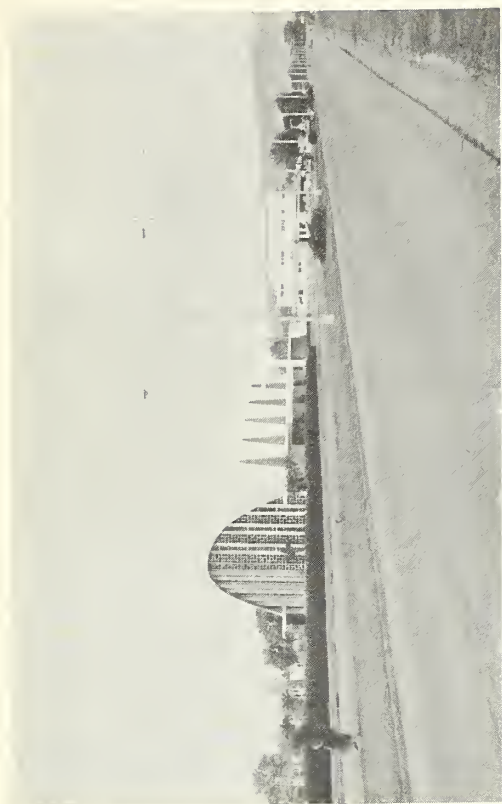
6

The performance of an elastomeric type of coating identified as "Hypalon" (a chlorosulfonated polyethylene roofing solution) was observed on the parabolic roof of the Santa Maria Reina Cathedral in Ponce, P.R., shown in Figure 6. The roof consisted of a 3-inch reinforced concrete shell supported by a series of 54-foot span catenary arches and had an area of about 240 squares. It was reported that two coats of "Hypalon" were applied by conventional pressure pot-spray equipment in January 1957. Our observations indicated the material had weathered quite well and no obvious defects were observed after 5 years exposure. A general view showed a somewhat mottled appearance indicating either unequal coverage or unequal weathering. It was felt that an additional application of the material should be applied in the near future.

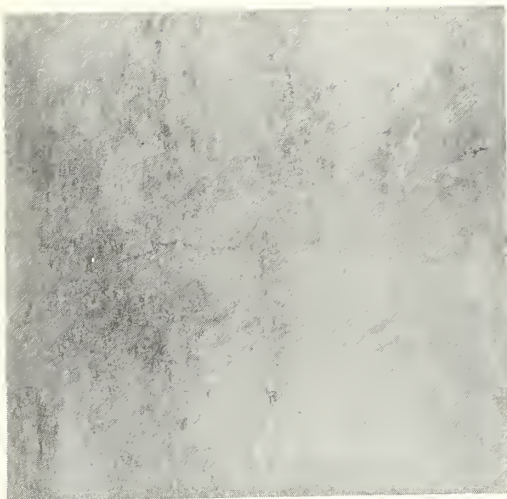
8

Protective coatings of various types were observed on many of the exposed slabs. These materials were, in many cases, employed for aesthetic reasons, but were primarily used to reduce temperatures by reflecting solar energy and, therefore, were pigmented white, aluminum, or other pastel shades. The use of these coatings apparently had little effect on the waterproofness of the slab. However, it was obvious that the light-colored coatings exerted a dominate influence on the temperatures attained by the slab. There is a tendency to think of unpainted concrete slabs as white in color, but this is not true in Puerto Rico where exposed slabs are quite dark due to biological growths, as illustrated in Figure 8.

- (5) In the warm, humid climate of Puerto Rico, concrete slabs become quite dark due to biological growths on the surface and, therefore, reflective coatings should be employed to reduce thermal movements in the slab.

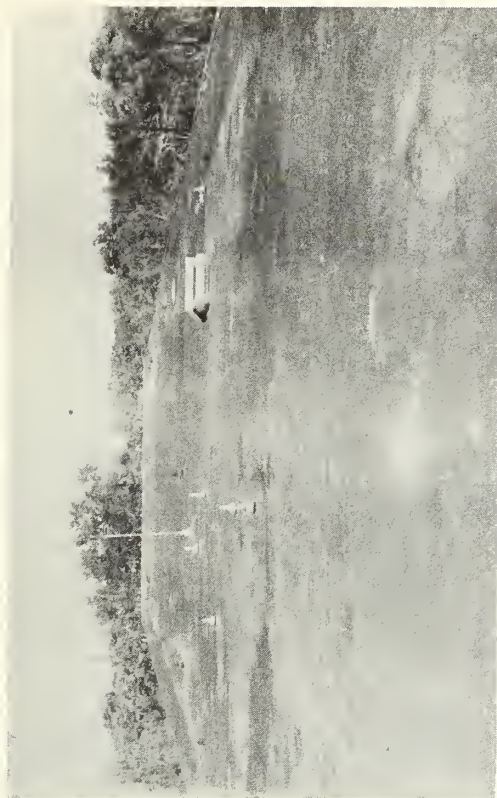
10

The exposed slab of one relatively large structure (EM Barracks, NCS, Sabana Seca, P.R.), illustrated in Figure 10, was relatively free of cracking and the occupants reported it to be watertight. This two-story structure was of reinforced concrete construction and was built in 1952. The roof slab had a broom finish. A biological growth, common to the exposed roofs in Puerto Rico, contributed to the dark roof surface, as shown in the photograph.

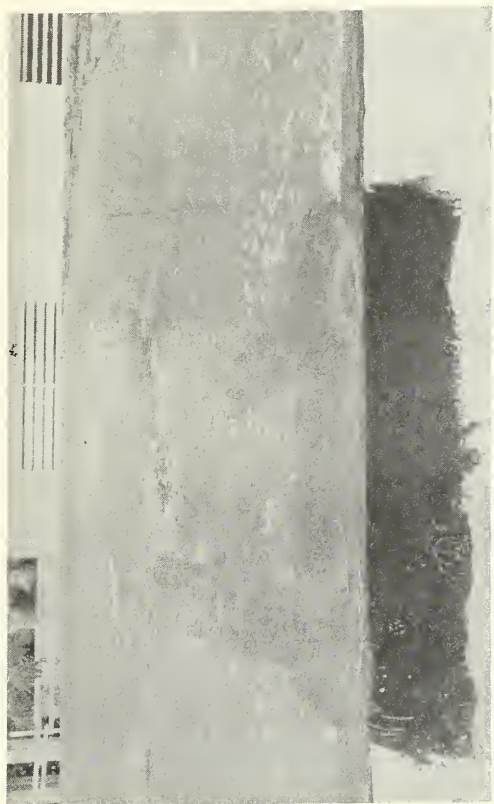
14

The repair method consisted of applying a mastic (bituminous emulsion, asphalt plastic cement, or proprietary materials of similar viscosity) over the crack and extending 4 to 6 inches on both sides of the crack. A reinforcing strip (generally woven glass fabric or glass mat) was embedded in the mastic and coated with a similar material. A typical roof employing such a system is illustrated in Figure 14.

This method of crack repair has proven the most successful of the many methods tried. However, it has many limitations. Our observations indicated that movements in the deck at the crack due to expansion and contraction sometimes resulted in a break in the system over the crack. In addition, poor adhesion between the fabric and the deck was observed, indicating poor preparation of the surface.
