NIST Special Publication 862

1994 Northridge Earthquake Performance of Structures, Lifelines, and Fire Protection Systems

*Diana Todd, Nicholas Carino, Riley M. Chung, H. S. Lew, Andrew W. Taylor,
William D. Walton, James D. Cooper, and Roland Nimis*

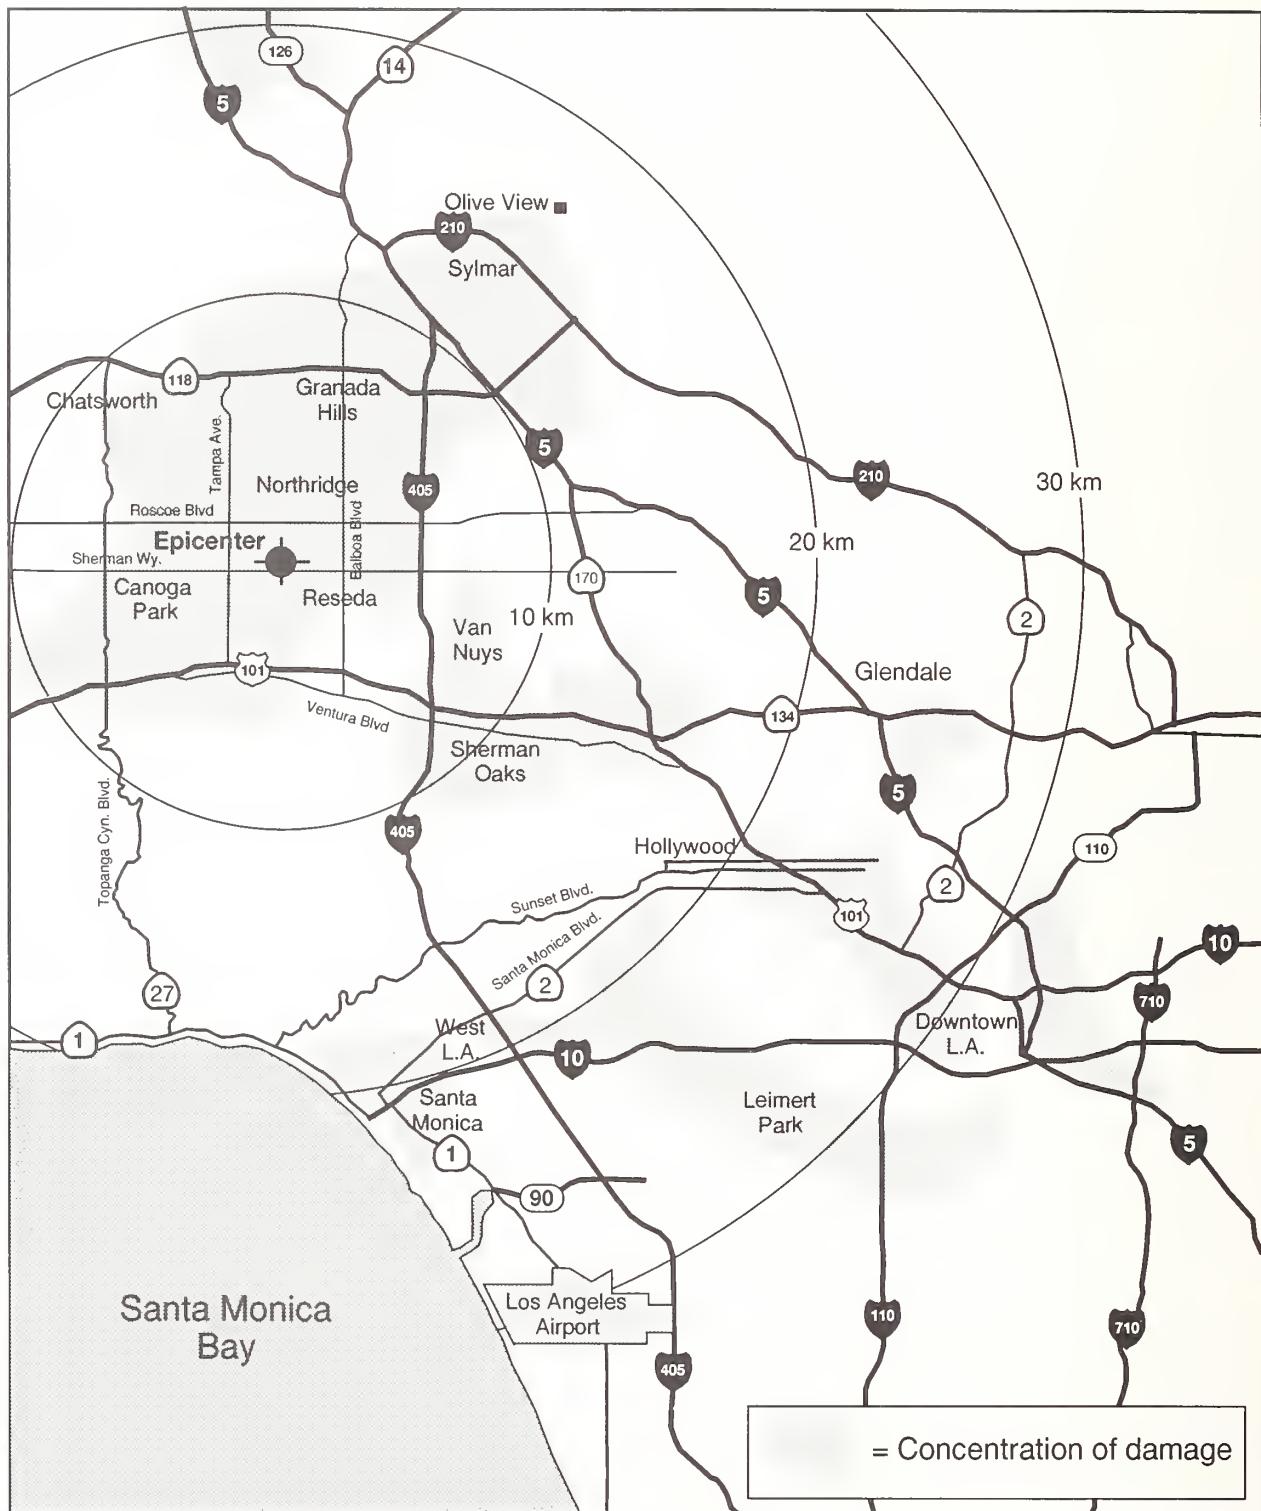
Figure 3.1. Serious damage to buildings caused by the magnitude 6.8 Northridge earthquake was widespread, but, outside of the epicentral area, seriously damaged buildings tended to occur in pockets.

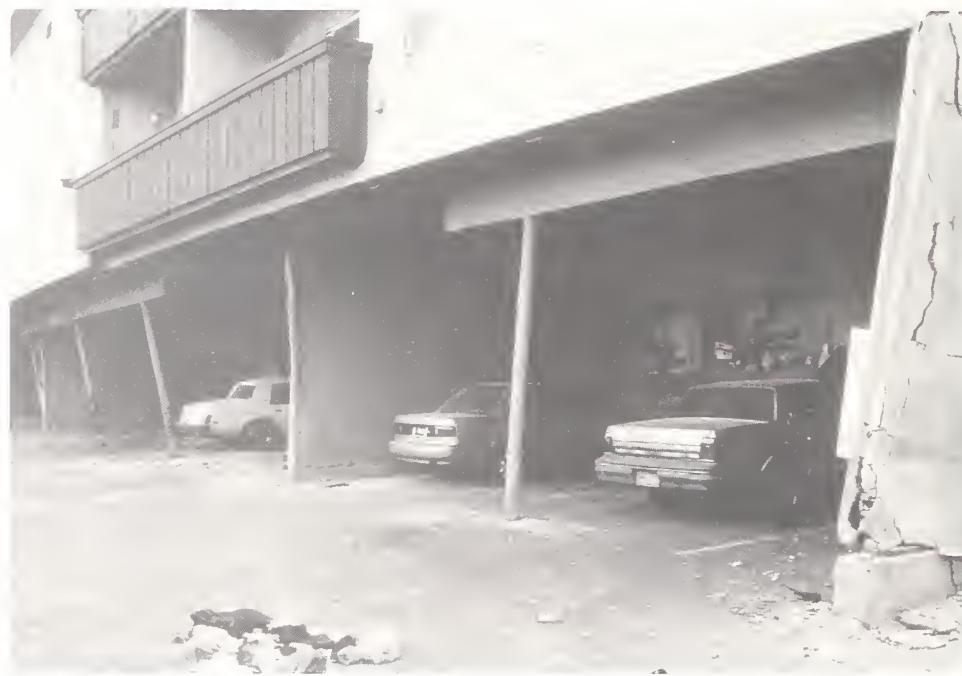
Figure 3.7. Racking, or leaning, of open first story parking areas was a common feature of damaged two and three-story apartment buildings.

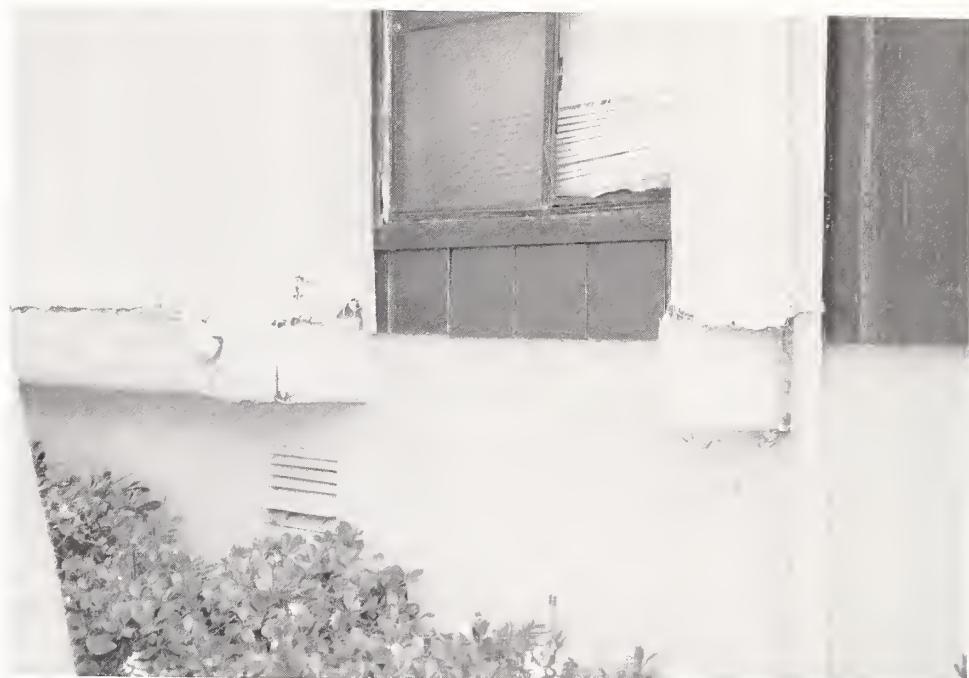
Figure 3.8. Horizontal cracks at the interface of the foundation wall (usually concrete) and the first story (typically wood-framed with stucco facade) were often seen in damaged low-rise apartment buildings.

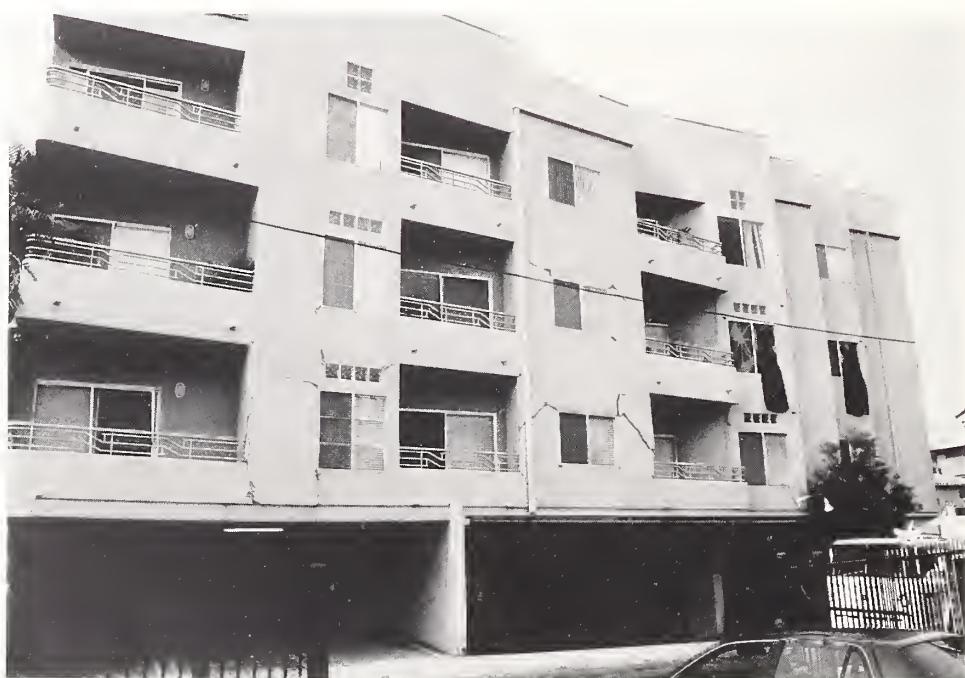
Figure 3.9. Typical damage in to low-rise apartment buildings included diagonal cracks in the stucco facade at the corners of windows and other openings.

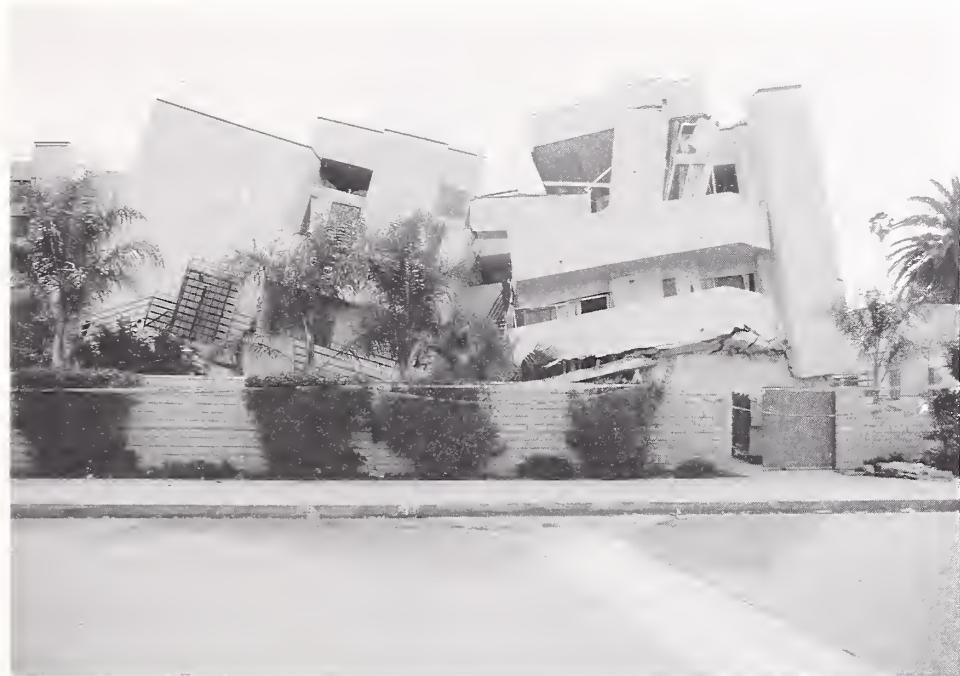
Figure 3.10. The central row of concrete first-story columns in a three story apartment building on Sherman Way in Van Nuys collapsed, causing the wood-framed upper stories to settle inward.

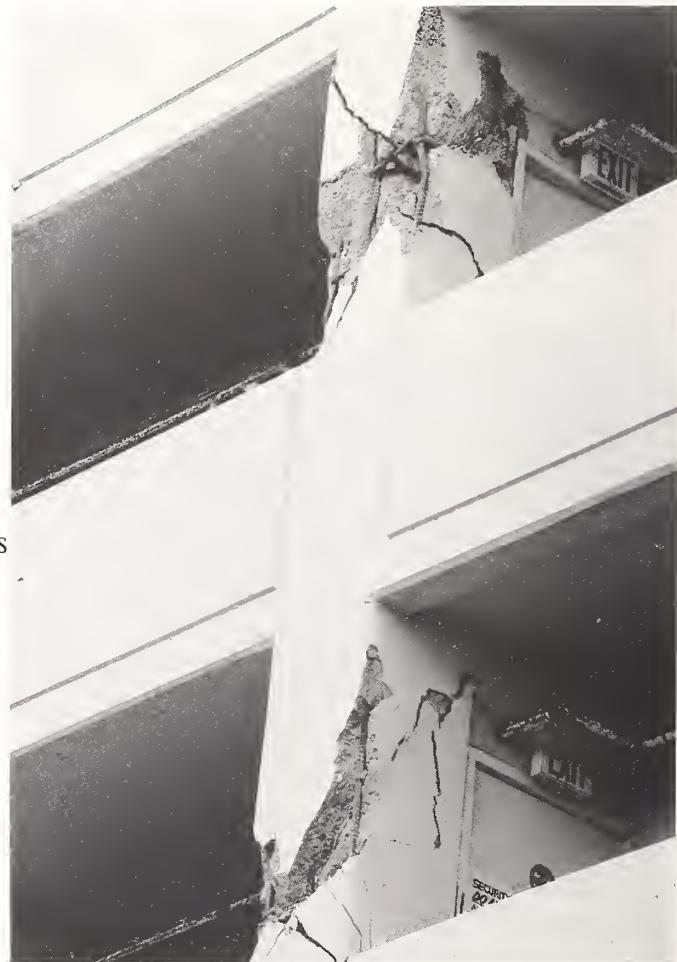
Figure 3.15. A closer view of the failed columns at the back of Champagne Towers shows minimal transverse reinforcement.

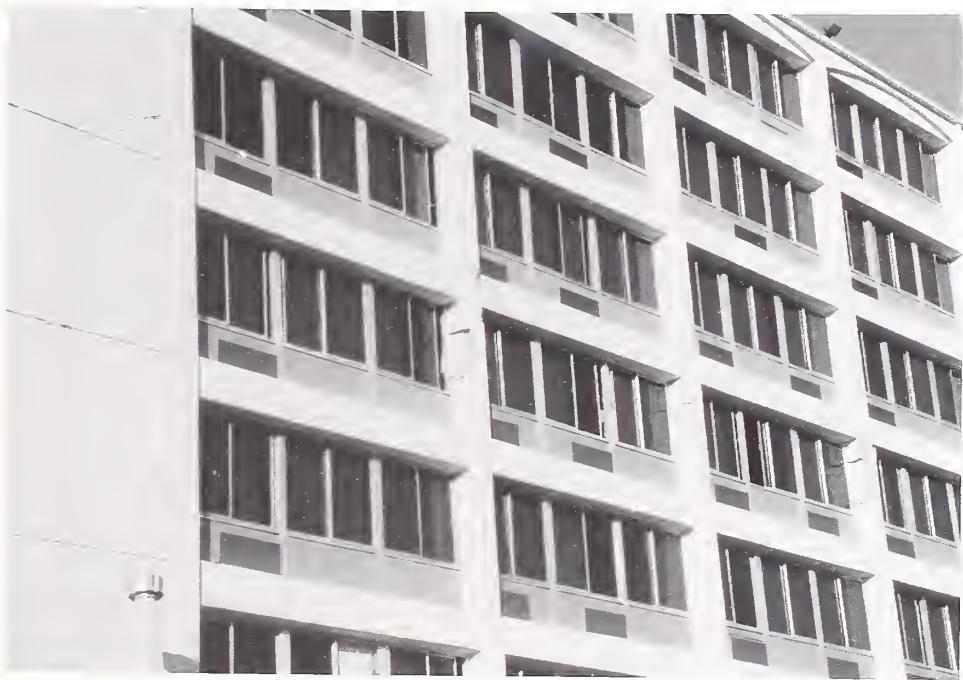
Figure 3.16. The bottom two stories of the concrete frame Holiday Inn in Van Nuys were damaged in the 1971 San Fernando quake and subsequently repaired. In the 1994 Northridge quake, damage was concentrated at the top of the fourth floor columns.

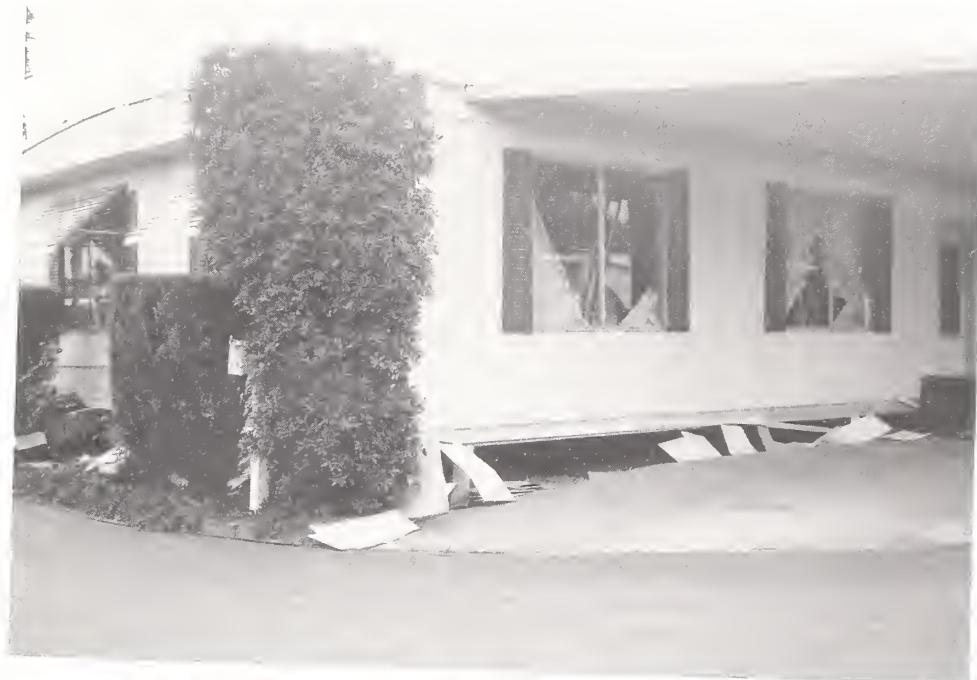
Figure 3.19.
Damage to
manufactured
homes caused by
collapsed supports
was common.

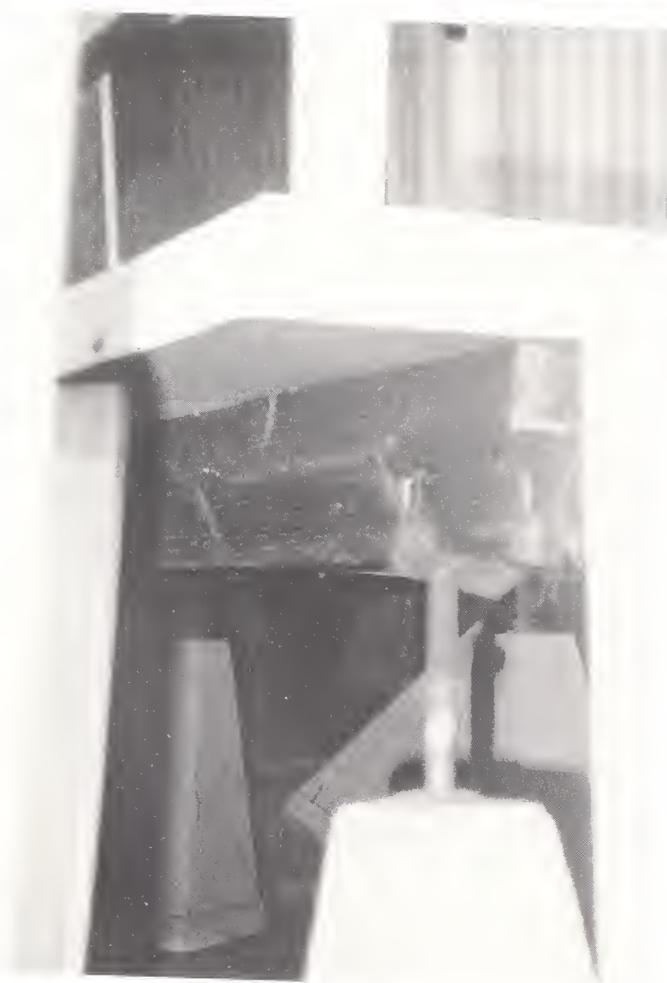
Figure 3.20. Small concrete base supports are a common foundation system used to support manufactured housing. This type of system provided little resistance to lateral forces.

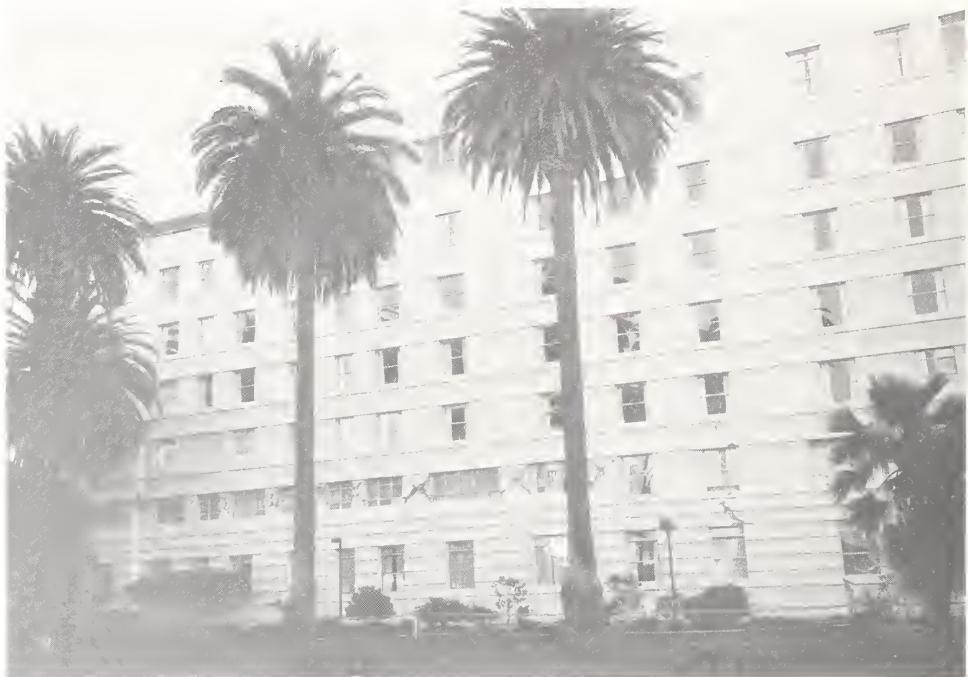
Figure 3.23. The seven-story northwest wing of St. John's hospital in Santa Monica experienced severe X-cracking in the piers between the second story windows.

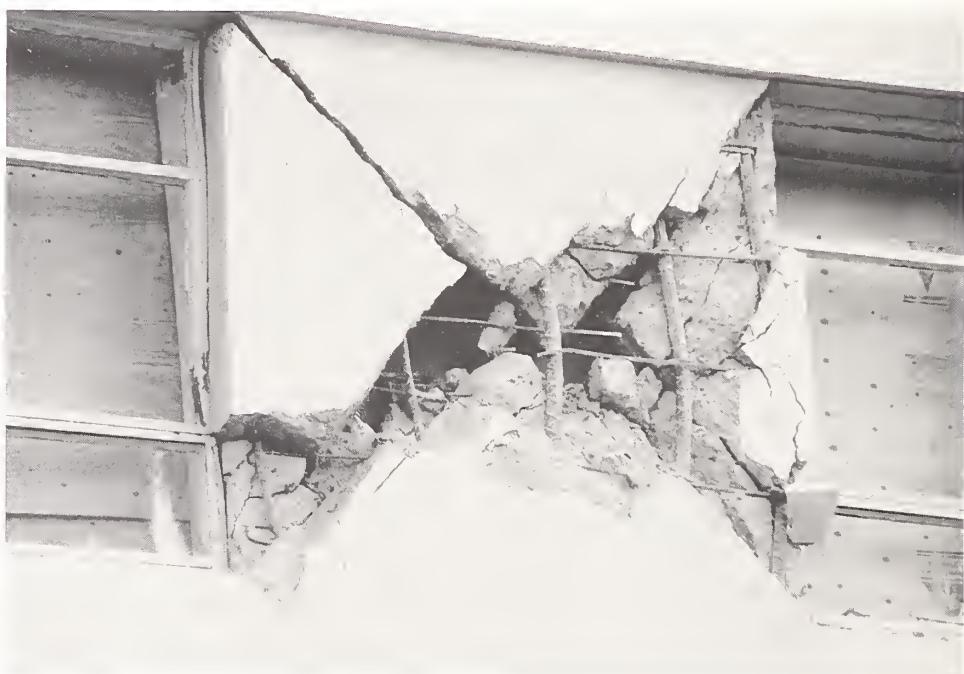
Figure 3.24. The transverse reinforcement in the St. John's hospital window piers was spaced at about 150-200 mm on center with 90° hooks at the ends, typical for construction of its age (about 50 years old).

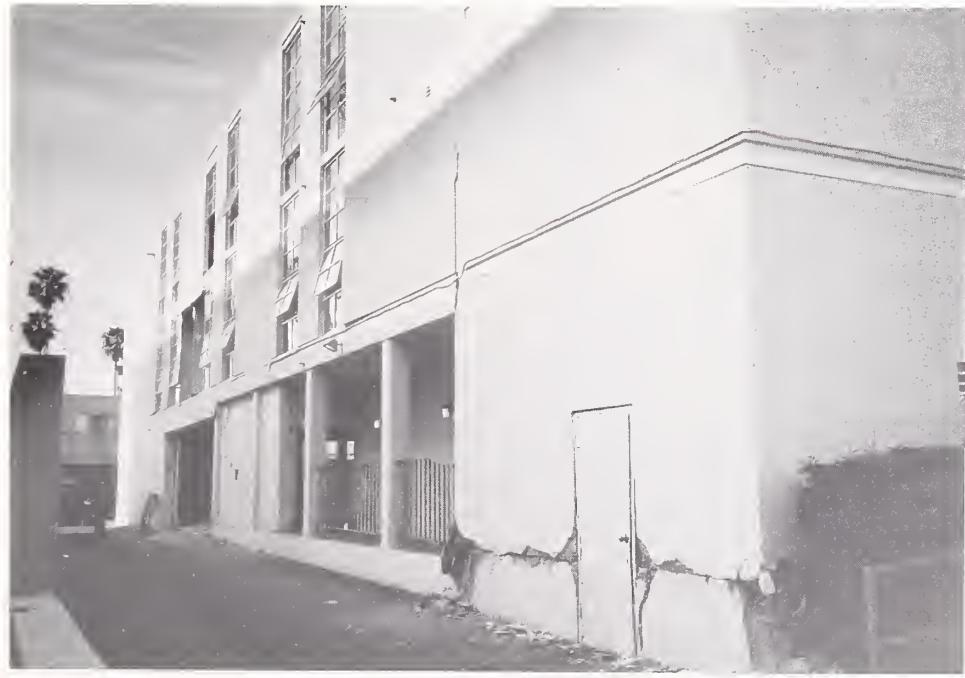
Figure 3.27. The facade of the five-story Berkley Convalescent Hospital directly adjacent to the St. John's Hospital complex consisted of two wythes of brick masonry with a reinforced and grouted space between. In some places, all three layers of this facade were destroyed along lines of diagonal cracking. The facility was evacuated.

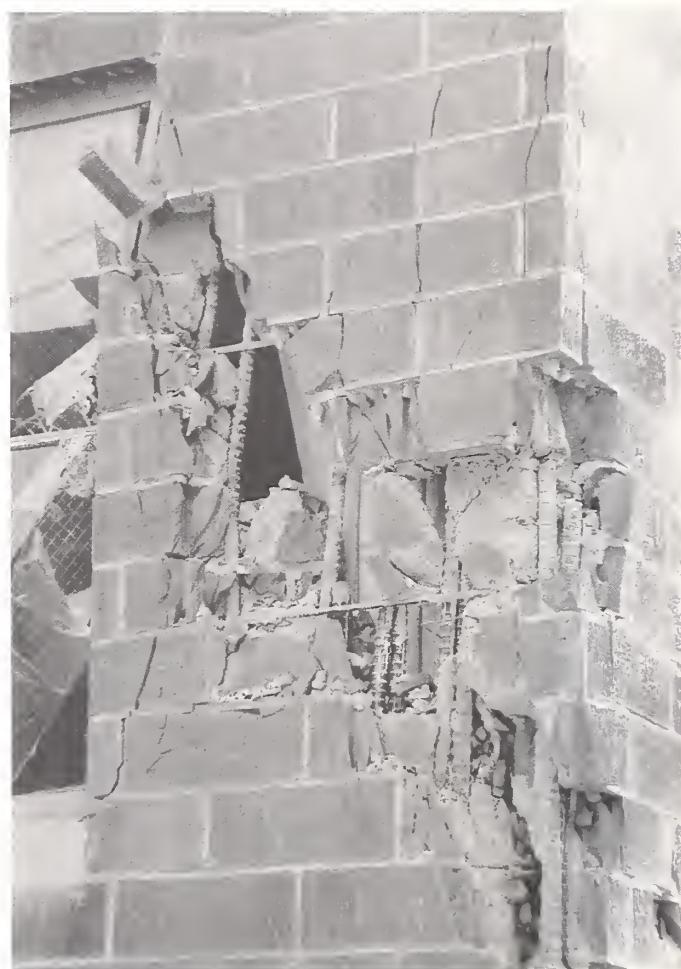
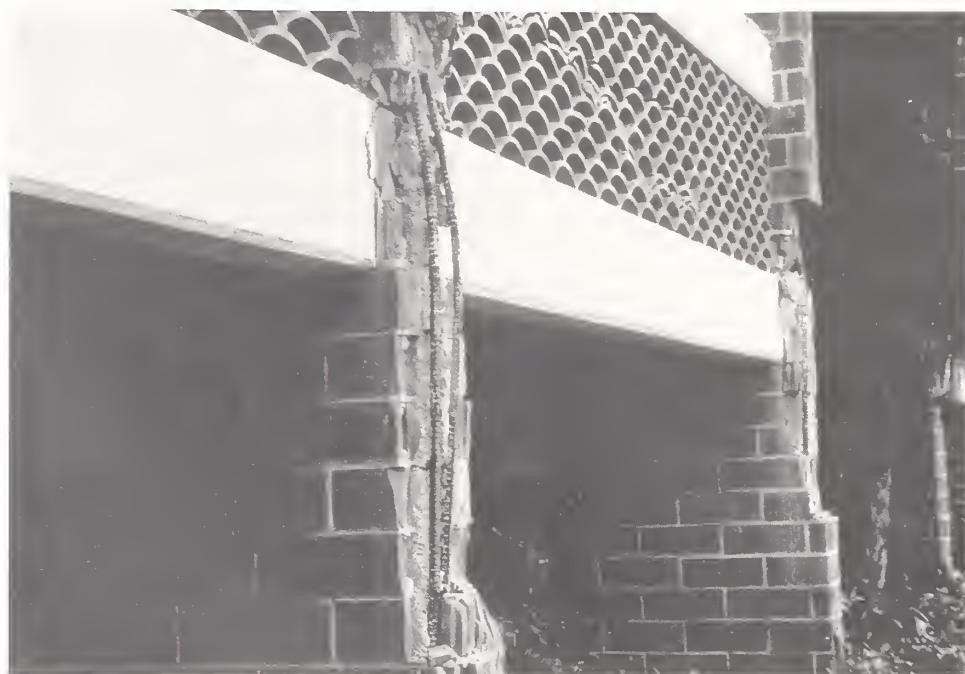
Figure 3.28. Two faces of the Berkley Convalescent Hospital had wing walls separating balconies. The ends of these wing walls spalled at the lower stories.

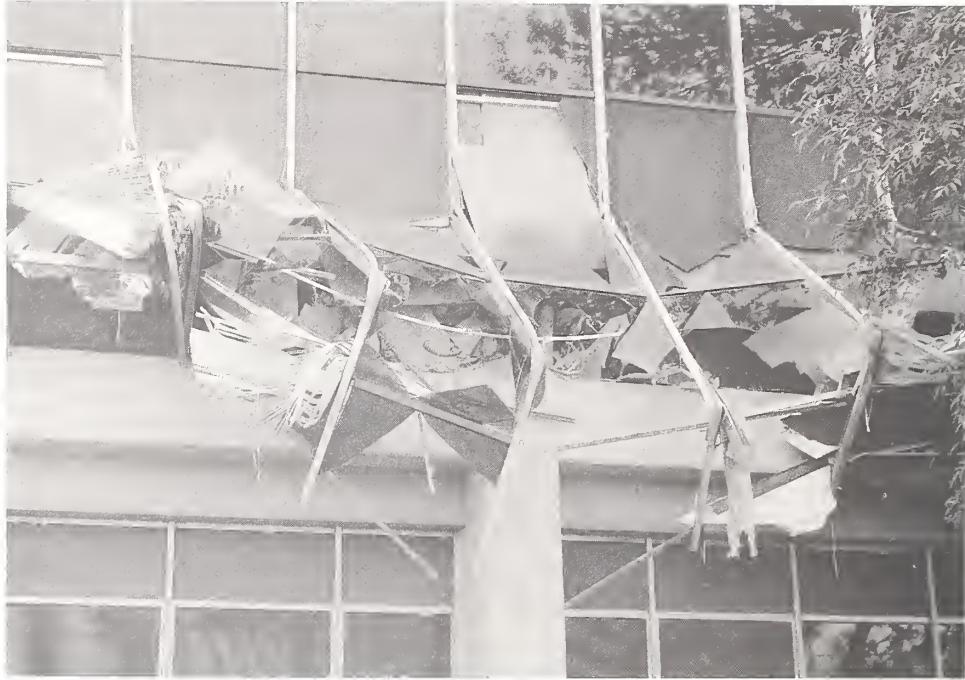
Figure 3.41. The second story of the concrete frame Kaiser Permanente office building on Balboa Avenue in Granada Hills completely collapsed. The first story was relatively undamaged, suggesting it was far stiffer than the story above.

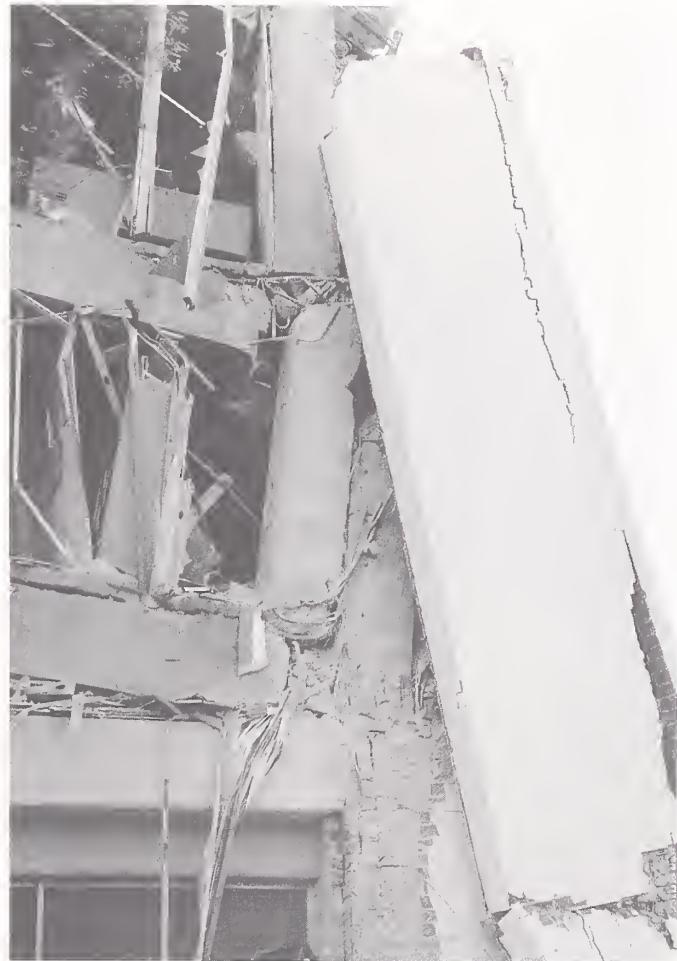
Figure 3.44. The exposed concrete frame of the Kaiser Permanente building, revealing deep beams, suggests that the building had a strong-beam, weak-column configuration. Except for the second story columns, the columns and beams remained intact while the joints disintegrated.

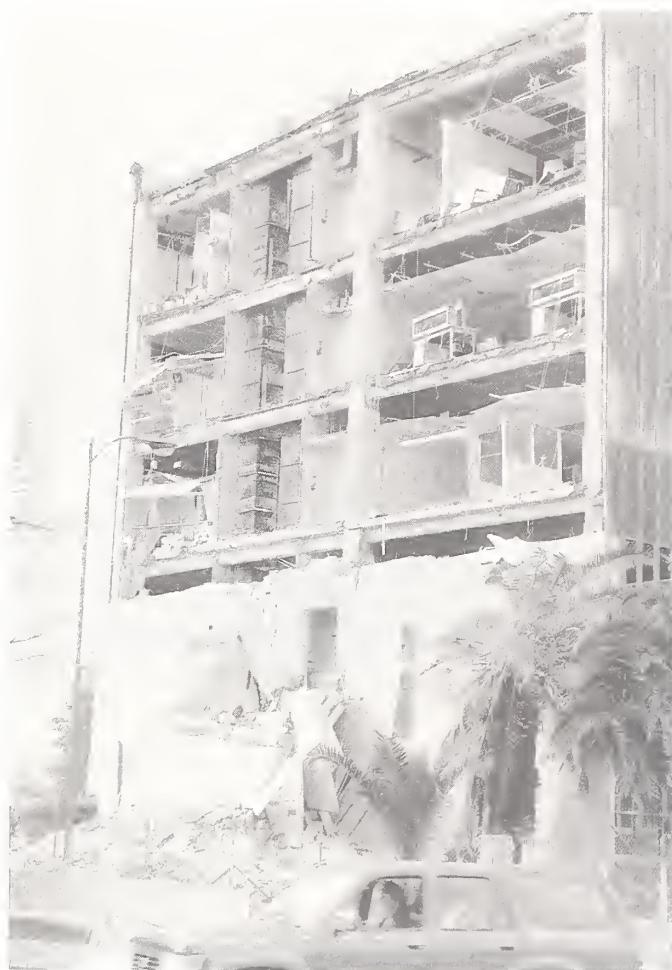
Figure 3.49. The east end wall and stair tower of a five-story apparently steel-framed office building on Sherman Way in Reseda collapsed. The enclosing masonry wall became detached from the structure and slid to the ground, with the upper stories remaining intact. The doorway opening in the wall, shown here resting at about the second story level, originally provided access from the top story to the stair tower.

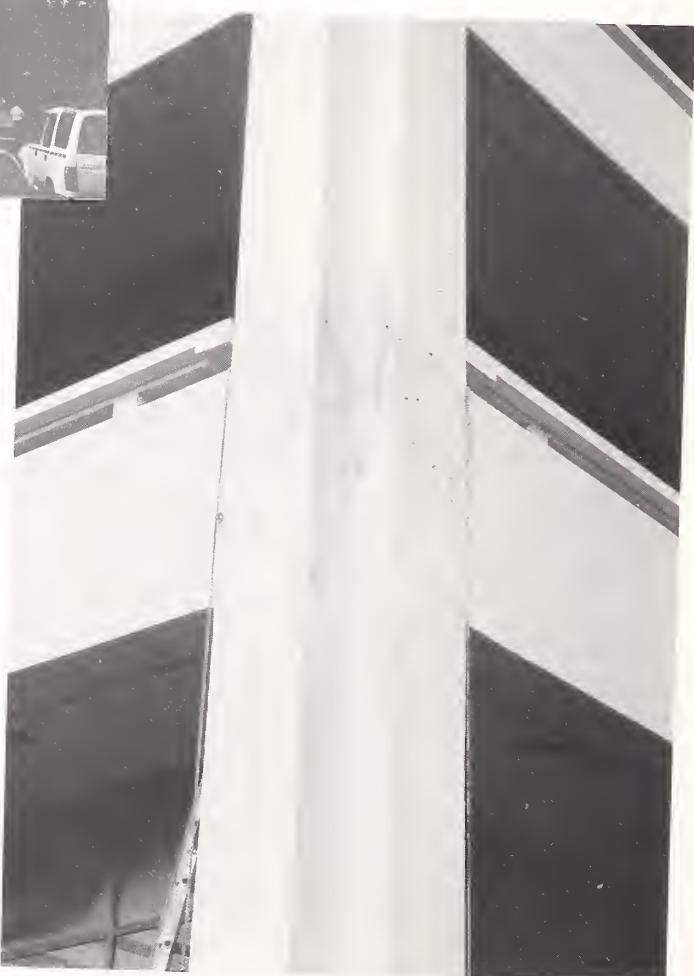
Figure 3.54. The cracked beam-column joints between the first and second stories of the Trans World Bank building were repaired using epoxy injection.

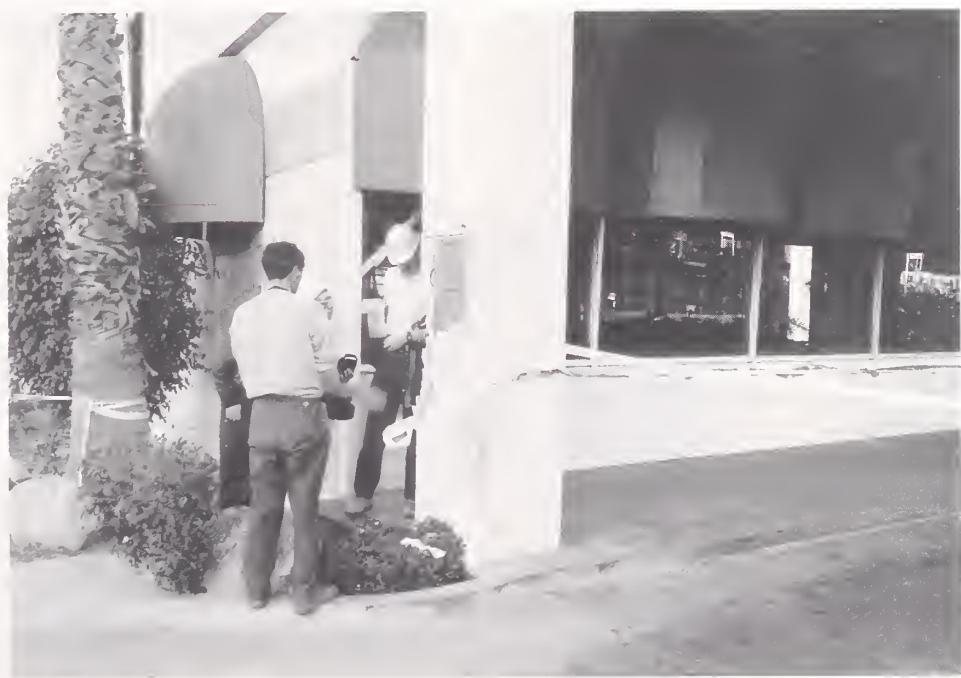
Figure 3.56. The columns supporting the three-story appendage at the front of the Radisson Hotel had serious shear cracks and related spalling.

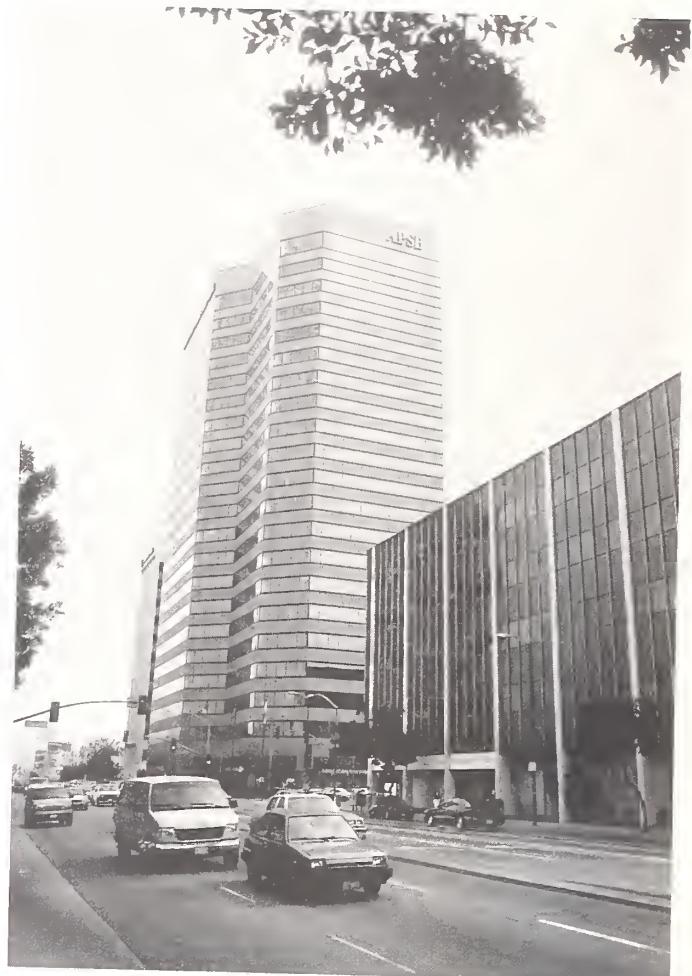
Figure 3.58. The reinforced masonry facade of this steel-framed building in Sherman Oaks was badly damaged.

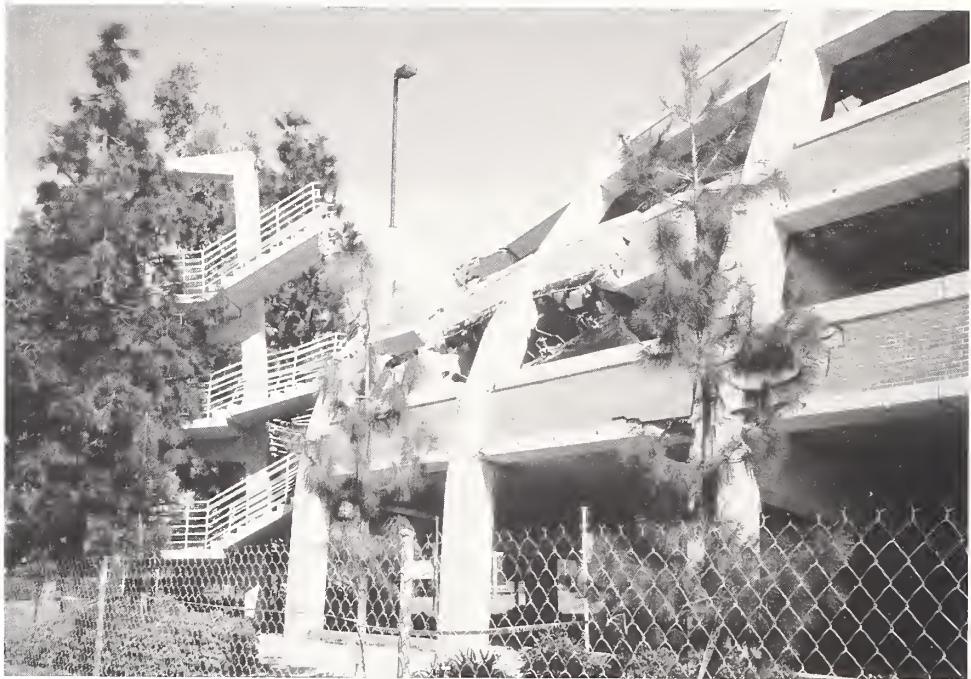
Figure 3.60. The three-year old four-level parking garage at the Northridge campus of California State University partially collapsed in the earthquake. The collapse apparently started at the interior, causing the exterior frame to be pulled in to the middle of the structure. Precast concrete "trees" were connected to form a moment-resisting frame at the exterior of the structure.

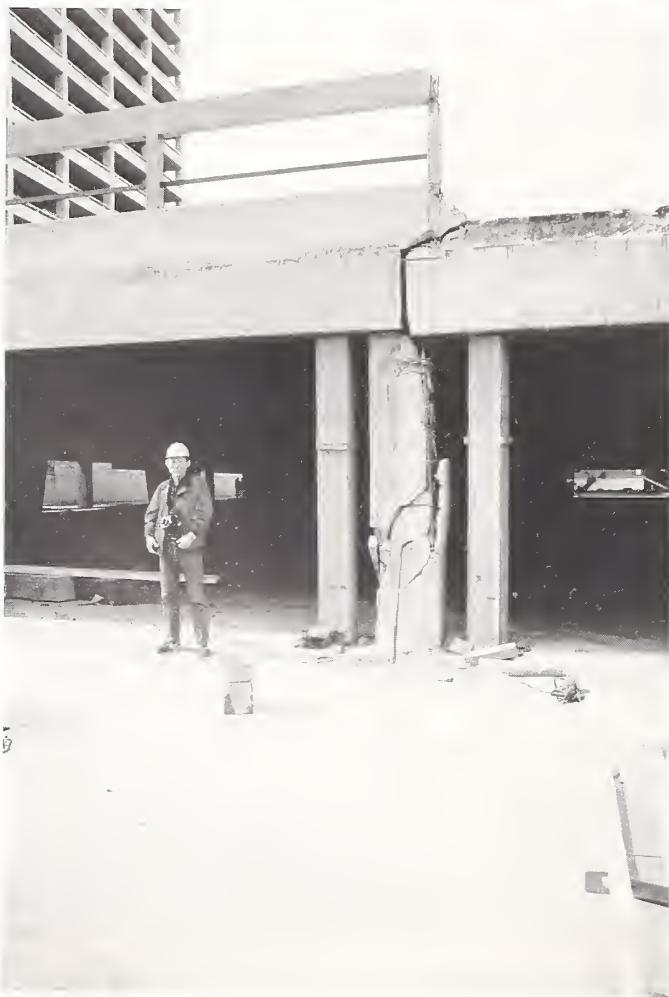
Figure 3.65. The exterior columns of the Trans World Bank parking garage, which had not been strengthened, were badly damaged.

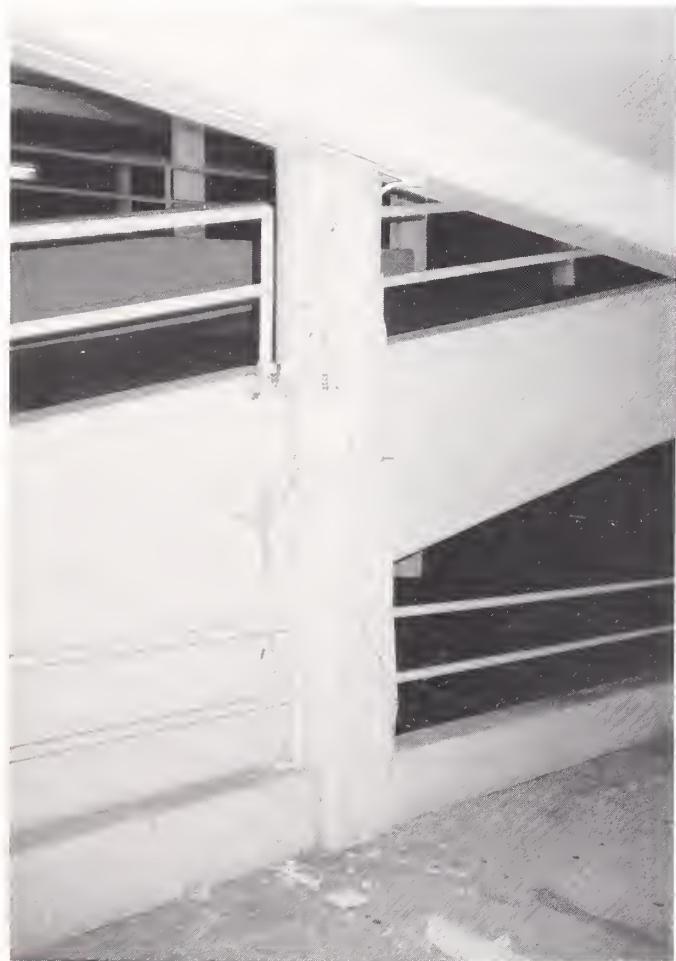
Figure 3.67. In parking garages, ramps can cause unintentionally shortened columns, which are vulnerable to damage, as shown here.

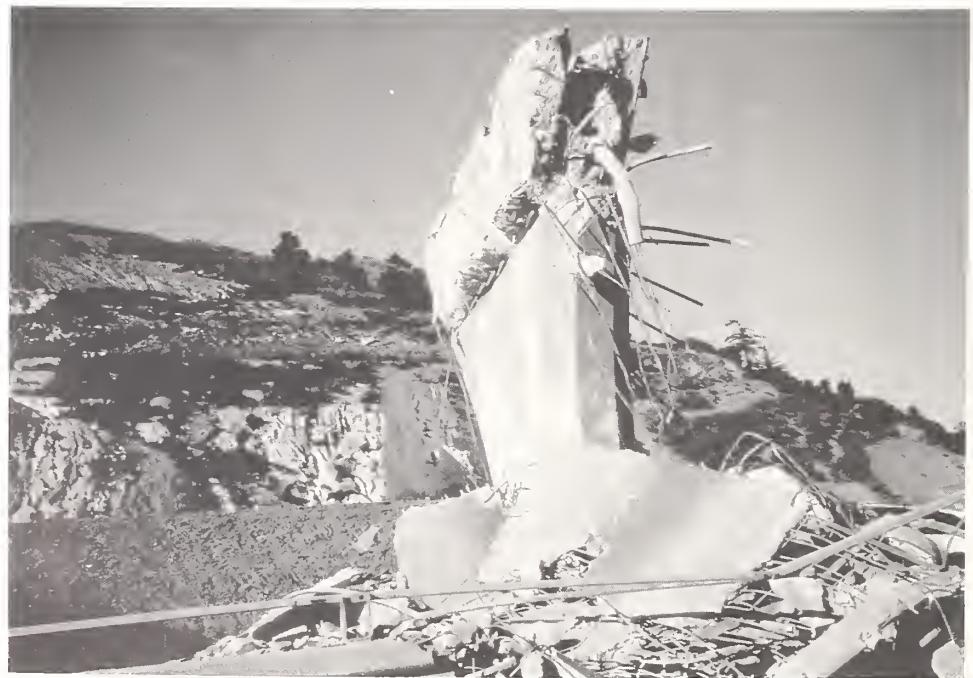
Figure 4.12. Damage at Pier 3 of the SR14/I5 Separation and Overhead, Ramp C, looking to the west (Photo courtesy of EERC).

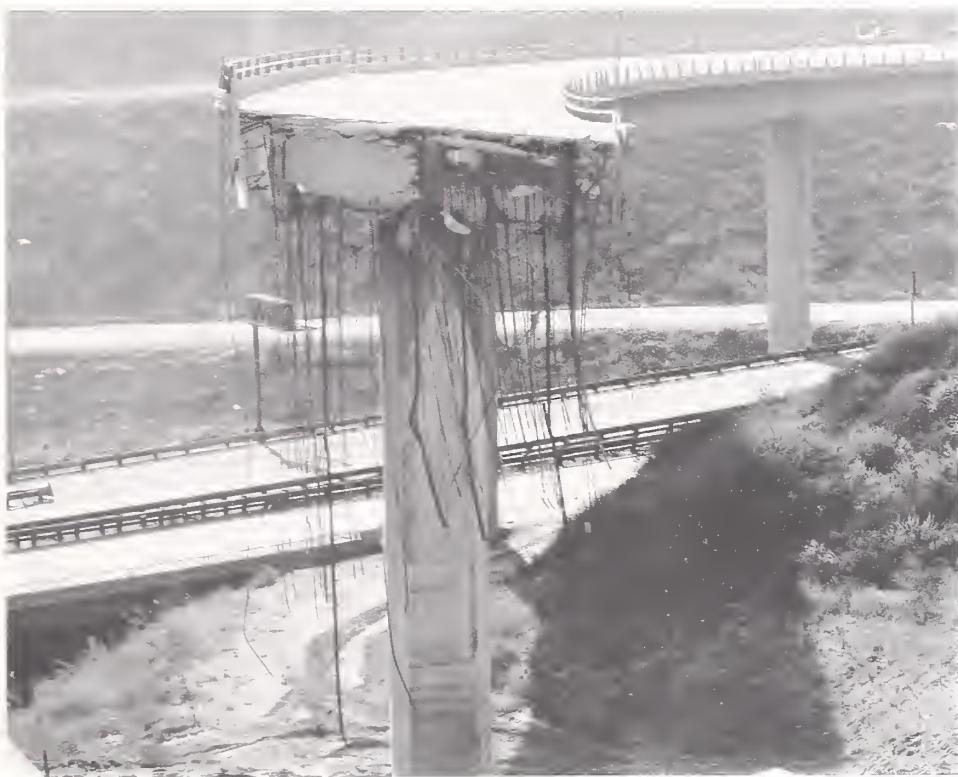
Figure 4.15. View of the flexural failure at Pier 3 of the SR14/I5 North Connector Overcrossing, looking to the south.

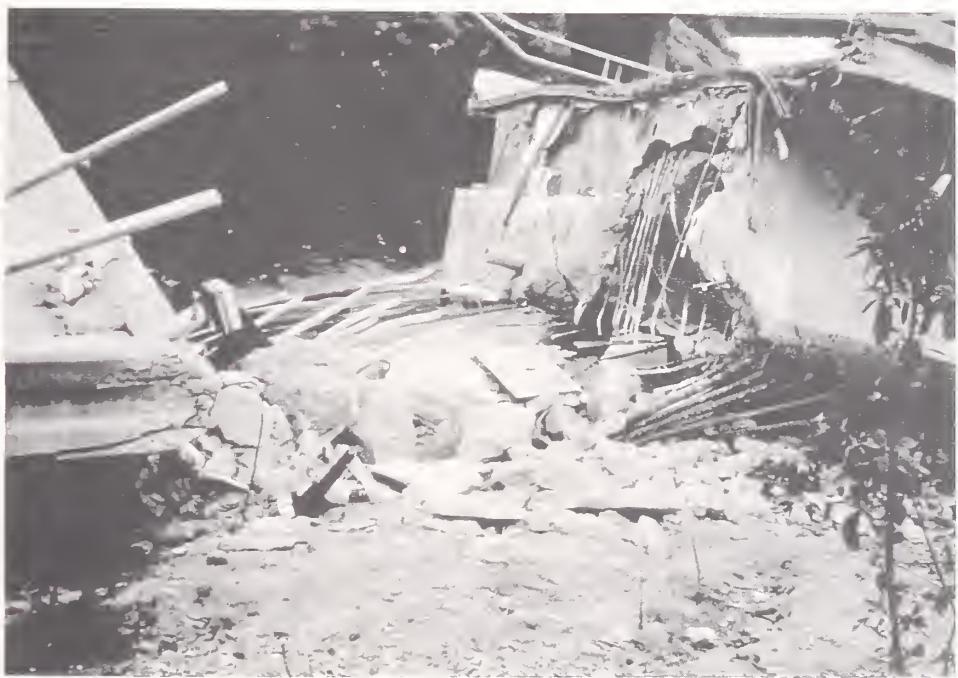
Figure 4.16. View of crushed Pier 2 and the hinge near Pier 2 (Photo courtesy EERC).

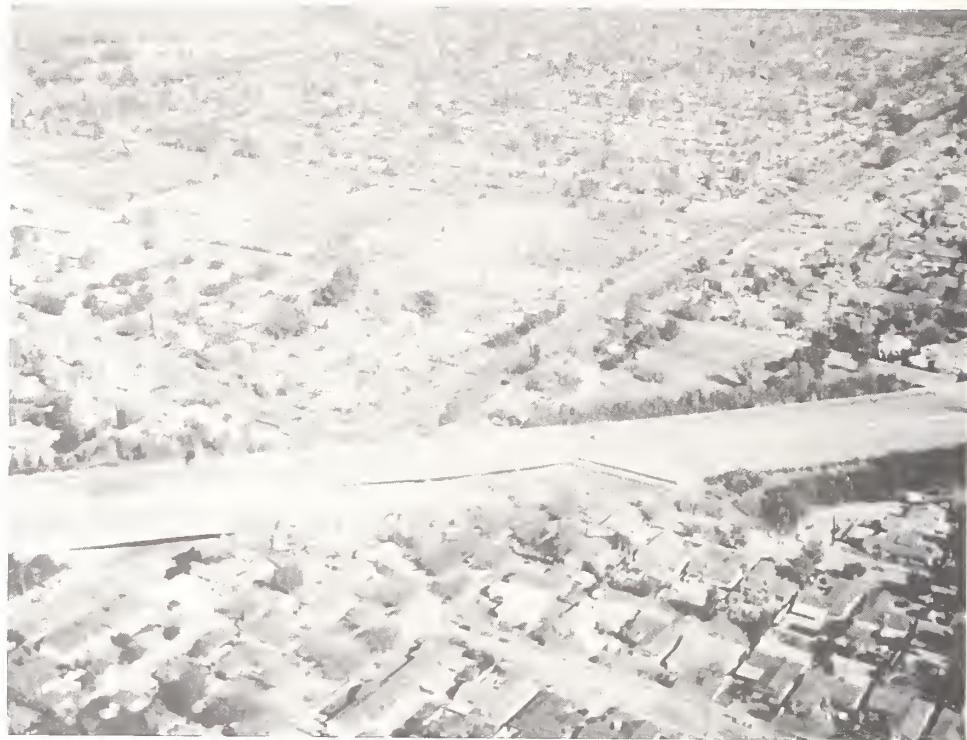
Figure 4.19. Aerial view of the SR118 Mission-Gothic Undercrossing, looking to the north showing collapsed eastbound bridge (Photo courtesy of FHWA).

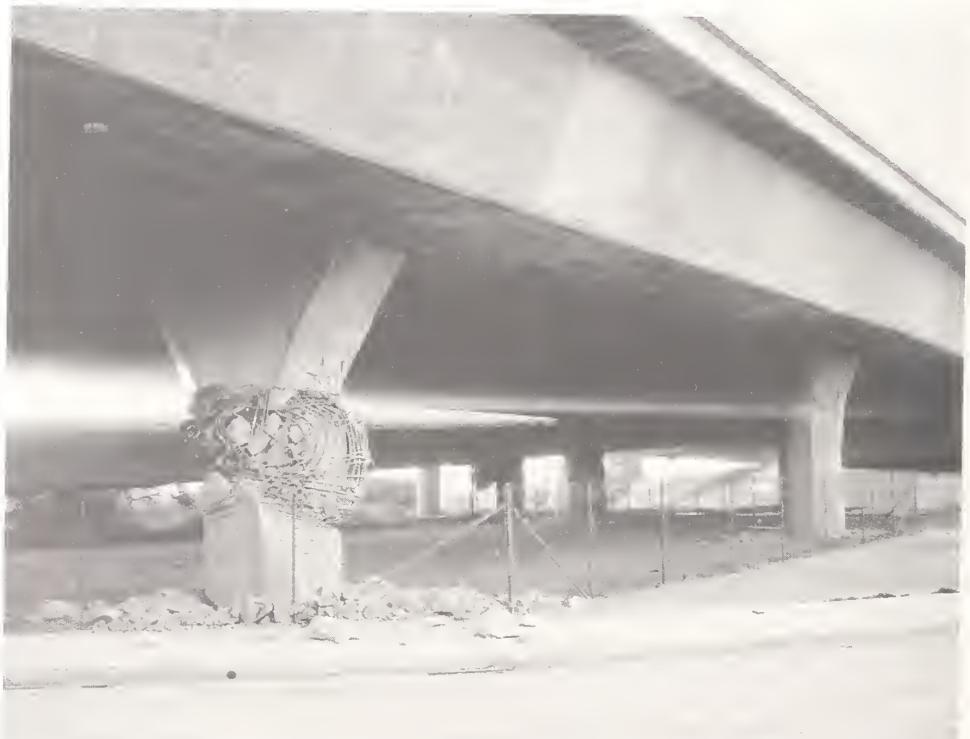
Figure 4.20. Damage to piers of the SR118 Mission-Gothic Undercrossing, looking to the northwest at the north face of the westbound bridge, Bents 3 (foreground) and 2.

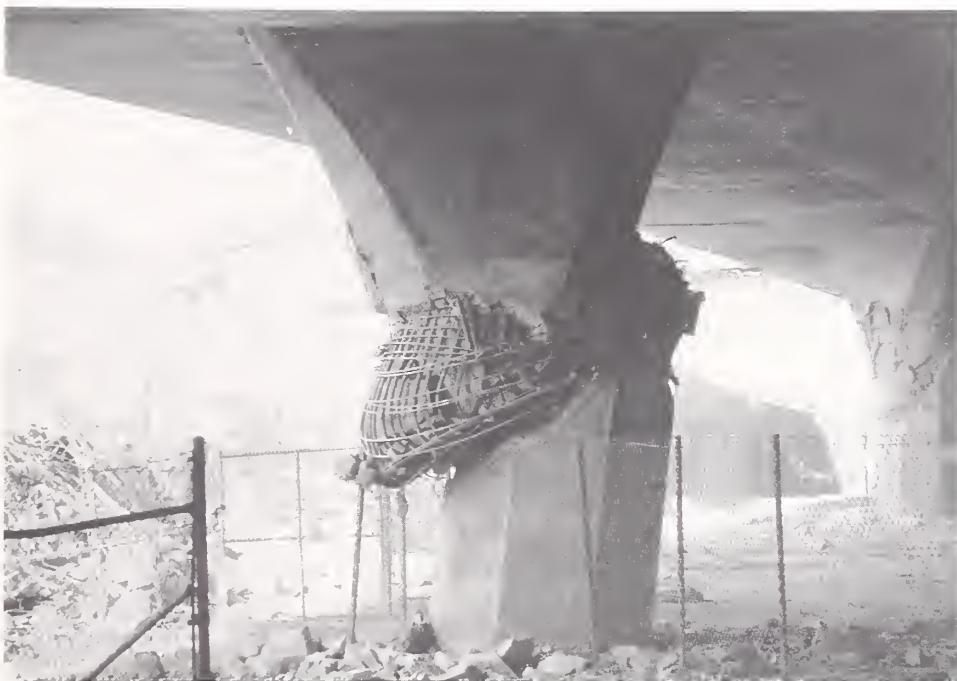
Figure 4.21. Damage to a pier of the SR118 Mission-Gothic Undercrossing, looking to the northwest at the southernmost pier of Bent 3 of the westbound bridge.

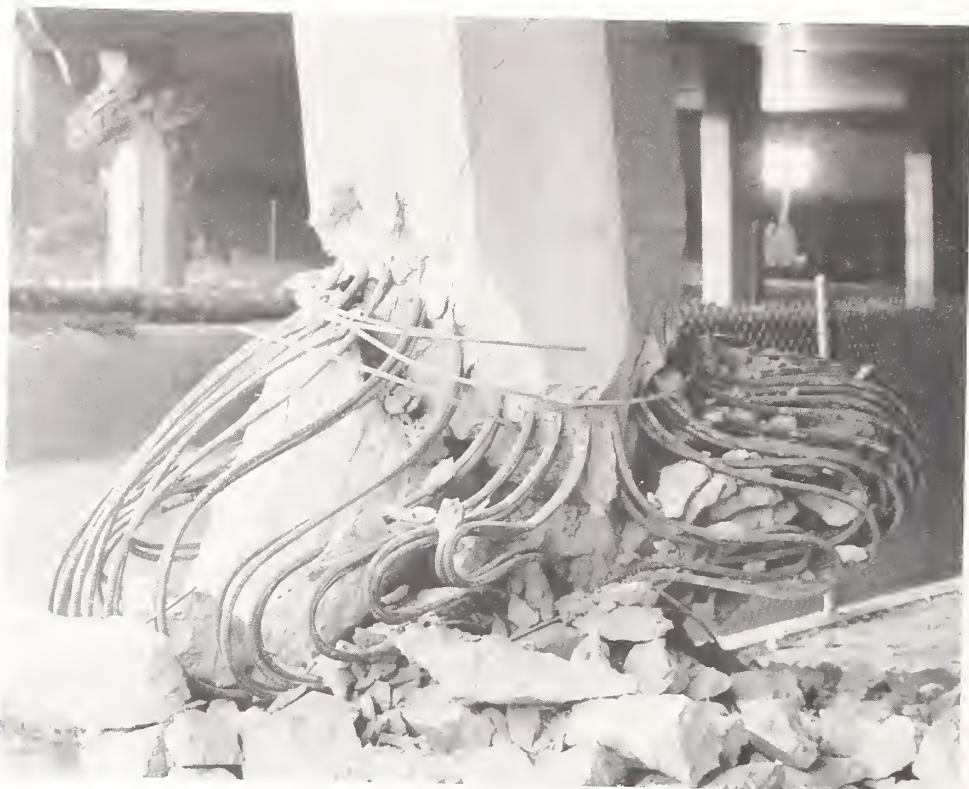
Figure 4.27. Damage to pier 3S-1 of State Route 118 at Bull Creek Canyon Channel, looking to the northwest.
