NIST Special Publication 862

1994 Northridge Earthquake Performance of Structures, Lifelines, and Fire Protection Systems

*Diana Todd, Nicholas Carino, Riley M. Chung, H. S. Lew, Andrew W. Taylor,
William D. Walton, James D. Cooper, and Roland Nimis*

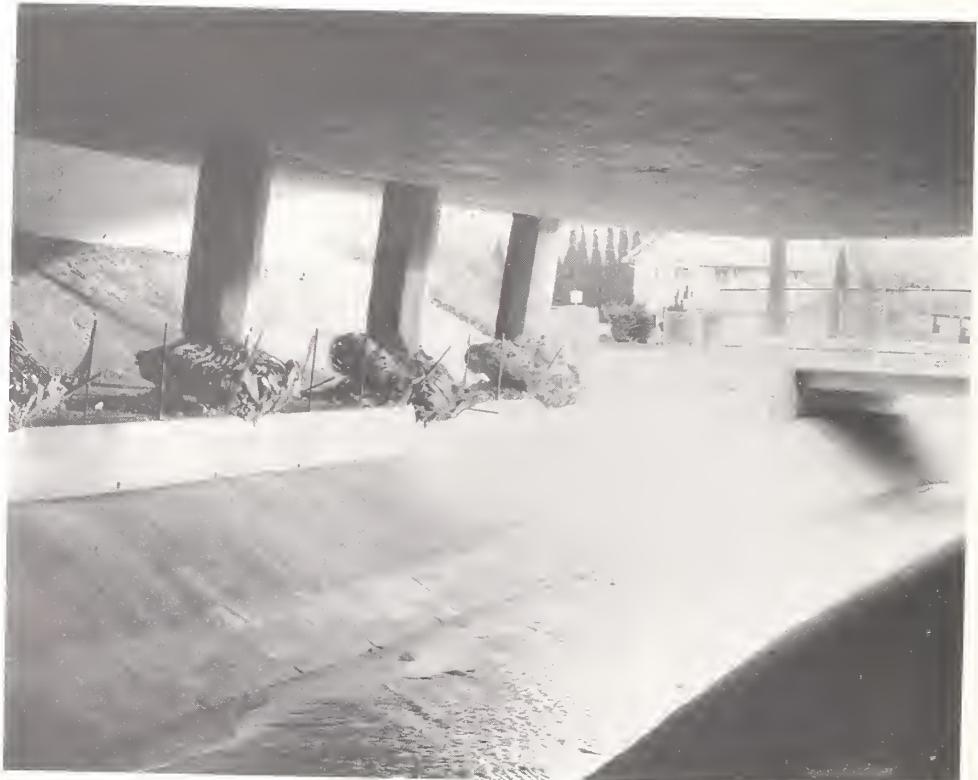
Figure 4.28. Damage to piers of Bent 3S of State Route 118 at Bull Creek Canyon Channel, looking to the southeast.

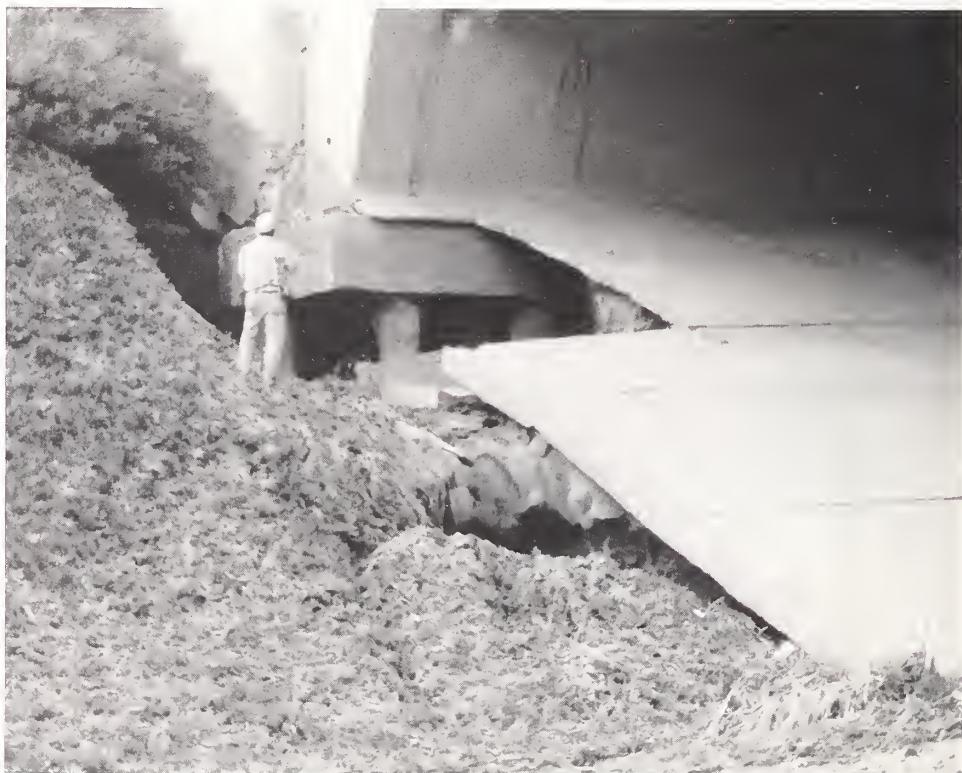
Figure 4.32. SR118 Balboa Avenue Overcrossing, view of the washout on the east side of the south abutment, caused by a ruptured water main.

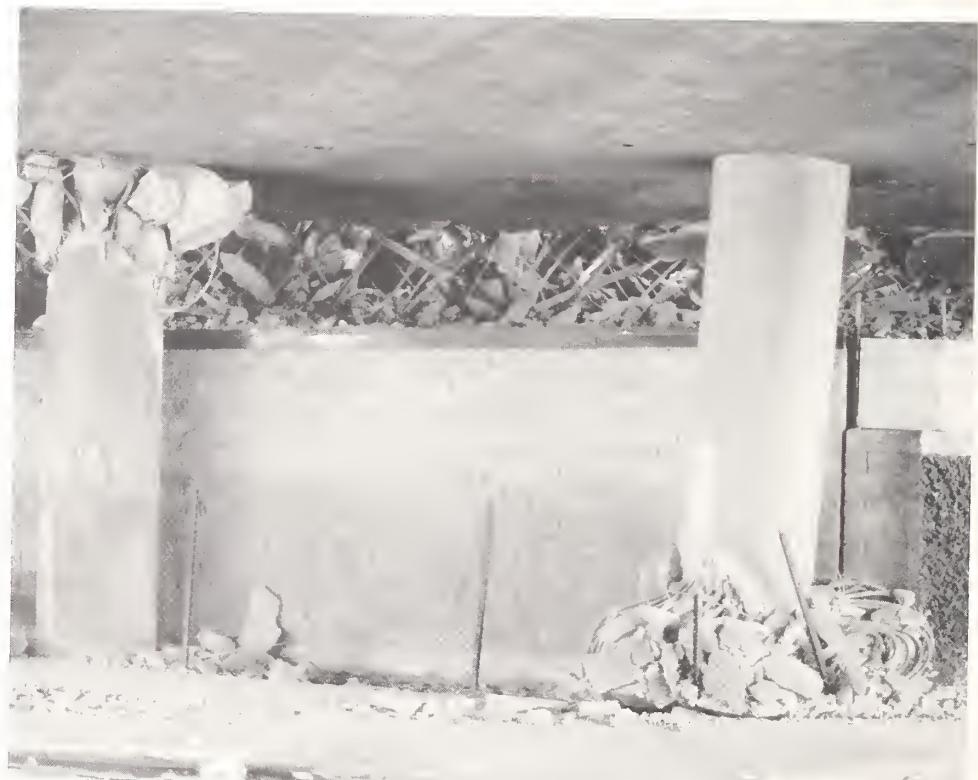
Figure 4.39. Failed piers in Bent 7 supporting westbound lane of I10 at Venice Blvd.

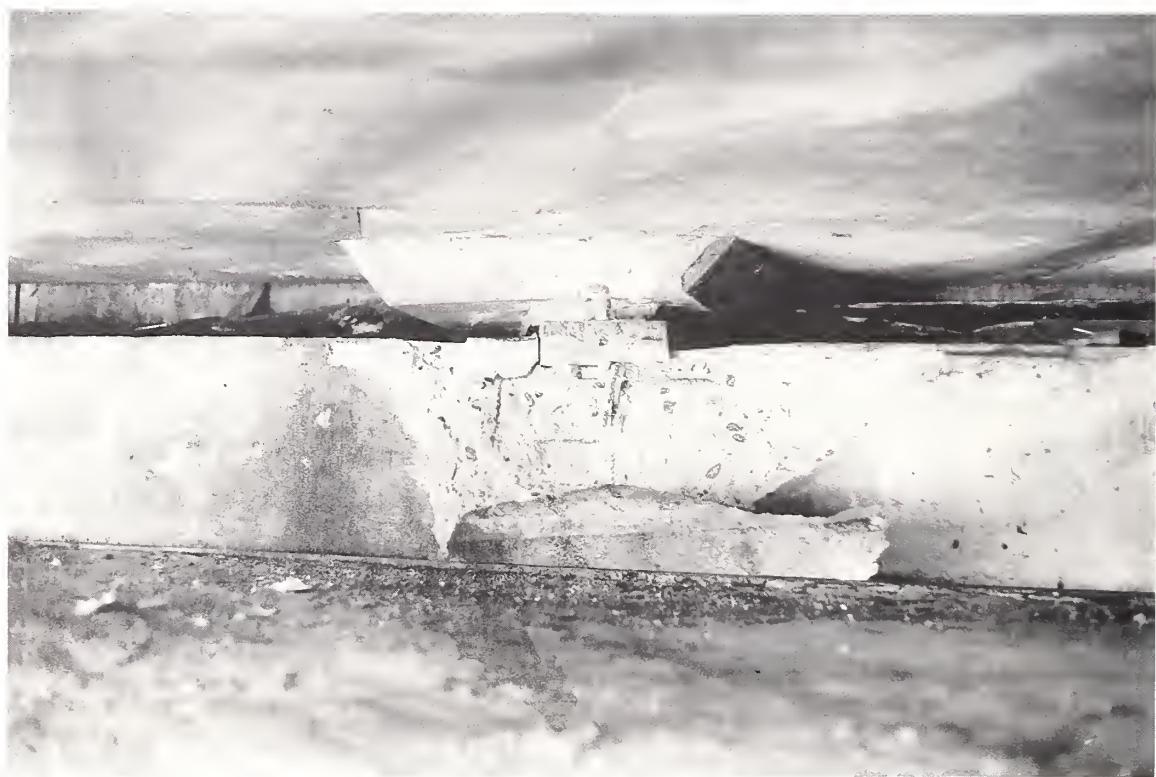
Figure 4.48. Abutment damage at sliding-type bearing.

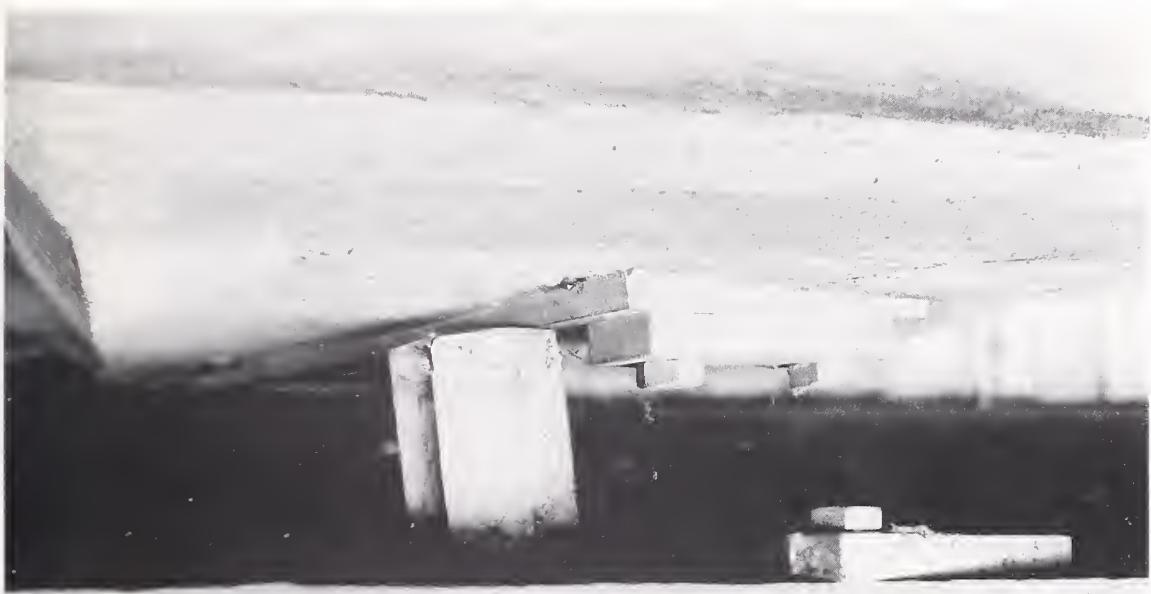
Figure 4.49. Displaced bearing block in rocker-type bearing.

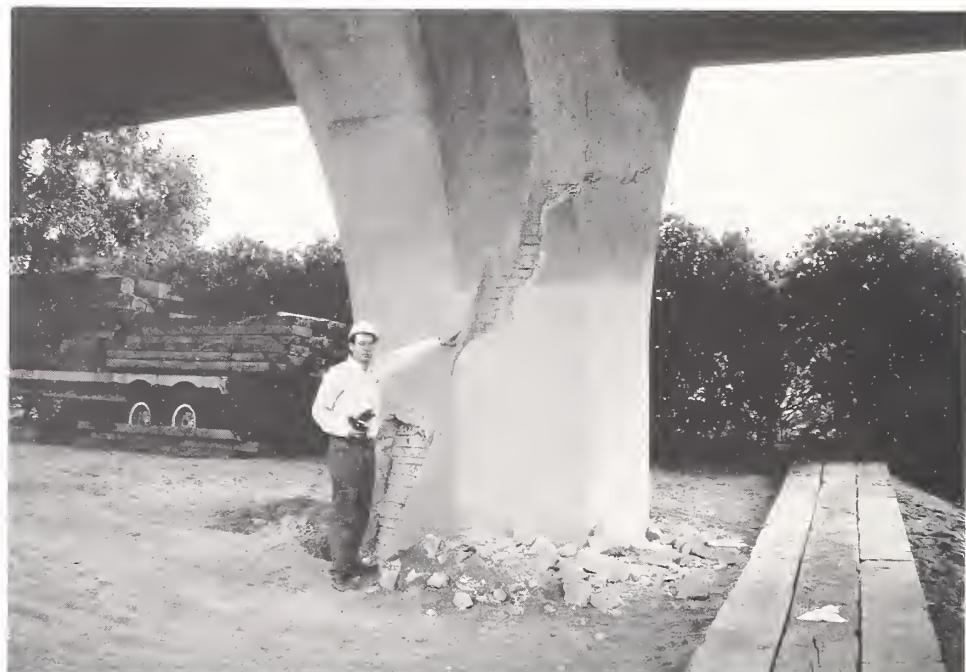
Figure 4.51. View of the westernmost pier at the Interstate 5, State Route 118, Southwest Connector, looking to the southeast. Loose cover concrete has been removed by Caltrans.

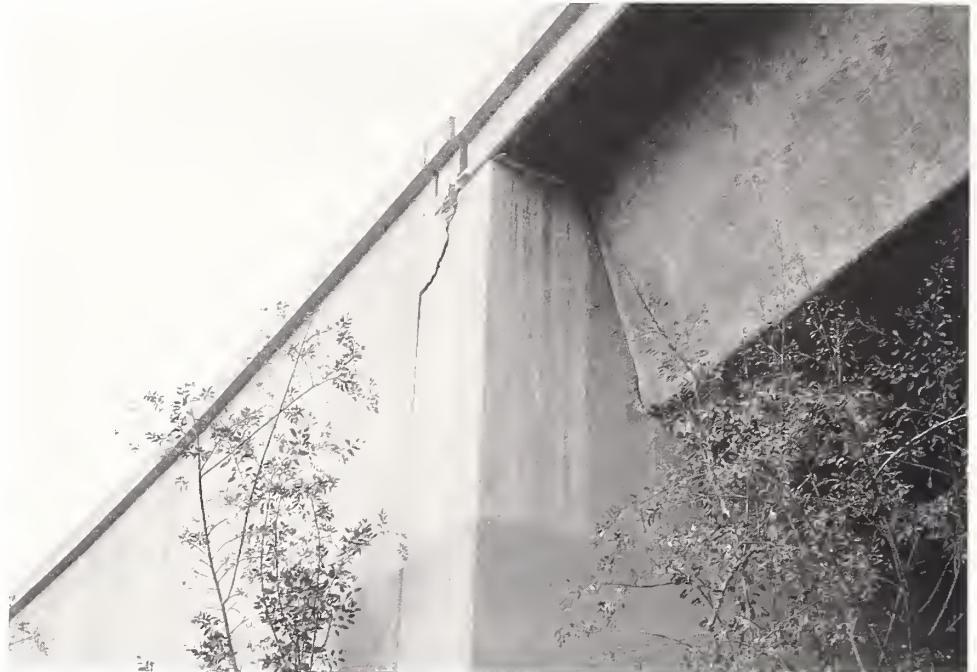
Figure 4.57. Close-up of abutment wall cracking at the east end of the ramp connecting eastbound SR118 with northbound I210.

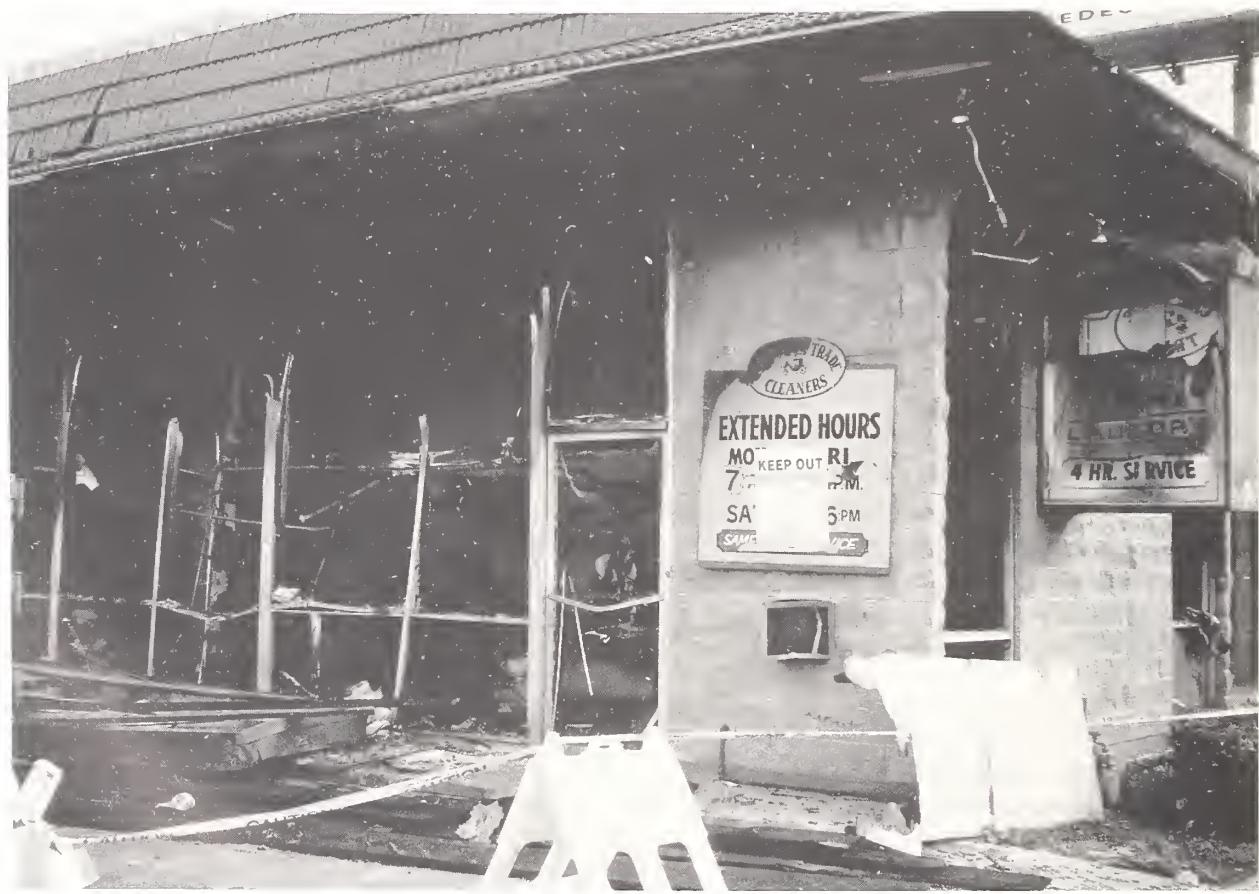
Figure 6.1. Fire damage in a single story commercial building.

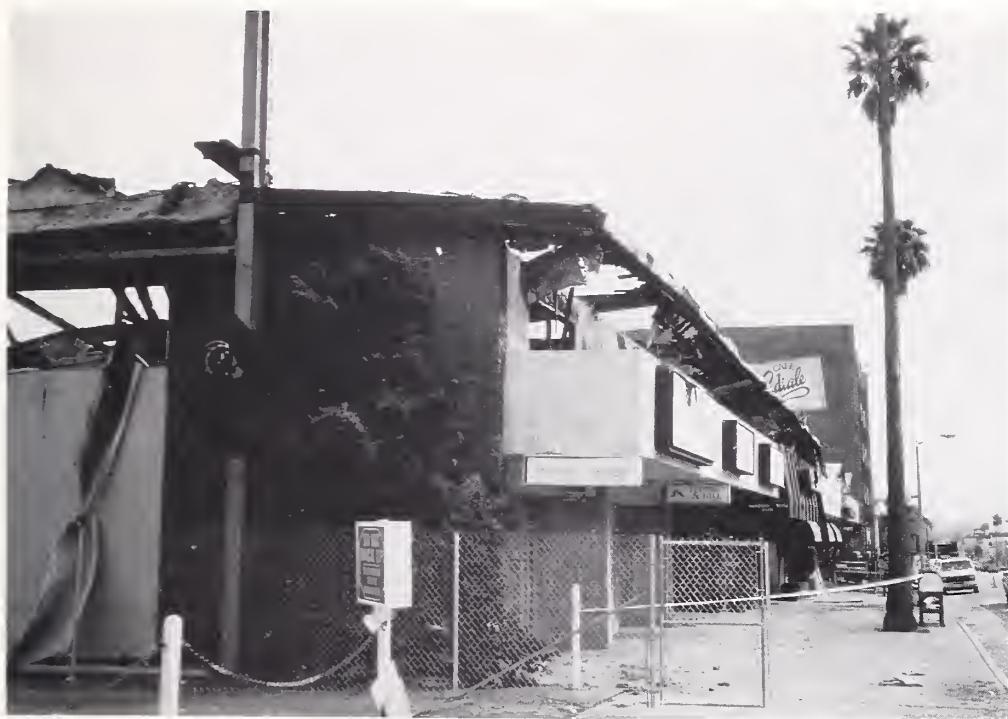
Figure 6.2. Fire damage in a two story commercial building.

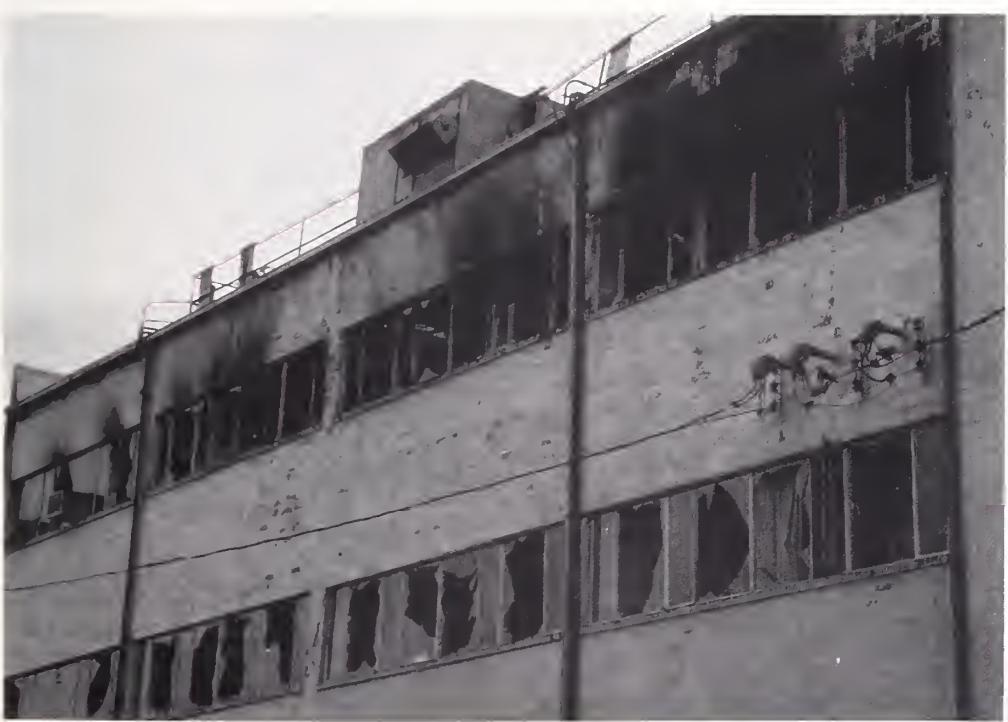
Figure 6.3. Fire damage in a three story commercial building.

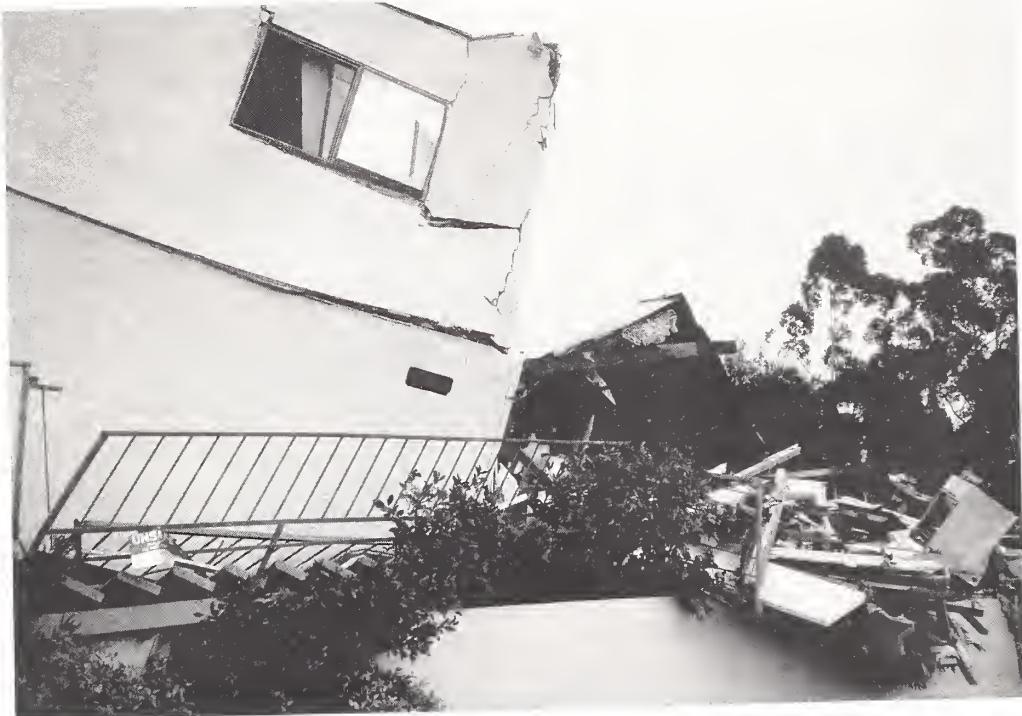
Figure 6.4. Partially collapsed apartment building with fire damage in the rear.

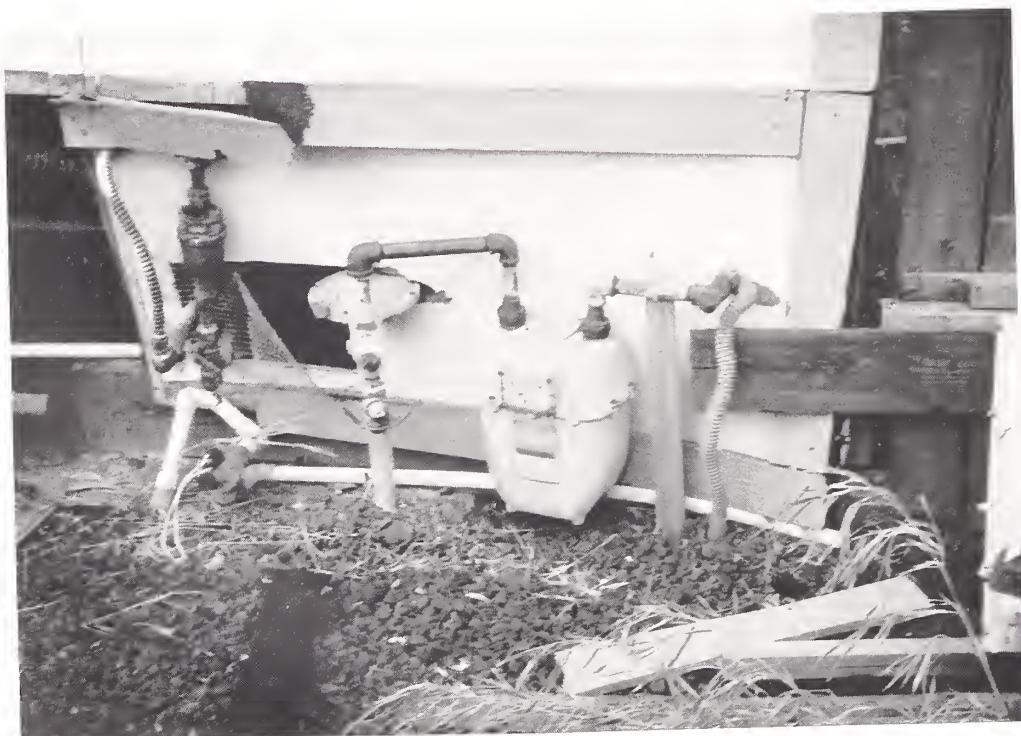
Figure 6.5. Damaged gas service in a manufactured housing development.

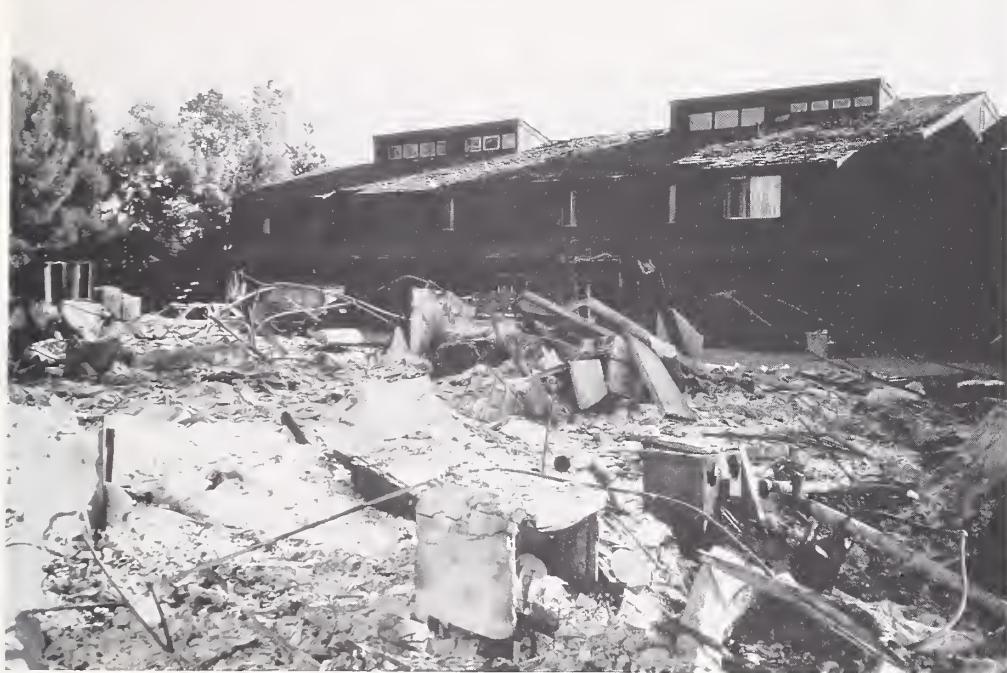
Figure 6.6. Multi-family residential building destroyed by fire.

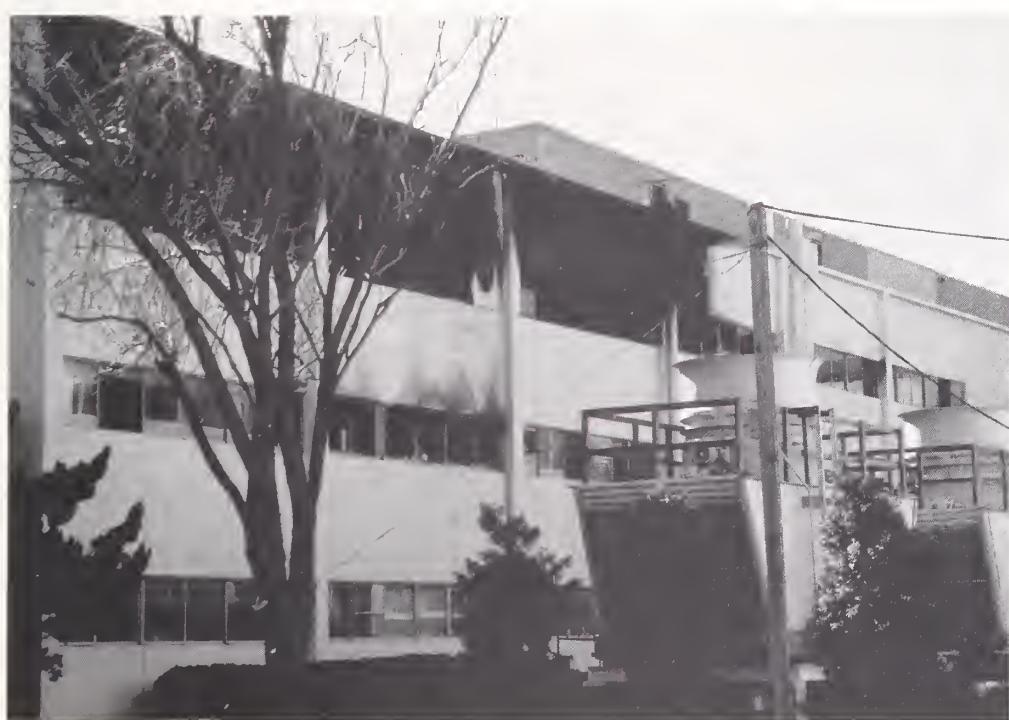
Figure 6.7. University science building damaged by fire.
