Investigation of the Skyline Plaza Collapse in Fairfax County, Virginia

E. V. Leyendecker and S. G. Fattal

Final Report

The collapse of the Skyline Plaza apartment building A-4 has been studied by using information contained in case records of the Occupational Safety and Health Administration (OSHA), U.S. Department of Labor and obtained from on-site inspections by investigators from the National Bureau of Standards.

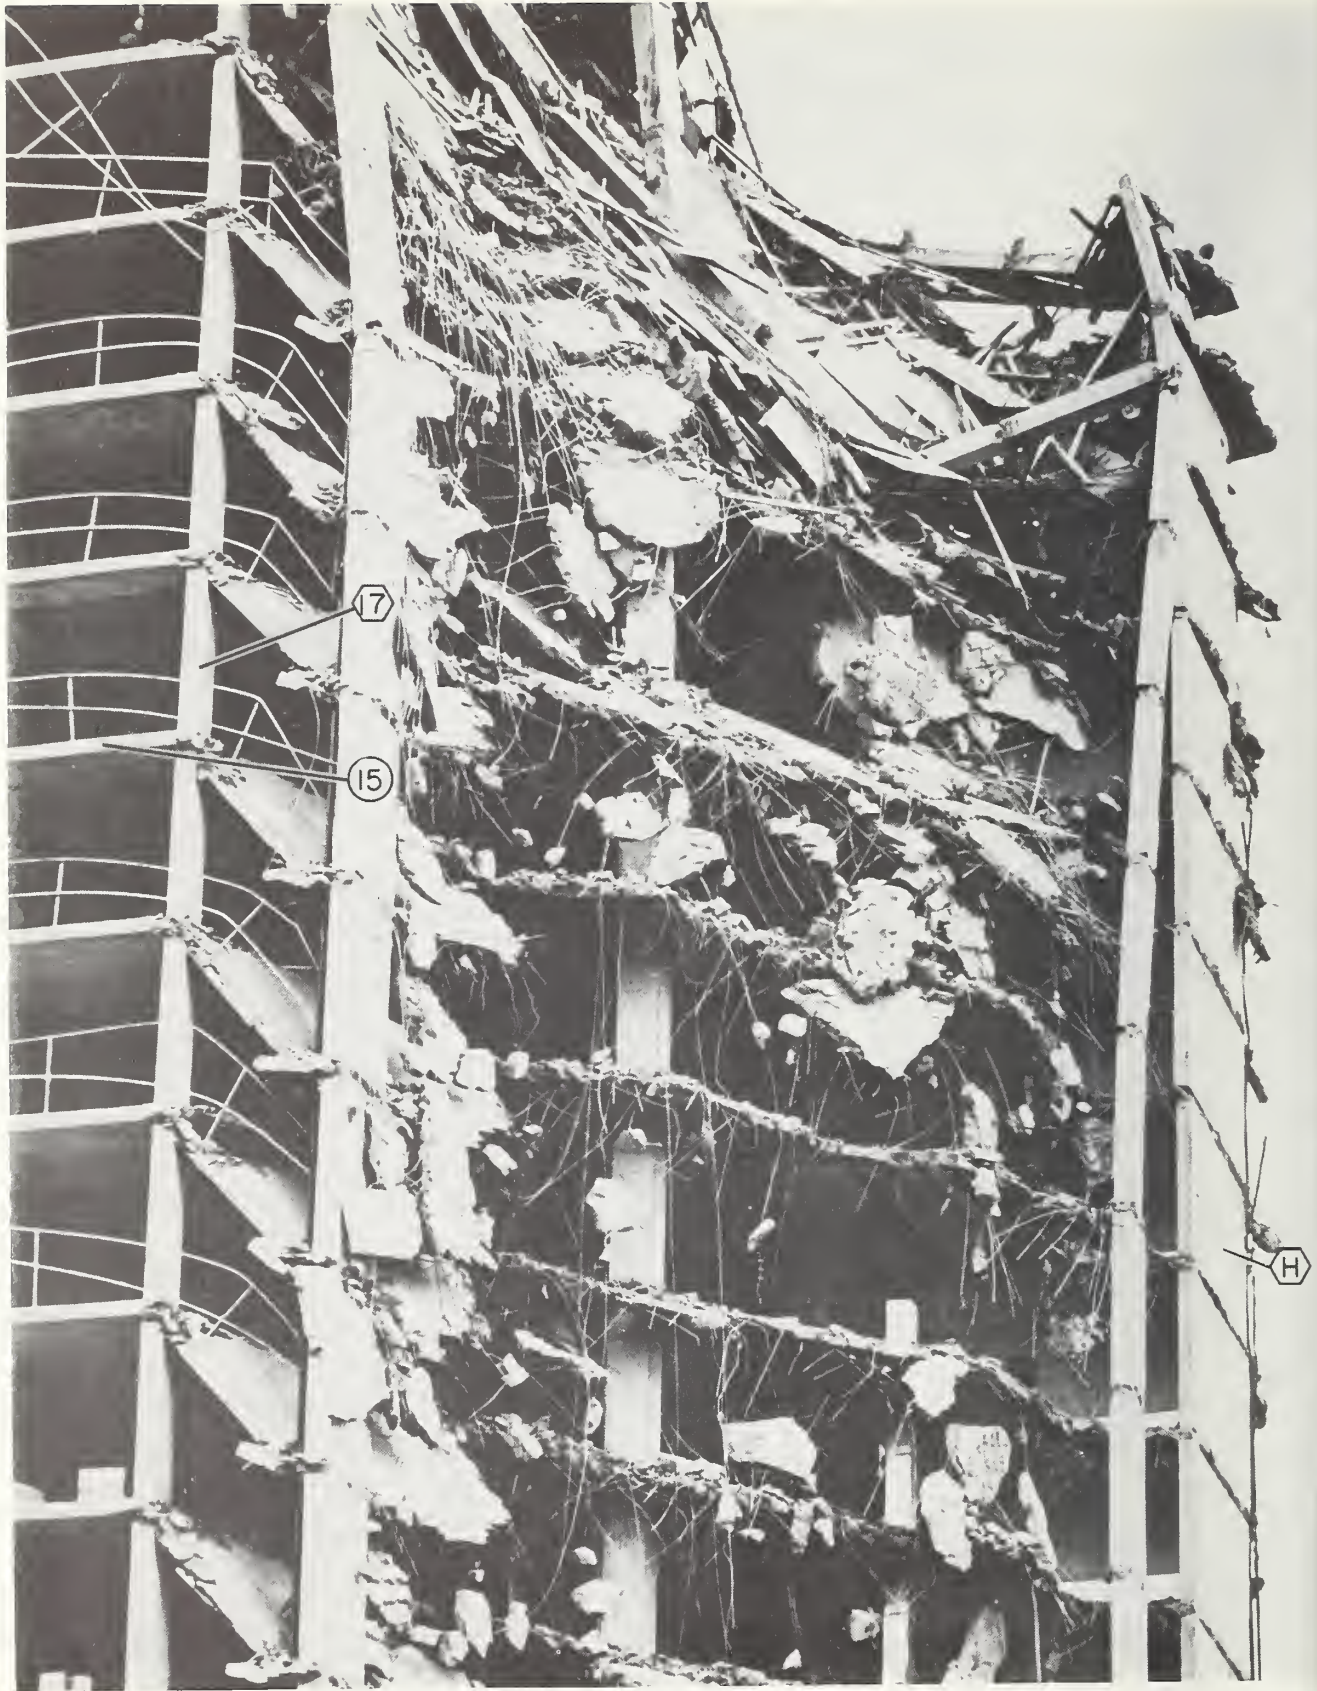
Figure 2.6 Closeup view of the top of the east end of the failure zone, looking south.

Figures 2.6 through 2.8 are closeup views of the east end of the failure zone. These figures require little comment at this time; however, it should be noted that the formwork is clearly visible in figure 2.6.

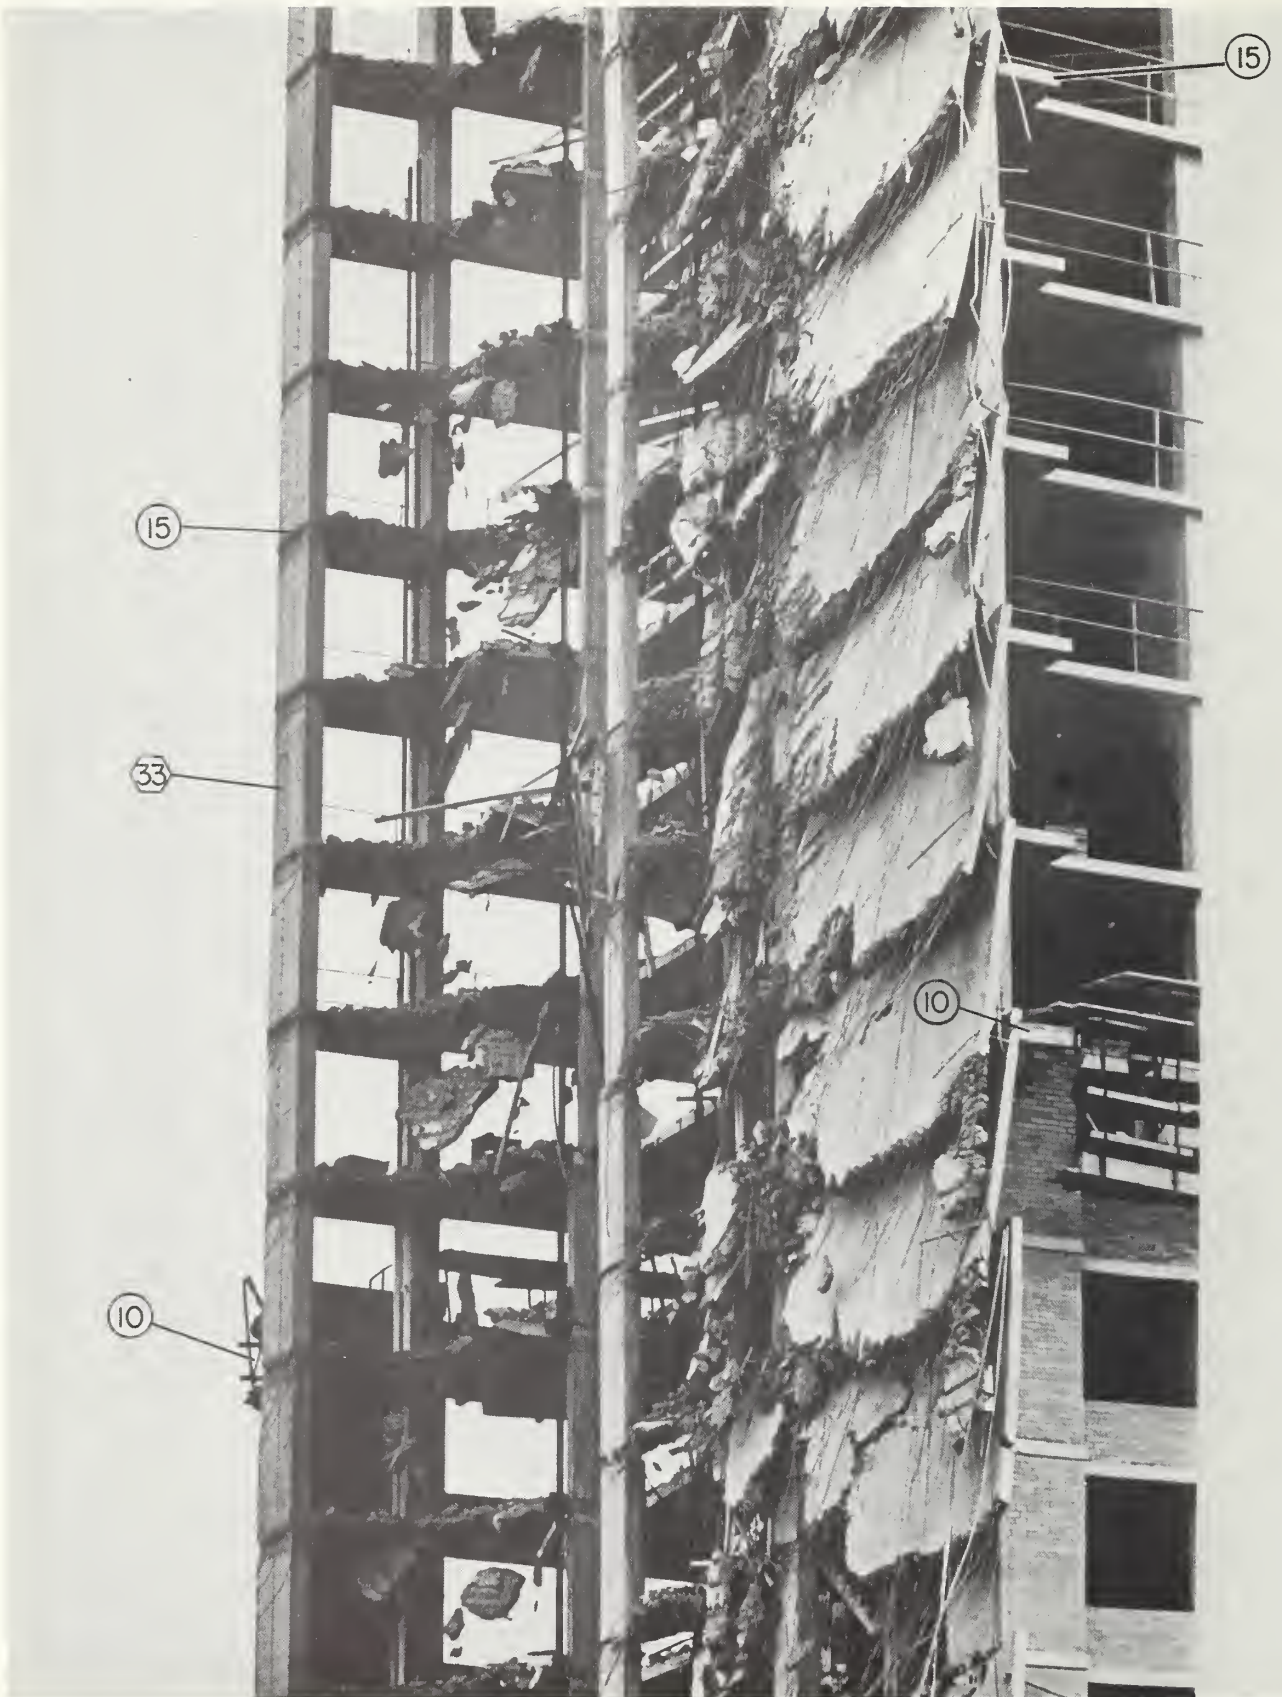
Figure 2.10 Closeup view of the top of the west end of the failure zone, looking southwest.

A general view of the west end of the failure zone is shown in figure 2.9 along with closeup views in figures 2.10 through 2.12. These figures also require little comment at this time; however, it should be noted that the formwork is clearly visible in figure 2.10.

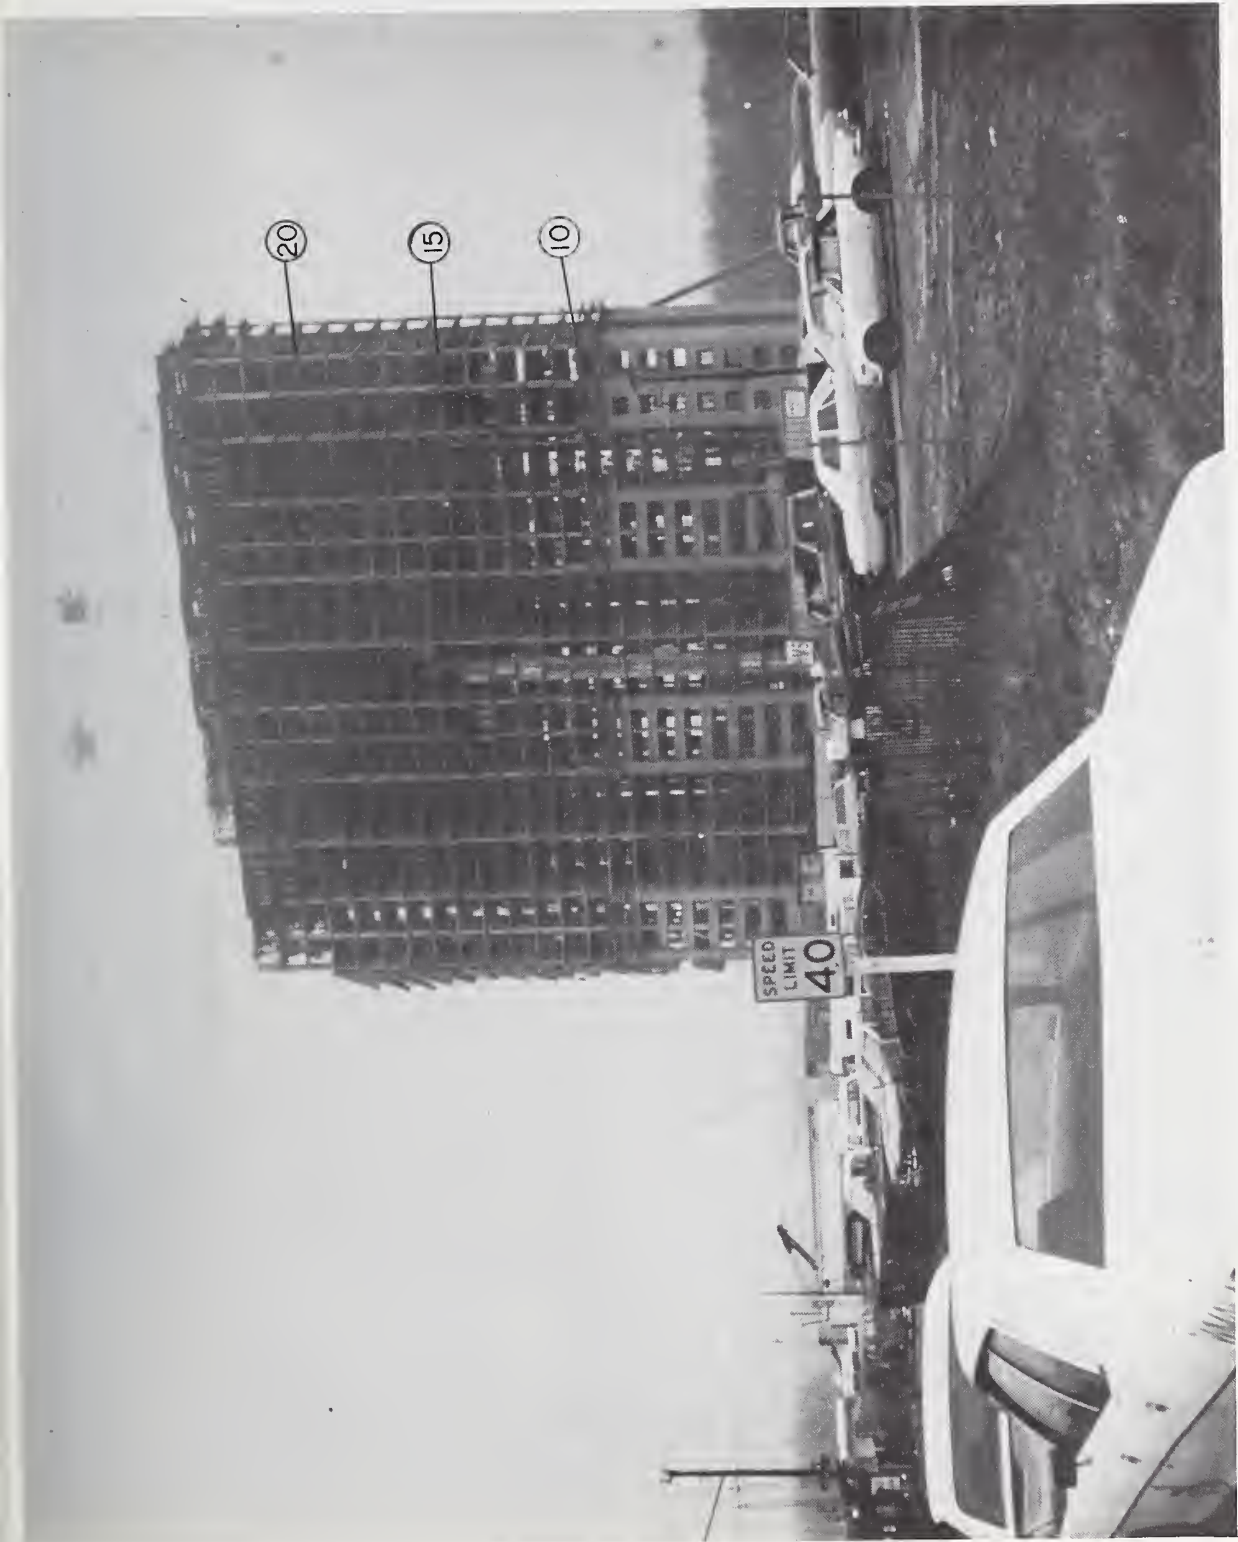
Figure 2.13 Appearance of A-4 after the removal of the east end of the building, viewed from the east.

On the night of March 4 the remaining portion of the building to the east of the failure zone was completely demolished, with the result shown in figures 2.13 and 2.14.

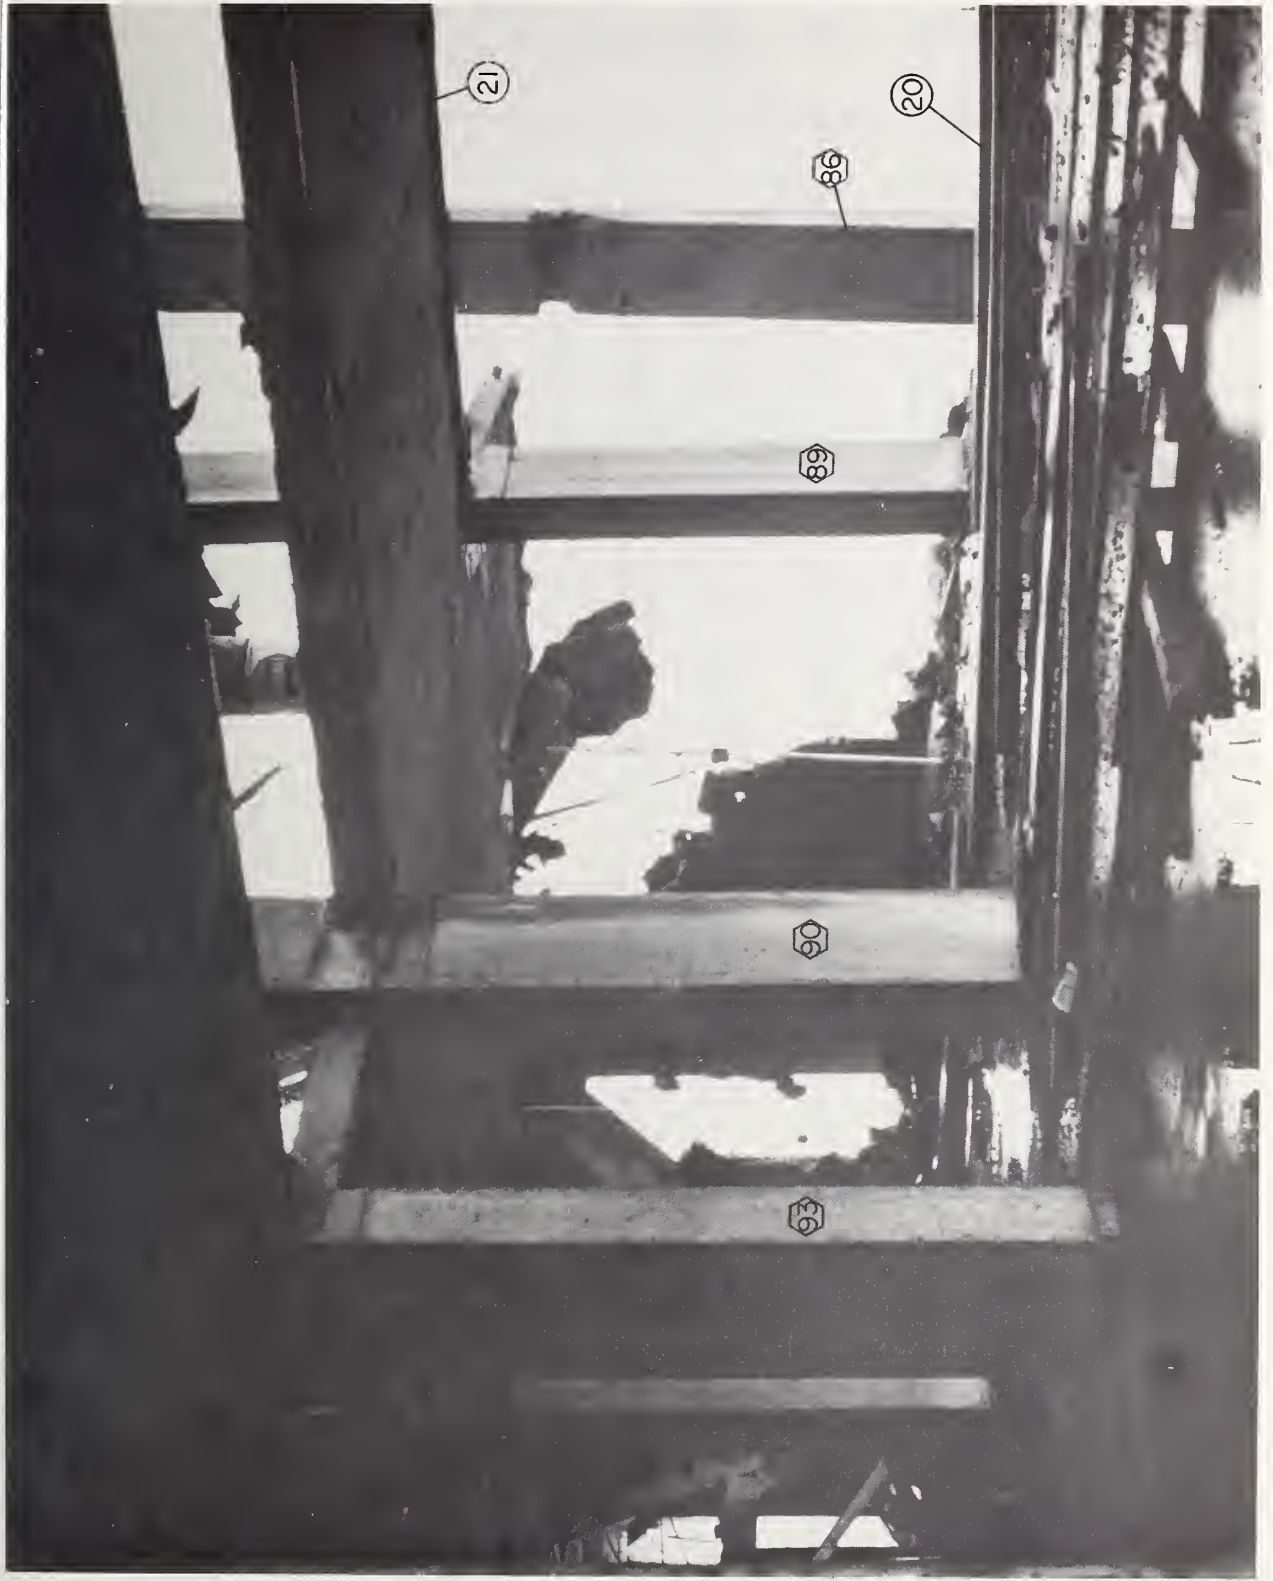
Figure 2.25 Section 1 and 2 of 20th story, looking east.

As shown in figure 2.25, the 20th floor was completely bare of reshoring. This was reportedly the case for sections 1 through 4. Note the presence of shear walls A and B. These walls were not present (the design did not require them) above the 20th story. Note also the erection crane which is barely visible to the left of the designation for shear wall A. A view of the failure section at the end of the 20th floor is shown in figure 2.26.

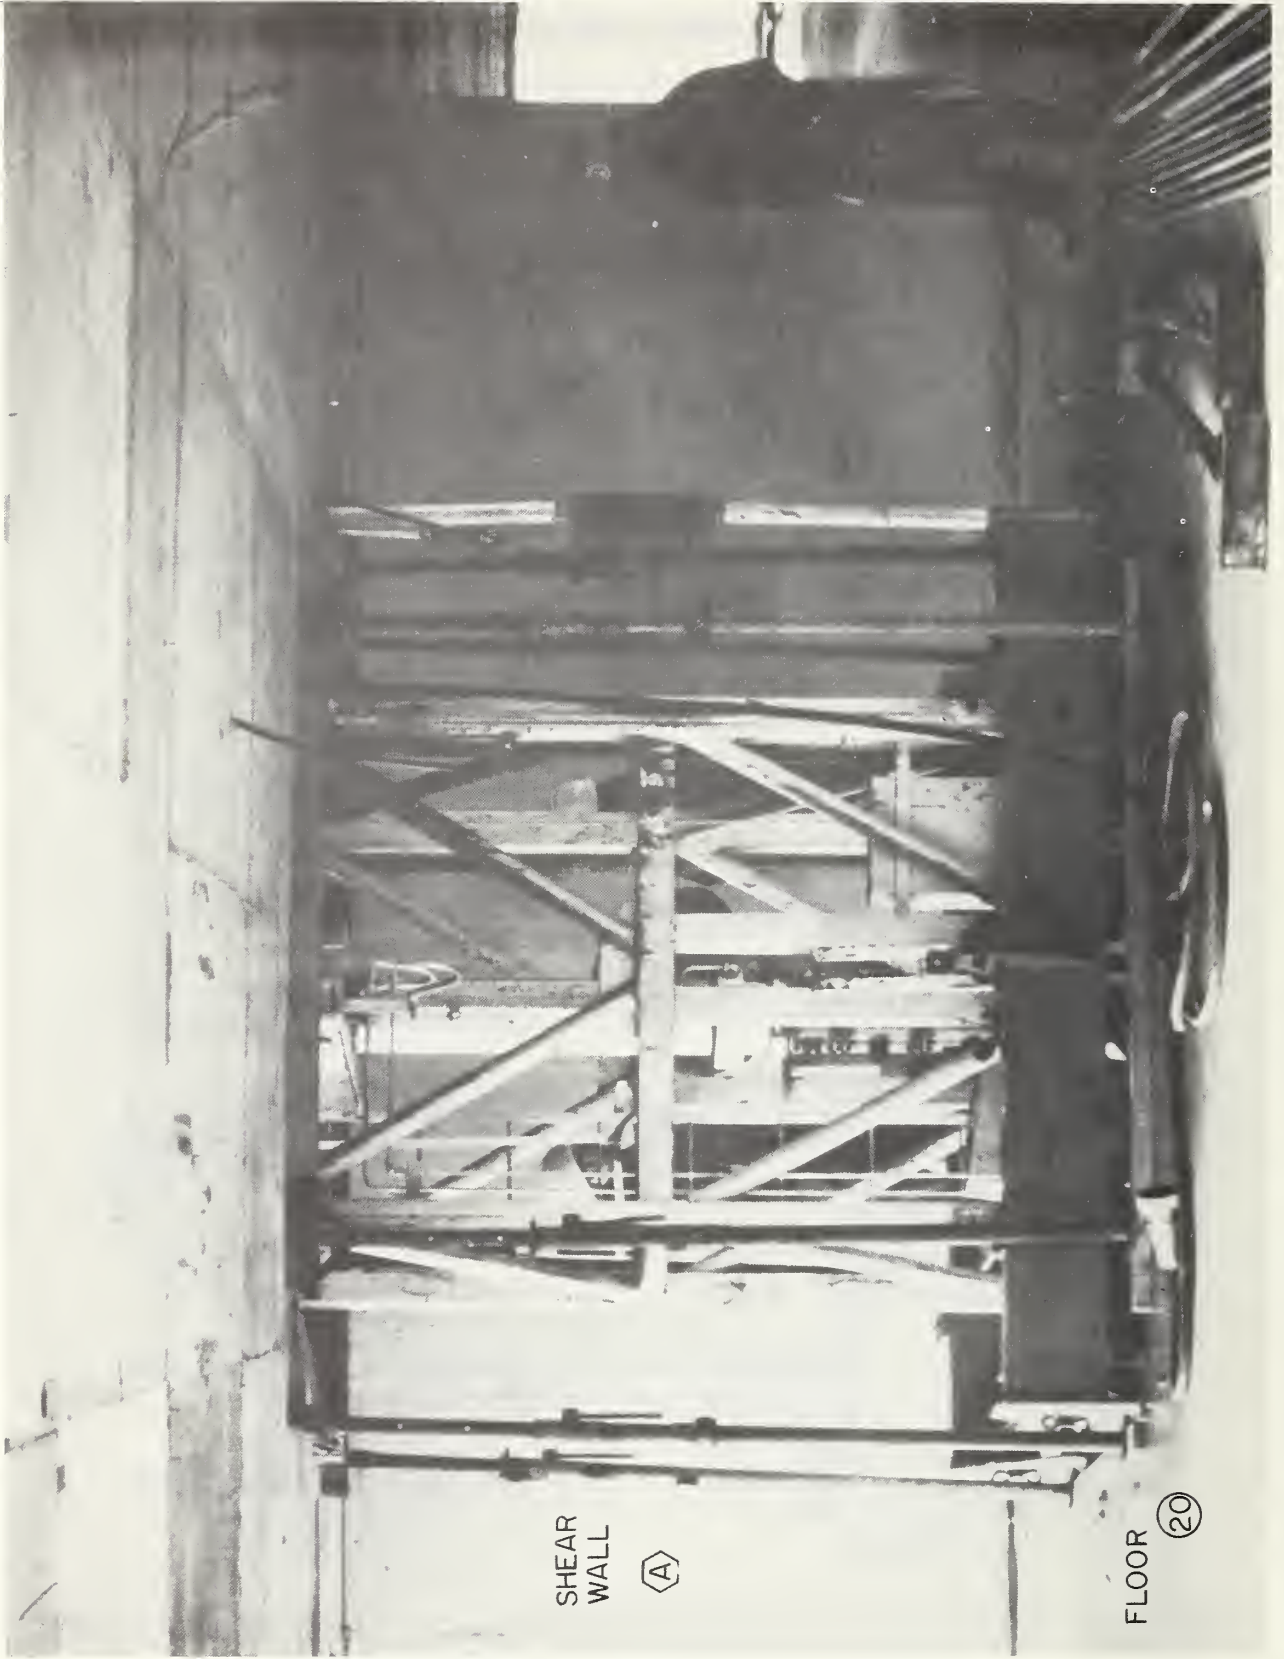
Figure 2.33 Climbing frame for crane no. 1.

Crane no. 1 was supported by the climbing frame, the lower support, on the 20th floor as shown in figure 2.33. The upper support was provided on the 22nd floor as shown in figure 2.34. This total distance is 18 ft, slightly less than the manufacturer's specified 18 ft 4 in. A typical corner clamp detail on the 22nd floor is shown in figure 2.35. Note the cracked slab where the clamp is attached.

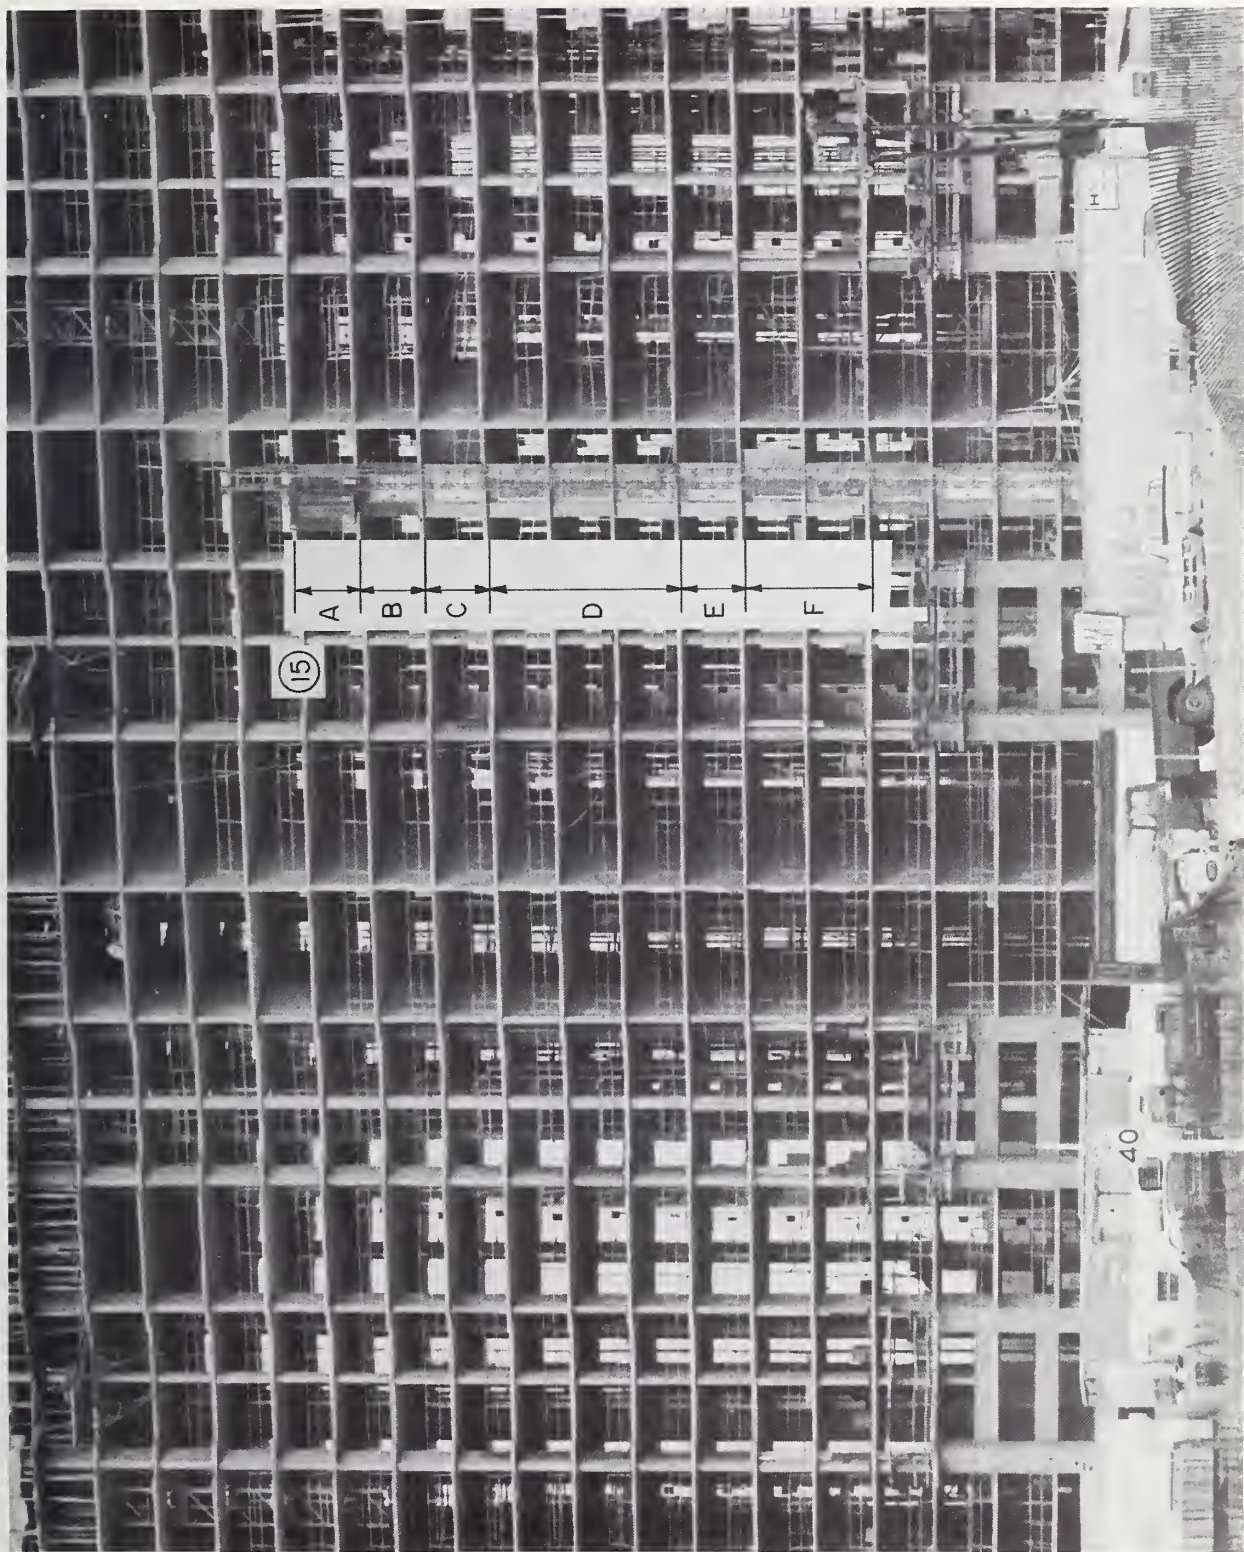
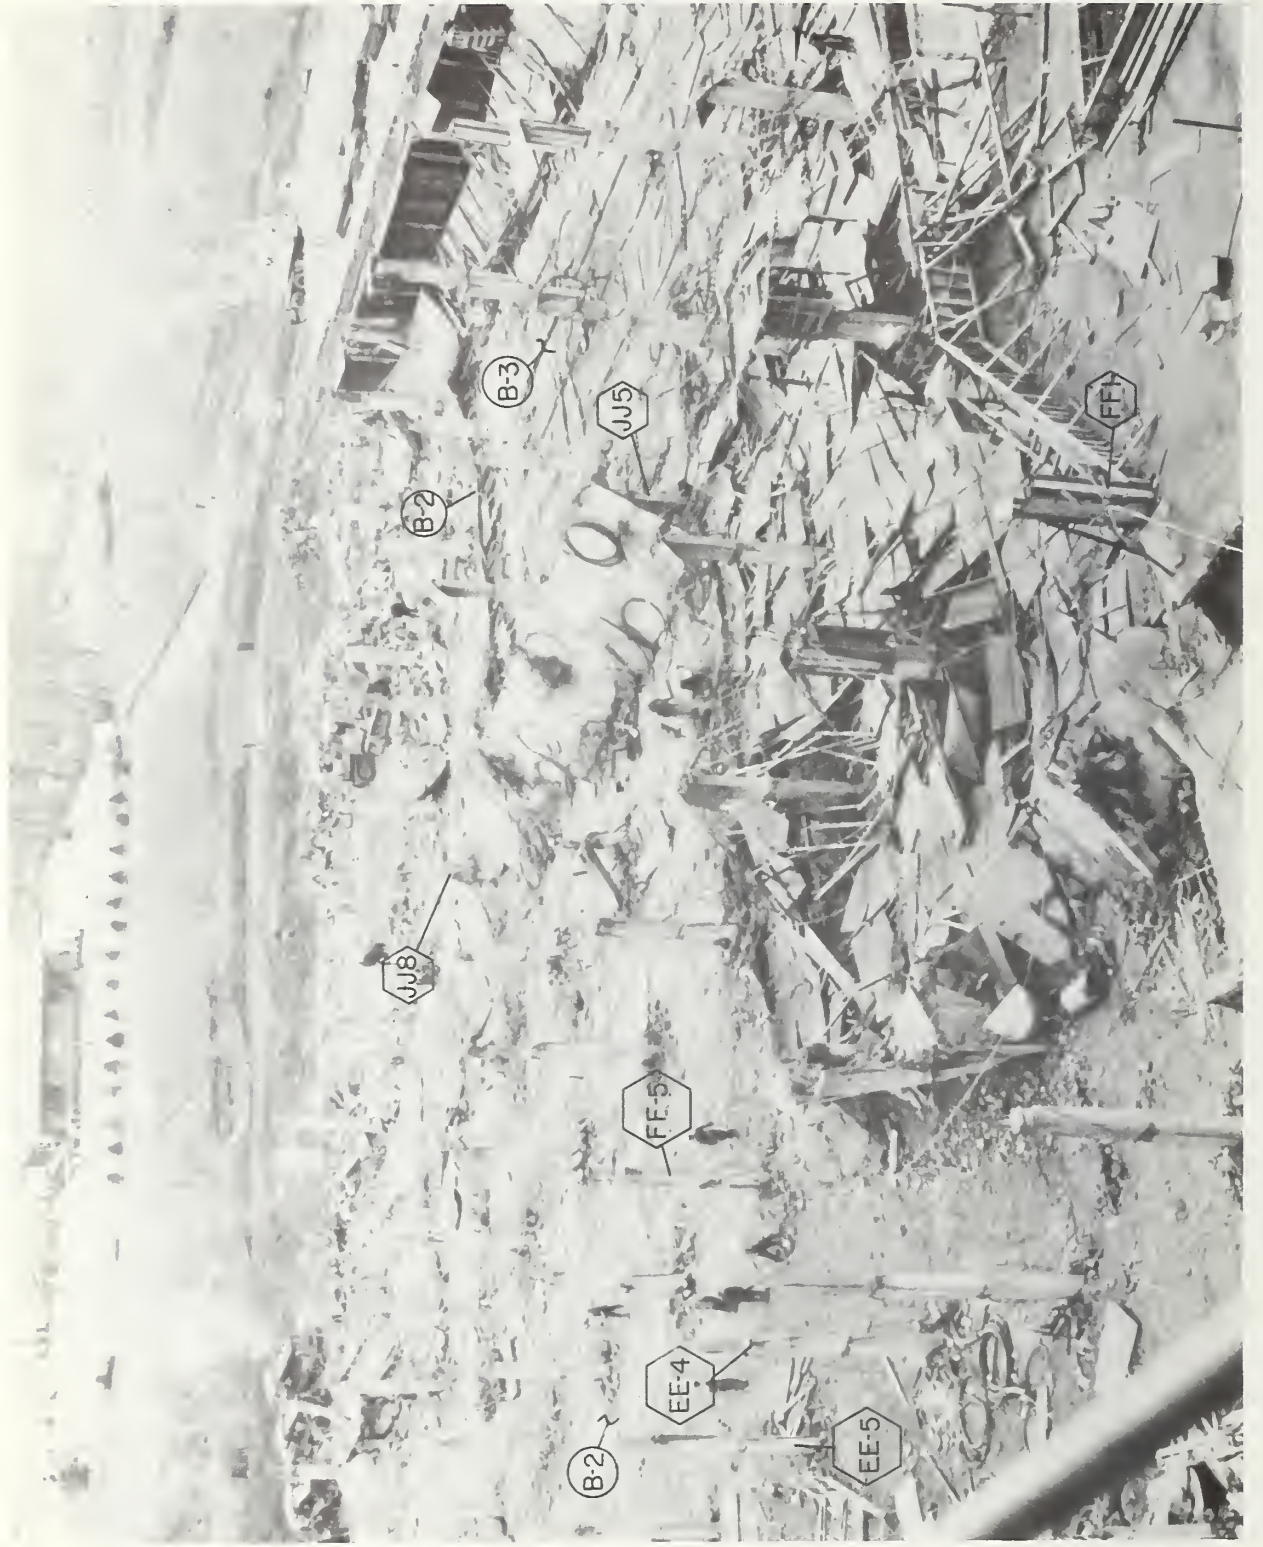
Examination of figures 2.40 and 2.42 indicates that either the crane shoring or the formwork for the concrete closure slab of the crane opening was in place in the third through thirteenth stories on the day of the photograph. Conditions below the third story are not visible in the photograph.

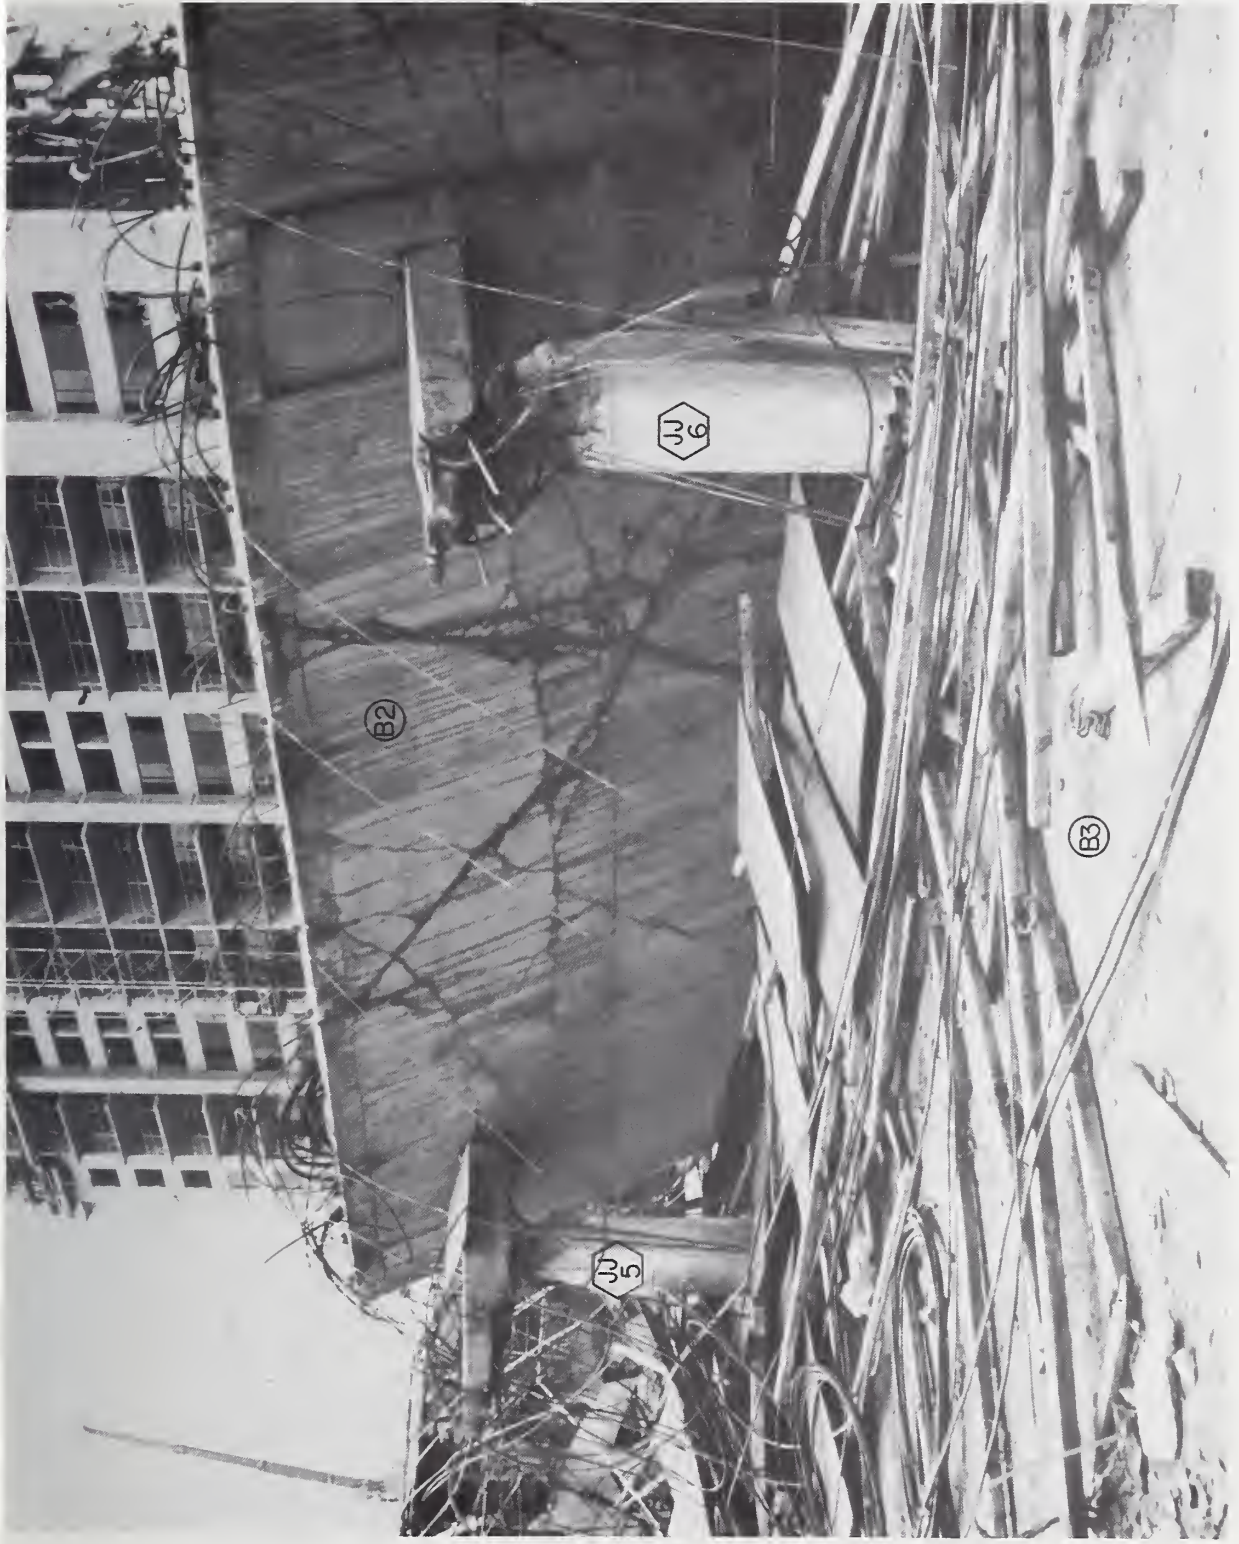
Figure 2.45 View looking west of slab B-2 between column lines HH and JJ.

The garage slabs generally came "straight" down except near the slab edges. In the latter cases the columns usually failed in bending. Figure 2.45 shows a view of slab B-2 with the edge between columns JJ-5 and JJ-8 visible on the left. The view of this edge from the south is shown in figure 2.46. Note that the columns failed at the B-3 level. Formwork can be seen lying on top of the slab B-3. These forms apparently were in place under slab B-2.

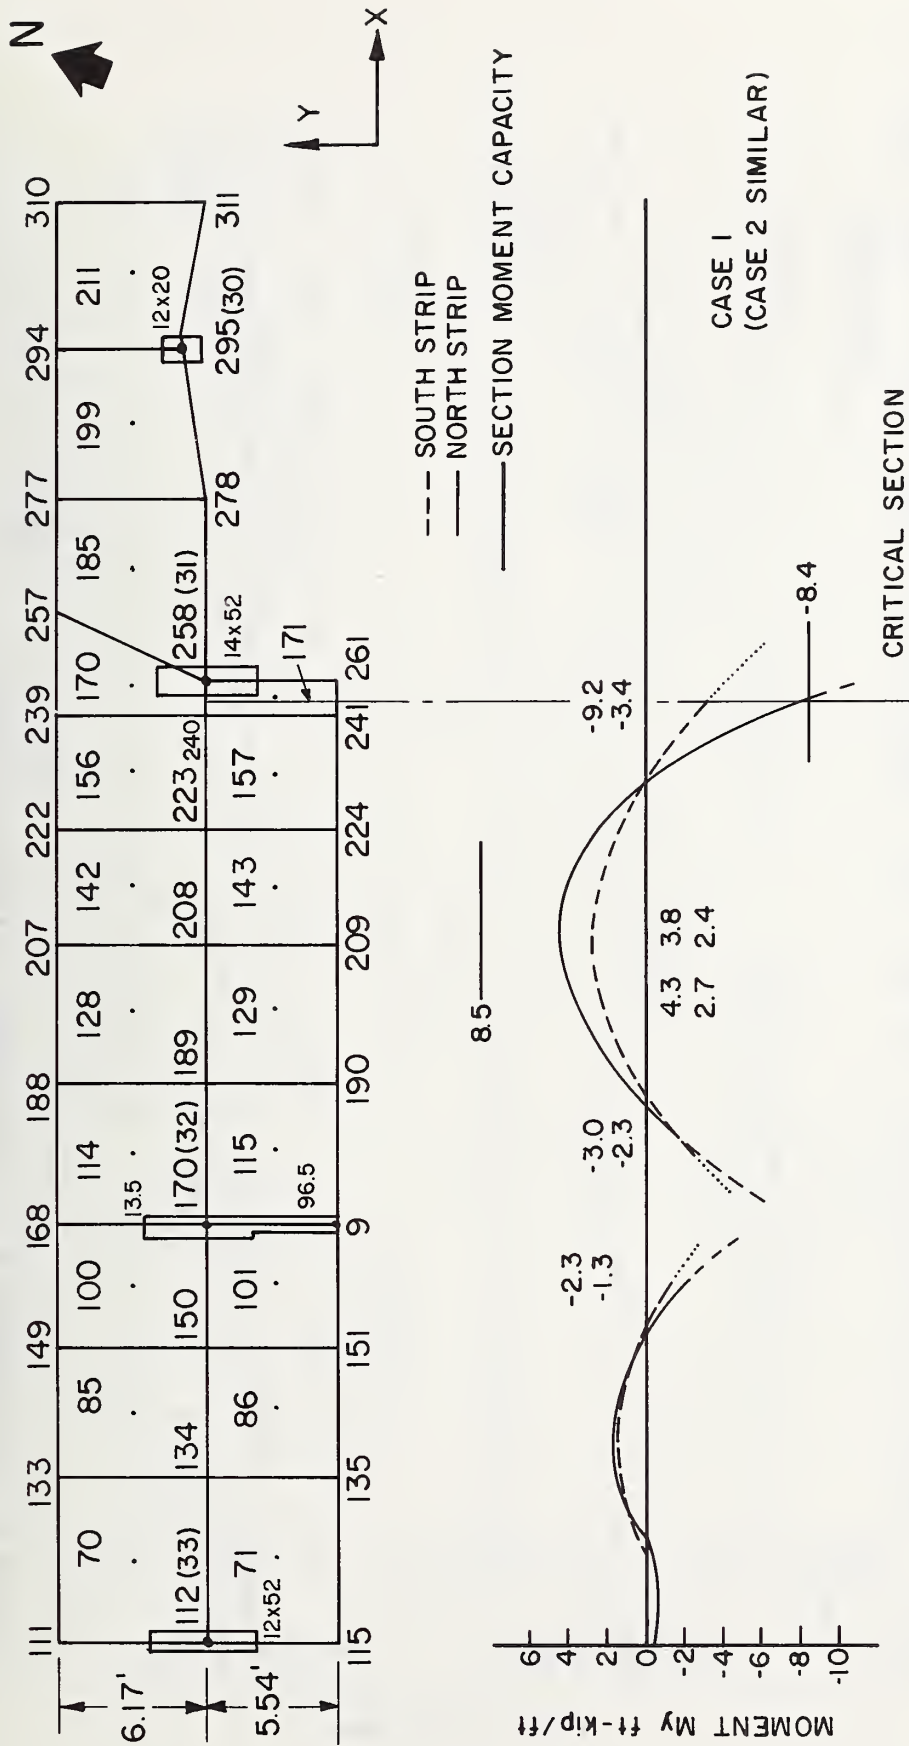
Figure 4.6 MOMENTS IN COLUMN STRIP 33-32-31-30

Altogether four column strips were investigated. Of these, the strip shown in figure 4.6 was found to be the one most critical in flexure. Case 1 negative moment at the critical section near column 31 (node 258) was about 9.2 ft-kips/ft. The moment capacity of the

slab at this section, determined on the basis of reinforcement details in the contract drawings, was found to be about 8.4 ft-kips/ft, indicating that the flexural capacity of the section was exceeded by about 10 percent. In this case, as in all other cases investigated, the flexural capacity of the section was found to be governed by yielding of the tensile reinforcement rather than by crushing of concrete in compression. Thus it is estimated that yielding occurred in the slab at column 31 and yielding propagated toward column 83 (see figure 4.1). However, this local yielding is not sufficient to cause a collapse mechanism of the 23rd story floor slab. In fact, a flat slab construction of the type used in Skyline Plaza building is generally recognized to have considerably greater moment capacity than the capacity at which the first local yielding occurs because of its inherent ability to redistribute peak moments to neighboring regions through the mechanism of yielding.
