# NBS TECHNICAL NOTE 783

## Durability and Maintenance as Related to the Selection of Flooring

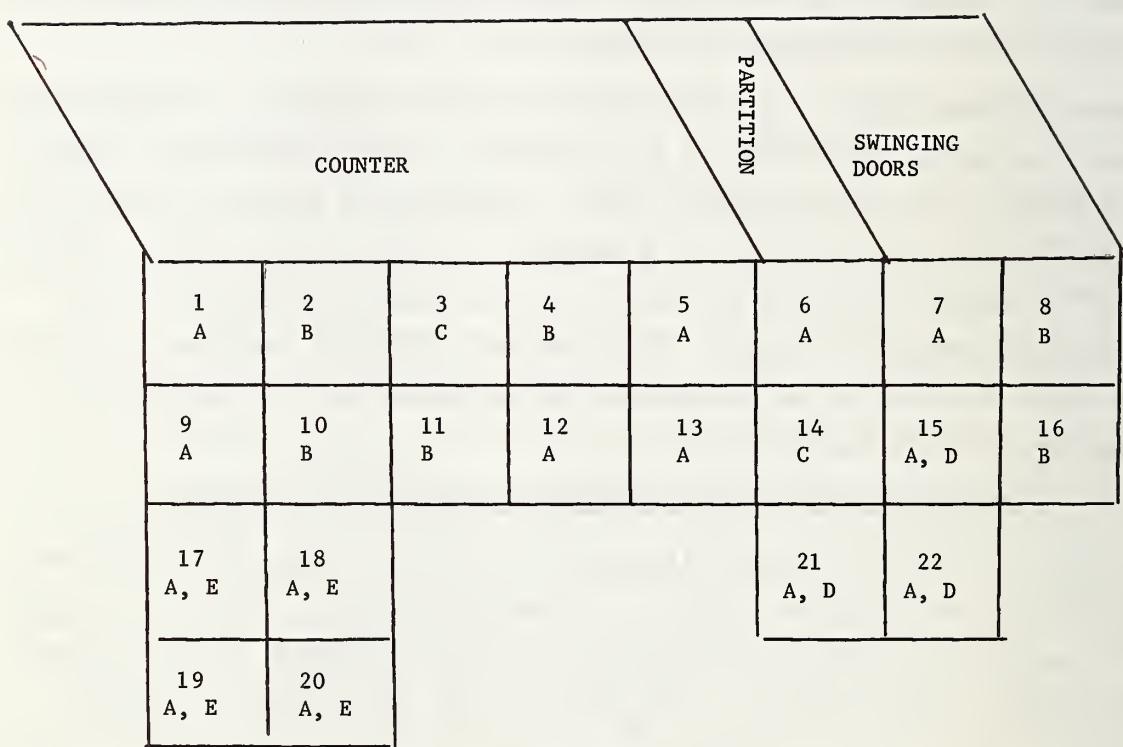
Figure I. Computer Test Area Flooring Layout

A test of resilient floor tiles was performed in front of the counter, partition, and swinging doors of a computer facility. The area behind the counter, partition, and swinging doors is occupied by the equipment and staff of the facility. The test area is illustrated in Figure I.

In Figure I, the access panels covered with test tiles are numbered and the test tiles are indicated by letters A through E. The original tile corresponds to letter A. The 2-foot square access panels, covered with 12-inch square vinyl tiles were installed in May 1967. After two years of service, the tile appeared scratched and scuffed and were somewhat hard to clean. Following is a table of the kinds of resilient tiles used in the test area and the dates of the installation:
