# Fire Tests of Wood-Framed Walls and Partitions With Asbestos-Cement Facings

United States Department of Commerce  
National Bureau of Standards  
Building Materials and Structures Report 123

Nolan D. Mitchell

Issued May 10, 1951

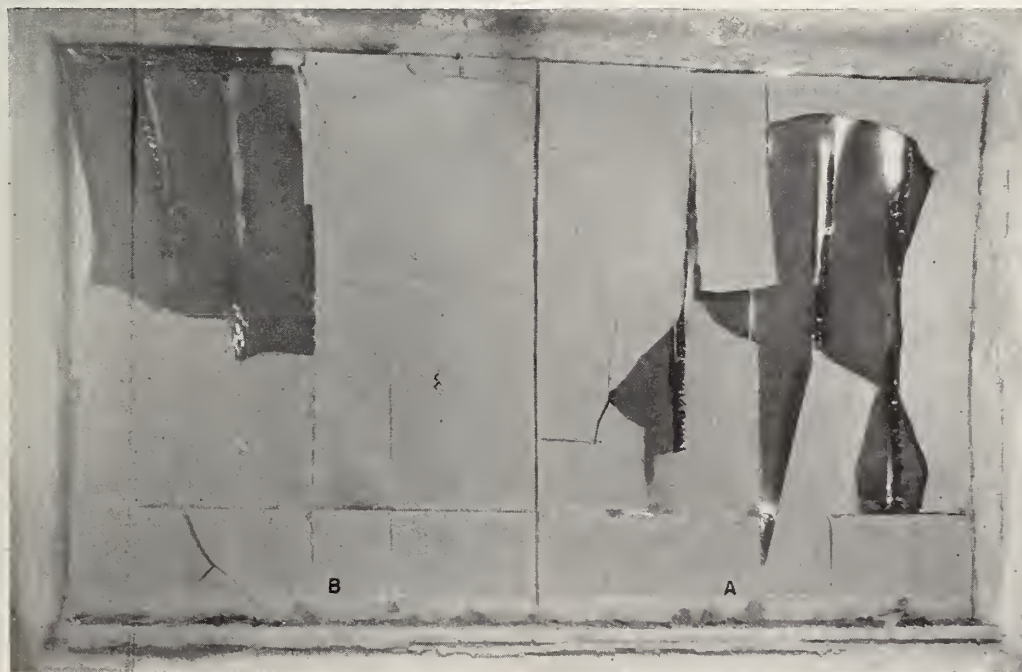
The limiting temperature rise of 250 deg F (139 deg C) on the unexposed face of this partition, test 1, was reached at 9 min for section B, and at 10 min for section A. The limiting rise of 325 deg F (181 deg C) at one point on the surface was reached at 10 min for both sections A and B. At a joint on the unexposed surface, where one sheet had bulged away from the stud, flames appeared at 27 min after the start of the fire. Glow, which was observed on the chair rail of section A at 36 min, developed into flame at 39 min. Other data for tests 1, 2, and 3 are shown in figure 3. Load failures of sections A and B occurred at 35 and 38 min, respectively.

Although buckling of the sheets on the fire-exposed side pulled them loose from the nail heads for lengths up to 30 in. along a few studs, only two sheets broke up to the time that failure under load occurred (see fig. 5). Buckling of sheets on the unexposed side also pulled nail heads through in a few locations, but no breaks were observed in this test before the load failures. The deflections of the midpoints of the two sections A and B were 2.2 in. and 1.8 in., respectively, at 30 min after the start of the test.

FIGURE 5. Exposed side of asbestos-cement sheet-faced partition, no insulation, after failure under fire and load. Test 1.

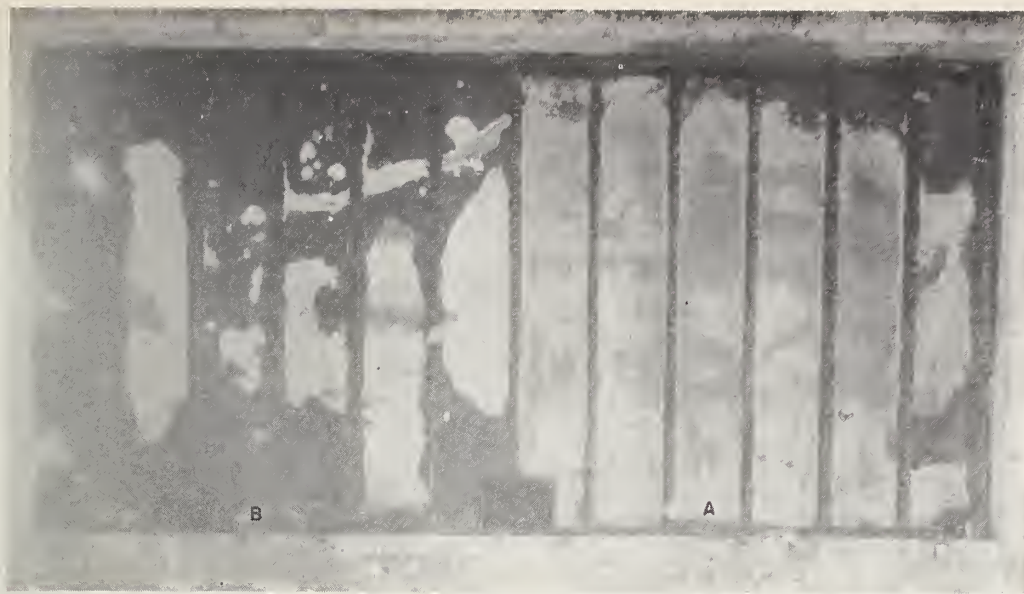
Fire and hose-stream test 3, made with a partition construction similar to that of test 2, resulted in the dislodgment of the sheets from the fire-exposed side when subjected to the impact of the hose stream after a 45-min exposure to fire. However, no hole through the partition developed nor did any other type of failure occur (fig. 6). Section A of this partition faced with 3/8-in. gypsum boards and 3/16-in. asbestos-cement sheets is considered to have qualified for a fire-resistance rating of 1 hour, combustible for both load-bearing and nonload-bearing partitions. As a load-bearing partition, section B, with facings of 1/2-in.-thick gypsum wallboards and 3/16-in. asbestos-cement sheets, by the same criterion qualified for the rating 1¼ hours, combustible, and as a nonload-bearing partition, 1½ hours, combustible.

FIGURE 6. *Exposed side of partition with gypsum sheathing under asbestos-cement sheets after 45 min exposure to fire followed by hose stream. Test 3.*

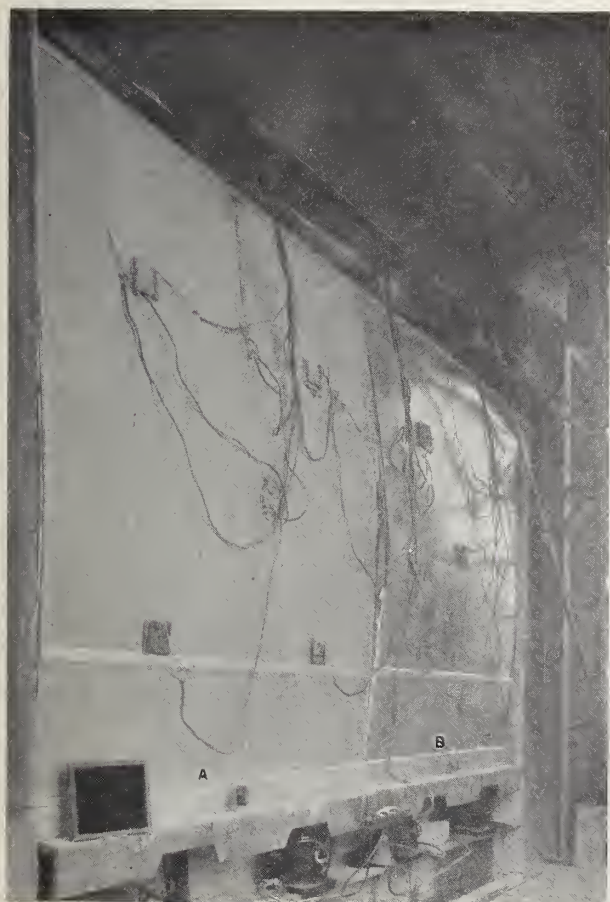
The partition in test 4 failed under load at 40 and 46 min for sections A and B, respectively. The limiting rise of surface temperatures was reached at 42 min at one point on section A, and the average rise on section B was reached at 46 min. The limiting rise of 250 deg F (139 deg C) as the average of five locations on the surface of section A occurred at 48 min. Glow was observed on the surface of section B at 46 min.

FIGURE 7. *Unexposed side of partition with mineral-wool fill after failure under load. Test 4.*

At 30 min after the start of the test, the midpoint of section A had deflected 2.2 in. away from the fire. The corresponding deflection of section B was 2.0 in. Each had deflected 1.4 in. farther at 36 min and another inch at 40 min.

A partition of similar construction except for asbestos-paper lining on the edges of the studs of one section (test 5) failed in 1 min from impact of the hose stream following a 30-min exposure to fire. The impact of the stream forced the sheets off the countersunk nail heads of the unexposed surface, the sheets having been broken and dislodged very quickly from the fire-exposed surface on application of the stream. The depth of char observed on the edges of the studs toward the fire varied from  $\frac{1}{2}$  to  $\frac{3}{8}$  in., and was estimated to average about  $\frac{3}{4}$  in. This resulted from a 30-min exposure of the wall to fire. No noticeable effect was observed in the asbestos paper on the edges of the studs, probably because the fire exposure was terminated before any limiting criterion of fire resistance was attained (see fig. 7).

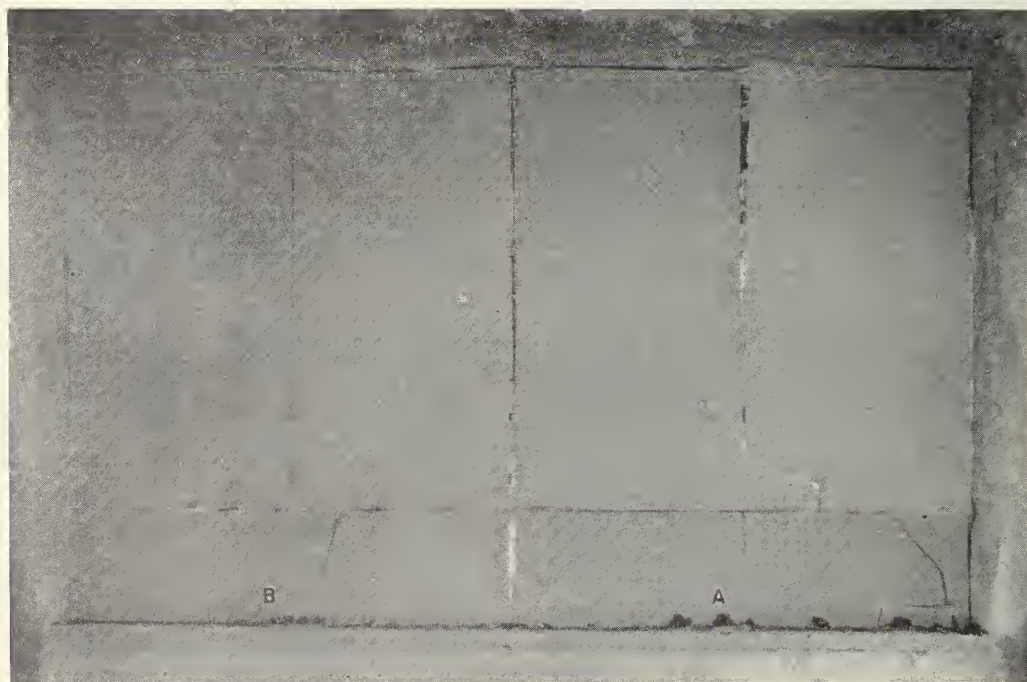
After the first 13 min of test 6, only section A of the partition was subjected to load and that to the extent of 210 lb/in.<sup>2</sup> of the wood studs. After the fire exposure of 1-hr 32-min duration had been terminated, and the pump that had failed was repaired, section A was subjected to a load of 13,750 lb, or 332 lb/in.<sup>2</sup> of the studs, and section B to 14,200 lb, or 344 lb/in.<sup>2</sup> of the studs, before failure occurred.

Failure by a temperature rise of 325 deg F (181 deg C) at one point of section A of the partition of test 6 occurred at 1 hr 19 min and on section B at 1 hr 22 min. The limiting rise of 250 deg F (139 deg C) as the average of five locations was reached at 1 hr 23 min on section A and at 1 hr 31 min on section B. Deflections of the midpoints of sections A and B toward the fire at 1 hr 25 min were 0.6 and 0.7 in., respectively. There was only minor cracking of the facing sheets on the unexposed surface. Figure 8 shows the face of the partition after 1-hr 32-min exposure to fire.

FIGURE 8. Partition with mineral-wool fill and gypsum-board strips on edges of studs. Fire-exposed face after 1 hr 32 min. — Test 6.

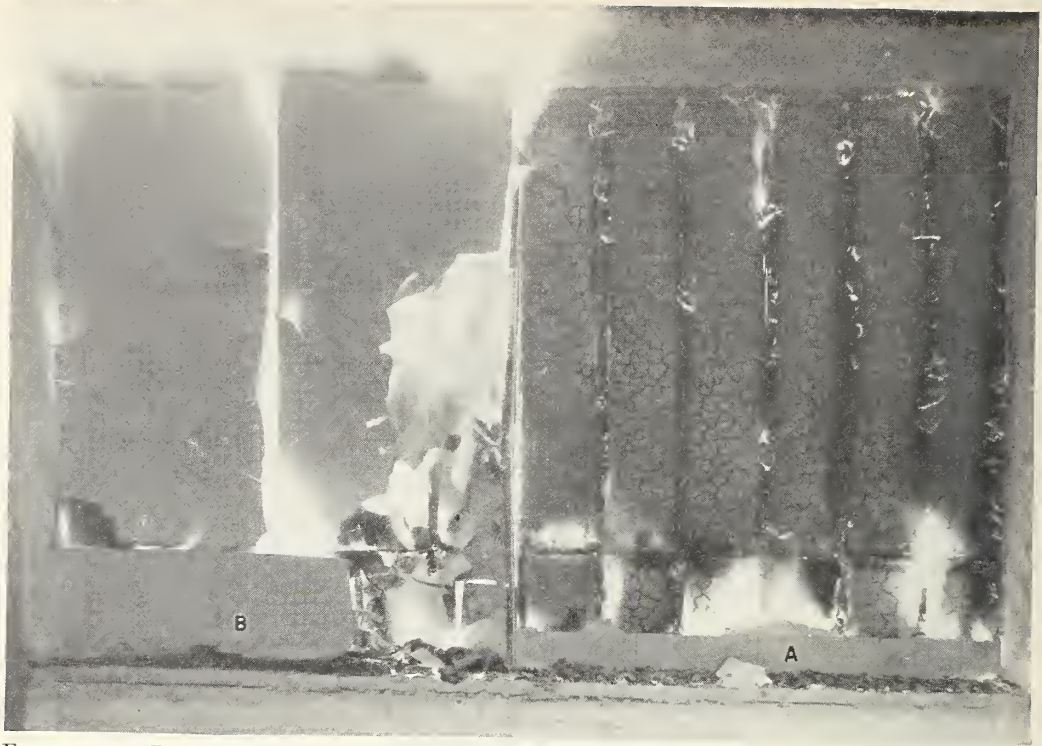
The wall having the interior facing of a composite insulated sheathing board and with no mineral-wool fill between studs, nor strips of gypsum-board lining the edges of the studs (test 8), failed in section B after a 32-min exposure to fire and in section A after a 34-min exposure (see fig. 11).

FIGURE 11. *Fire-exposed face of wall with composite insulated sheathing board, no mineral-wool fill between studs. Test 8.*

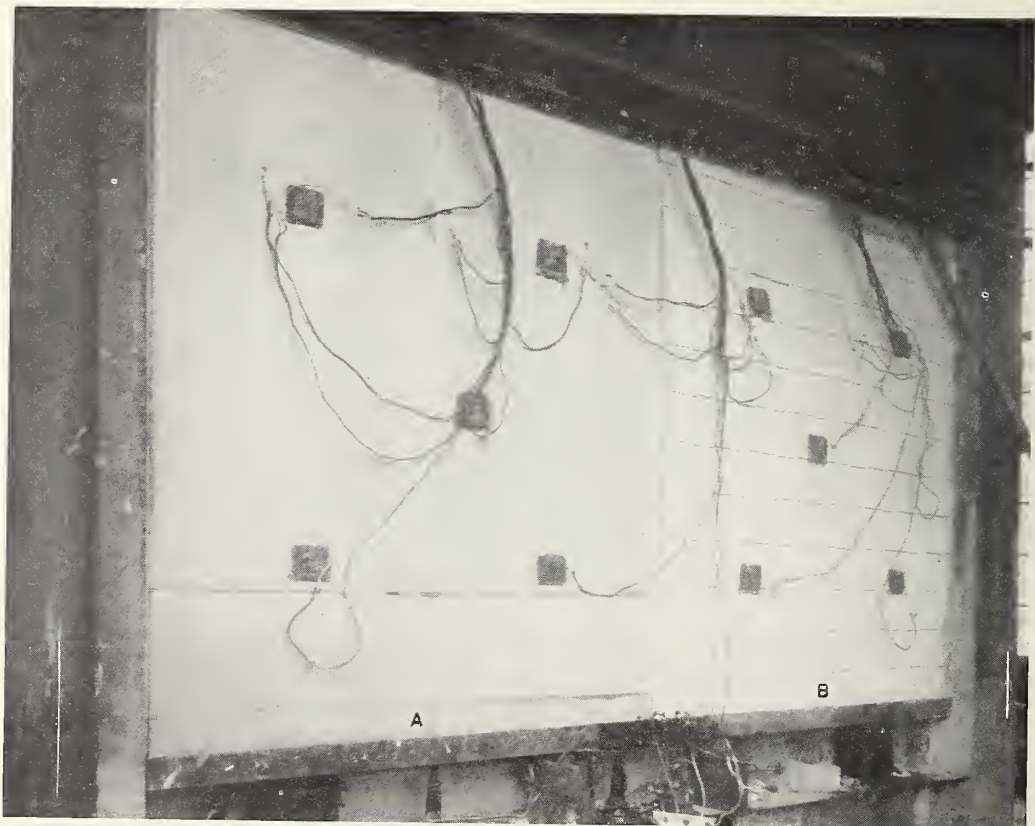
The wall having the edges of the studs lined with 4-in. by  $\frac{3}{8}$ -in.-thick gypsum-board strips before the asbestos-cement sheets were applied, and with a single-layer fill of full-thick batts of mineral wool weighing 1.05 lb/ft<sup>2</sup> (test 9) failed under load in section B after a 42-min exposure and in section A after a 51-min exposure to fire. Fully two-thirds of the cross-sectional area of the studs

was charred in the 1-hr fire-exposure period. The deflection away from the fire of the midpoint of section B was 1.9 in. at 36 min, and of section A, 2.9 in. at 45 min (see fig. 12).

FIGURE 12. *Unexposed face of wall with mineral-wool fill, after 42 min of fire endurance. Test 9.*
