Investigations of Near-Edge Ballistic Impacts on Law Enforcement Body Armor

Kirk D. Rice, Amanda L. Forster, Michael A. Riley,
and Nicholas G. Paulter, Jr.

September 2014

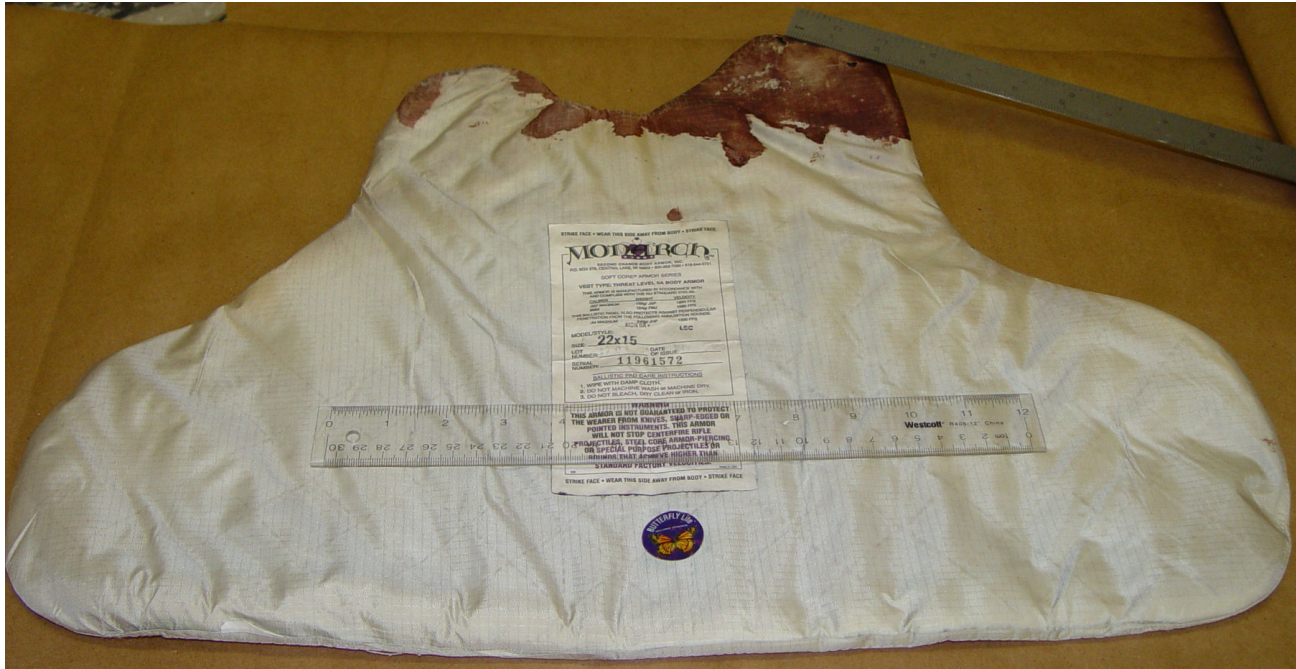
Figure 2.1: Strike Face (Front) of Panama City Beach Armor Ballistic Panel.

Although it was not documented in writing, it was understood from discussions with law enforcement personnel that the officer was leaning over to look into the vehicle at the time he was shot. The bullets impacted his armor high up on the left shoulder, between the neck scoop and where the armor terminates for the left arm. This can be observed in the photograph of the strike face of the armor panel in Figure 2.1.

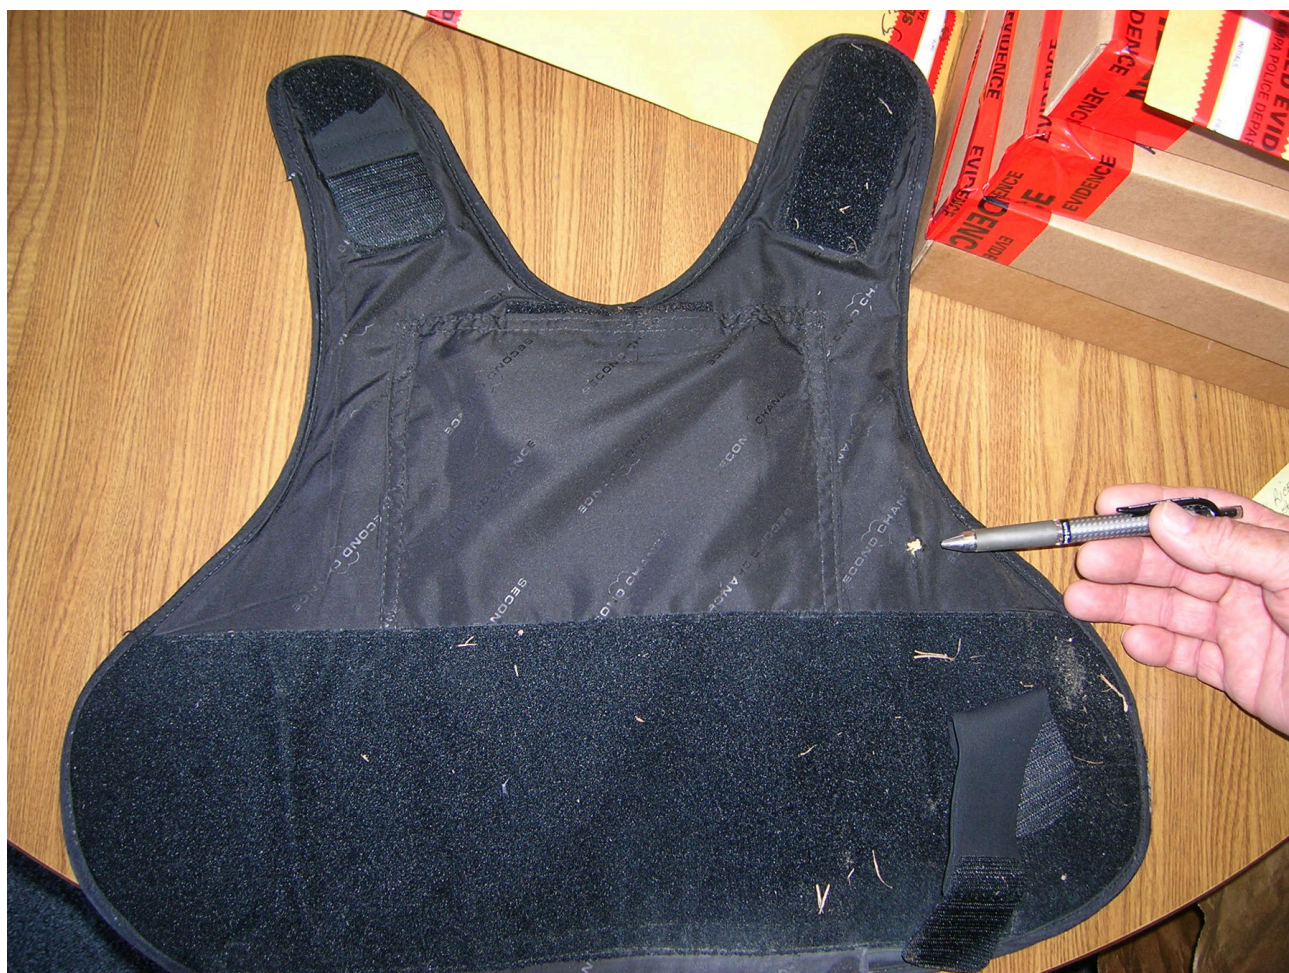
Figure 2.6: Front of Tampa Armor with Bullet Entry Hole Indicated.
Photograph provided by Tampa Police Department

According to a representative of the Tampa Police Department, the bullet struck in the center of the officer's left breast pocket, passed through the center of a small spiral bound notepad in that pocket, and entered the body armor. Given how a uniform shirt fits over the armor carrier, this meant the bullet struck the body armor approximately 32 mm (1.25 in) from the armor panel edge near the lower left underarm area. The location where the bullet perforated the armor carrier can be seen in Figure 2.6. Since the bullet struck at a wide angle, with the direction of flight angled outward toward the edge of the armor panel, the bullet exited near the edge of the armor panel and entered the officer's torso somewhere between his left breast and underarm. The location where the bullet exited from the armor can be seen in the photograph in Figure 2.7.

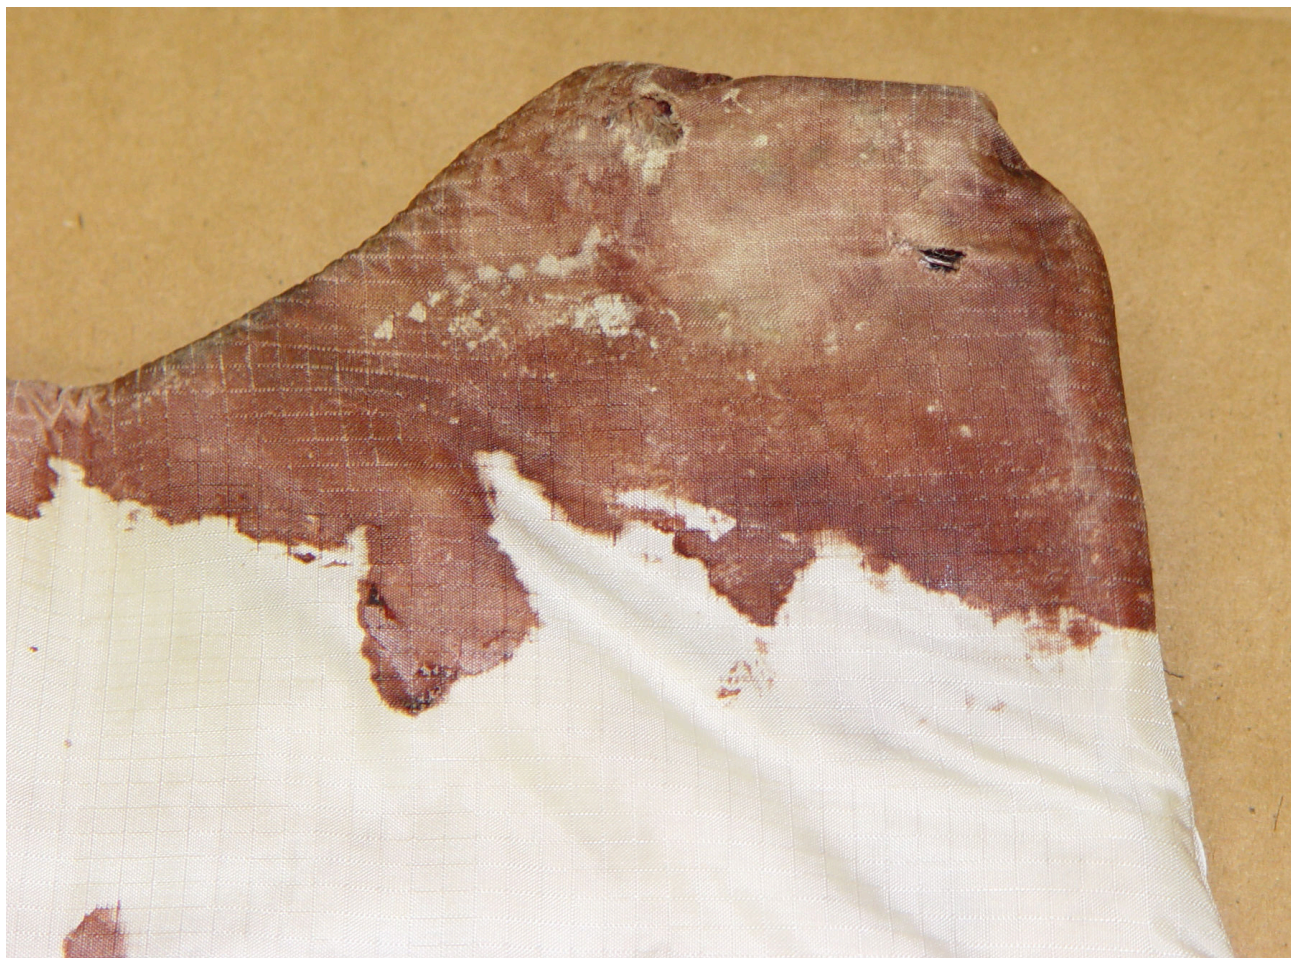
Figure 3.1: Entry Holes on Upper Left Shoulder of Panama City Beach Incident Panel.

The location of the entry holes on the ballistic panel cover may be seen in Figure 3.1. These two bullet impact locations will be described as *neck-side* and *arm-side*, because one shot was located close to the armor edge nearer to the neck, while the other shot was located closest to the armor edge nearer to the arm. The visual examination also revealed that both bullets exited the body side of the armor panel covering. The damage to the body side of the ballistic panel can be seen in the photograph in Figure 3.2.

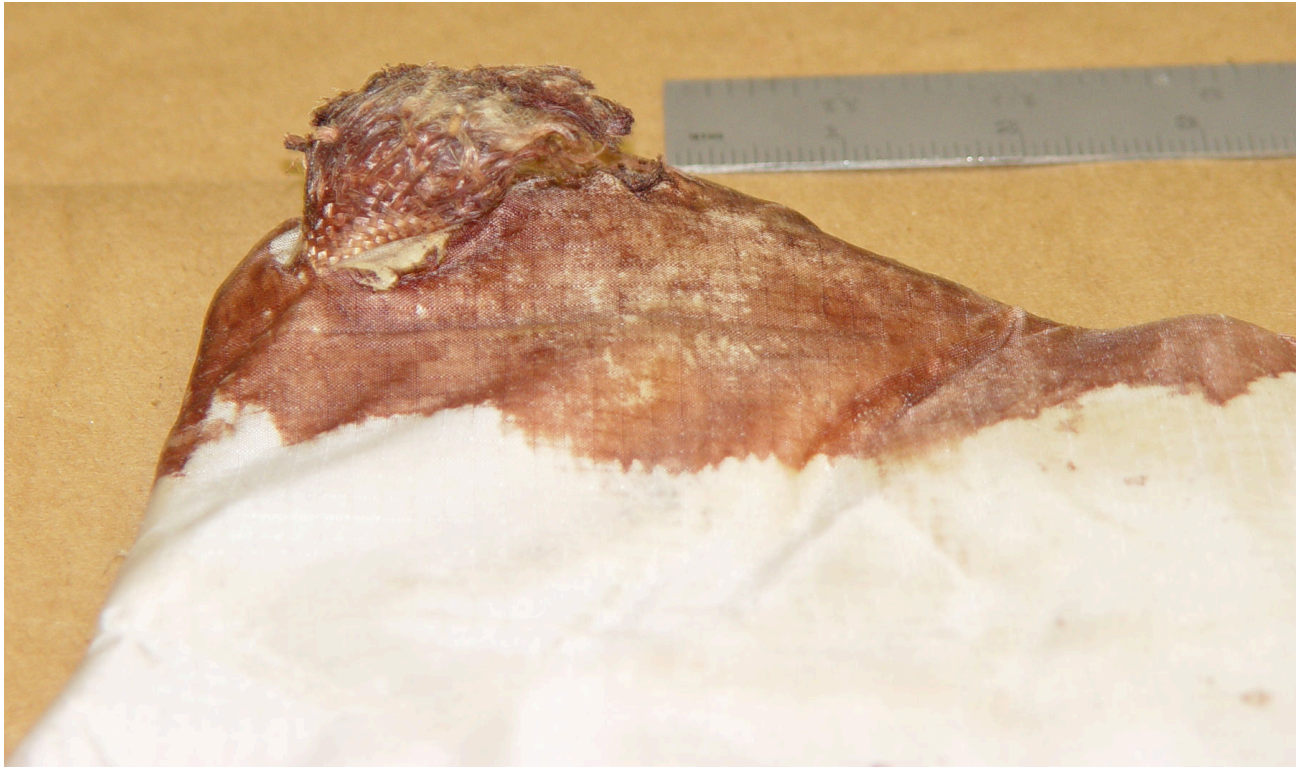
Figure 3.2: Exit Holes on Upper Left Shoulder of Panama City Beach Incident Panel.

The back of the incident panel revealed that the neck-side hole appeared to be relatively clean, with no indication of any material extruding out the back of the panel. The arm-side hole revealed a significant amount of extrusion, with a large tuft of ballistic fibers protruding, as can be observed in Figure 3.2. The extruded fiber lengths were generally between 13 mm (0.5 in) and 25 mm (1.0 in). The fibers formed a tightly clustered tuft of approximately 25 mm (1.0 in) diameter. The lack of any material extrusion from the neck-side hole suggests that little to no ballistic-resistant material was engaged by the bullet that perforated that location. When a perforation occurs in a typical laboratory test, ballistic-resistant material is driven rearward, causing some extrusion of the material through the armor panel cover and rupture of the panel cover. Evidence of ballistic-resistant material extrusion from the arm-side hole is an indicator that the bullet was engaged by the armor, but there appears to have been very little material available and a typical deformation cone would not have been able to form.

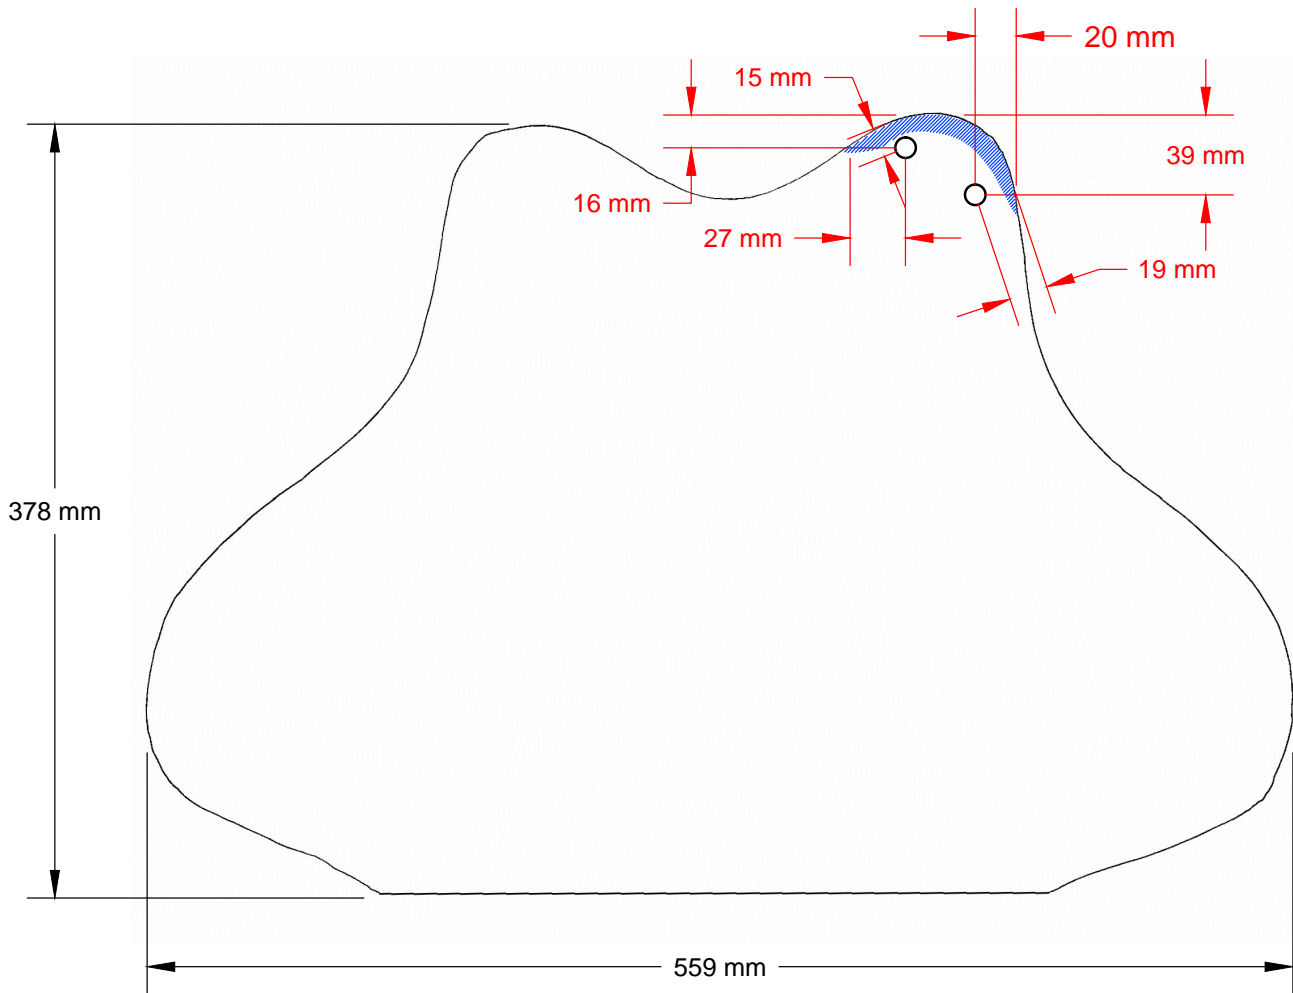
Figure 3.3: Sketch of Bullet Entry Locations on Panama City Beach Incident Panel.
(Blue hatch indicates approximate area of weave unraveling on undamaged shoulder.)

Measurements were made to characterize the position of the two bullet impact locations relative to the edge of the armor panel cover. The estimated dimensions are shown graphically on an approximate outline of the armor panel in Figure 3.3 and can be observed in the photograph in Figure 3.4. All distances measured to a bullet hole were referenced to the approximate center of the entrance hole.

The arm-side hole was located a horizontal distance of approximately 20 mm (0.79 in) from the edge, and a vertical distance of approximately 39 mm (1.5 in)

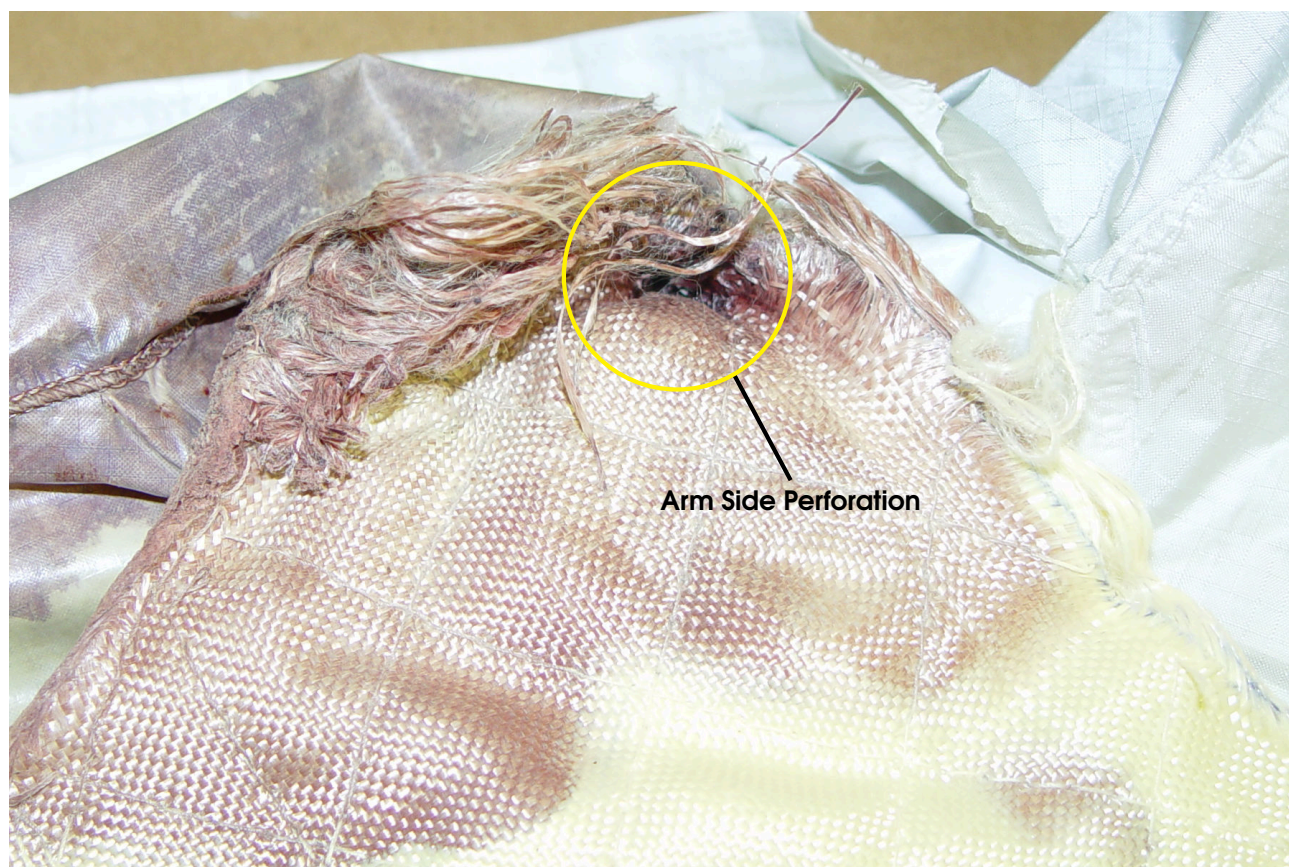
Figure 3.4: Damaged Area of Panama City Beach Incident Panel with Cover Removed.

Both shots were found to have engaged very little ballistic-resistant material that would have been bound together through the fabric weave and stitching used to construct the armor panel. Figure 3.4 shows how little ballistic-resistant material there was between the arm-side hole and the edge of the panel. A close examination of the arm-side hole revealed that the edge of the ballistic panel, proximal to the impact location, buckled and was extruded through the body side of the armor panel cover, allowing the bullet passage. The exact location of the neck-side hole in the ballistic-resistant material was difficult to determine with certainty, although it appears to have passed through the frayed and unraveled yarns at the extreme edge of the armor panel.

Generally, shots located very near an edge are unlikely to be stopped, simply because there is not enough ballistic fabric surrounding the impact location [34, 35]. This appears to be the condition that led to the perforations in this incident. The bullets that struck the armor engaged very little ballistic fabric, because they struck the armor panel at the extreme edge. There is no reasonable expectation that a conventional armor panel can perform satisfactorily when impacted in this region; therefore, the perforation of the armor at this location is not surprising.

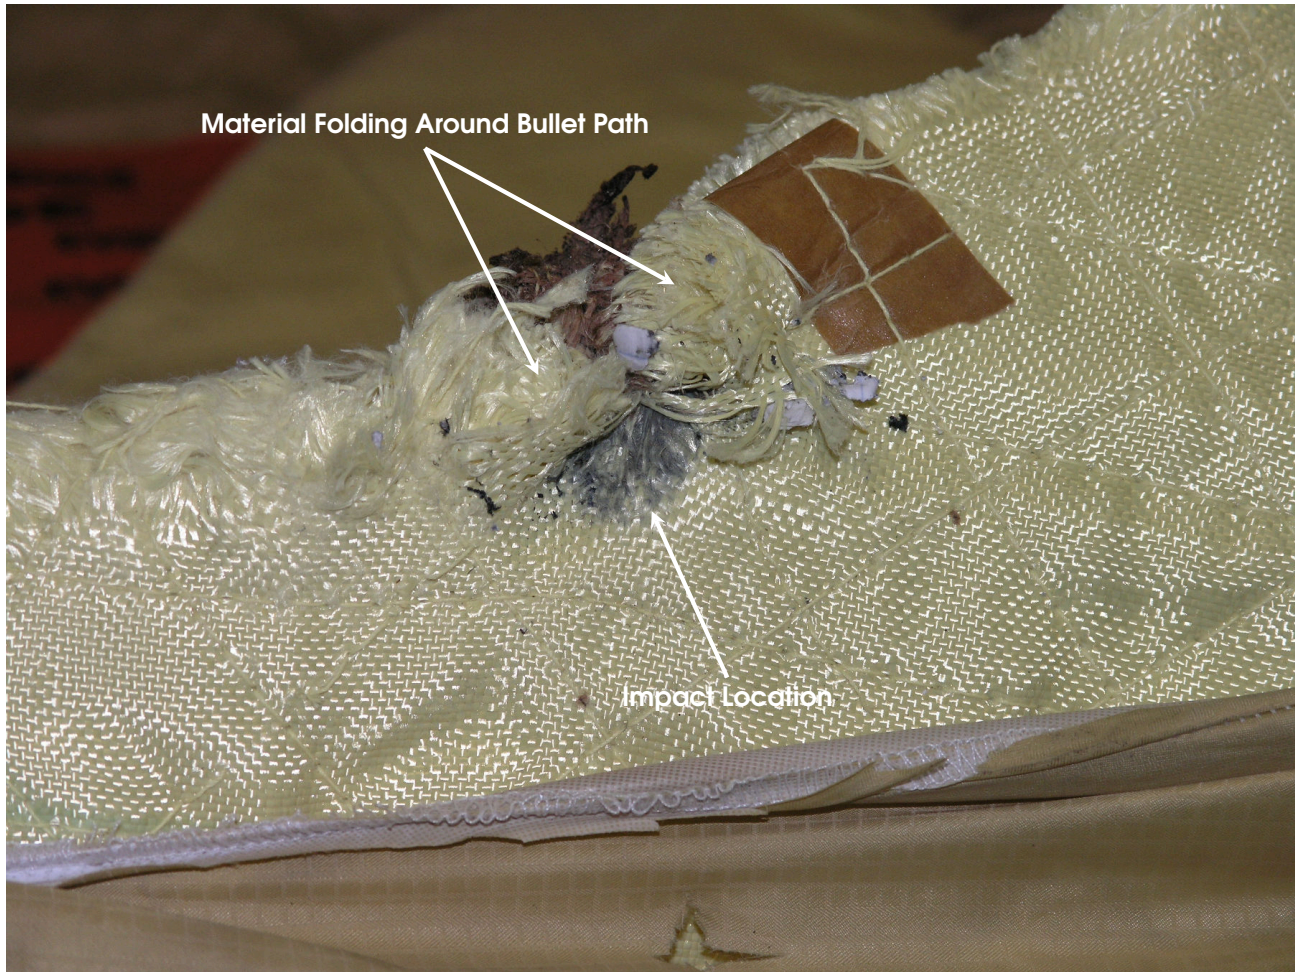
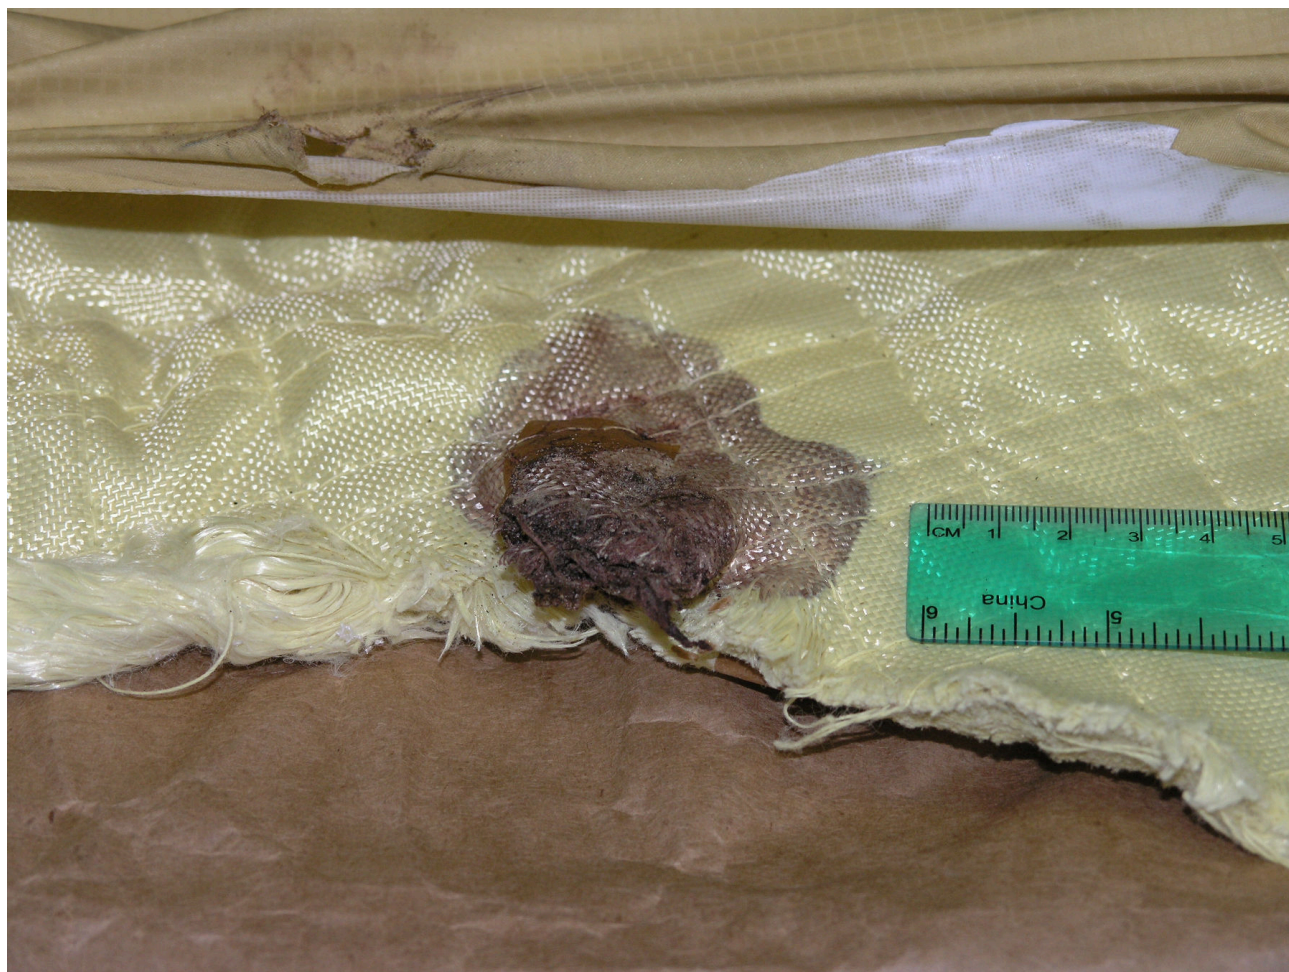
Close-up photographs of the bullet impact location on the strike face and the body side of the armor panel, with the panel cover removed, are shown in Figures 3.10 and 3.11. The body side does not indicate much about the bullet impact location, but the strike face shows that the ballistic-resistant material deformed inward while the material immediately above and below the bullet impact location deformed outward and folded around the impact site. The folds created in the armor panel over the bullet impact location are visible in the photograph (Figure 3.10). These folds create what appears to be a channel through the armor panel. This type of behavior has been observed in other armor testing with near-edge shots.

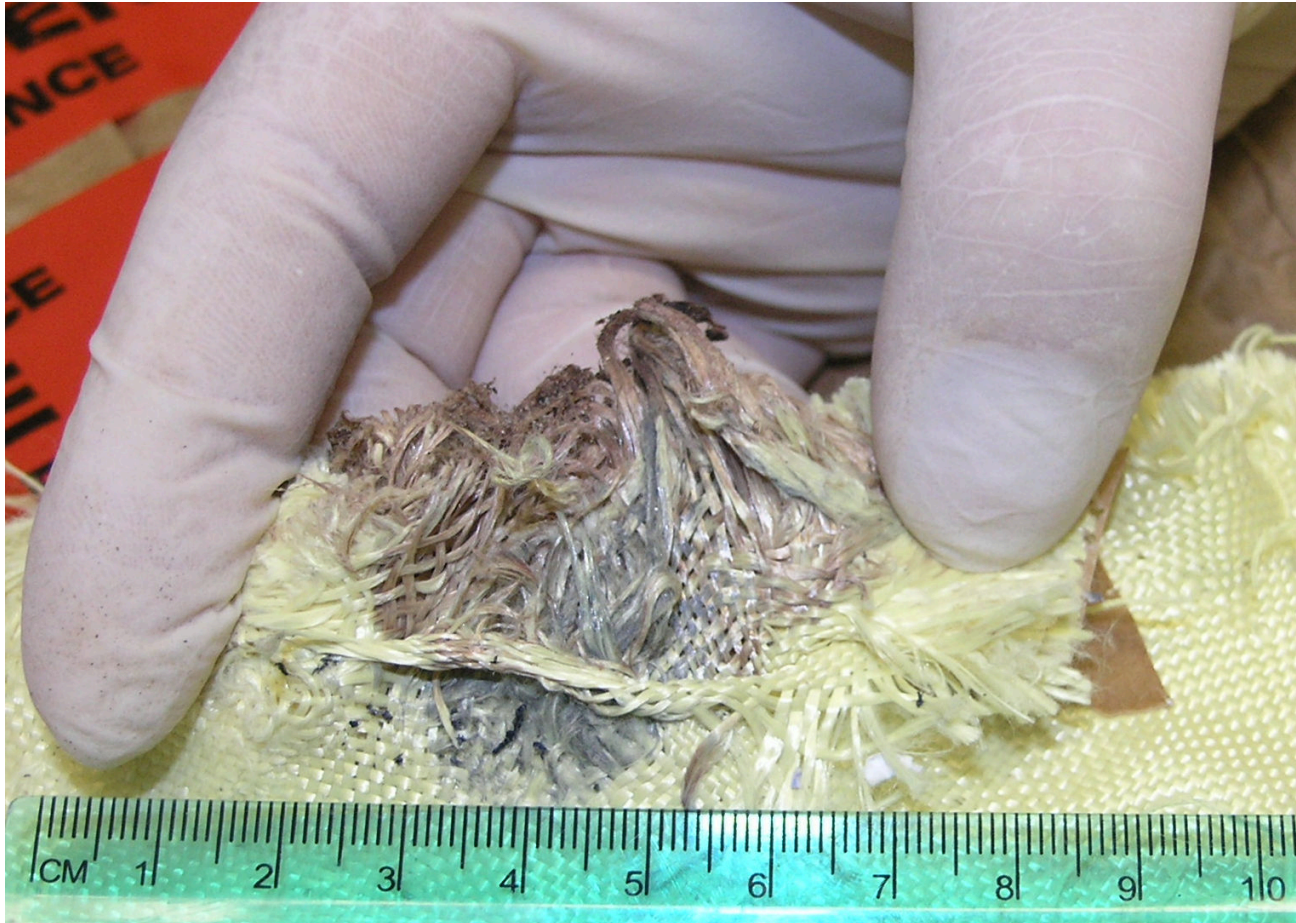
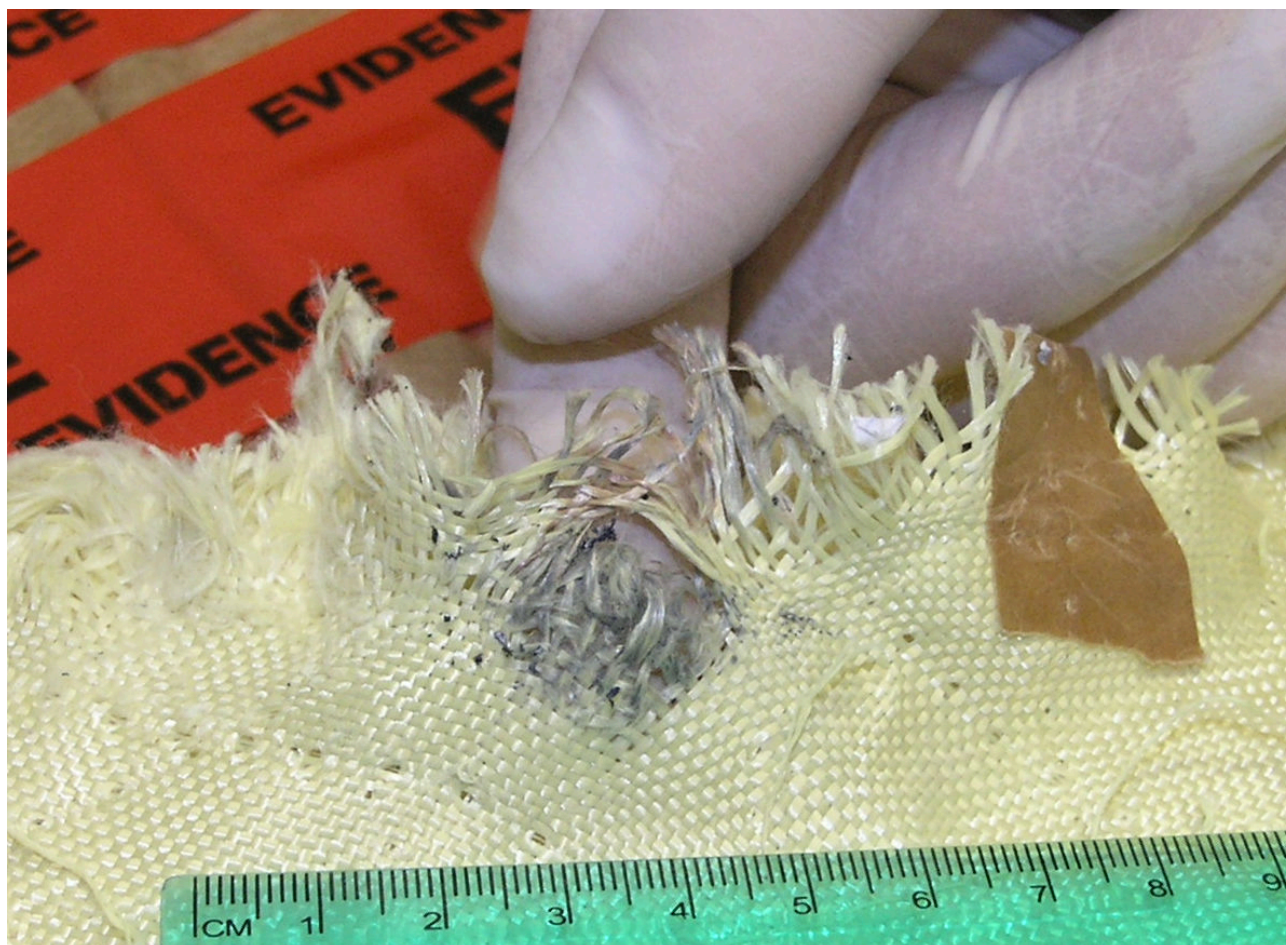
Figures 3.12 and 3.13 show the strike face (layer 1), with the ballistic-resistant material pulled flat to expose the bullet impact location. As shown in the photographs, only a small amount of woven material was available to stop or deflect the bullet at the bullet impact location. In Figure 3.13, the first layer of the ballistic-resistant material (the strike face) is separated from the underlying layers to expose the location where the bullet contacted the armor. Penetration into the first few layers is to be expected, and this type of damage is typical of

bullet impacts during armor testing. Since the bullet was a jacketed soft point, the lead core is exposed on the nose of the bullet, which produces the blackened markings on the materials, indicating the bullet path.

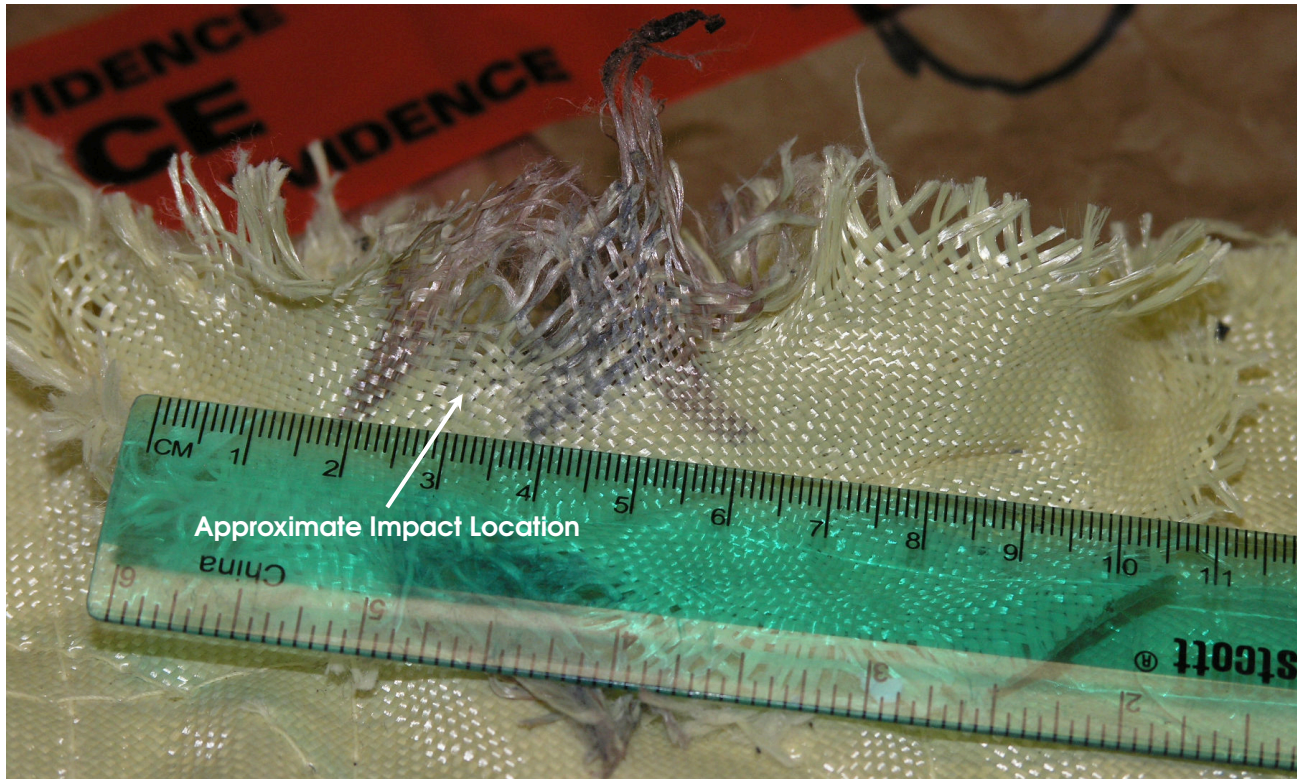
Figure 3.14: Incidence Location on Layer 2 of the Tampa Ballistic Material.

During the examination of the armor, some quilt stitching was removed in order to examine the interior layers of the ballistic panel. The photograph in Figure 3.14 shows the second layer of the incident armor from the strike face side. Layer 1 is folded back to expose layer 2. In this and subsequent photographs where upper fabric layers are folded back, the edges of those upper layers can be seen under the transparent green scale. The arrow points to a distortion in the fabric that indicates where the bullet went through, although no yarns appear to have been broken by the bullet. This situation appears to be common in near-edge shots, where the edge of the armor panel buckles due to a lack of material to stop the bullet.

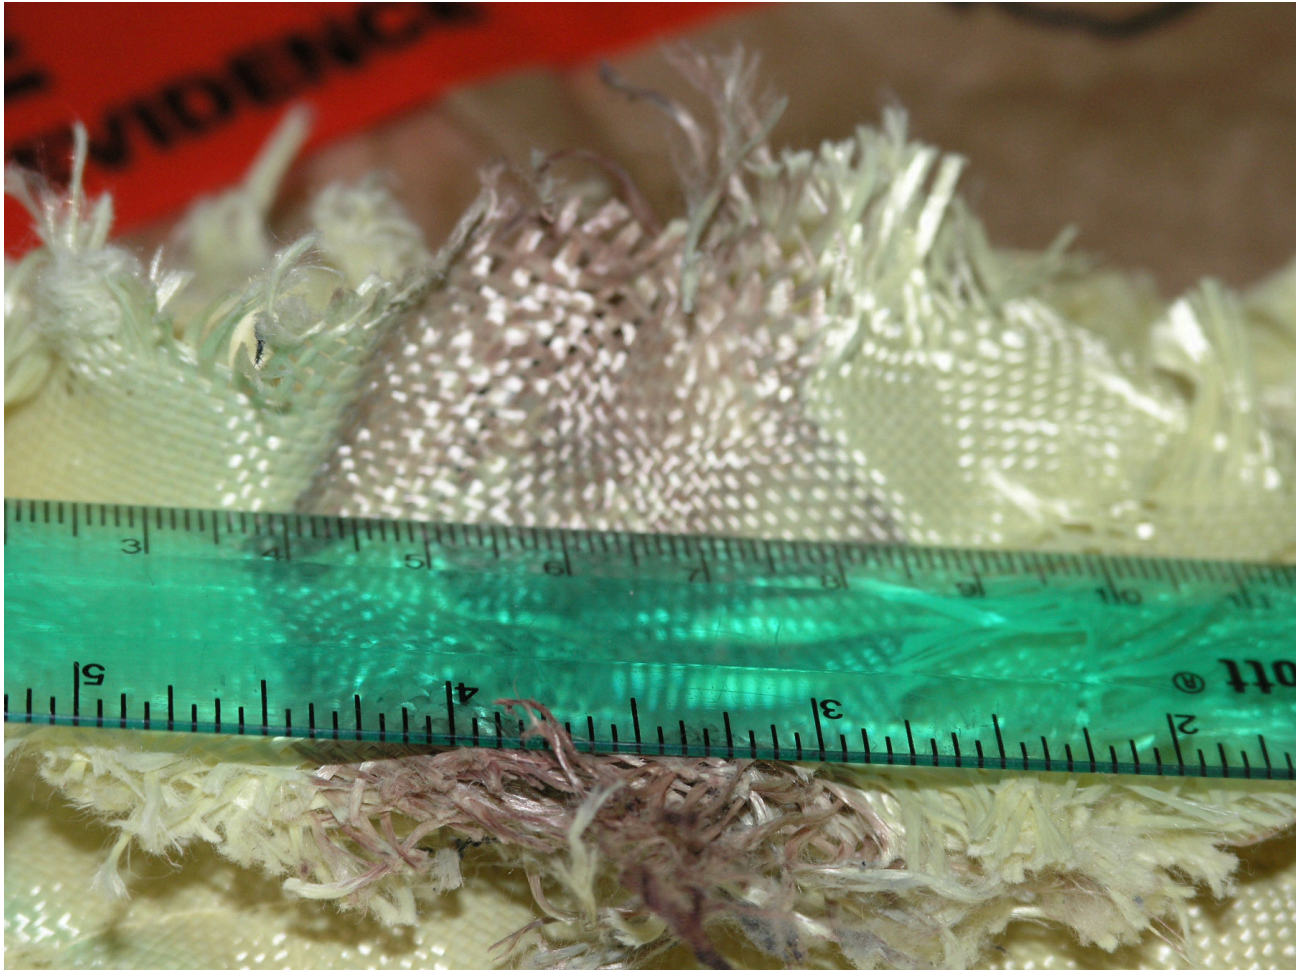
Figure 3.17: Incidence Location on Layer 5 of the Tampa Ballistic Material.

The final photograph (Figure 3.17) of the incident armor shows layer 5.

There appears to be little distortion of this layer, indicating that the bullet had likely exited through the edge of the armor panel before it reached this layer. From these observations, it appears that this near-edge, angled shot, simply slid out of the armor between layers, due to the angle and close proximity to the edge, without perforating or damaging most of the layers of ballistic-resistant material.

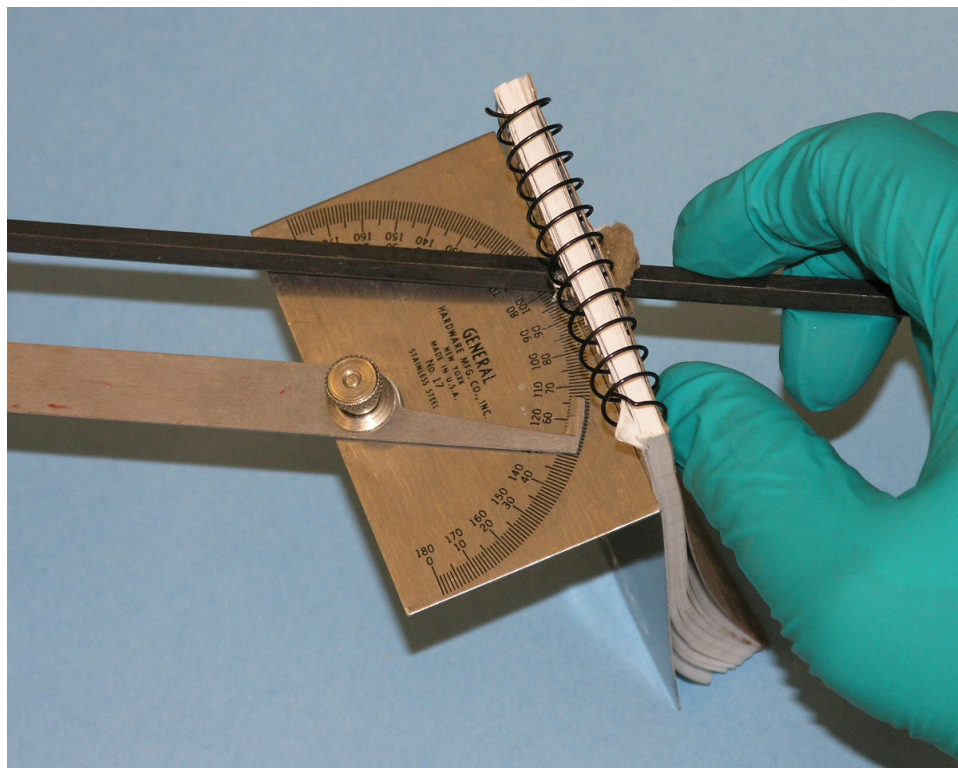
Figure 3.18: Estimation of Impact Angle from Tampa Officer's Notebook.

As described above and noted in some of the press articles [7, 5], the officer who was shot had carried a small spiral-bound notepad (top bound) in his left breast pocket. The bullet perforated the notepad prior to striking the body armor. A probe was inserted through the bullet hole in the notepad to estimate the angle of impact. As shown in the photograph in Figure 3.18, the bullet appears to have struck the notepad at an angle of approximately 30° from the perpendicular.

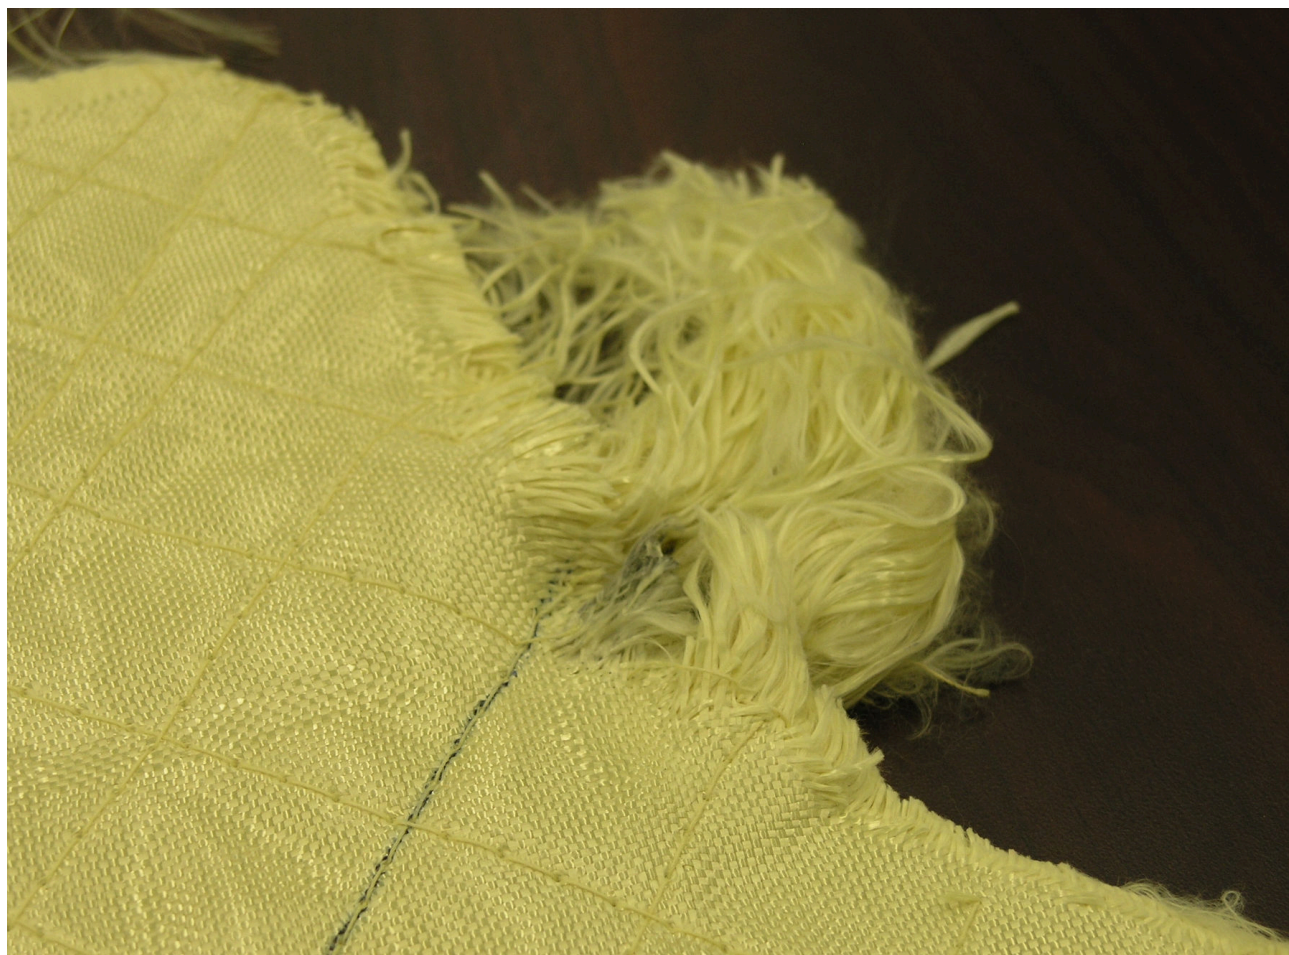
Figure 4.3: Shot Location 4 on Near-edge Impact Test Armor.

The third and fourth shots were fired at the left and right edges of the chest area of the panel, at locations that were similar to the location of the incident shot, and at an angle of 30°. Both bullets damaged the outer layers of the armor, caused the ballistic-resistant material to fold over into the BFS cavity, and exited the armor into the clay without perforating the back layers. The fourth shot, in particular, appeared to do little damage to the material, primarily bending back the panel. The damage caused by both bullets is visible in the photograph in Figure 4.2, while a close-up of the fourth impact location can be seen in the photograph in Figure 4.3.

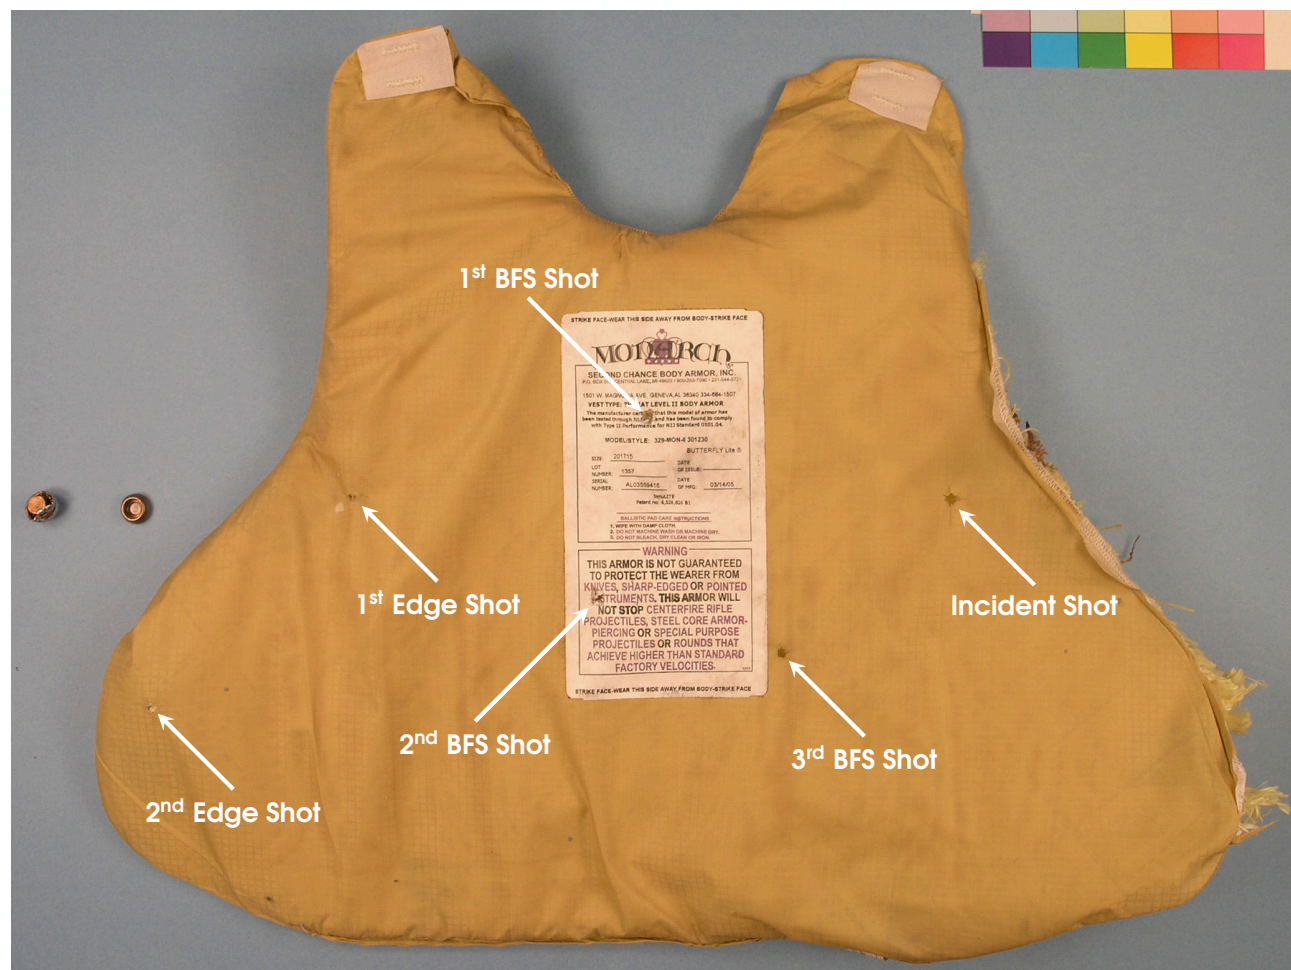
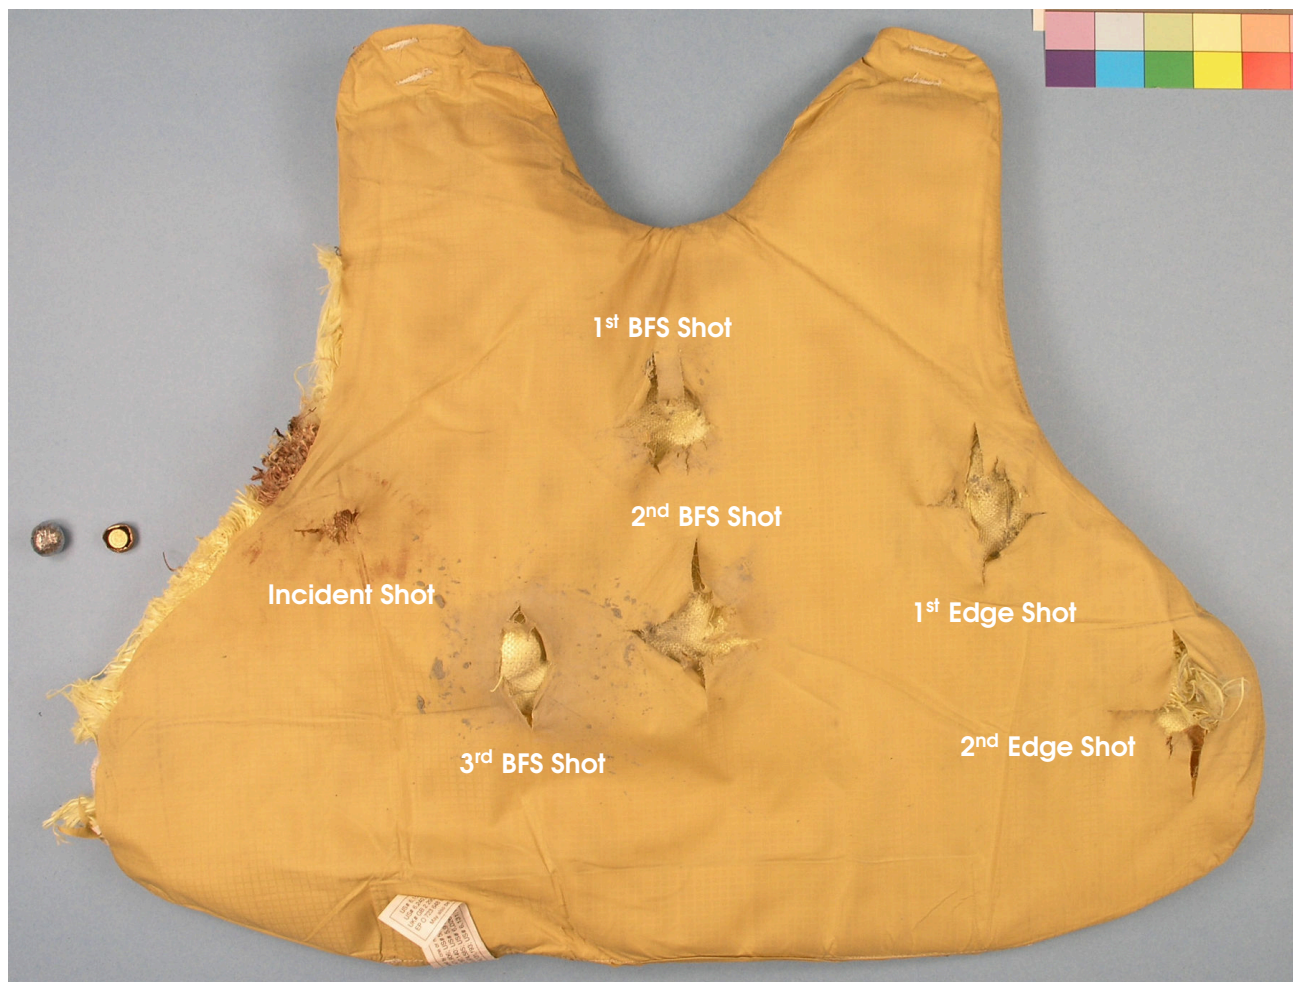
The first bullet impacted the armor on target, approximately 25 mm to 32 mm (1.0 in to 1.3 in) from the edge of the panel. The armor successfully stopped this impact, which produced 45 mm (1.77 in) BFS. The photographs in Figures 4.5 and 4.6 show where the armor was impacted by the bullet, labeled as “1st Edge Shot”, and the resulting damage to the body side of the armor panel. While this BFS exceeds the limit in the NIJ standard, as noted above, the standard test does not require impacts this close to the edge of the armor, and the depth of BFS indentations tend to increase significantly when the shot-to-edge distance is reduced.

The second bullet impacted the armor closer to the edge, approximately 19 mm (0.75 in) from the edge. The bullet damaged the first few layers of the ballistic-resistant material, before the edge of the armor collapsed and the bullet exited through the side of the armor. A careful examination of the damage showed that less than seven layers were damaged, and that the mode of damage appeared to be similar to the shot that wounded the officer. This impact location was closer to the edge of the armor than either the prior test bullet impact location or the incident bullet impact location; moreover, this impact location, near the edge of the right wing, was in an area where there is minimal surrounding material to prevent the edge of the armor from folding over. Again, the location where the second bullet struck the ballistic panel, labeled as “2nd Edge Shot”, and the damage to the body side of the ballistic panel can be seen in Figures 4.5 and 4.6.
